MM-IN-RD-9100-P06-04 Rev.2

| 出張先 Customer | Ferrotec Shanghai | 相手先 面談者 Attendance | Mr Zhang - R&D<br>Ms Julia - QC |
| 出張目的 Visit Purpose | <input checked="" type="checkbox"/> 138x190x0.38 FR Bending strenght & visual defect<br><input checked="" type="checkbox"/> 138x190x0.38 HBS2 Bending strenght & visual NG | 会議フロア アップ項目 Meeting Follow Up | <input checked="" type="checkbox"/> As attach in below table<br><input type="checkbox"/><br><input type="checkbox"/> |

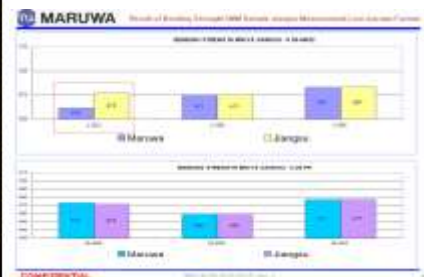
Measurement comparison between MM & Jiangsu

Topic 1 - Bending strenght failure at Jiangsu

Upon confirming the sample from MM to jiangsu. Requested Jiangsu to measure as shown in data below. The same data was key in in our system for bending strenght measurement  
 ==> Result shows all measurement are within the spec.

Explained to Ferrotec team on this status and have accepted there is an error at Jiangsu.

Both MM & Ferrotec team review the calculation method and found that MM is using the excel & Ferrotec is using the minitab.  
 Both team will check on their individual system to conclude later.

Jiangsu also have shown a sginifocant low value of bending strenght at 250 & 302. This will confirm by Ferrotec shanghai
