# Conveyor Design

# Defects Detection

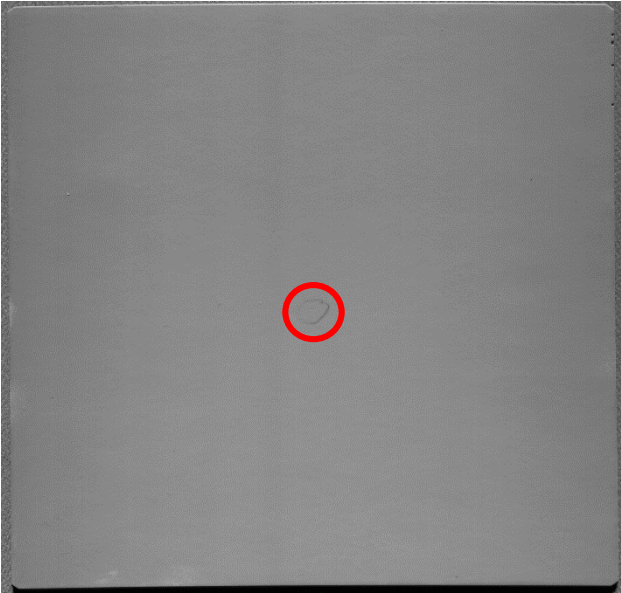
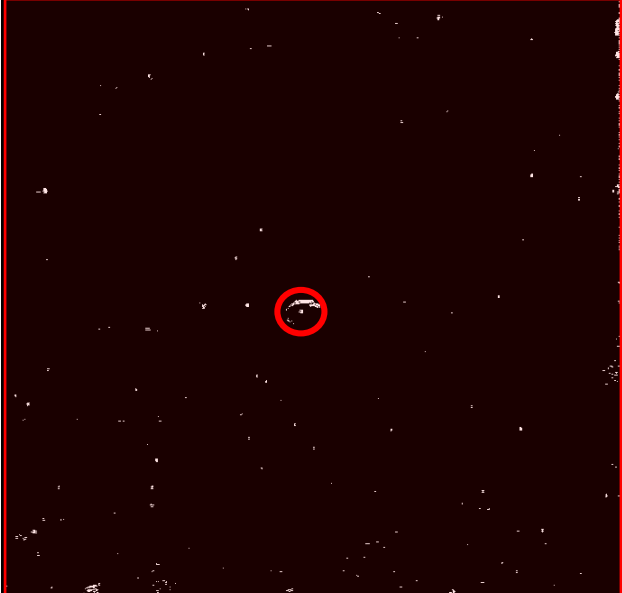
| No. | Defect Name | Unprocessed Image | | Processed Image | |
|---|---|---|---|---|---|
| 1 | Katasuki | | | | |

Can see unwanted marks due to:

- Dust
- Improper part handling (scratch, fingerprints)

- Usage of sticky roller and ionizer to remove dust
- Run part on conveyor to reduce improper handling

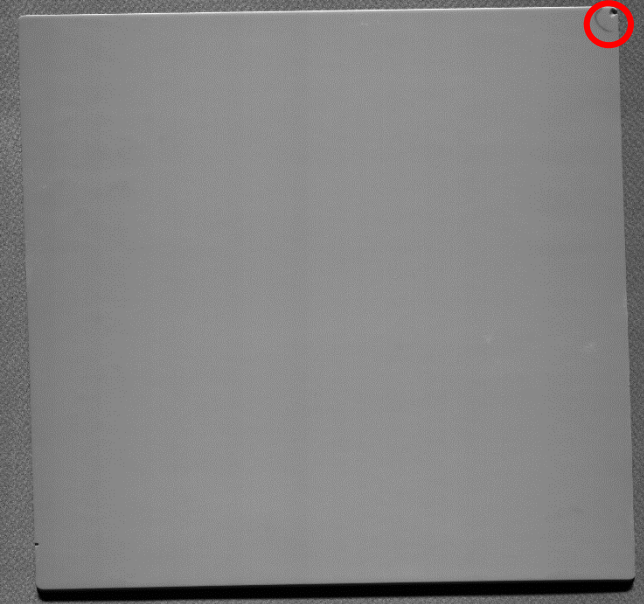
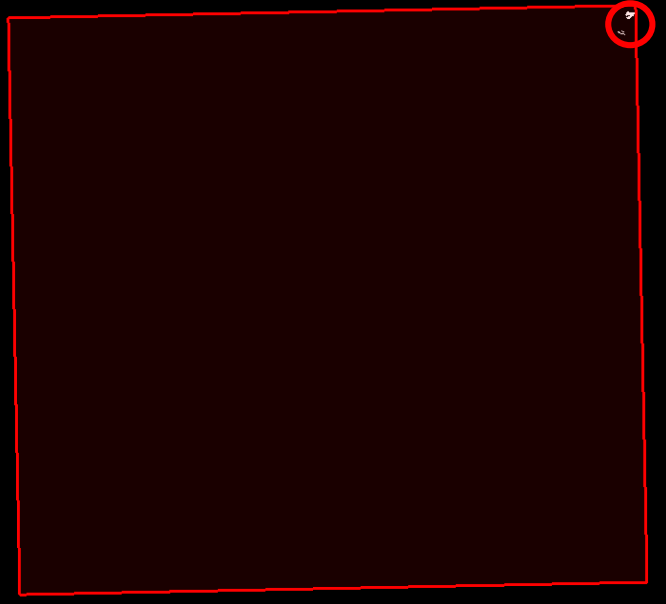
| No. | Defect Name | Unprocessed Image | | | Processed Image | | |
|---|---|---|---|--|---|---|--|
| 2 | Pinhole | | | | | | |

Can detect defect

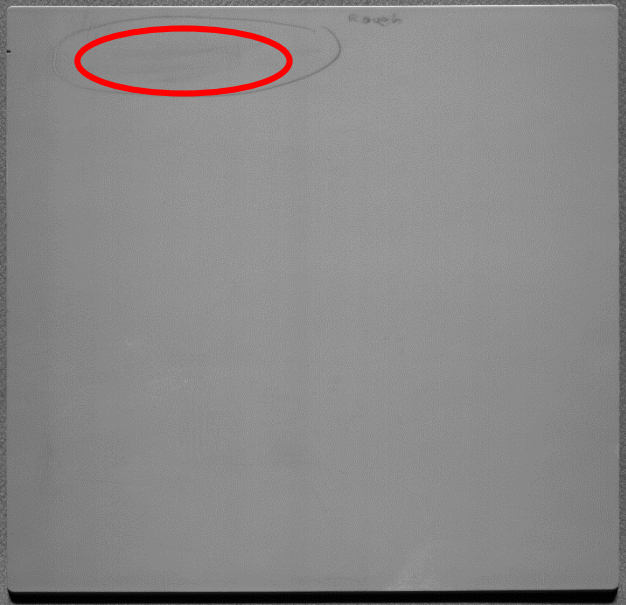
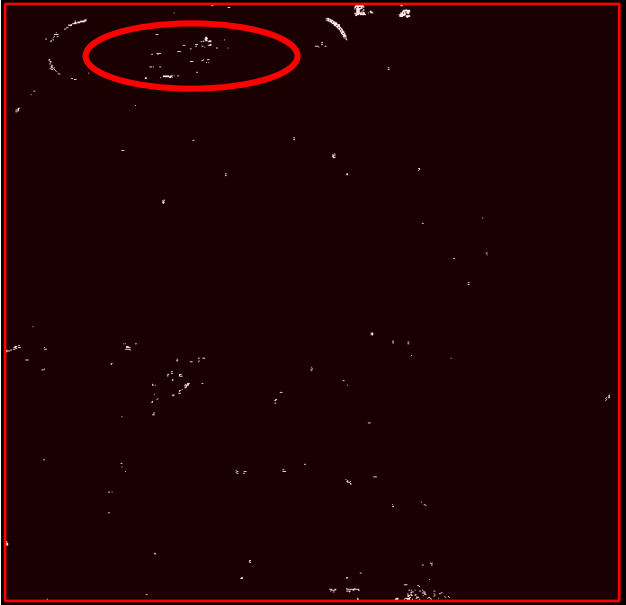
| No. | Defect Name | Unprocessed Image | | Processed Image | |
|---|---|---|---|---|---|
| 3 | Rough | | | | |

Can see unwanted marks due to:

- Dust
- Improper part handling (scratch, fingerprints)

- Usage of sticky roller and ionizer to remove dust
- Run part on conveyor to reduce improper handling

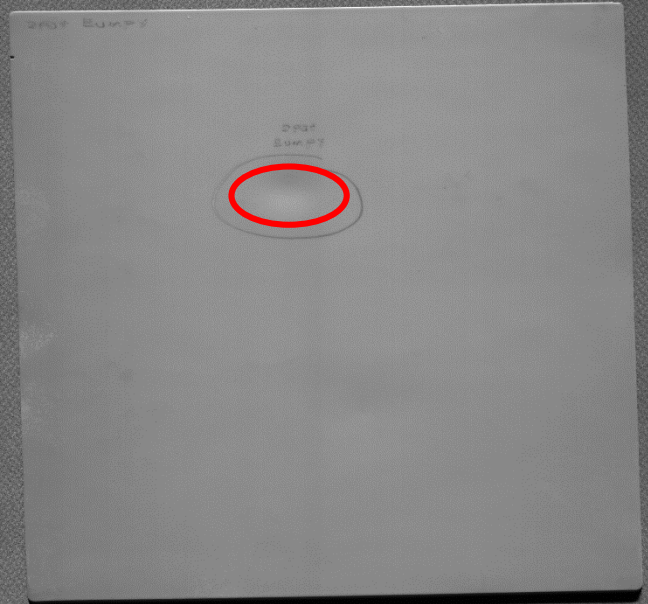
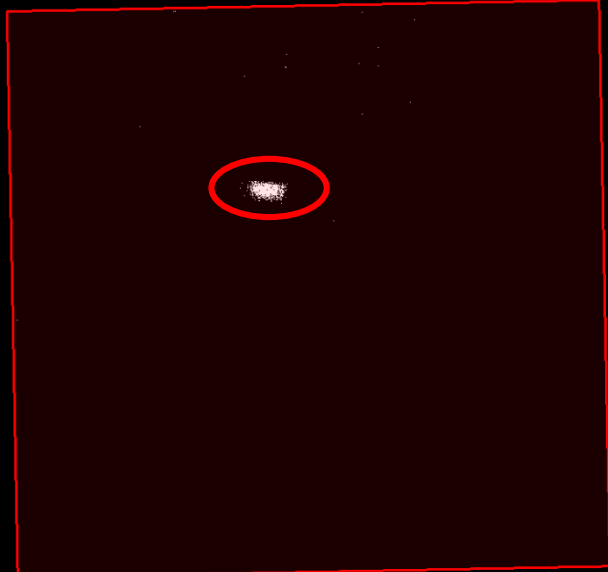
| No. | Defect Name | Unprocessed Image | | Processed Image | |
|---|---|---|---|---|---|
| 4 | Spot Bumpy | | | | |

Can see unwanted marks due to:

- Dust
- Improper part handling (scratch, fingerprints)

- Usage of sticky roller and ionizer to remove dust
- Run part on conveyor to reduce improper handling

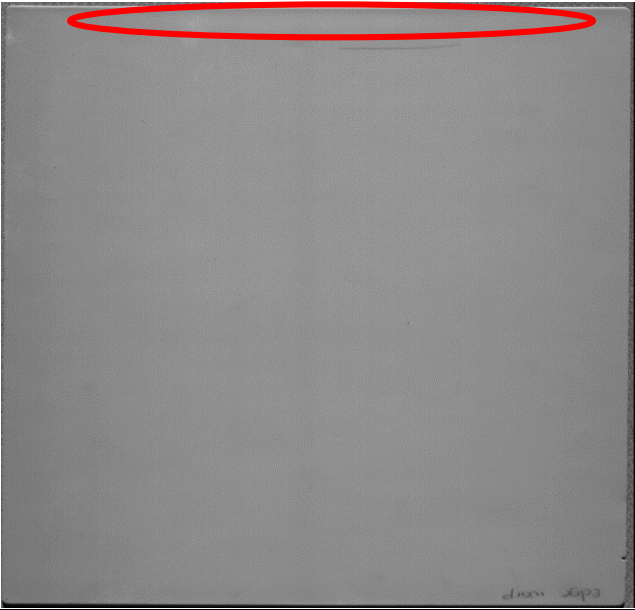
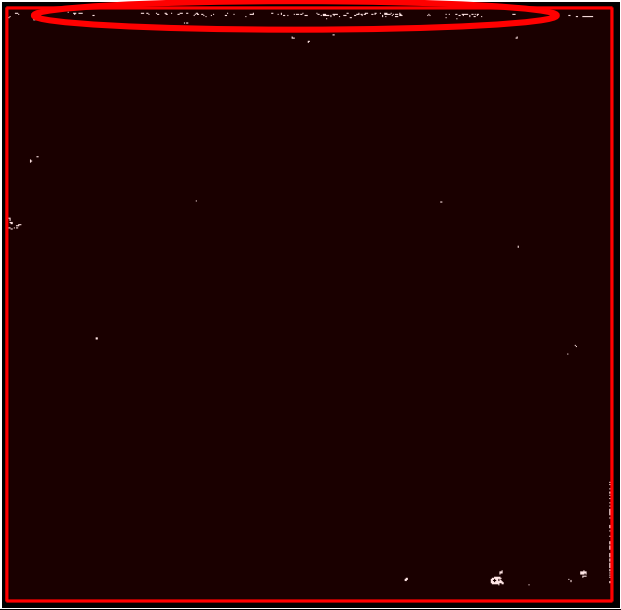
| No. | Defect Name | Unprocessed Image | Processed Image |
|---|---|---|---|
| 5 | Edge Warp | | |

Can detect defect.

- Suggestion to use 3D Laser Profiler for better accuracy

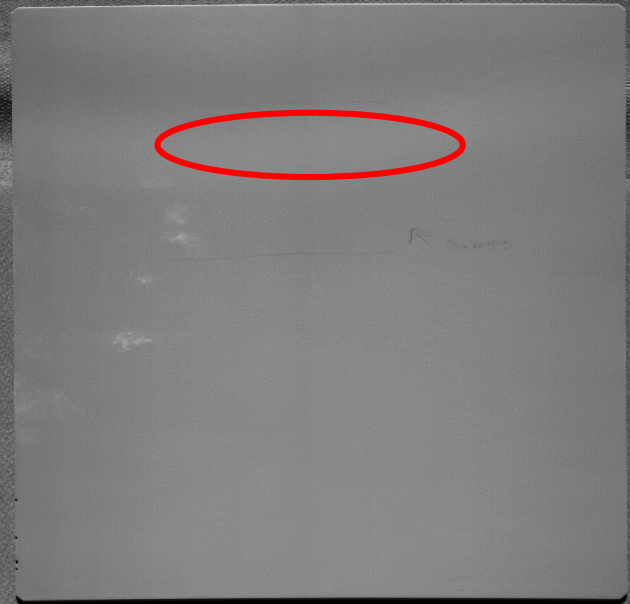
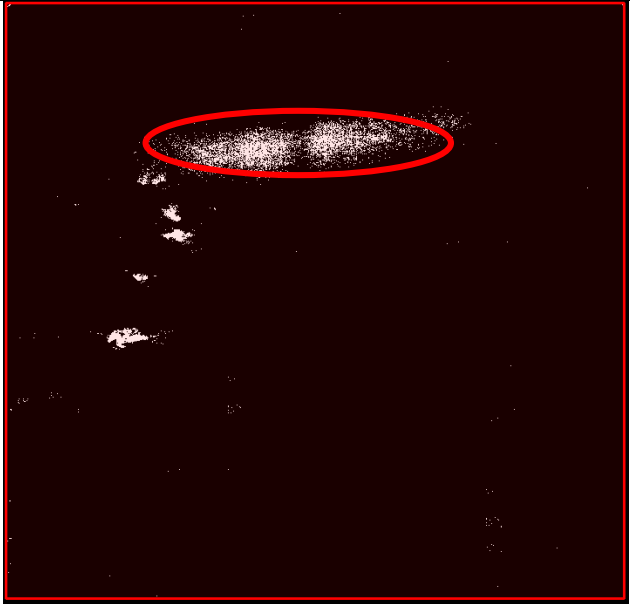
| No. | Defect Name | Unprocessed Image | | Processed Image | |
|---|---|---|---|---|---|
| 6 | Bumpy | | | | |

Can detect defect.

- Suggestion to use 3D Laser Profiler for better accuracy
