| Customer: Haemonetics Penang | | Date: 28-Nov-23 | Time: 9:00 |

1. Unground / Uneven Surface

## SEAL ROTATING CERAMIC - UNGROUND CAUSE & ACTION

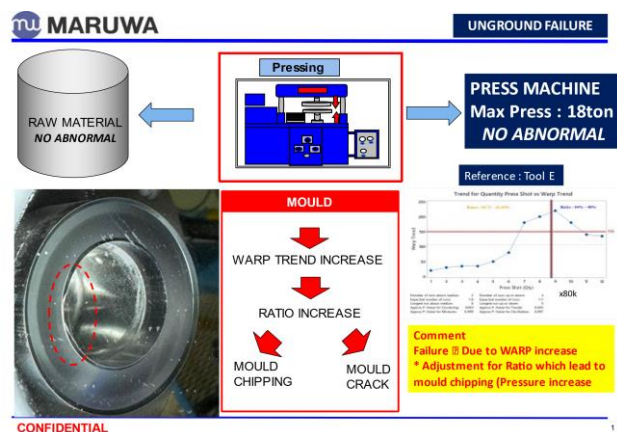
SRONG ROUNG FAILURE

| Tool | Ratio | Warp | Ingrind | Problem | Effect | Action Taken | Current condition |
|---|---|---|---|---|---|---|---|
| D | 40.57% | >150μ | 11.87 | Adjustment of Press Ratio from 40.57% ~ 42% to 50.3% ~ 52% | Mold started to chip especially at the upper punch & 2nd Lower Punch (Chamfer area) | Evaluate to get the optimal ratio condition 44% ~ 48% | Under monitoring - warp <150μ |
| E | 40.57% | >150μ | 12.79 | | | | |
| H | 40.57% | >150μ | 7.35 | | | | |

Maruwarequesting change the KPIV of Ratio spec from 40% ~ 42% ➔ 40% ~ 48%

Maruwa requested to widen the Ratio spec from 40% ~ 42% => 40% ~ 48%

=> Maruwa: New spare tool expected incoming on 30th Nov => Effective 03rd Dec : Eliminate burr cutting process in Maruwa

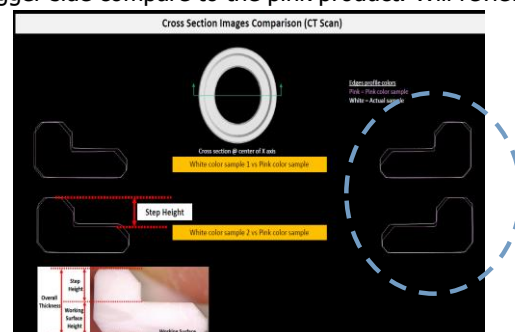
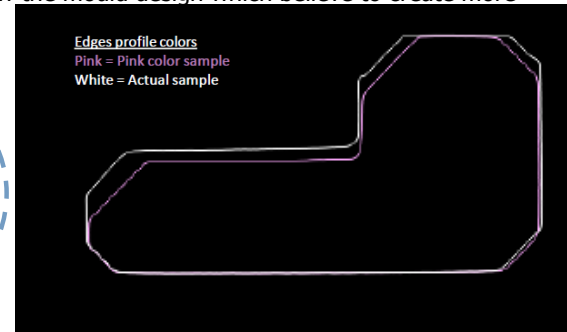
Product comparison with CT Scan between Pink Ceramic & Maruwa Ceramic

=> Maruwa's product generally showing on bigger side compare to the pink product. Will review the mould design which believe to create more stability at the chamfer area

Maruwa ceramic showing larger trend compare to pink ceramic. Adjustment of product angle will improve further the product strenght

Maruwa : Will discuss further with tool maker
