# Pre Purchase Building Inspection Report

11 Dunster Street  
Christchurch, Burnside 8053

## Description Of Property

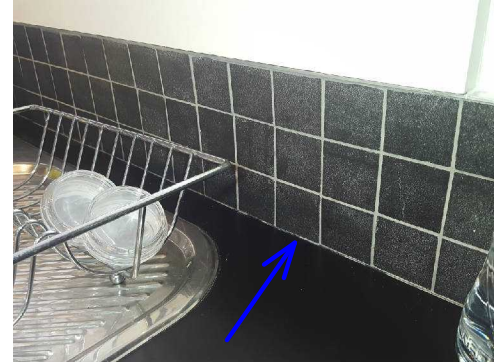
**Counter Tops:** Granite / Formica - The splash back tiles should be silicone sealed against the bench top to create a water tight seal.

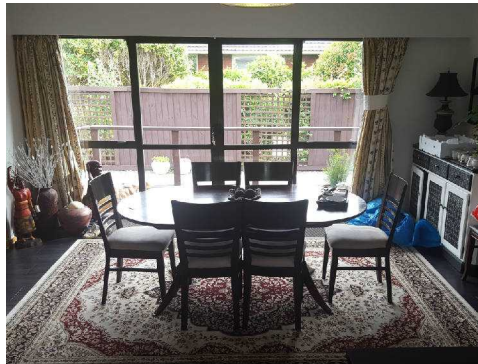
### Open Plan Dining Living Space

**External Doors:** Aluminum Single Glazed (standard glass) - The handles are broken but still lockable at time of inspection, this will need replacing in the near future.

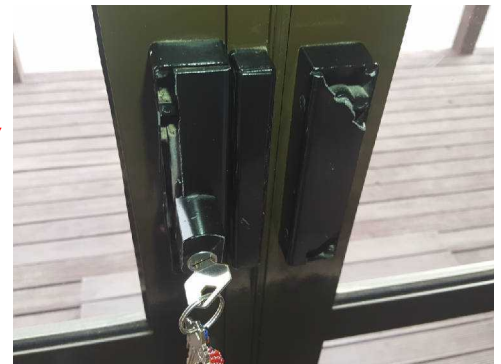
**Open Plan Dining Living Space External Doors:** Aluminum Single Glazed (standard glass)- The handles are broken but still lockable at time of inspection, this will need replacing in the near future.

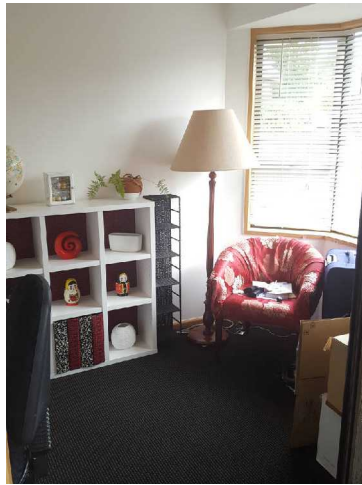
### Study (off dining area) Living Space

**Ceiling:** Plaster Board- Area of missing insulation as indicated in the thermal image.

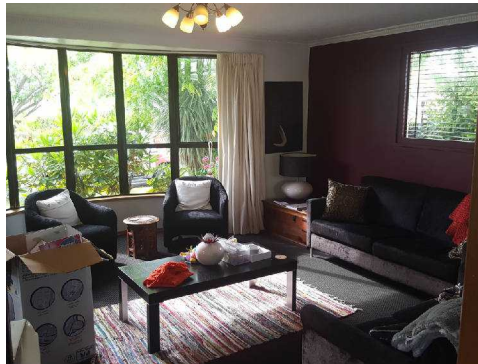
### Separate Lounge Living Space

**External Doors:** Aluminum Single Glazed  
(standard glass) - The handle is broken and  
unable to lock, recommend replacing.

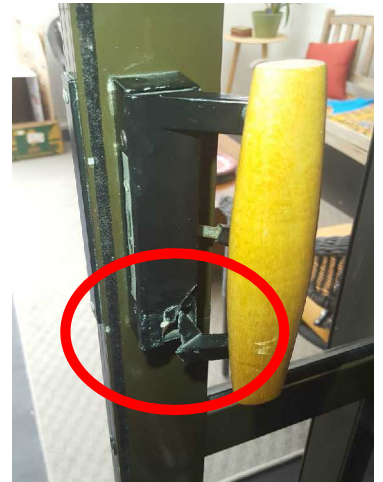
**Separate Lounge Living Space External Doors:** Aluminum Single Glazed (standard glass)- The handle is broken and unable to lock, recommend replacing.

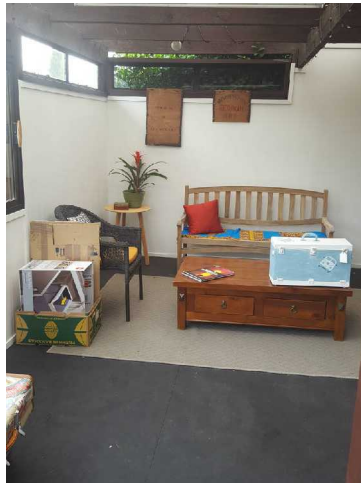
**Please Note:** This room is not a consented living space, the pergola over the deck has been nearly fully enclosed with some areas open to the elements.

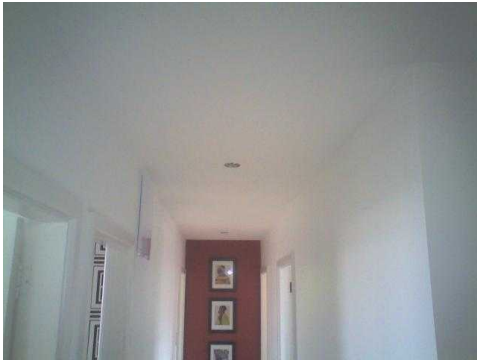
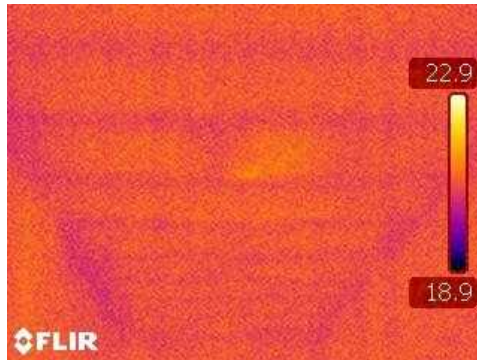
**Ceiling:** Plaster Board- Typical thermal image with no significant thermal abnormalities at time of inspection.

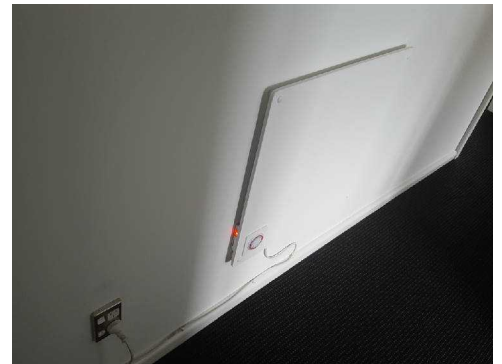
**Heating:** Radiant Panel- Operational at time of inspection but thermostats are not verified.

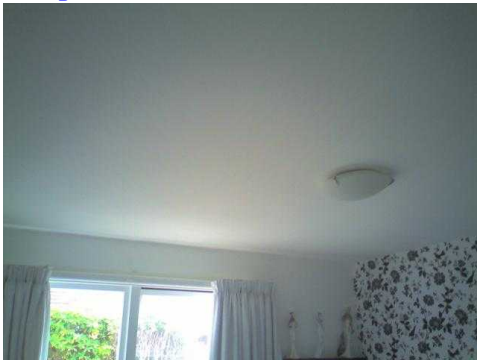
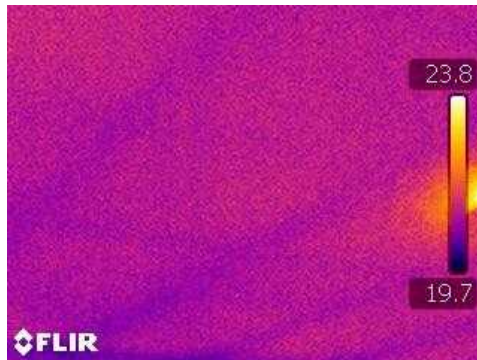
**Ceiling:** Plaster Board- Typical thermal image with no significant thermal abnormalities at time of inspection.

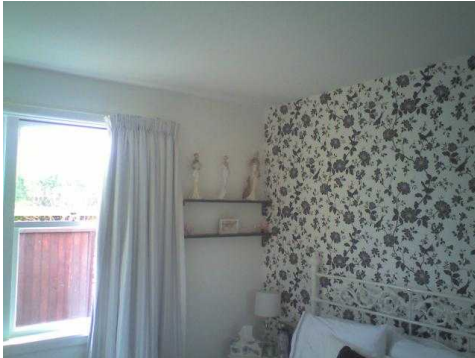
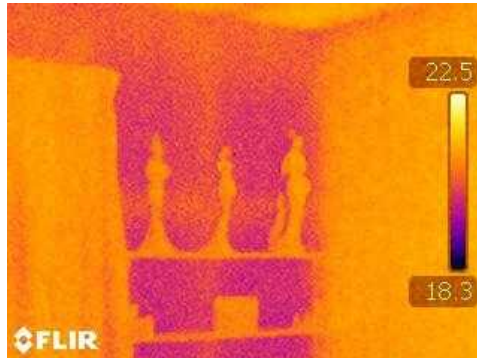
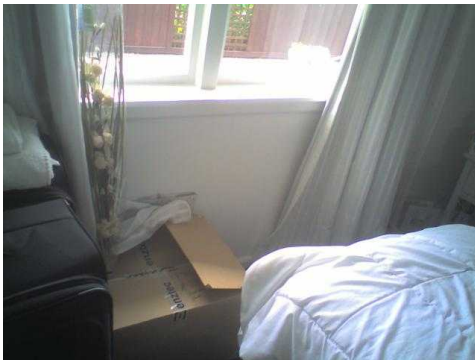
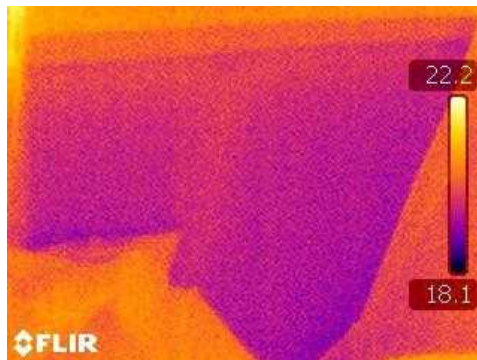
**Walls:** Plaster Board- Typical thermal image with no significant thermal abnormalities at time of inspection.

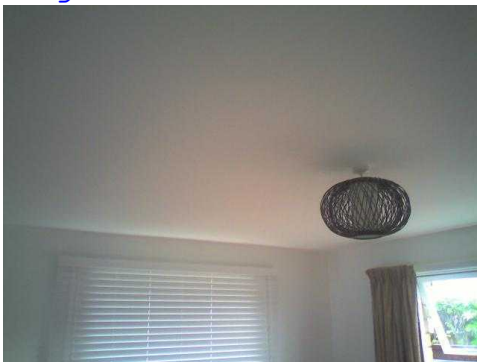
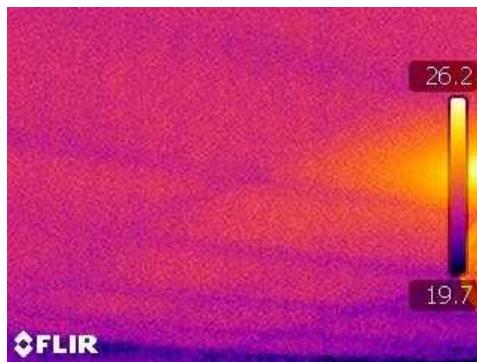
**Ceiling:** Plaster Board- Typical thermal image with no significant thermal abnormalities at time of inspection.

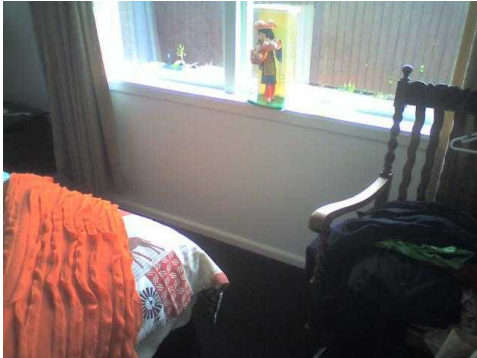
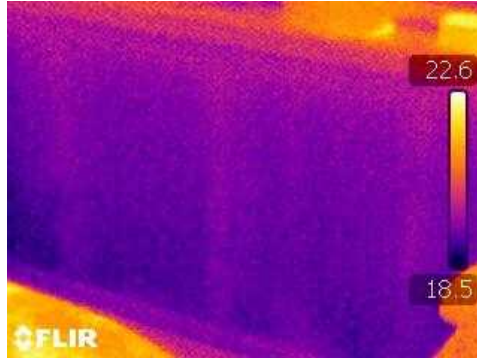
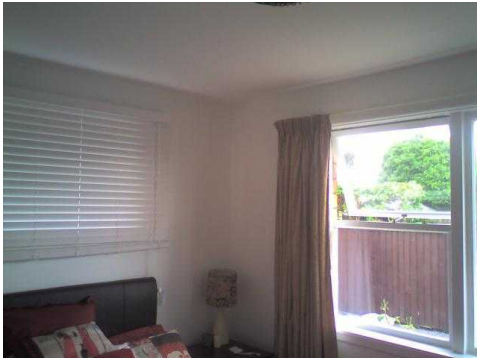
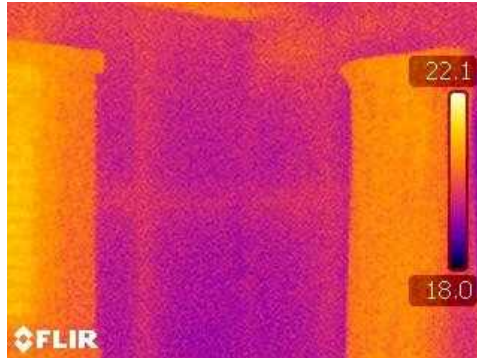
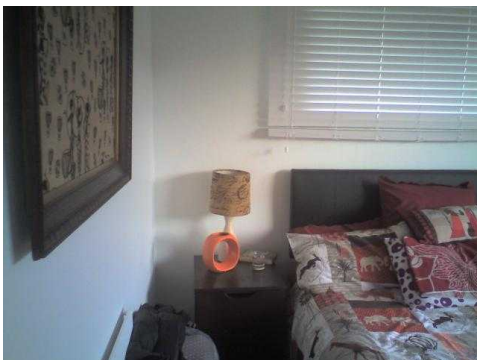
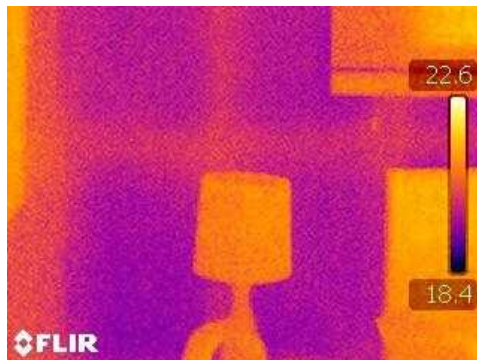
**Walls:** Plaster Board- Typical thermal image with no significant thermal abnormalities at time of inspection.

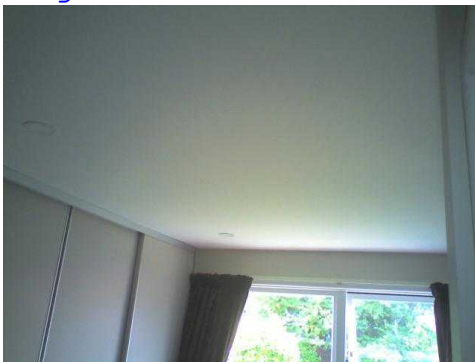
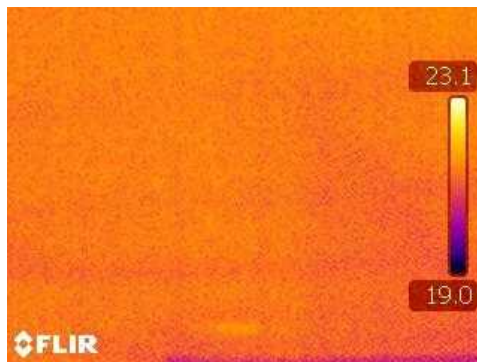
**Ceiling:** Plaster Board- Typical thermal image with no significant thermal abnormalities at time of inspection.

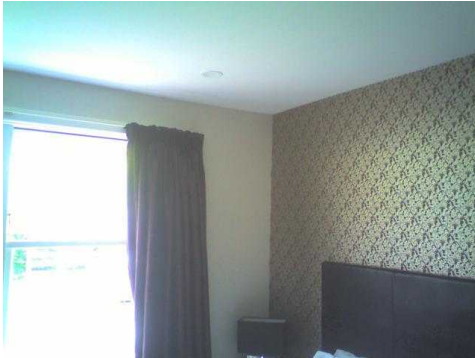
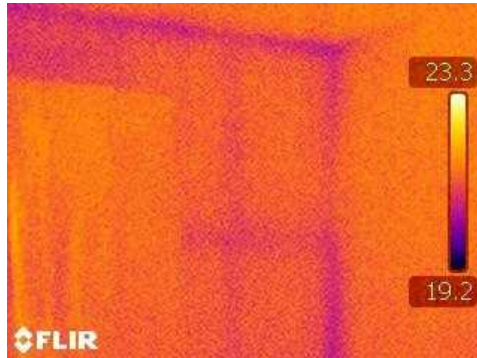
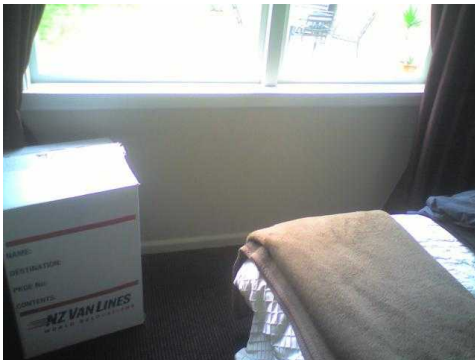
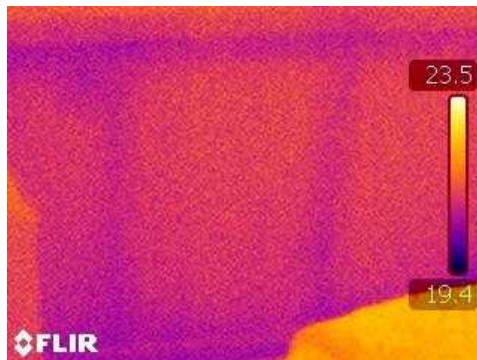
**Walls:** Plaster Board- Typical thermal image with no significant thermal abnormalities at time of inspection.

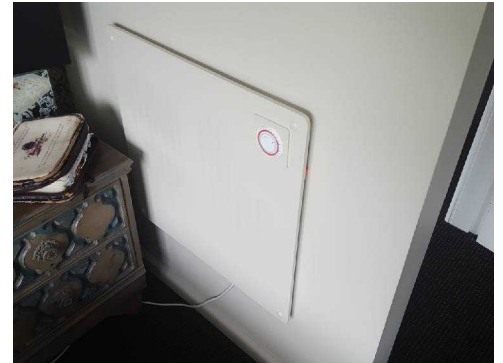
**Heating:** Radiant Panel- Operational at time of inspection but thermostats are not verified.

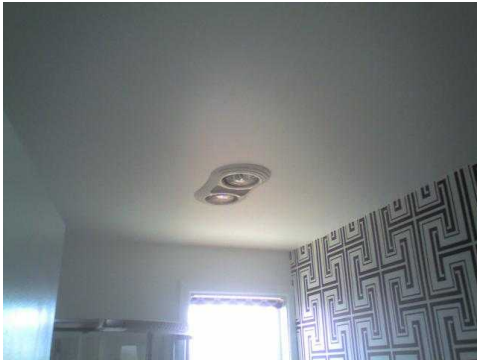
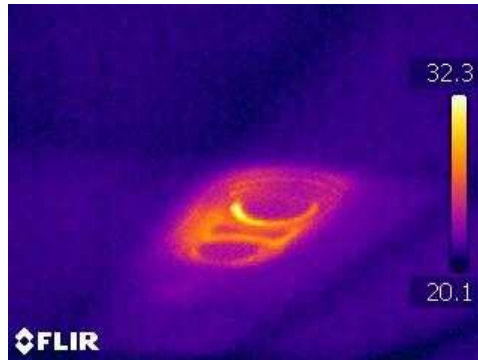
**Ceiling:** Plaster Board- Typical thermal image with no significant thermal abnormalities at time of inspection.

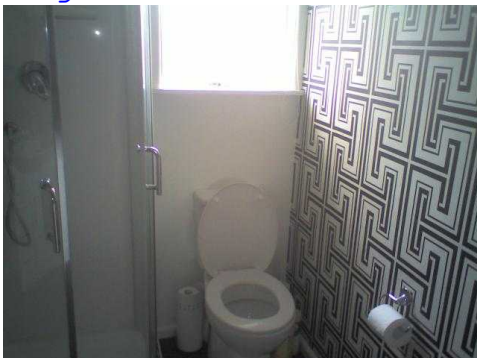
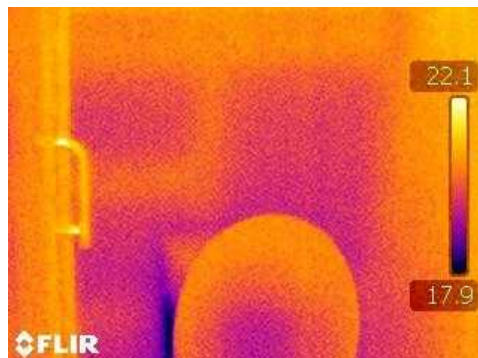
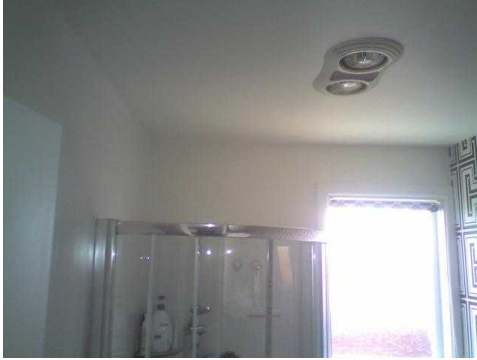
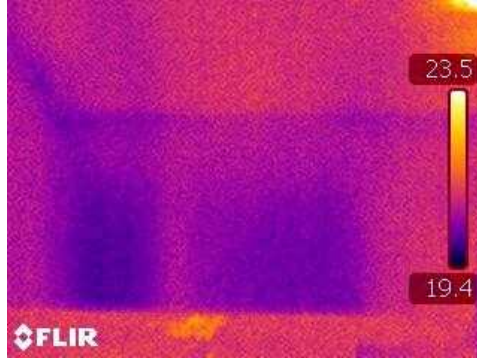
**Walls:** Plaster Board- Typical thermal image with no significant thermal abnormalities at time of inspection.

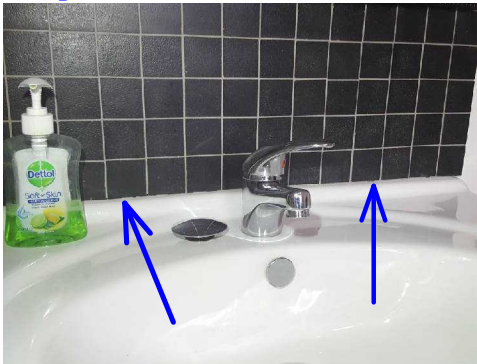
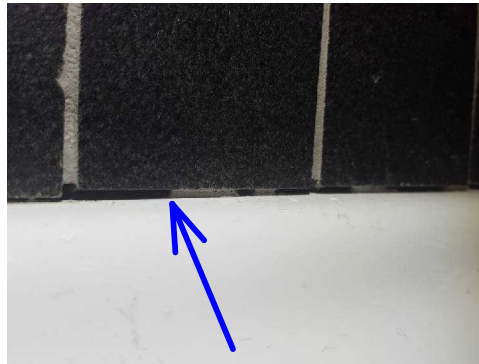
**Vanity:** Melamine (ceramic top) - The splash back tiles should be silicone sealed against the vanity top to create a water tight seal.

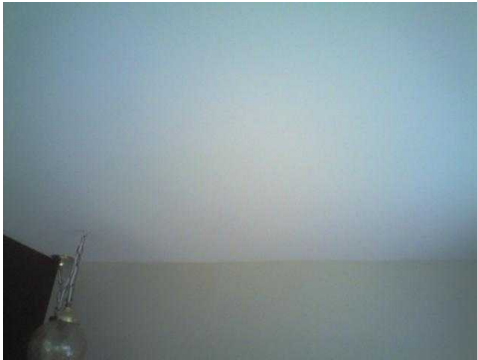
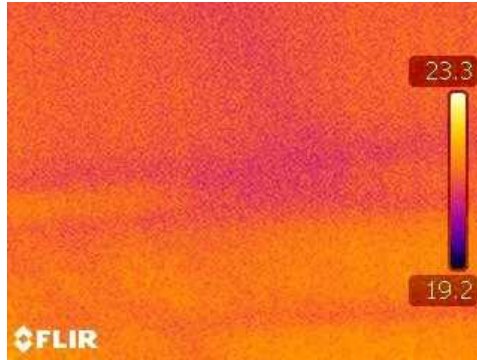
**Ceiling:** Plaster Board- Typical thermal image with no significant thermal abnormalities at time of inspection.

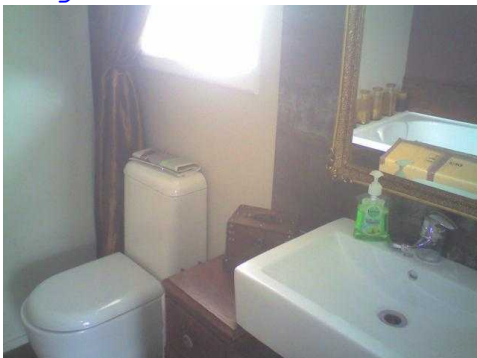
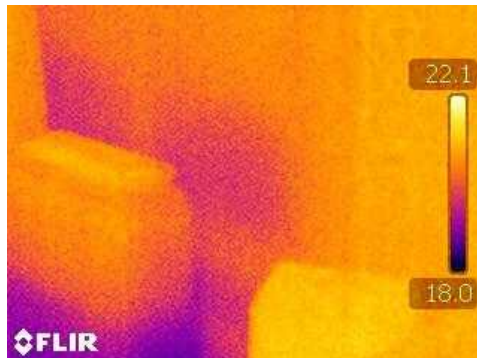
**Walls:** Plaster Board- Typical thermal image with no significant thermal abnormalities at time of inspection.

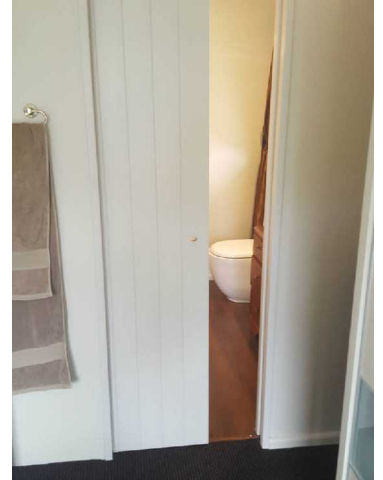
**Internal Doors:** Hollow Core- The door needs to be adjusted as it will not fully close due to rubbing on the floor, the door hardware is missing also.

**Master Ensuite Bathroom Internal Doors:** Hollow Core- The door needs to be adjusted as it will not fully close due to rubbing on the floor, the door hardware is missing also.

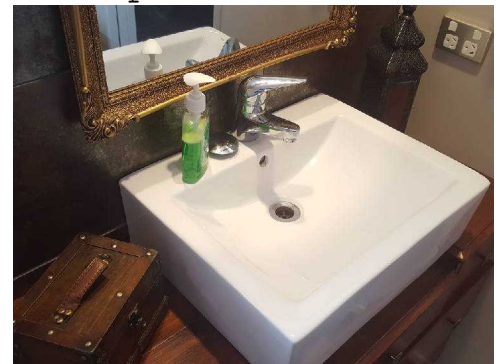
**Vanity:** Timber (ceramic bowl) - The bowl should be silicone sealed against the tiles to create a water tight seal.

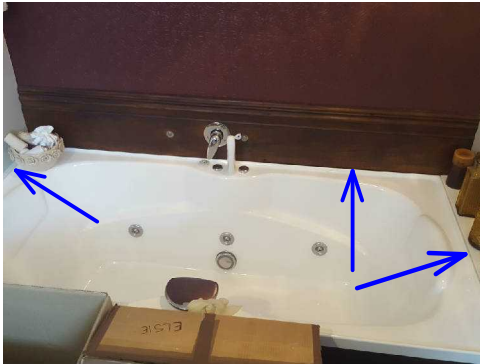
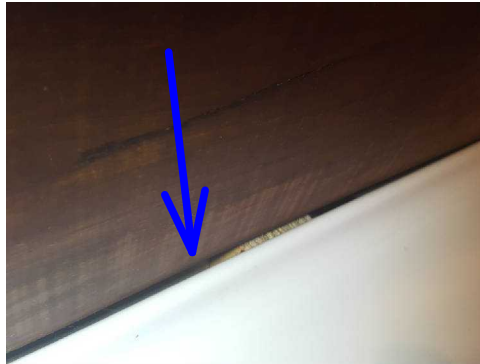
**Bath:** Moulded Plastic (spa operation not tested) - The perimeter of the bath should be silicone sealed against the walls to create a water tight seal.

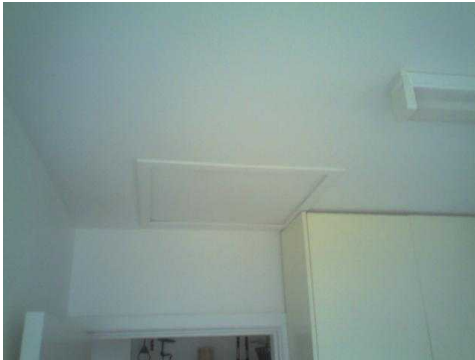
**Ceiling:** Plaster Board- No insulation over the access cover as indicated in the thermal image.

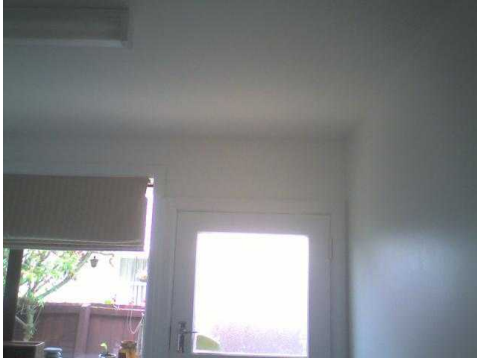
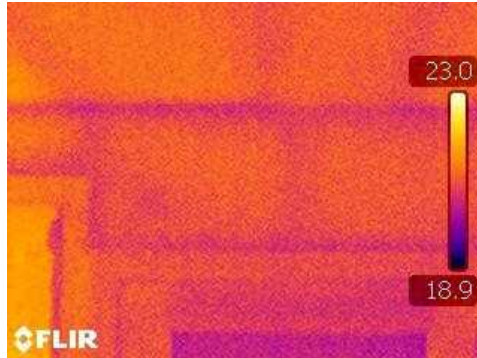
**Walls:** Plaster Board- Typical thermal image with no significant thermal abnormalities at time of inspection.

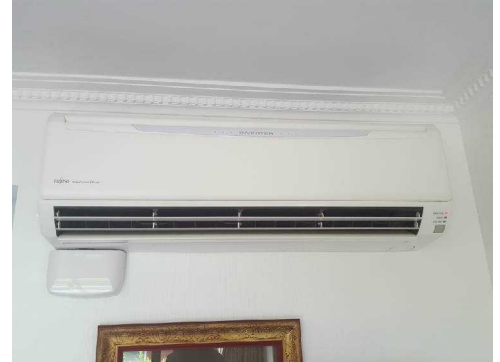
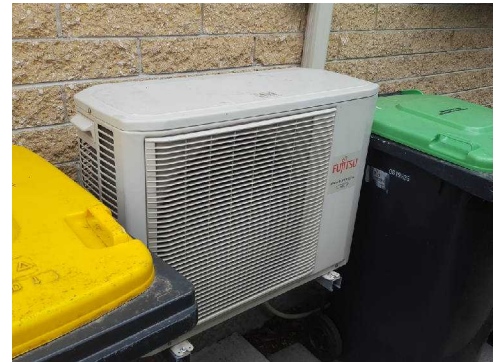
**Type:** Air Conditioning Heat Pump-  
Operational at time of inspection but  
thermostats are not verified.

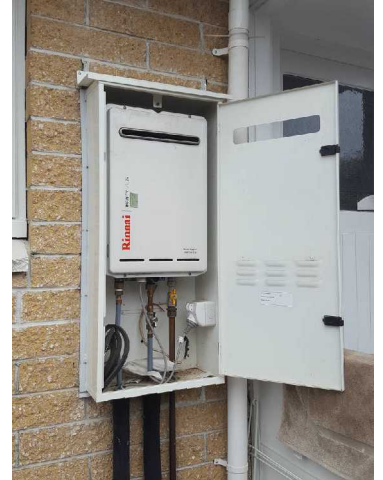
**Type:** Gas- Operational at time of inspection  
but thermostats are not verified.

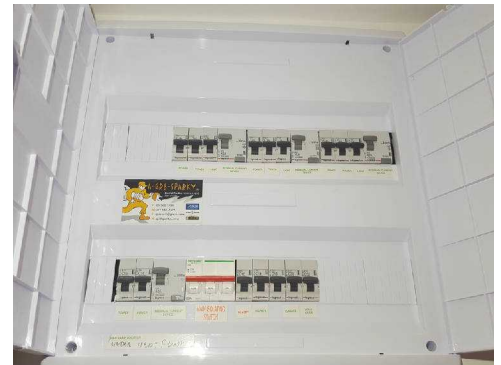
**Switch Board Location:** Hallway- New switch board recently installed (electrical certificate was sighted).

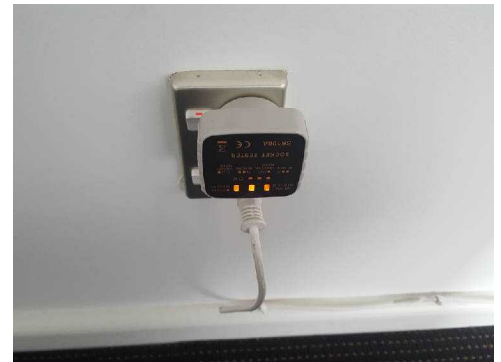
**Electrical Sockets:** All accessible sockets throughout the house were tested at time of inspection, all the sockets that were tested were operational.

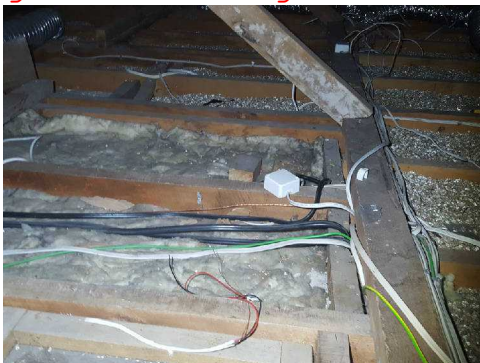
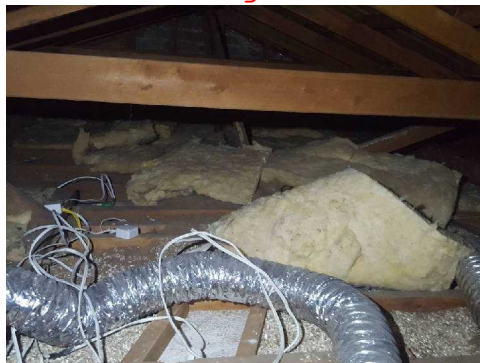
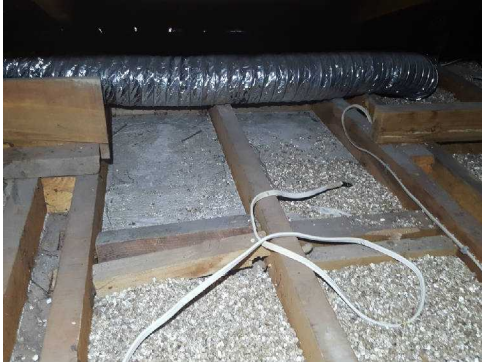
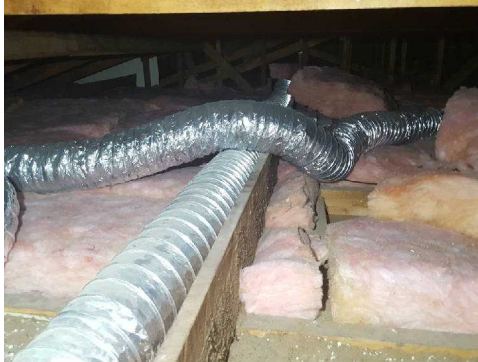
**Insulation:** Vermiculite / Loose Fluff / Batts- Some areas of insufficient or missing insulation as well as some areas of good coverage. Recommend adding insulation where needed.

**Ceiling Space Insulation:** Vermiculite / Loose Fluff / Batts- Some areas of insufficient or missing insulation as well as some areas of good coverage. Recommend adding insulation where needed.

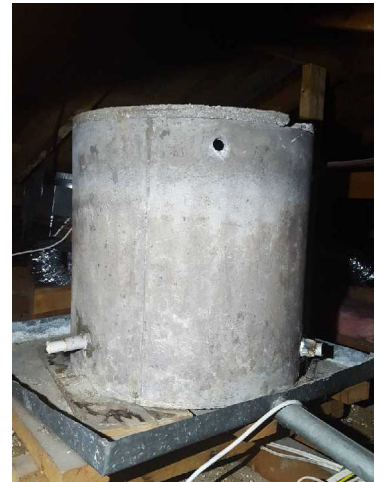
**Header Tank:** Concrete (disconnected) –  
Recommend securing in position or removing  
from the ceiling space.

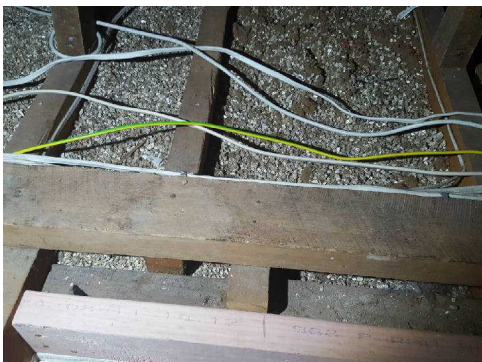
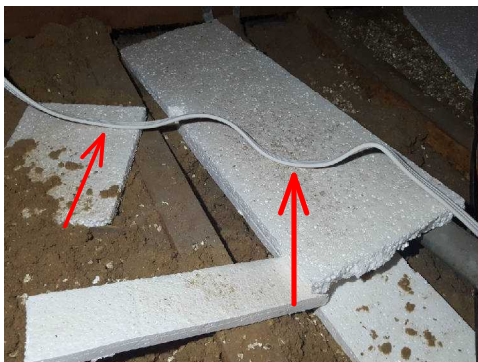
**Electrical:** Thermoplastic-Sheathed Cable (TPS) – The wiring  
should be secured as not to be a trip hazard near the access  
point.

Also noted electrical wiring in contact with polystyrene,  
these two materials often react with each other.

**Ceiling Space Electrical:** Thermoplastic-Sheathed Cable (TPS)- The wiring should be secured as not to be a trip hazard near the access point. Also noted electrical wiring in contact with polystyrene, these two materials often react with each other.

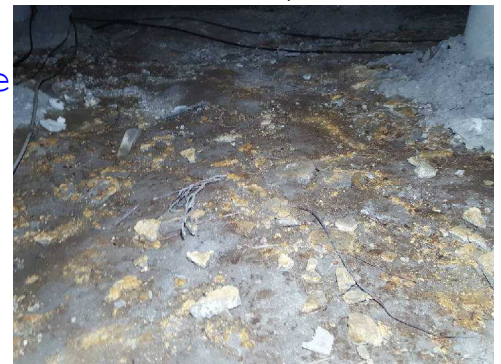
**Ground Condition:** Damp In Some Areas-  
Recommend fitting a ground cover moisture  
barrier to reduce any rising damp.

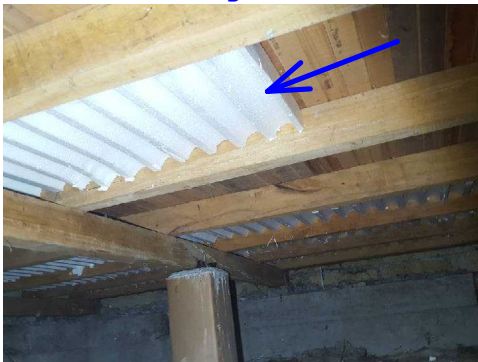
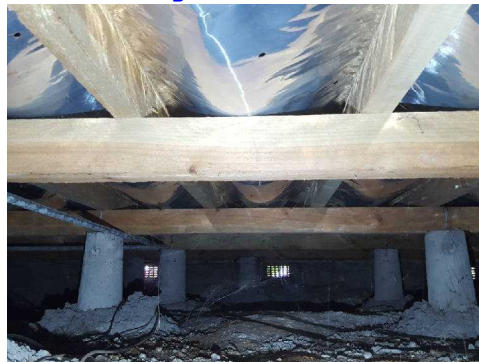
**Insulation:** Polystyrene- Small area of insulation below master  
bedroom but has been fitted upside-down.  
Insulating foil to the lounge extension.

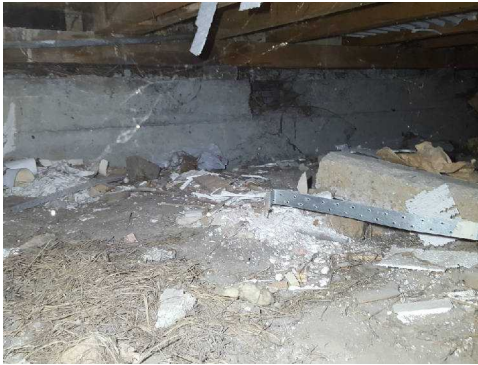
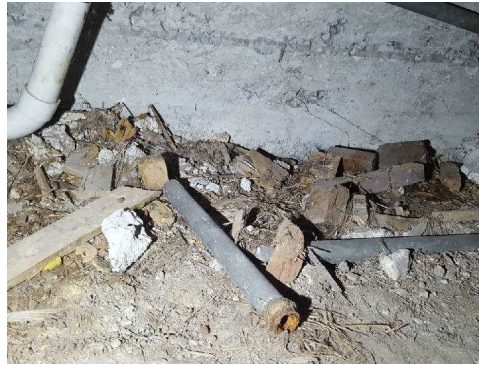
**Debris:** Construction and renovation debris left on the ground may attract pests/insects such as but not limited to borer, recommend removing.

**Sub Floor Debris:** Construction and renovation debris left on the ground may attract pests/insects such as but not limited to borer, recommend removing.

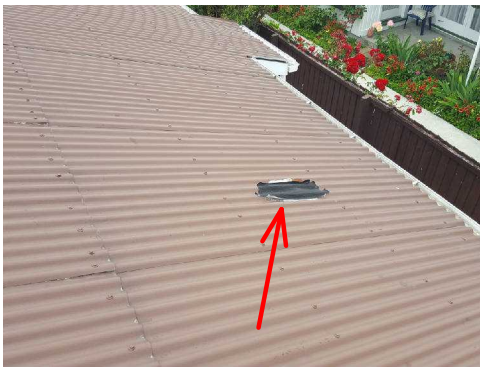
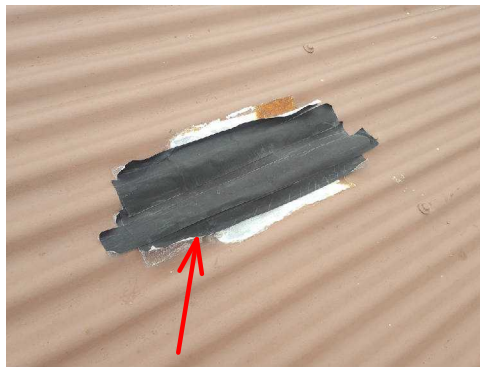
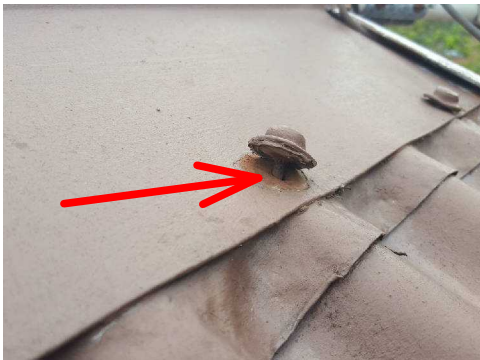
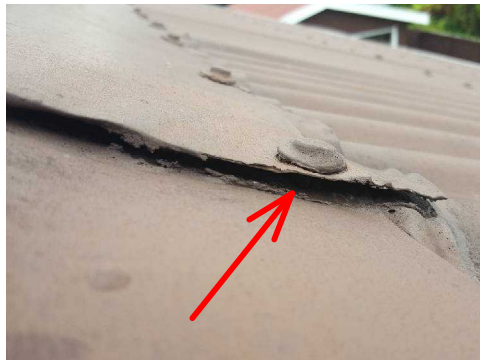
**Material:** Original Corrugated Iron With Lead Head Nails- Tape covering old roof penetration hole, recommend repairing sufficiently.

A number of lifting nails typical for age.

Areas of significant rust (rust may be more extreme beneath the joints) recommend a qualified roofer to advise on repair or replace. (not all nails or rust spots photographed).

**Roof Surface Material:** Original Corrugated Iron With Lead Head Nails- Tape covering old roof penetration hole, recommend repairing sufficiently.

Areas of significant rust (rust may be more extreme beneath the joins) recommend a qualified roofer to advise on repair or replace. (not all nails or rust spots photographed).

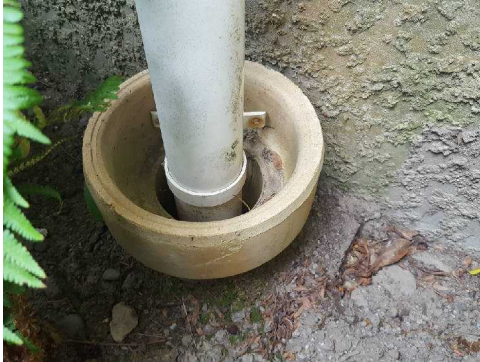
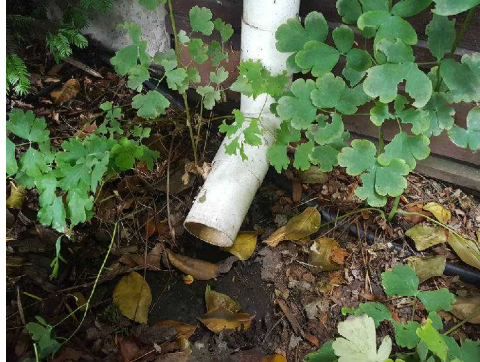
No guarantees can be given in regards to the integrity of the under ground pipes (if any) due to seismic or historical damage.

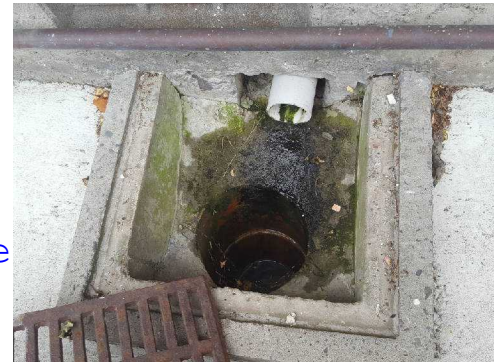
**Gully Traps:** Clay- No guarantees can be given in regards to the integrity of the under ground pipes due to seismic or historical damage although no sign of blockage at time of inspection. Due to the seismic events it is advisable to have the under grounds drains cctv inspected.

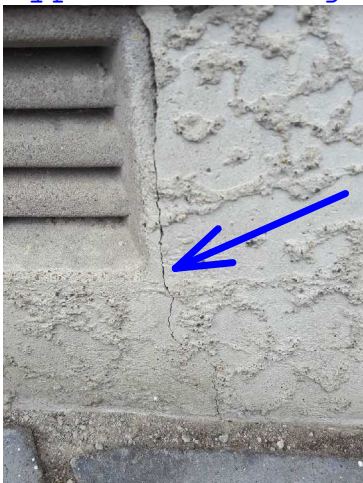
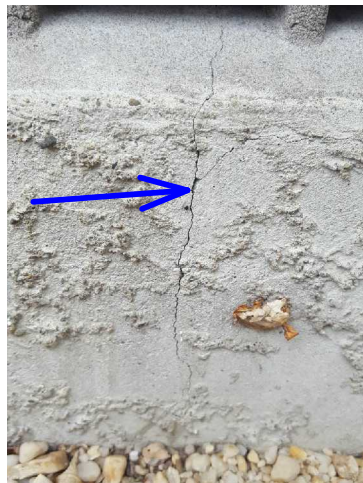
**Foundation:** Concrete Ring Footing- Minor cosmetic cracking typical for age.

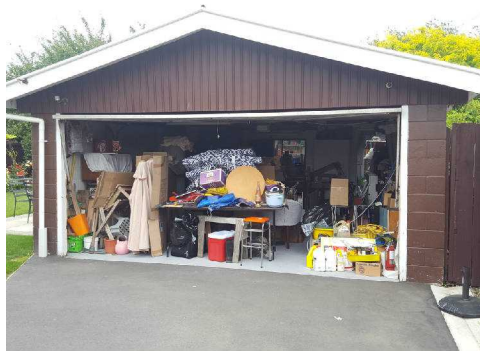
**Floor/Foundation:** Concrete- The garage floor is at the same level as the driveway with evidence of water pooling.

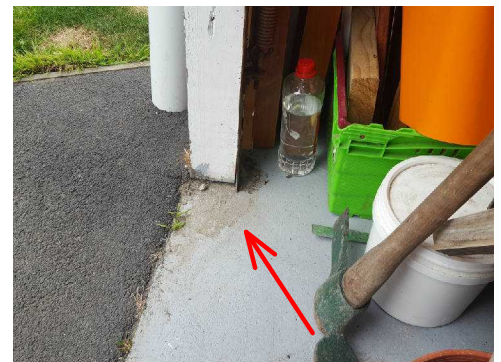
**Garage Floor/Foundation:** Concrete- The garage floor is at the same level as the driveway with evidence of water pooling.

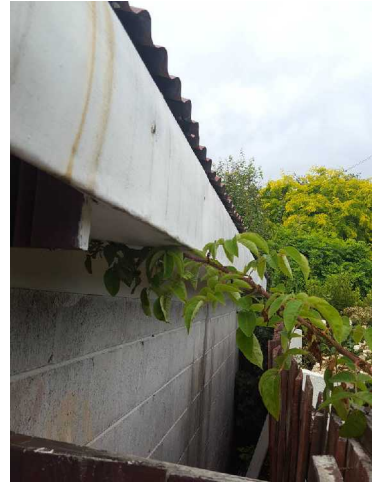
**Spouting:** Plastic- No spouting on the boundary side.

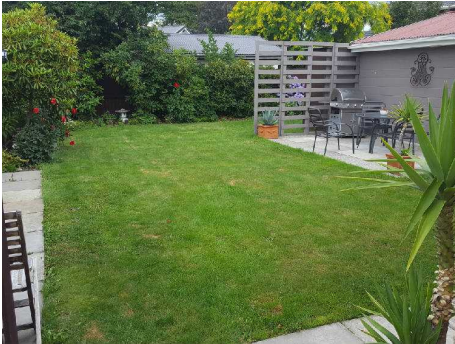
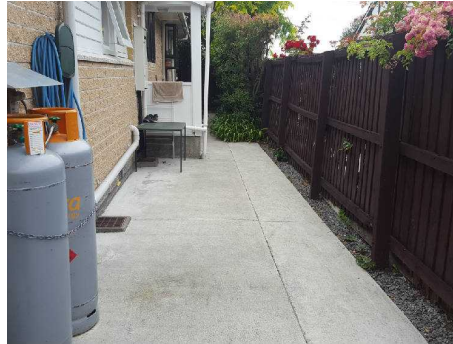
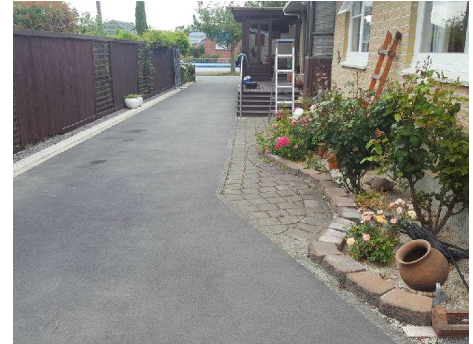
**Fences:** Timber Paling (up to 1.8m) - Raised gardens and soil against the fence will accelerate deterioration (bottom rails below ground level in some areas).

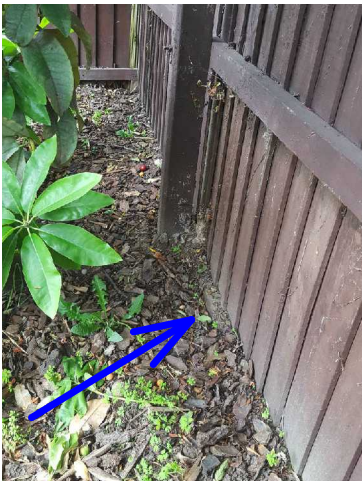
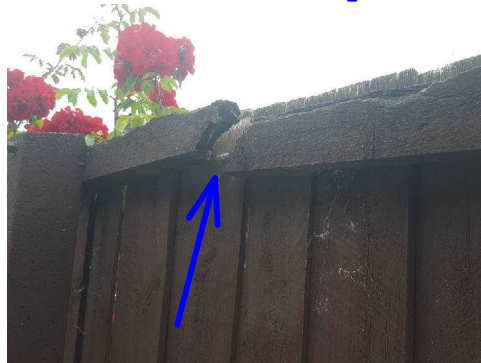
Other areas of maintenance required typical for age.
