# Overheated electrical joints: fire, danger to life and the cost of heat

Research report on the distribution-board joints photographed at the Chiang Rai site, with evidence, case studies, a before-and-after comparison and recommended practice

Site: Chiang Rai · Photographs dated: 1 September 2026 · Monitoring data: 28 September to 3 October 2026

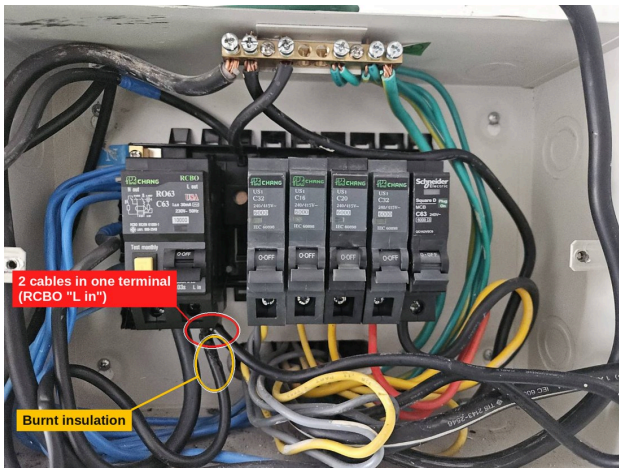
More than one cable, including a twisted bundle, is clamped in one RCBO terminal. The joint has overheated: insulation is melted and copper is corroded. A second board shows the same habit.

**The board.** The red circle marks the RCBO line-in terminal; the yellow outline marks scorched cable below it.

- ✓ **Inspect the RCBO terminal:** replace the RCBO if the terminal or body is discoloured, pitted or melted.
- ✓ **One conductor per terminal:** unless the maker states that the terminal accepts more.

- ✓ **Split the circuits properly:** use a busbar, a rated terminal block, or a separate breaker for each circuit.
- ✓ **Use ferrules on stranded wire and tighten to the maker's torque:** then pull-test each conductor.

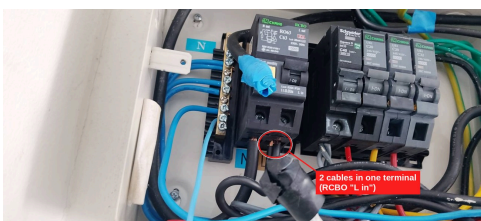
## The same practice on a second board

Another board, judging by its different breakers, shows two conductors joined under tape and taken into one RCBO terminal. No burn is visible there yet. The fault looks like a working habit, not a one-off, so every board by the same installer should be opened and checked.

- ✓ **Open every board by the same installer:** the second board shows the same practice
- ✓ **Scan under machine load:** record the temperature of every joint on the supply path to the 57 kW machine

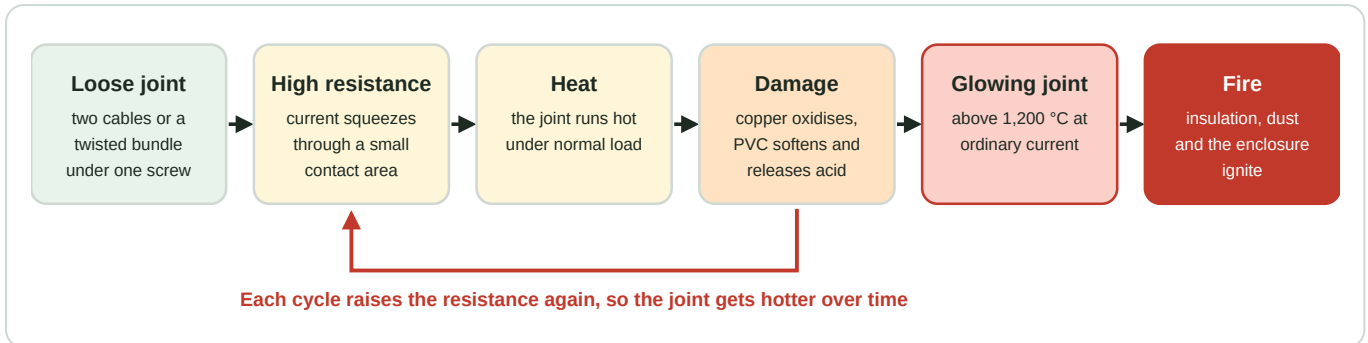
## 2 The mechanism: how a loose terminal becomes a fire

### Why several wires under one screw are loose

The screw bears on the outer strands only. Inner wires sit slack, and every heating and cooling cycle lets the bundle settle further. A twisted joint is also several circuits drawing current through one point.

An MCB reacts to too much current and an RCBO to current leaking to earth. A hot joint causes neither: tests show it wastes only about 5 to 50 W, with normal load current flowing. The protection sees nothing wrong.

Overheated PVC releases hydrogen chloride. With moisture it forms acid that turns copper into green copper salts. The deposit conducts poorly, which raises the resistance again.
