# Overheated electrical joints: fire, danger to life and the cost of heat

Research report on the distribution-board joints photographed at the Chiang Rai site, with evidence, case studies, a before-and-after comparison and recommended practice

Site: Chiang Rai · Photographs dated: 1 September 2026 · Monitoring data: 26 September to 3 October 2026

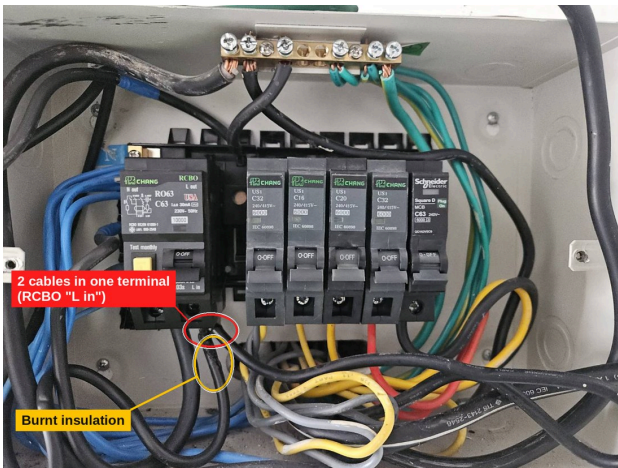
More than one cable, including a twisted bundle, is clamped in one RCBO terminal. The joint has overheated: insulation is melted and copper is corroded. A second board shows the same habit.

**The board.** The red circle marks the RCBO line-in terminal; the yellow outline marks scorched cable below it.

- ✓ **Inspect the RCBO terminal:** replace the RCBO if the terminal or body is discoloured, pitted or melted.
- ✓ **One conductor per terminal:** unless the maker states that the terminal accepts more.

- ✓ **Split the circuits properly:** use a busbar, a rated terminal block, or a separate breaker for each circuit.
- ✓ **Use ferrules on stranded wire and tighten to the maker's torque:** then pull-test each conductor.

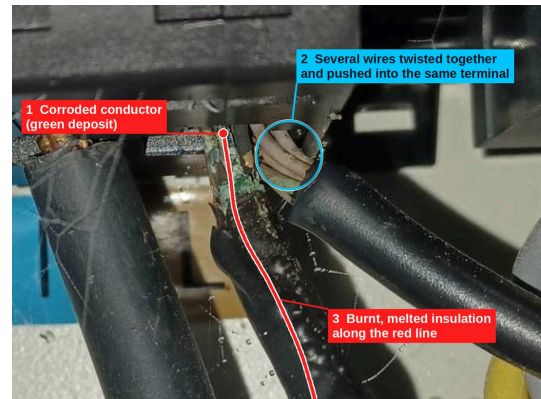
**The terminal, enlarged.** The numbers match the findings below.

### 1 Corroded conductor

Green deposit on the copper where it enters the terminal: a sign of heat, moisture and acid from overheated PVC.

### 2 Several wires in one terminal

Separate wires twisted into a bundle and forced in beside the main cable. The screw cannot grip them evenly.

### 3 Burnt, melted insulation

The damage runs down the cable from the terminal, which shows the heat started at the joint.

- ✓ **Test the insulation:** measure the insulation resistance of every circuit before re-energising, and record the values.
- ✓ **Correct the phasing:** confirm which phase feeds each circuit and the phase sequence, then label the board.

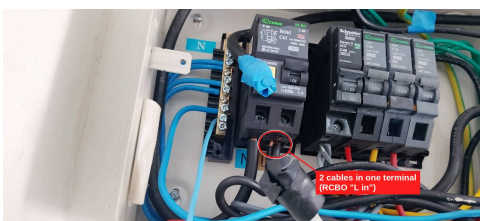
Another board, judging by its different breakers, shows two conductors joined under tape and taken into one RCBO terminal. No burn is visible there yet. The fault looks like a working habit, not a one-off, so every board by the same installer should be opened and checked.

- ✓ **Open every board by the same installer:** the second board shows the same practice
- ✓ **Scan under machine load:** record the temperature of every joint on the supply path to the 57 kW machine

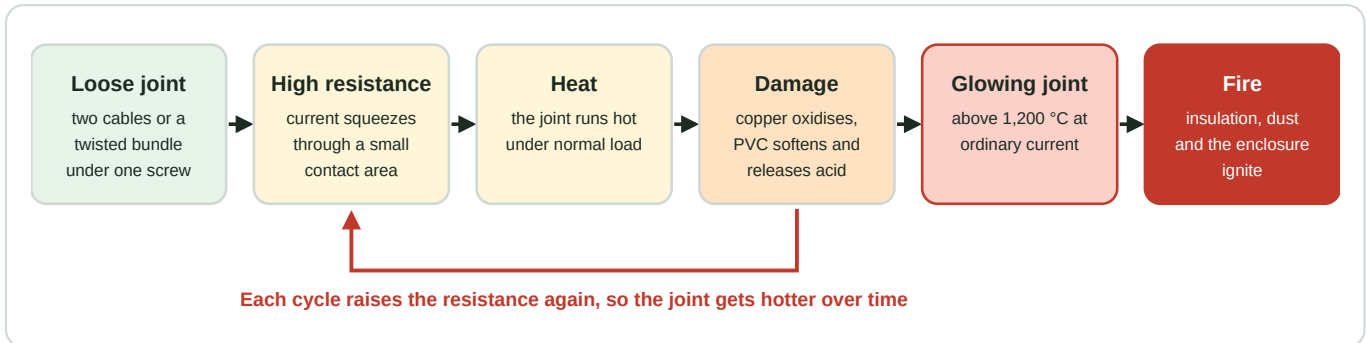
## 2 The mechanism: how a loose terminal becomes a fire

### Why several wires under one screw are loose

The screw bears on the outer strands only. Inner wires sit slack, and every heating and cooling cycle lets the bundle settle further. A twisted joint is also several circuits drawing current through one point.

An MCB reacts to too much current and an RCBO to current leaking to earth. A hot joint causes neither: tests show it wastes only about 5 to 50 W, with normal load current flowing. The protection sees nothing wrong.

Overheated PVC releases hydrogen chloride. With moisture it forms acid that turns copper into green copper salts. The deposit conducts poorly, which raises the resistance again.

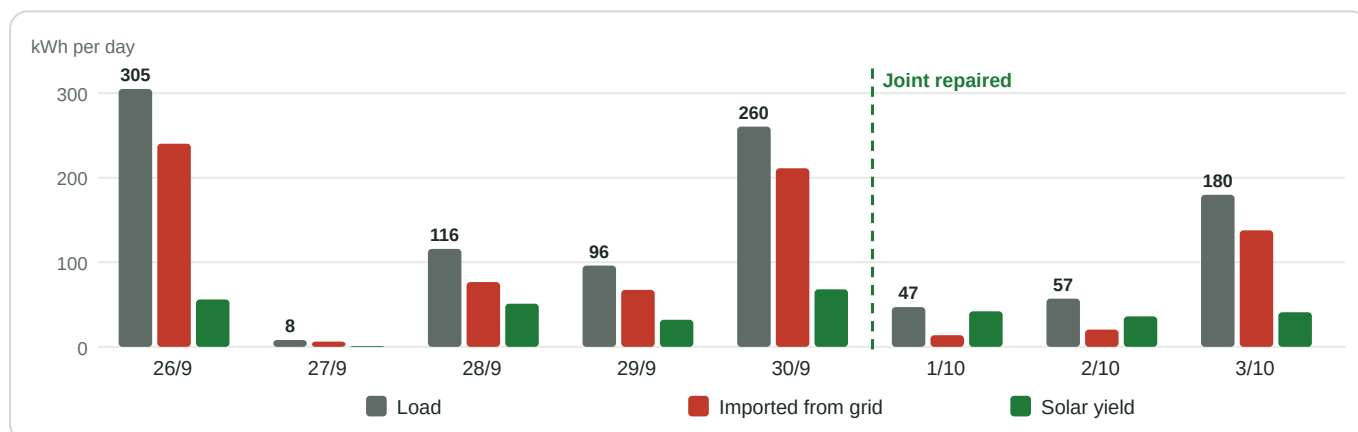
## 7 Measured energy before and after the repair

### Average per day
