# 24H3-191C

Single Gate

## Structure Summary

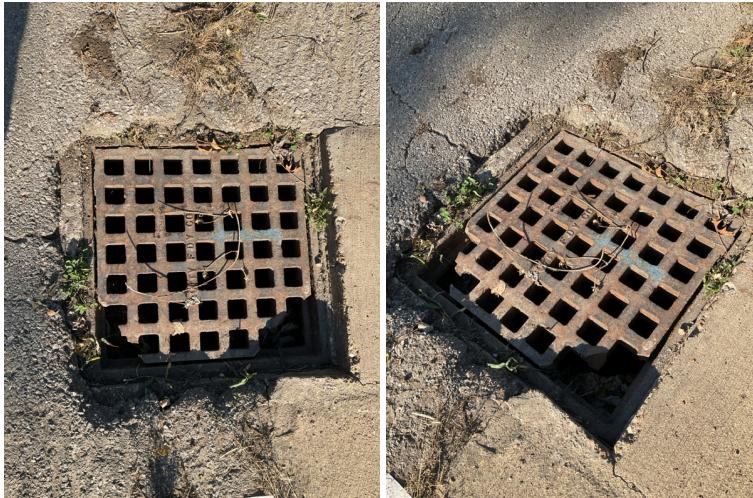
Issue Photo

Emergency Repair?	No
Issue Description	Bottom corners of the grate are broken, lid is on the rim but barely.

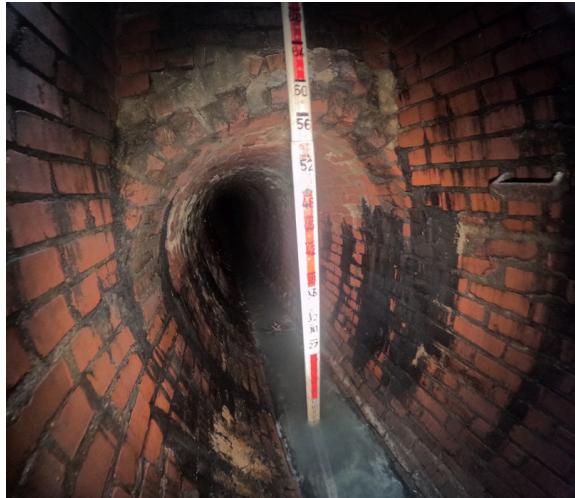
#### Pipe Photo - Report

### Pipe Connections - 1. 6, Out, (BR) Brick, 24H3-196C

MSD pipe facility ID	24H3-191C:24H3-196C
Pipe System	C
Pipe Number	1
Can you verify pipe characteristics?	Yes
Trench Grate Y/N	No
Pipe Status	Active
Clock Position	6
Pipe Direction	Out
Pipe Type	(GR) Gravity Connection
Pipe Shape	(E) Egg Shaped
Pipe Height	56
Pipe Material	(BR) Brick
Rehab Type	NONE
Connecting Structure ID	24H3-196C

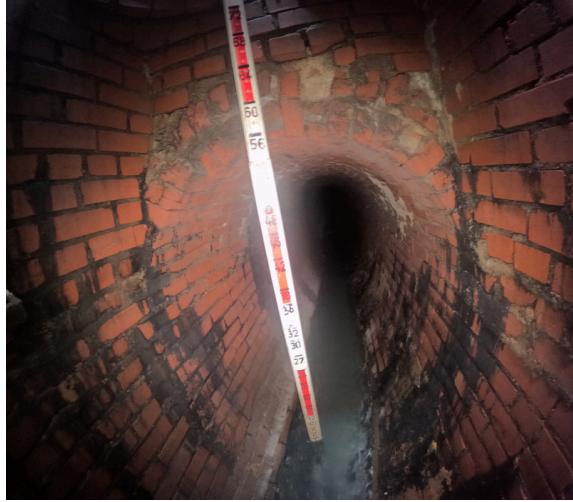
**Pipe Photo - Report**

### Pipe Connections - 2. 12, In, (BR) Brick, 24H3-190C

Trench Grate Y/N	No
Pipe Status	Active
Clock Position	12
Pipe Direction	In
Pipe Type	(GR) Gravity Connection
Pipe Shape	(E) Egg Shaped
Pipe Height	56
Pipe Material	(BR) Brick
Rehab Type	NONE
Connecting Structure ID	24H3-190C
