I Inspection Report Overview

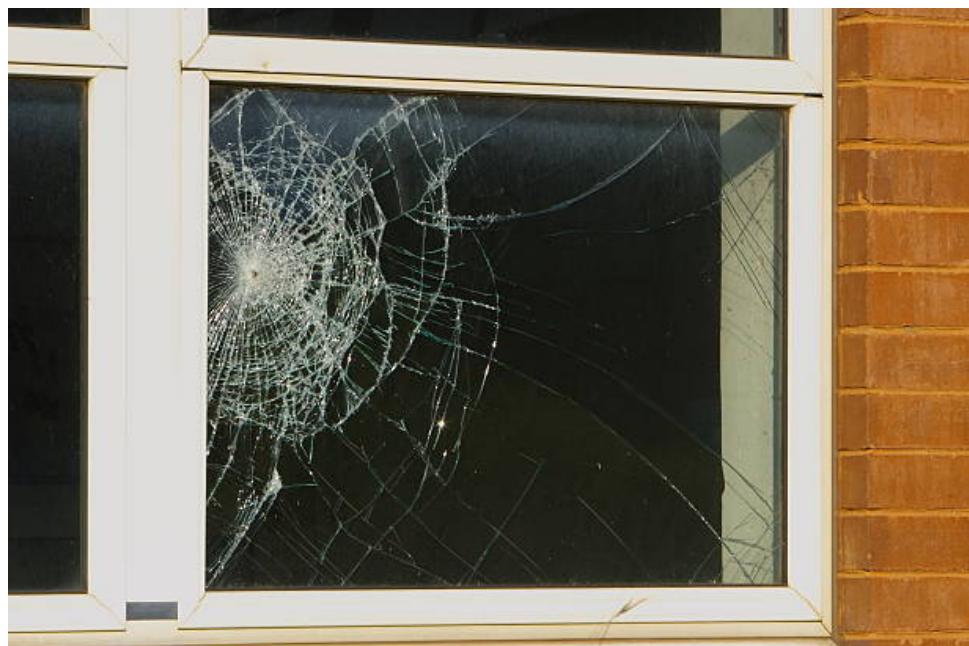
2. Cracked Window Pane

The damaged glass pane may expose sharp edges and reduce the thermal barrier against the elements. Further evaluation by a qualified contractor is recommended to repair or replace the damaged window as needed.

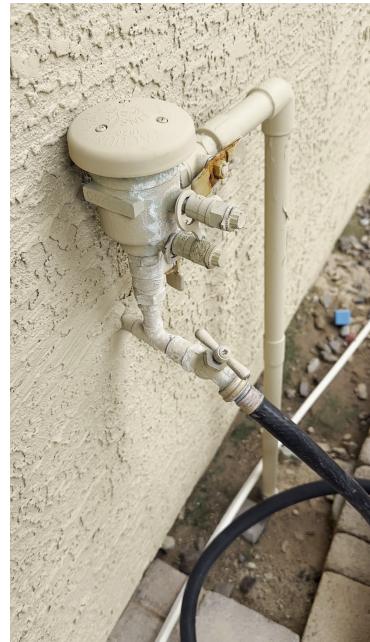
10. Hose Bib Handle Damaged or Missing

The handle for the exterior spigot was damaged or missing. Repairs or replacement as needed are recommended to be performed by a qualified individual to ensure proper operation.

Annotated image: defective hose bib at Back Yard

Original image: defective hose bib at Back Yard

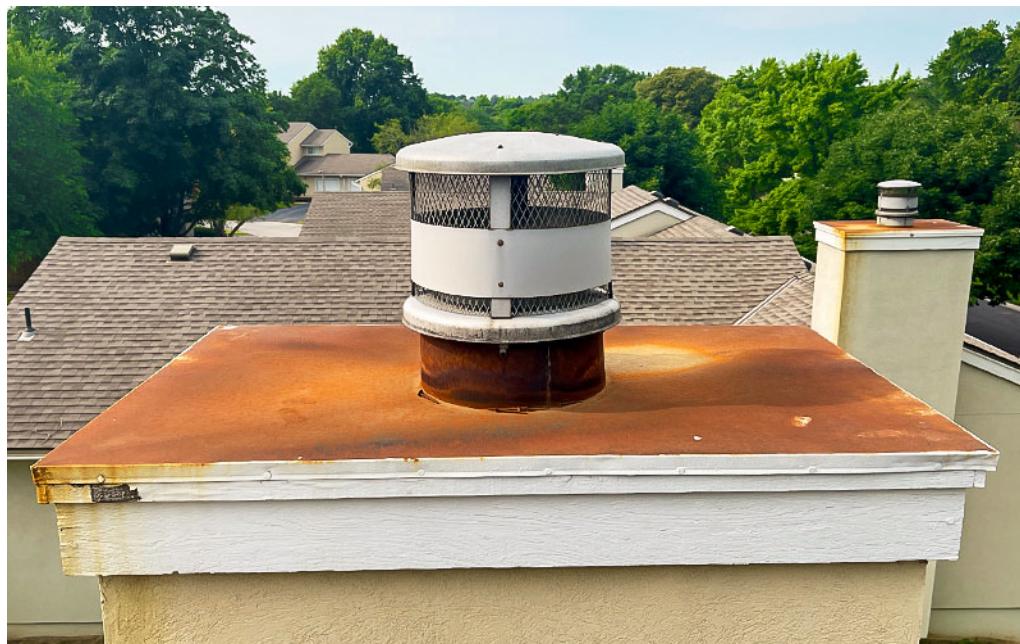
2. Corroded Chimney Cap

The chimney cap displayed signs of corrosion. Regular maintenance, such as sealing, is recommended to prevent further damage and extend its longevity.

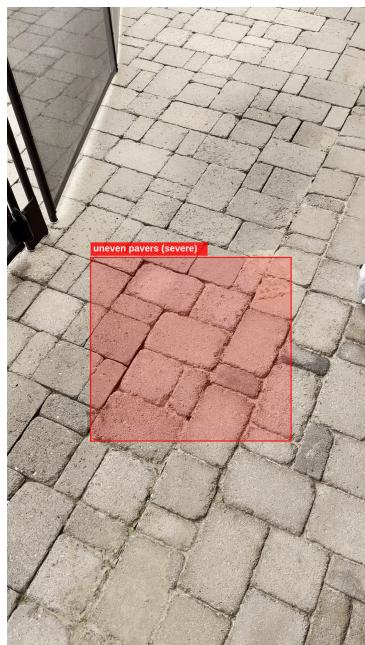
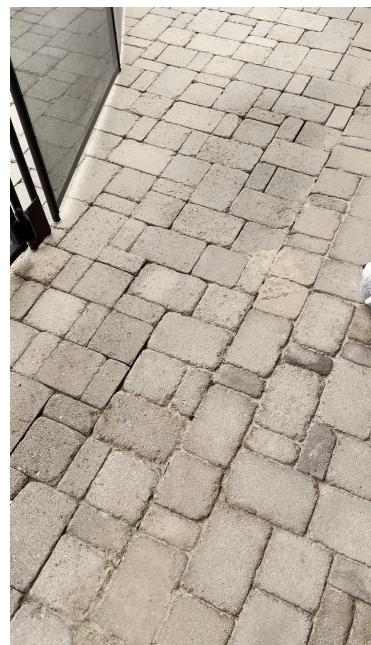
1. Uneven Pavers — Trip Hazard

Uneven paver stones were observed in the backyard, creating a potential trip hazard to occupants and visitors. This condition presents an immediate safety concern and should be corrected. Recommend evaluation and repair by a qualified hardscape contractor or landscaper to re-level, reset, or replace affected pavers to eliminate the trip hazard.

Annotated image: uneven pavers at Back Yard

Original image: uneven pavers at Back Yard

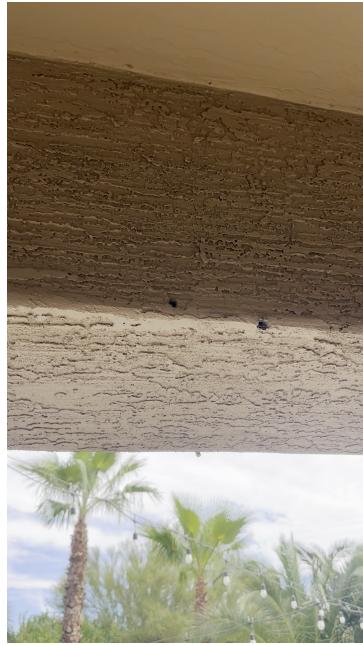
2. Stucco Cracks/Damage

Stucco damage was observed. Gaps or cracks in stucco can allow for moisture intrusion, accelerating deterioration. It is recommended that a qualified contractor evaluate and perform necessary repairs.

Original image: stucco damage at Back Yard

Annotated image: stucco damage at Back Yard

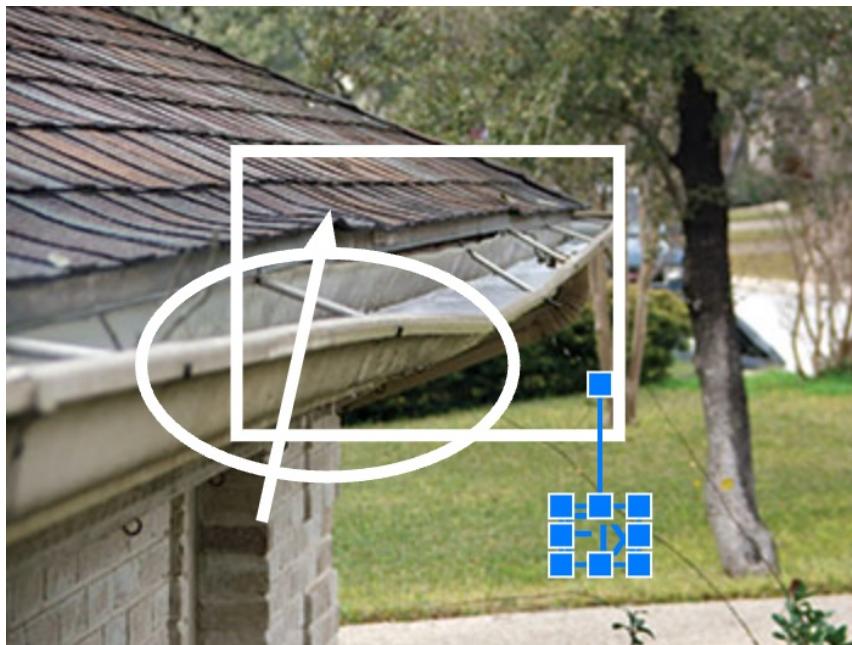
2. Missing or Damaged Gutter Hanger

A gutter hanger was observed to be missing or damaged. It is recommended to properly secure or replace the gutter hangers to ensure the intended stability and proper alignment of the gutter system.

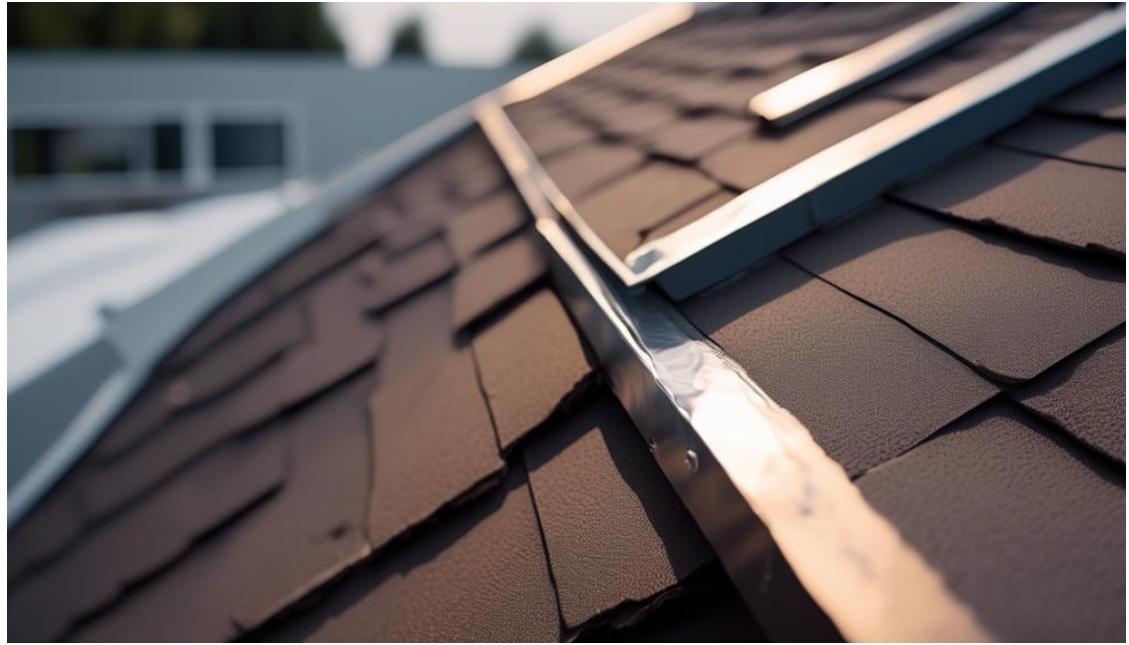
1. Compromised Flashing or Sealant Integrity

Observations indicate the presence of openings or gaps within the flashing or sealant materials. Such breaches can compromise the water-resistant barrier of the roof, potentially leading to water penetration. It is recommended to engage a certified roofing contractor to address and repair these areas to prevent future moisture intrusion.

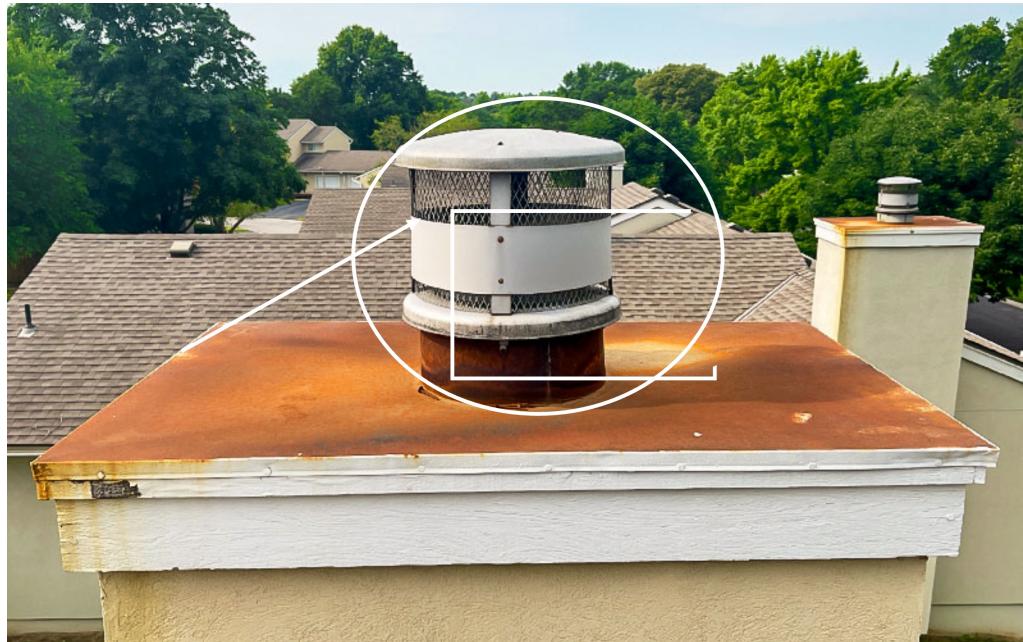
1. Vent Cover Damaged or Missing

A damaged or missing vent cover could allow debris and small pests to enter. It is recommended to repair or replace the vent cover to ensure proper operation.

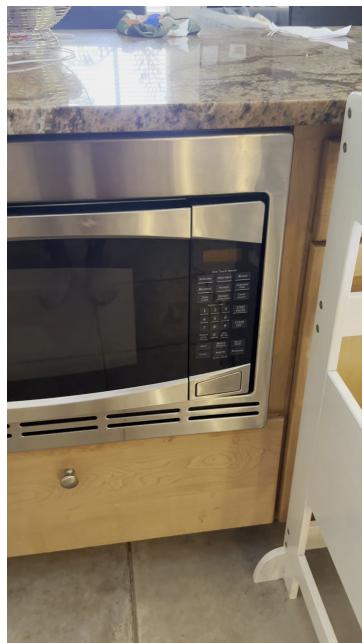
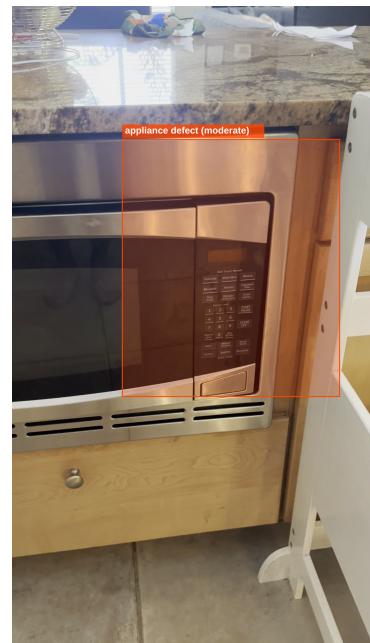
1. Unit Non-Functional or Malfunctioning

The microwave oven appeared to be non-operational or was malfunctioning. It is advised that a qualified appliance technician evaluate and perform necessary repairs or replacement.

Original image: appliance defect at Kitchen

Annotated image: appliance defect at Kitchen

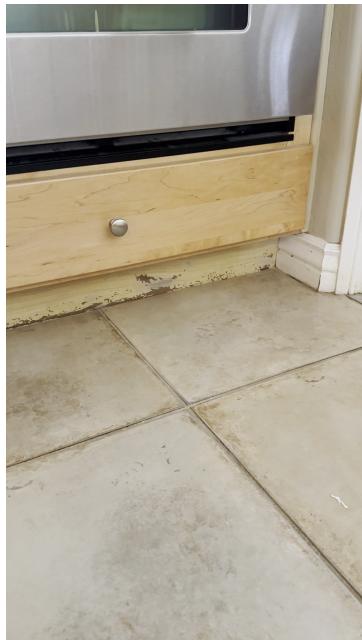
Original image: damaged toe kick at Kitchen

Annotated image: damaged toe kick at Kitchen

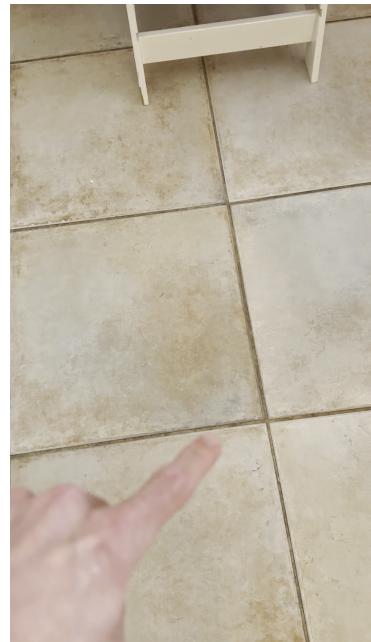
1. Cracked Floor Tile

Two small cracks were observed in the kitchen floor tile. Cracked tile can allow moisture to penetrate the substrate and may deteriorate further over time. Recommend repair or replacement of the affected tile(s) by a qualified flooring contractor and verify the integrity of the surrounding substrate and grout. Obtain estimates as needed.

Annotated image: cracked tile at Kitchen

Original image: cracked tile at Kitchen

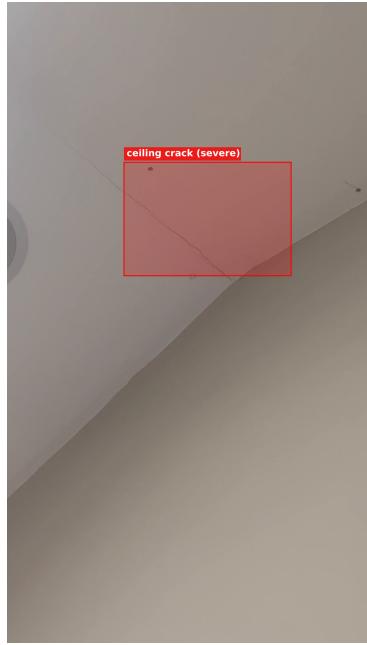
Significant drywall imperfections, including damage, cracking, or inconsistencies, were noted in the referenced area(s). It is advisable to inquire with the current homeowner(s) regarding any past alterations. Repairs should be undertaken by a drywall contractor as desired.

Original image: ceiling crack at Living Room

Annotated image: ceiling crack at Living Room

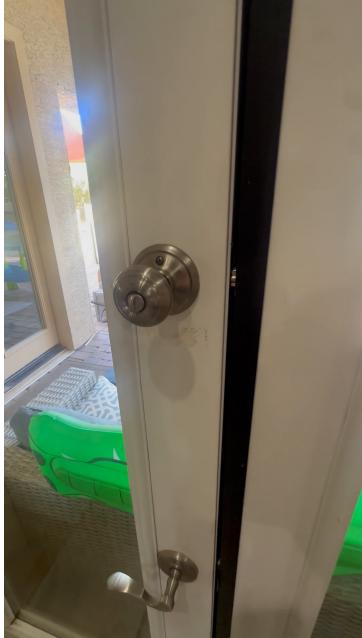
2. Loose, Damaged, or Missing Door Hardware

Various exterior door hardware components, including locksets, hinges, and pulls, were observed to be inoperable, damaged, loose, or absent. It is advised that a qualified contractor perform necessary repairs or replacements.

Original image: broken door handle at Living Room

Annotated image: broken door handle at Living Room

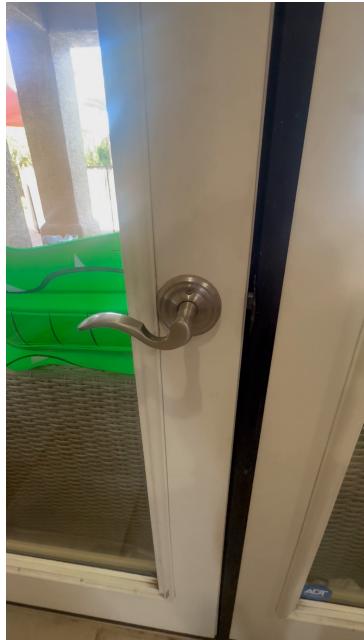
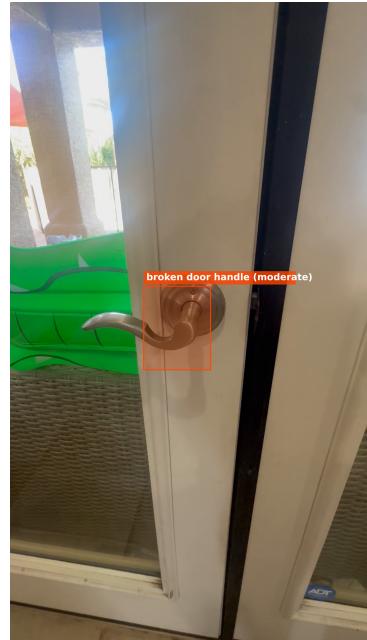
3. Damaged or Missing Door Hardware

The door handle is either damaged or missing. It is recommended that a qualified professional evaluate and repair or replace it as necessary.

Original image: broken door handle at Living Room

Annotated image: broken door handle at Living Room

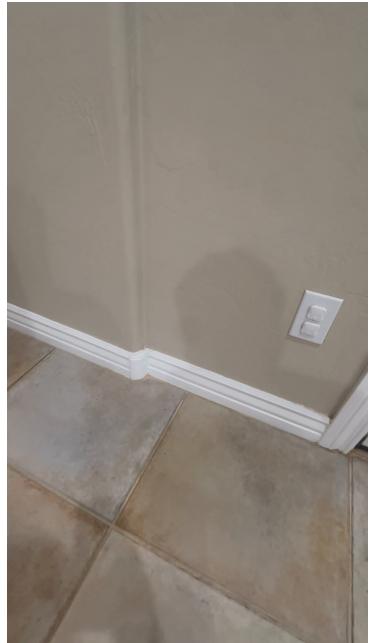
Water damage was observed on the subflooring during the assessment. This damage may signify a historical or ongoing leak. It is advised to consult with the seller regarding the nature of the damage and any prior repairs. Alternatively, monitor the affected area for any subsequent deterioration.

Annotated image: water damage at Living Room

Original image: water damage at Living Room

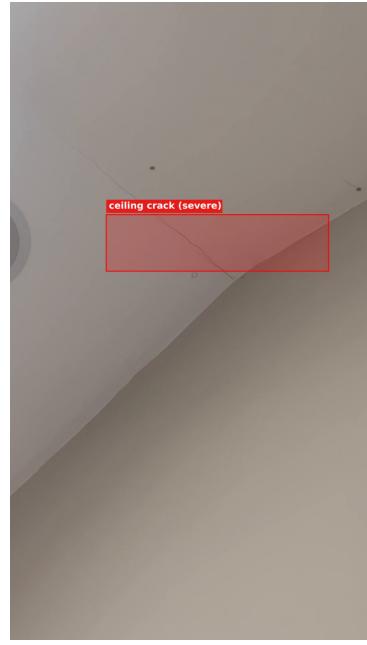
Significant cracking was observed in the ceiling in the Living Room that may indicate underlying structural movement or damage. A licensed contractor or structural engineer should be engaged to evaluate the extent and cause of the cracking and to recommend necessary repairs. This condition may represent a safety risk and should be addressed promptly.

Original image: ceiling crack at Living Room

Annotated image: ceiling crack at Living Room

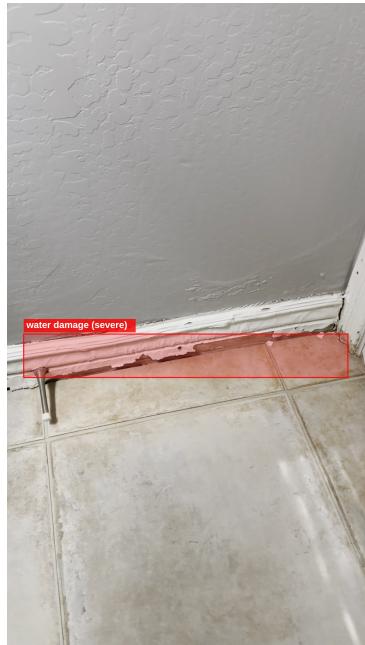
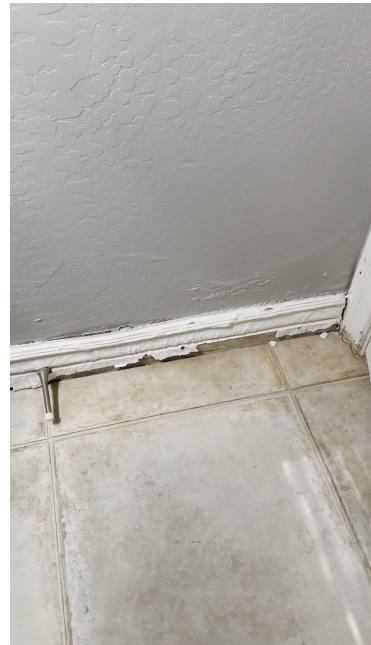
1. Evidence of Active Moisture Intrusion

The observed leakage could cause additional damage to the framing member and floor decking. Water staining and dampness were noted in one or more areas, as confirmed by a moisture meter. This condition increases the risk of insect infestation, mildew, and decay. It is recommended to consult a licensed contractor to identify and rectify the source of the dampness, which may involve improving exterior drainage, installing a waterproofing system, or sealing foundation cracks.

Annotated image: water damage at Master Bathroom

Original image: water damage at Master Bathroom

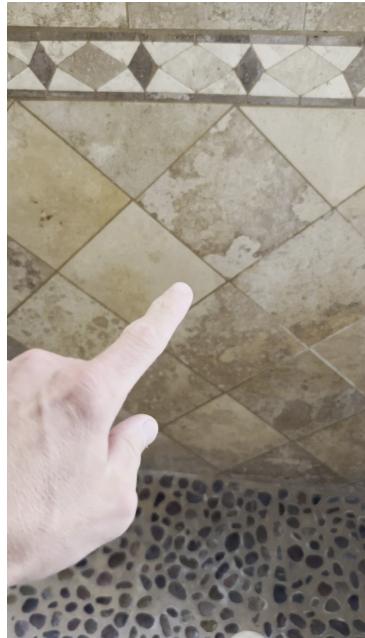
3. Loose Shower Wall Tiles — Safety Hazard

Loose tiles were observed in the master bathroom shower and were reported as a potential safety hazard. Loose or detached tiles can fall or create sharp edges and often indicate compromised substrate or prior water intrusion. It is recommended to discontinue use of the shower until a qualified tile contractor or licensed plumber assesses the condition, secures or replaces loose tiles, and evaluates the underlying substrate for moisture damage or continued leaks. Prompt repair is advised to prevent injury and further deterioration.

Original image: loose tiles at Master Bathroom Shower

Annotated image: loose tiles at Master Bathroom Shower
