## I Inspection Report Overview

## II General Inspection Disclosures

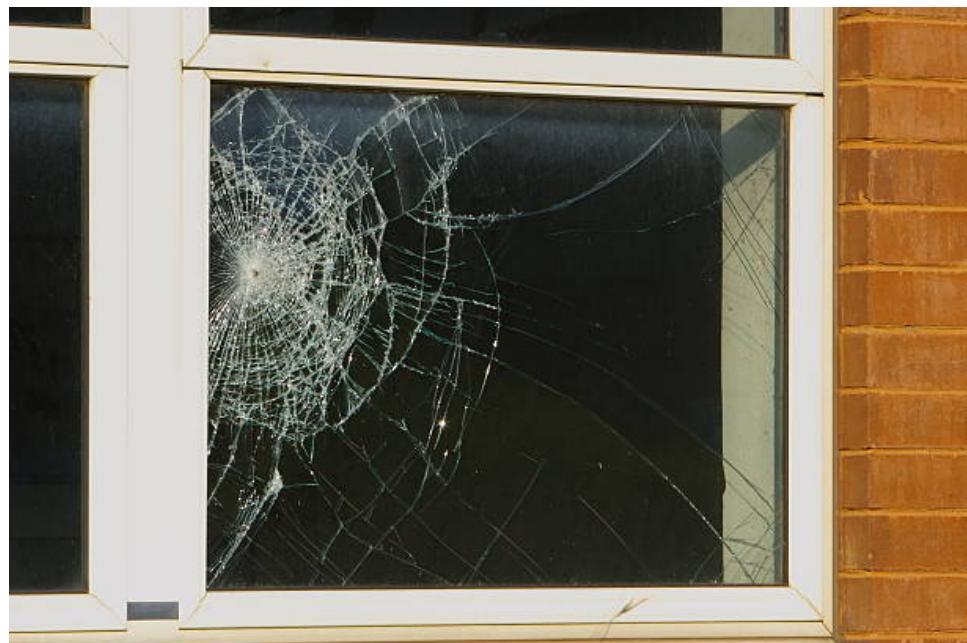
#### **2. Cracked Window Pane**

The damaged glass pane may expose sharp edges and reduce the thermal barrier against the elements. Further evaluation by a qualified contractor is recommended to repair or replace the damaged window as needed.

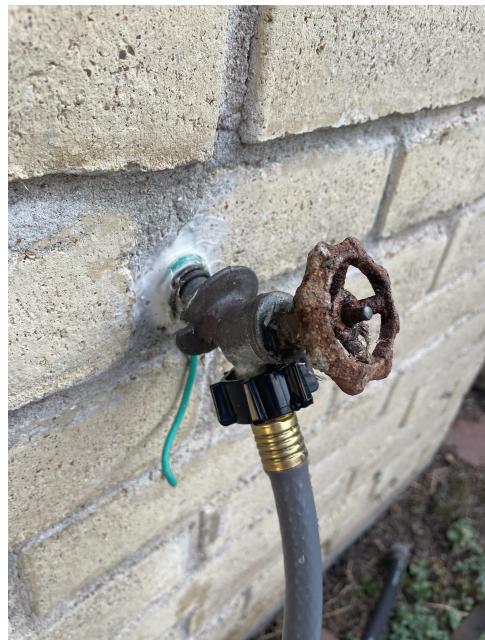
### 8. Hose Bib Repair / Replacement Recommended

Inspector recommends repairing or replacing the exterior hose bib to make it fully operational. Confirm functionality after repair and check for leaks. Obtain quotes from a licensed plumber or qualified contractor as needed.

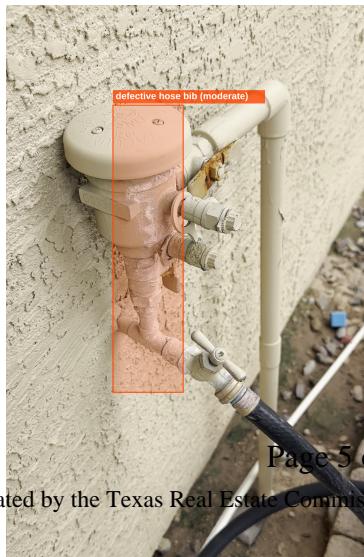
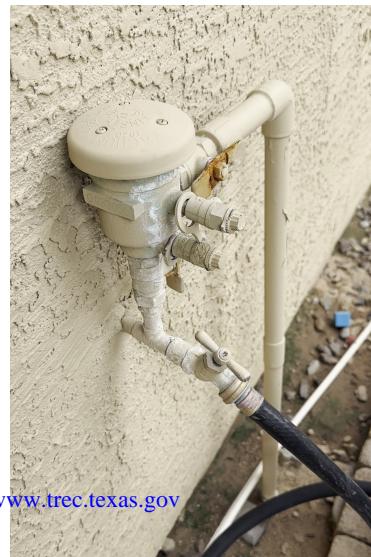
### 10. Hose Bib Handle Damaged or Missing

The handle for the exterior spigot was damaged or missing. Repairs or replacement as needed are recommended to be performed by a qualified individual to ensure proper operation.

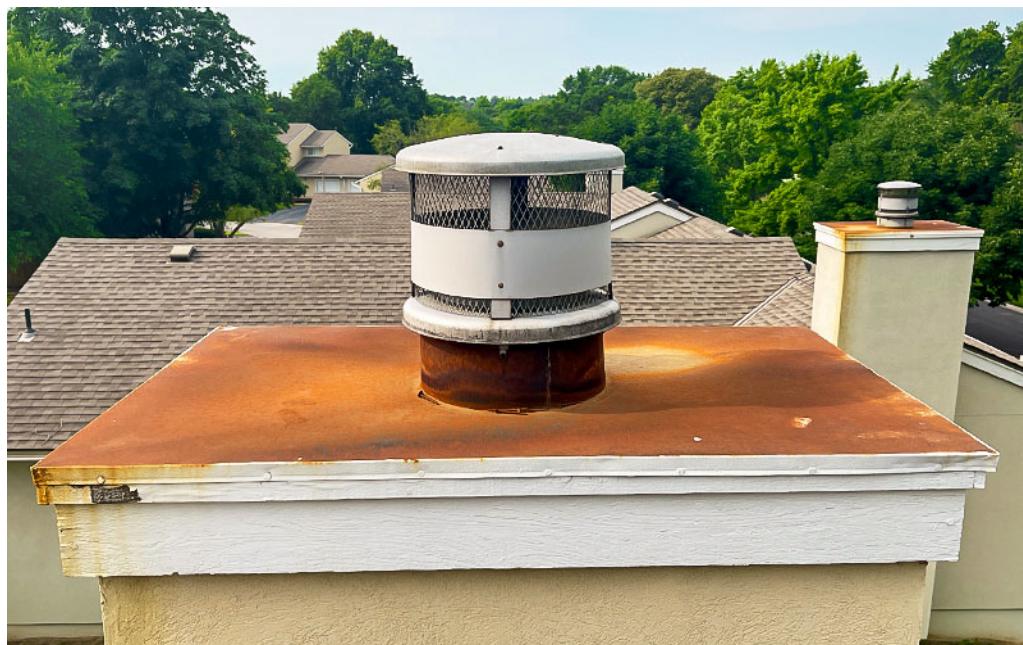
### **2. Corroded Chimney Cap**

The chimney cap displayed signs of corrosion. Regular maintenance, such as sealing, is recommended to prevent further damage and extend its longevity.

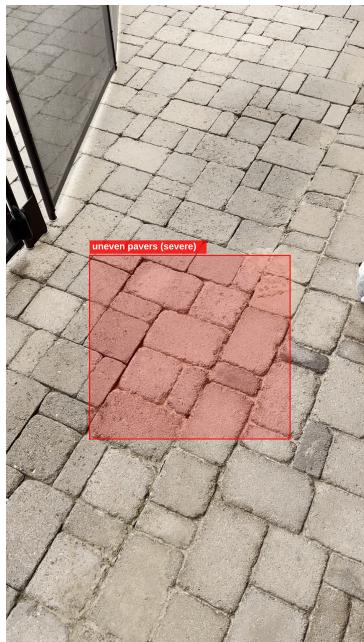
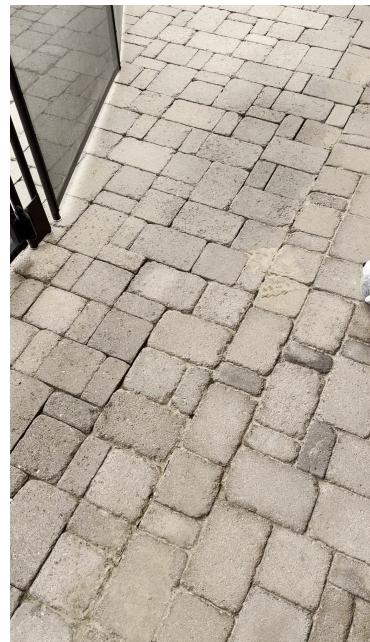
#### 1. Uneven Pavers — Trip Hazard

Uneven paver stones were observed in the backyard, creating a potential trip hazard to occupants and visitors. This condition presents an immediate safety concern and should be corrected. Recommend evaluation and repair by a qualified hardscape contractor or landscaper to re-level, reset, or replace affected pavers to eliminate the trip hazard.

Annotated image: uneven pavers at Back Yard

Original image: uneven pavers at Back Yard

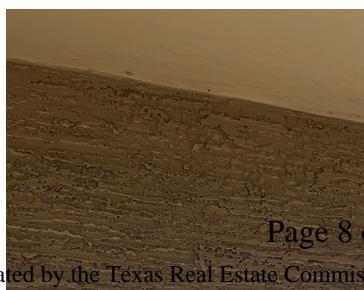
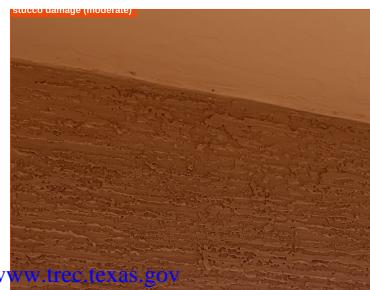
#### 2. Stucco Cracks/Damage

Stucco damage was observed. Gaps or cracks in stucco can allow for moisture intrusion, accelerating deterioration. It is recommended that a qualified contractor evaluate and perform necessary repairs.

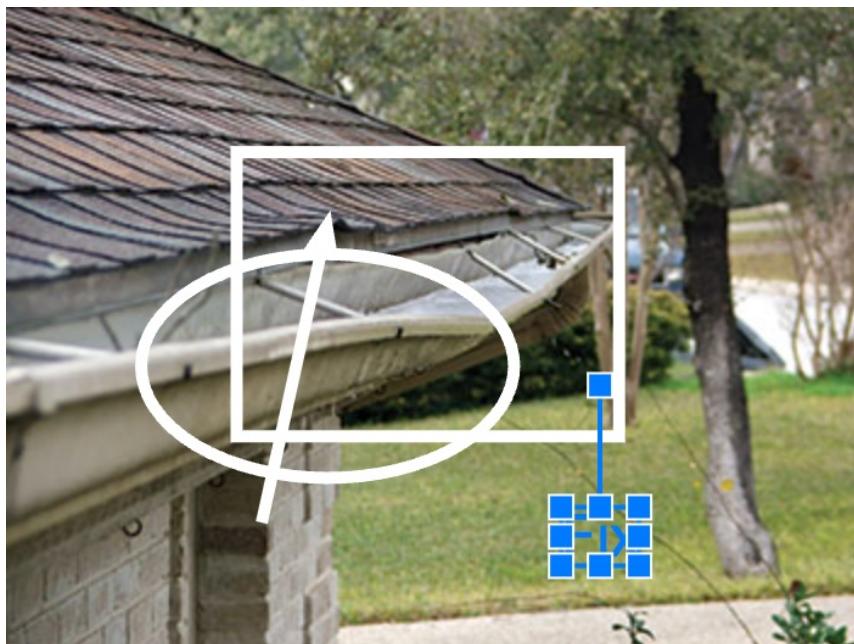
#### 2. Missing or Damaged Gutter Hanger

A gutter hanger was observed to be missing or damaged. It is recommended to properly secure or replace the gutter hangers to ensure the intended stability and proper alignment of the gutter system.

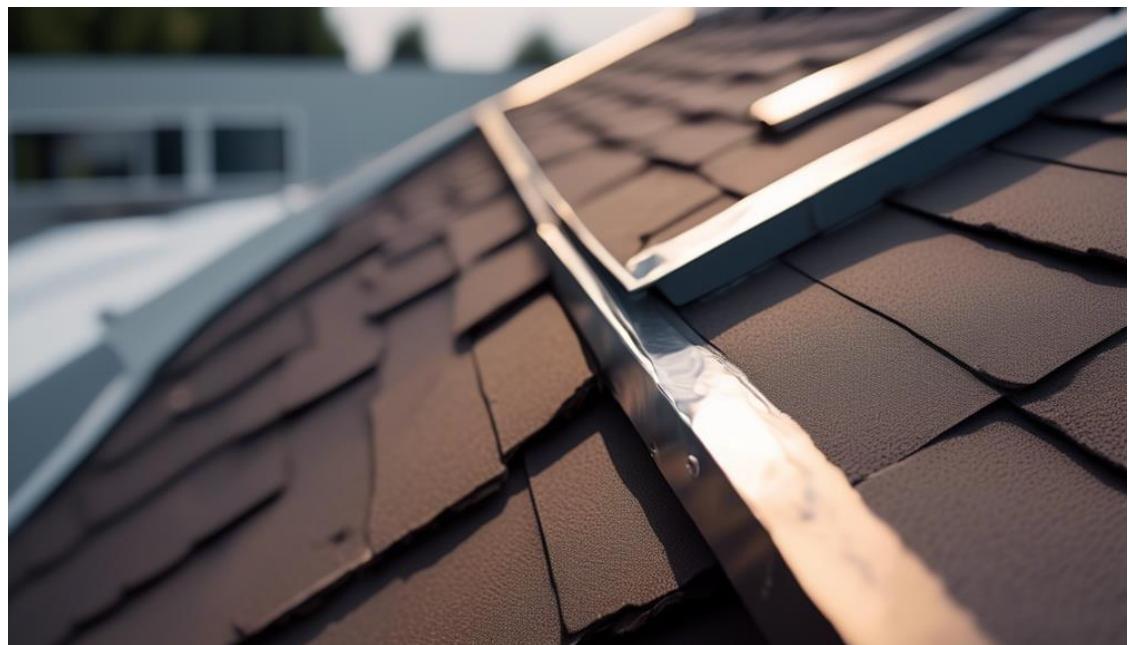
#### 1. Compromised Flashing or Sealant Integrity

Observations indicate the presence of openings or gaps within the flashing or sealant materials. Such breaches can compromise the water-resistant barrier of the roof, potentially leading to water penetration. It is recommended to engage a certified roofing contractor to address and repair these areas to prevent future moisture intrusion.

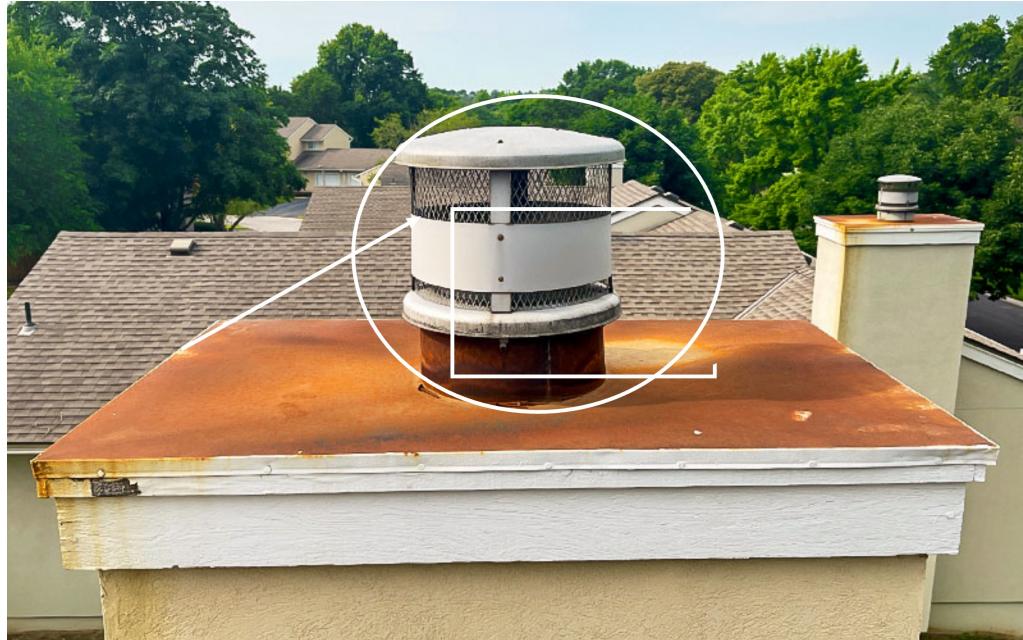
### 1. Vent Cover Damaged or Missing

A damaged or missing vent cover could allow debris and small pests to enter. It is recommended to repair or replace the vent cover to ensure proper operation.

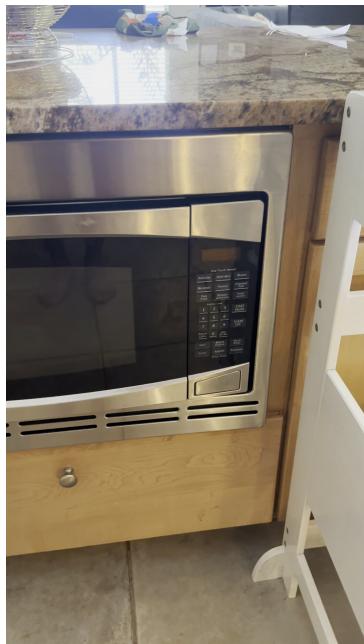
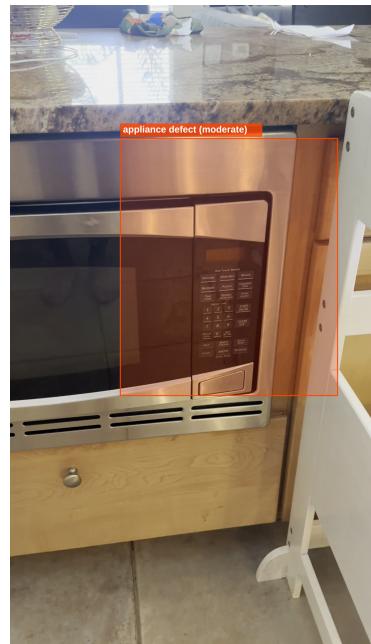
### 1. Unit Non-Functional or Malfunctioning

The microwave oven appeared to be non-operational or was malfunctioning. It is advised that a qualified appliance technician evaluate and perform necessary repairs or replacement.

*Original image: appliance defect at Kitchen*

*Annotated image: appliance defect at Kitchen*

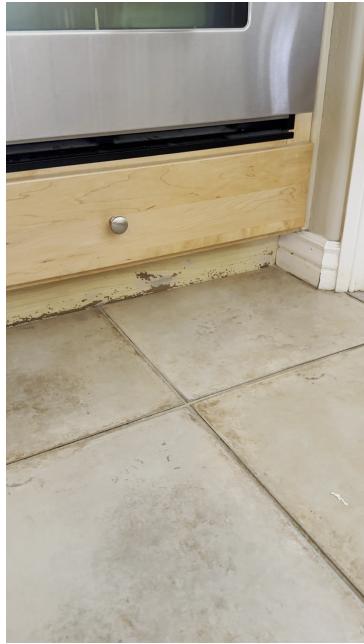
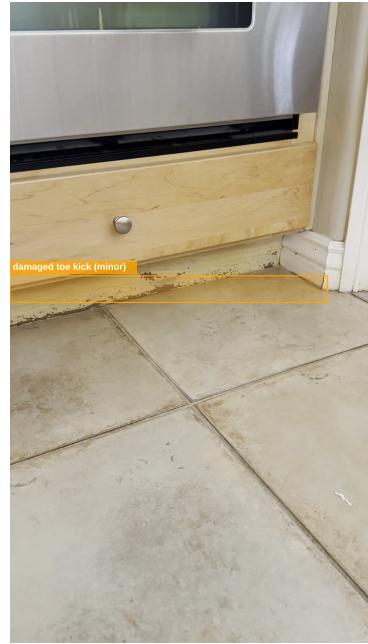
### 3. Failing or Peeling Paint

The paint finish exhibited signs of failure or peeling in one or more locations. It is recommended that a qualified contractor perform the necessary repairs.

Original image: damaged toe kick at Kitchen

Annotated image: damaged toe kick at Kitchen

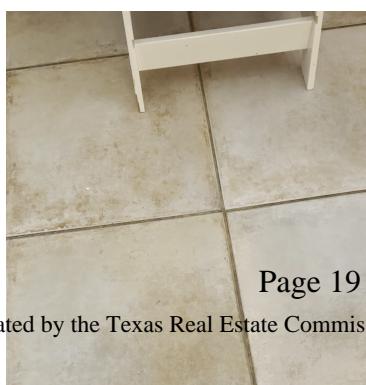
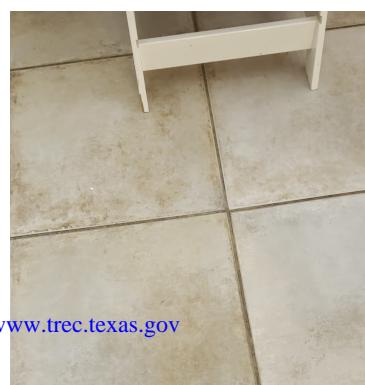
### **1. Cracked Floor Tile**

Two small cracks were observed in the kitchen floor tile. Cracked tile can allow moisture to penetrate the substrate and may deteriorate further over time. Recommend repair or replacement of the affected tile(s) by a qualified flooring contractor and verify the integrity of the surrounding substrate and grout. Obtain estimates as needed.

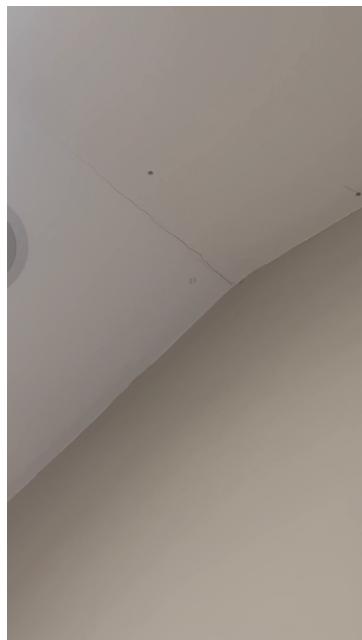
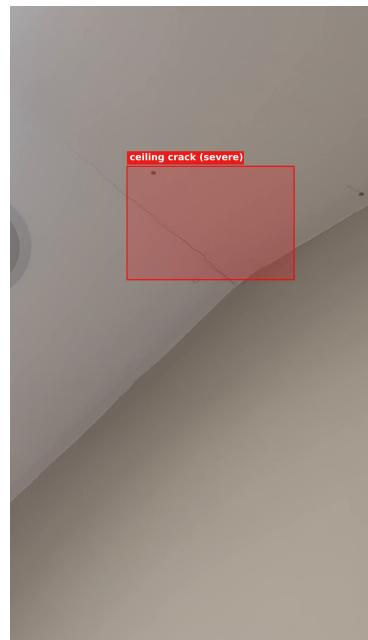
##### **1. Significant Drywall Cracking**

Significant drywall imperfections, including damage, cracking, or inconsistencies, were noted in the referenced area(s). It is advisable to inquire with the current homeowner(s) regarding any past alterations. Repairs should be undertaken by a drywall contractor as desired.

Original image: ceiling crack at Living Room

Annotated image: ceiling crack at Living Room

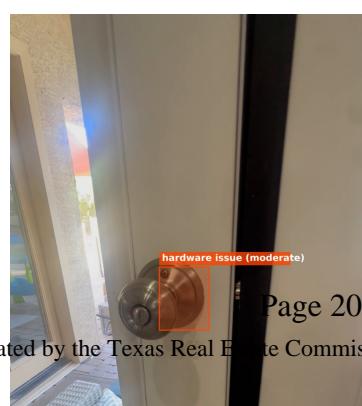
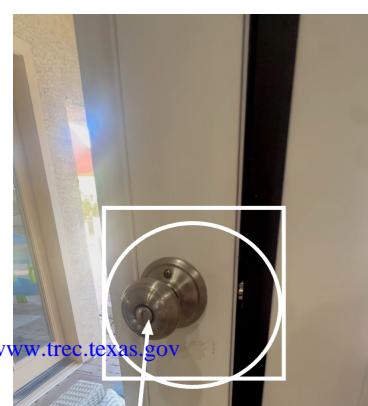
##### **1. Inoperable or Difficult Door Handle Lock**

The handle lock on one or more exterior entryways was found to be inoperable or challenging to use. Replacement of the locking doorknob by a qualified professional is recommended.

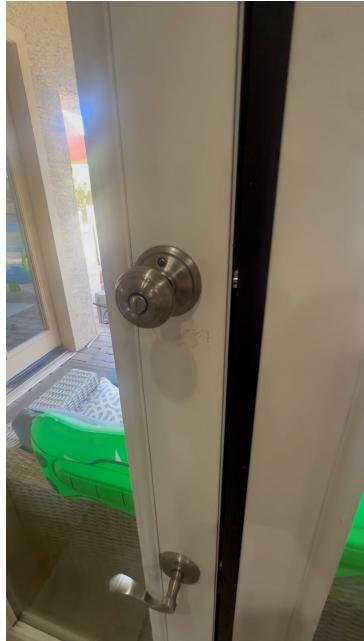
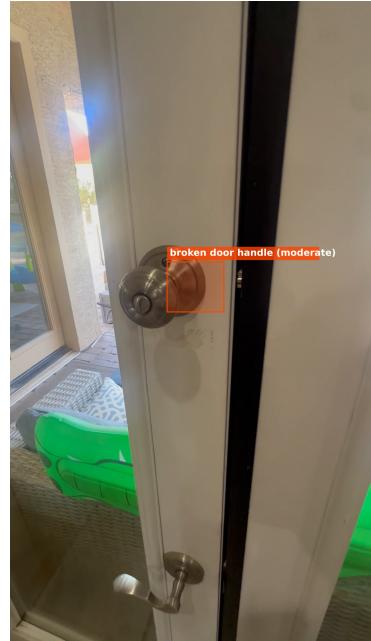
## 2. Loose, Damaged, or Missing Door Hardware

Various exterior door hardware components, including locksets, hinges, and pulls, were observed to be inoperable, damaged, loose, or absent. It is advised that a qualified contractor perform necessary repairs or replacements.

Original image: broken door handle at Living Room

Annotated image: broken door handle at Living Room

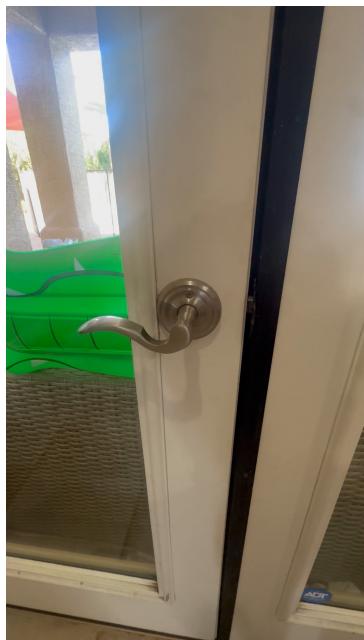
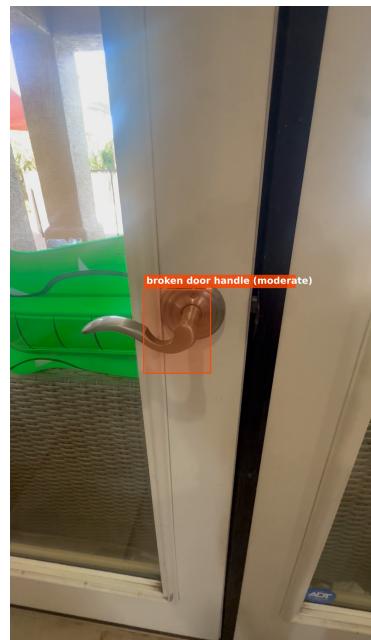
## 3. Damaged or Missing Door Hardware

The door handle is either damaged or missing. It is recommended that a qualified professional evaluate and repair or replace it as necessary.

Original image: broken door handle at Living Room

Annotated image: broken door handle at Living Room

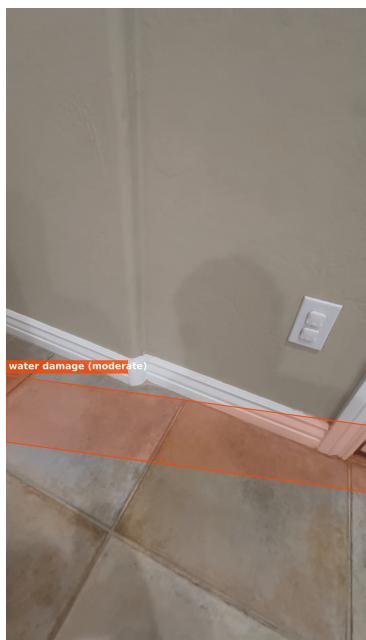
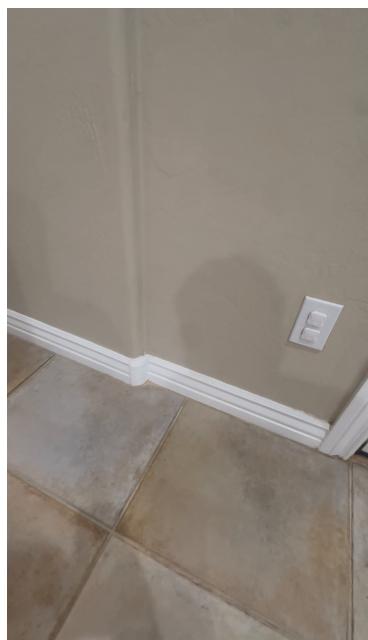
##### 1. Subflooring Water Damage

Water damage was observed on the subflooring during the assessment. This damage may signify a historical or ongoing leak. It is advised to consult with the seller regarding the nature of the damage and any prior repairs. Alternatively, monitor the affected area for any subsequent deterioration.

Annotated image: water damage at Living Room

Original image: water damage at Living Room

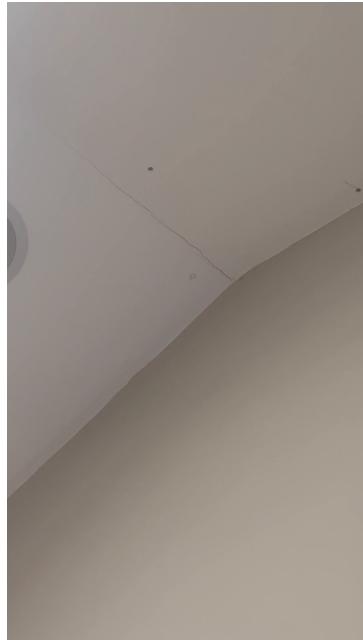
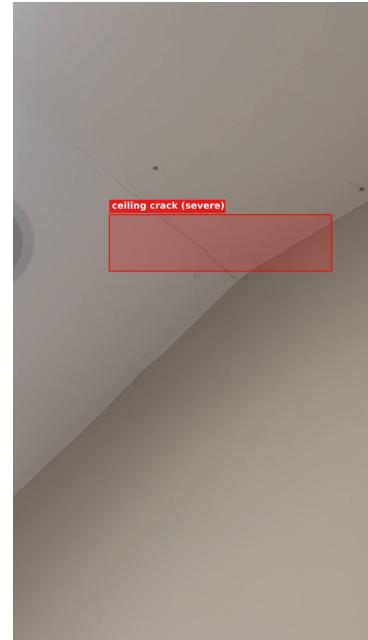
### 1. Ceiling Crack — Possible Structural Concern

Significant cracking was observed in the ceiling in the Living Room that may indicate underlying structural movement or damage. A licensed contractor or structural engineer should be engaged to evaluate the extent and cause of the cracking and to recommend necessary repairs. This condition may represent a safety risk and should be addressed promptly.

*Original image: ceiling crack at Living Room*

*Annotated image: ceiling crack at Living Room*

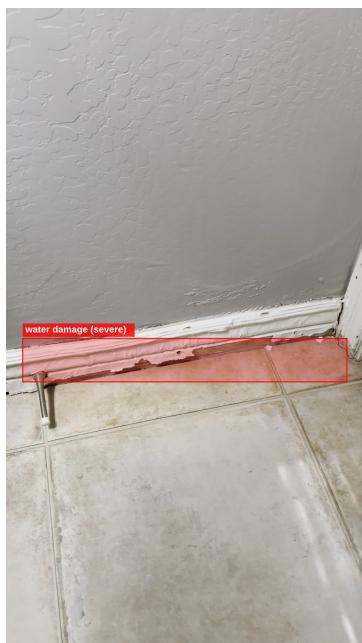
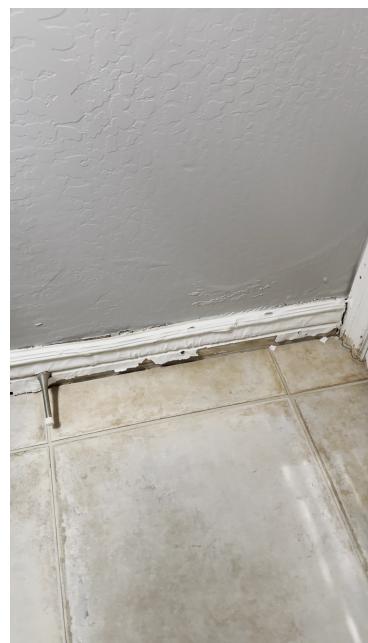
### 1. Evidence of Active Moisture Intrusion

The observed leakage could cause additional damage to the framing member and floor decking. Water staining and dampness were noted in one or more areas, as confirmed by a moisture meter. This condition increases the risk of insect infestation, mildew, and decay. It is recommended to consult a licensed contractor to identify and rectify the source of the dampness, which may involve improving exterior drainage, installing a waterproofing system, or sealing foundation cracks.

Annotated image: water damage at Master Bathroom

Original image: water damage at Master Bathroom

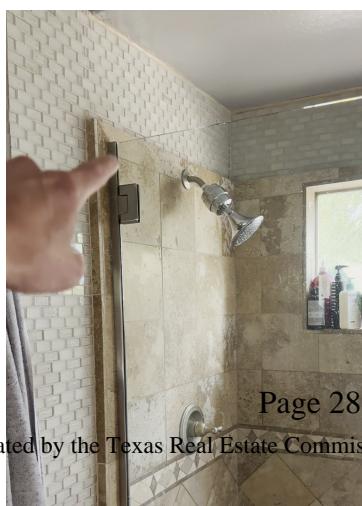
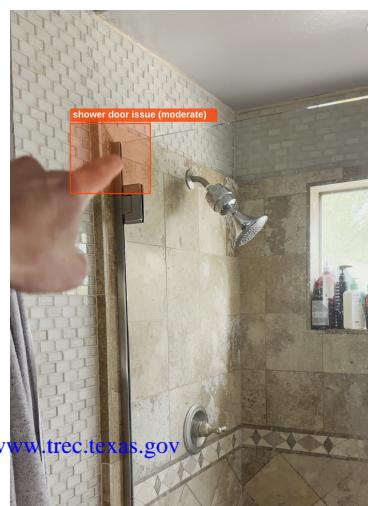
### 2. Shower Door Misalignment / Impacting Glass

The shower door was observed to be striking the adjoining glass and is misaligned. This condition can cause damage to the glass or hardware and may lead to failure if not corrected. It is recommended that a qualified glass/frameless-shower contractor or handyman evaluate the door alignment, adjust hinges or track, and install additional support or reinforcement as necessary to prevent further damage.

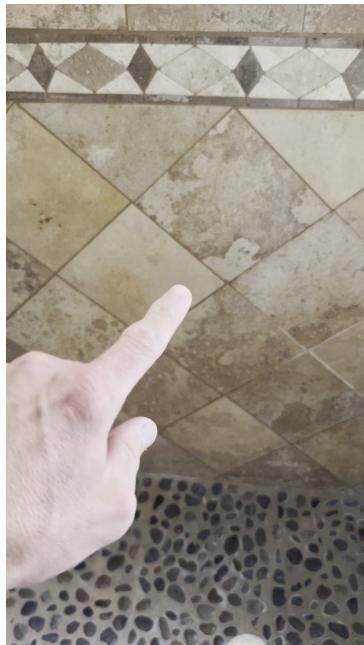
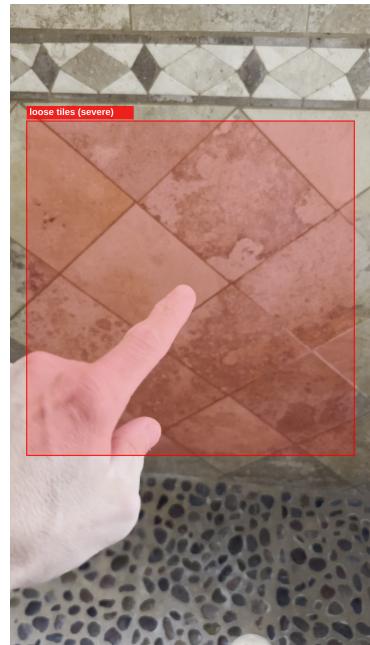
### 3. Loose Shower Wall Tiles — Safety Hazard

Loose tiles were observed in the master bathroom shower and were reported as a potential safety hazard. Loose or detached tiles can fall or create sharp edges and often indicate compromised substrate or prior water intrusion. It is recommended to discontinue use of the shower until a qualified tile contractor or licensed plumber assesses the condition, secures or replaces loose tiles, and evaluates the underlying substrate for moisture damage or continued leaks. Prompt repair is advised to prevent injury and further deterioration.

Original image: loose tiles at Master Bathroom Shower

Annotated image: loose tiles at Master Bathroom Shower
