## I Inspection Report Overview

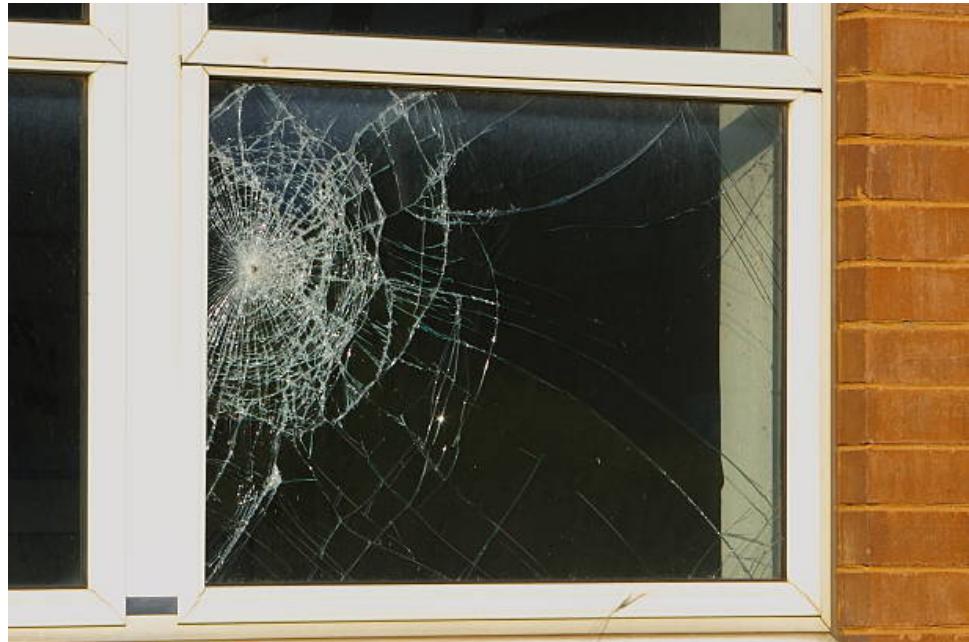
##### **2. Cracked Window Pane**

The damaged glass pane may expose sharp edges and reduce the thermal barrier against the elements. Further evaluation by a qualified contractor is recommended to repair or replace the damaged window as needed.

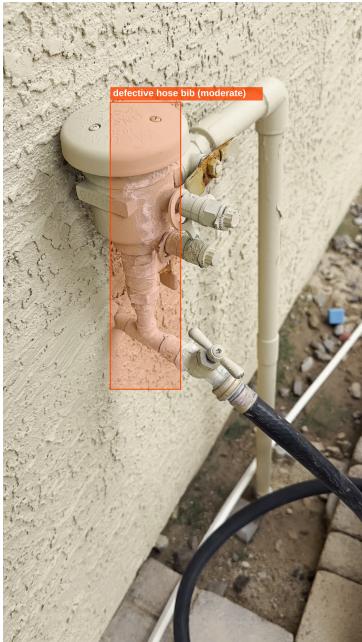
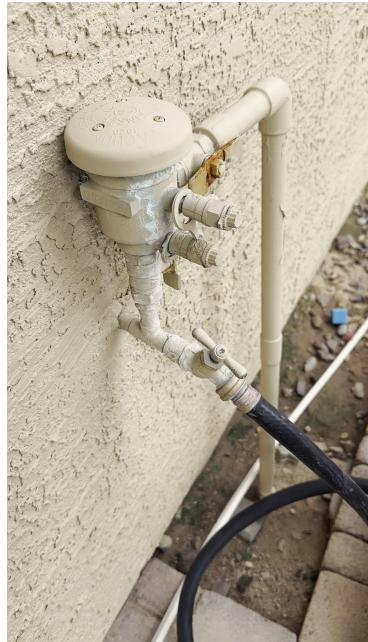
#### **10. Hose Bib Handle Damaged or Missing**

The handle for the exterior spigot was damaged or missing. Repairs or replacement as needed are recommended to be performed by a qualified individual to ensure proper operation.

Annotated image: defective hose bib at Back Yard

Original image: defective hose bib at Back Yard

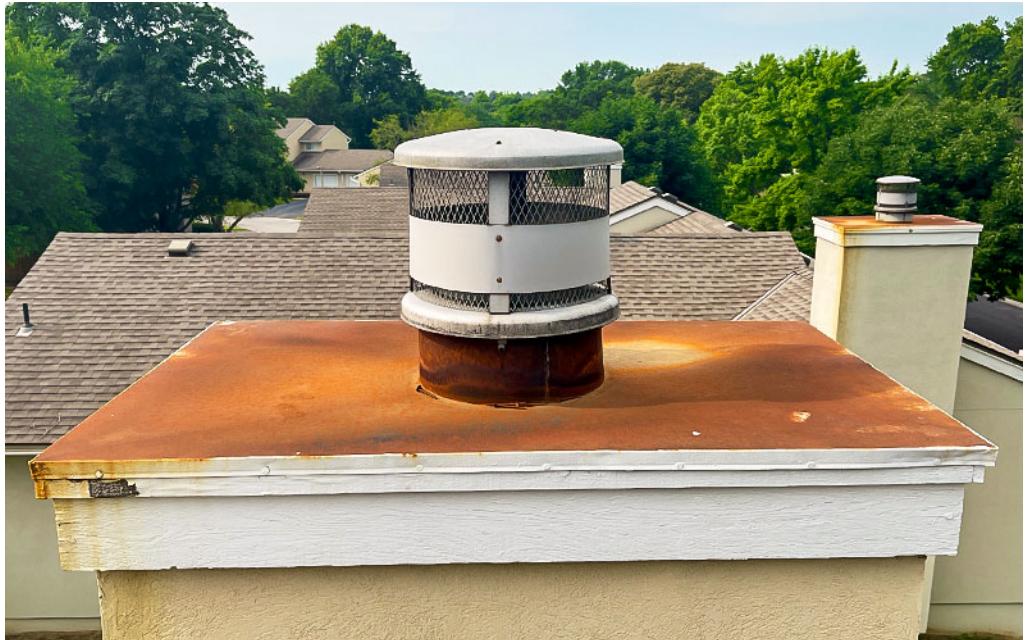
#### **2. Corroded Chimney Cap**

The chimney cap displayed signs of corrosion. Regular maintenance, such as sealing, is

recommended to prevent further damage and extend its longevity.

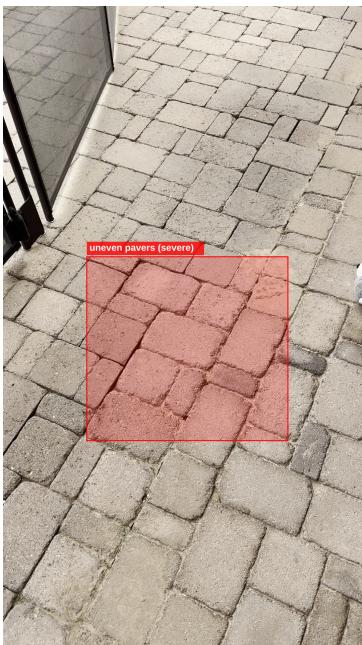
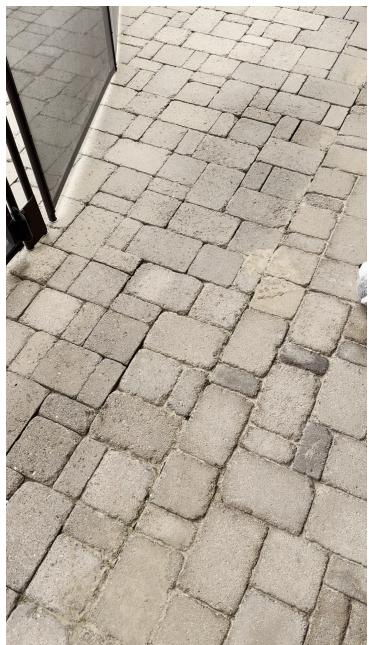
### 1. Uneven Pavers — Trip Hazard

Uneven paver stones were observed in the backyard, creating a potential trip hazard to occupants and visitors. This condition presents an immediate safety concern and should be corrected.

Annotated image: uneven pavers at Back Yard

Original image: uneven pavers at Back Yard

Recommend evaluation and repair by a qualified hardscape contractor or landscaper to re-level, reset, or replace affected pavers to eliminate the trip hazard.

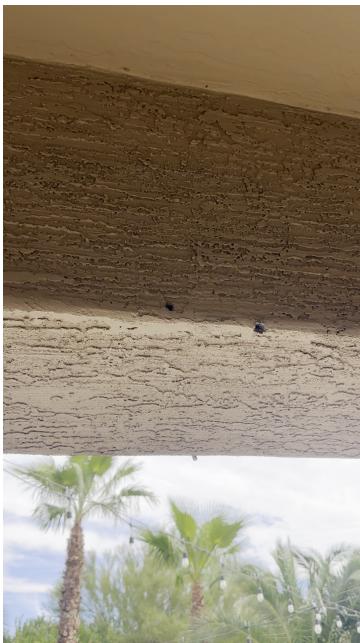
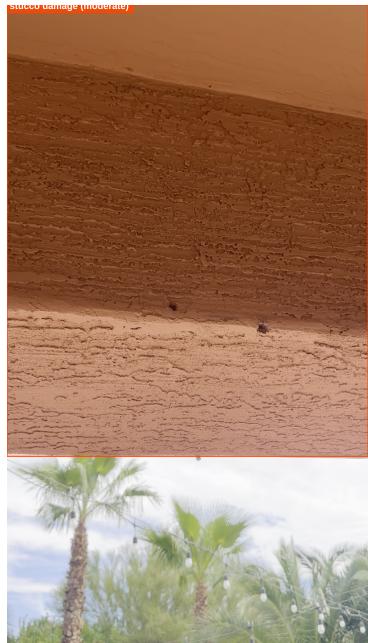
### **2. Stucco Cracks/Damage**

Stucco damage was observed. Gaps or cracks in stucco can allow for moisture intrusion, accelerating deterioration. It is recommended that a qualified contractor evaluate and perform necessary repairs.

Original image: stucco damage at Back Yard

Annotated image: stucco damage at Back Yard

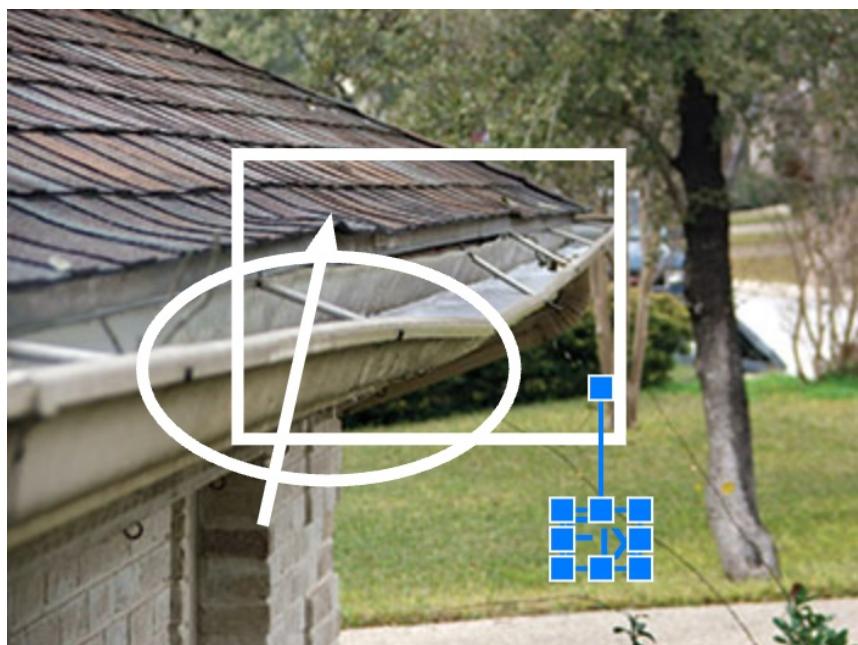
### 2. Missing or Damaged Gutter Hanger

A gutter hanger was observed to be missing or damaged. It is recommended to properly secure or replace the gutter hangers to ensure the intended stability and proper alignment of the gutter system.

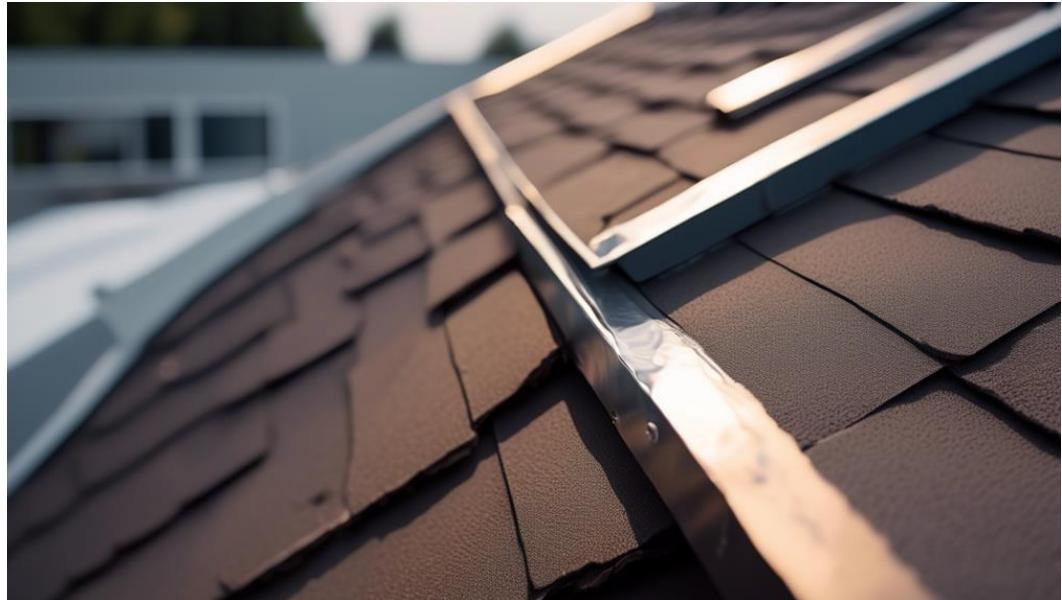
#### **1. Compromised Flashing or Sealant Integrity**

Observations indicate the presence of openings or gaps within the flashing or sealant materials. Such breaches can compromise the water-resistant barrier of the roof, potentially leading to water penetration. It is recommended to engage a certified roofing contractor to address and repair these areas to prevent future moisture intrusion.

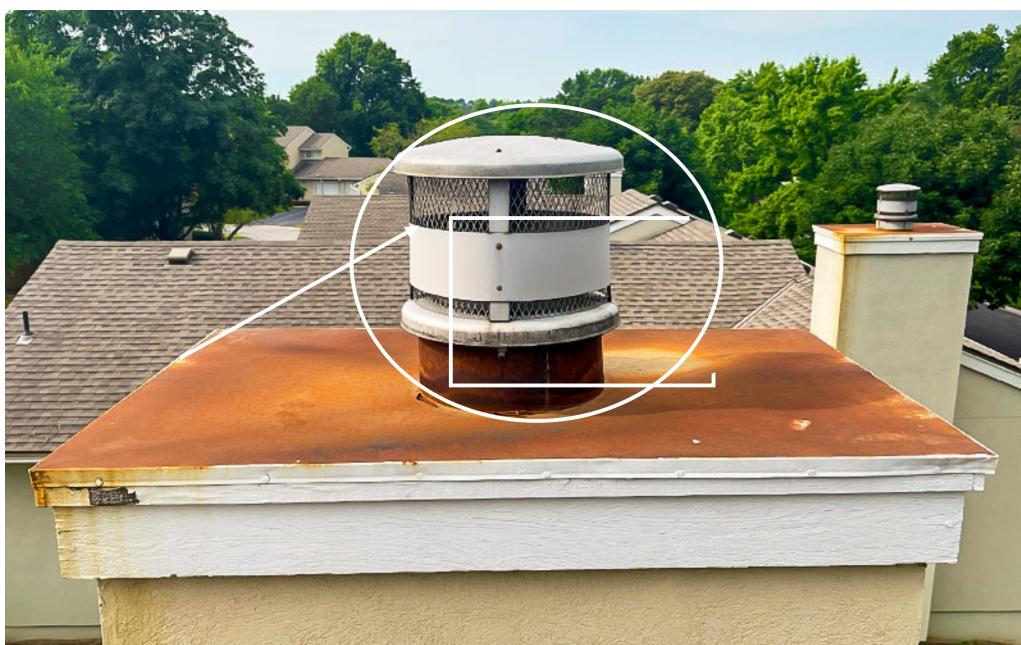
#### **1. Vent Cover Damaged or Missing**

A damaged or missing vent cover could allow debris and small pests to enter. It is recommended to repair or replace the vent cover to ensure proper operation.

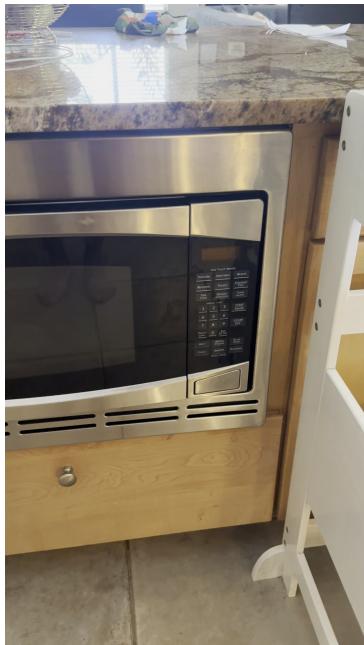
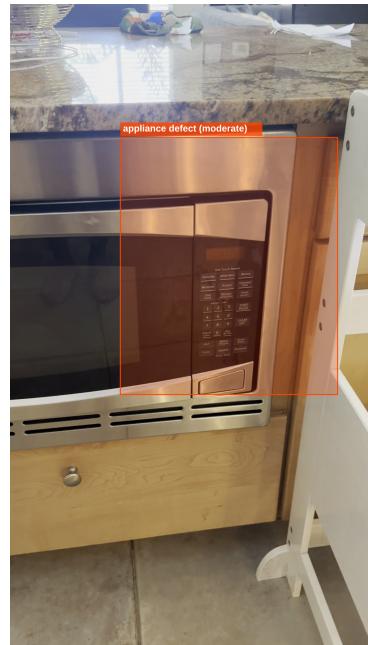
The microwave oven appeared to be non-operational or was malfunctioning. It is advised that a qualified appliance technician evaluate and perform necessary repairs or replacement.

*Original image: appliance defect at Kitchen*

*Annotated image: appliance defect at Kitchen*

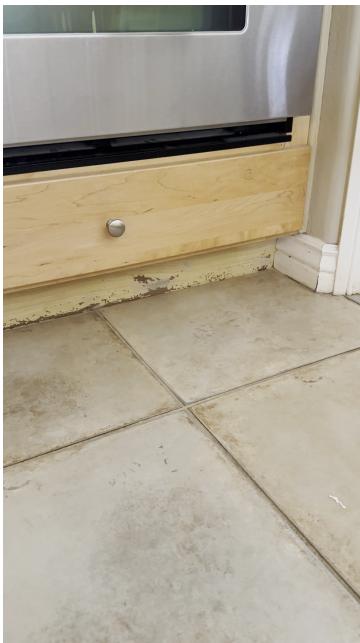
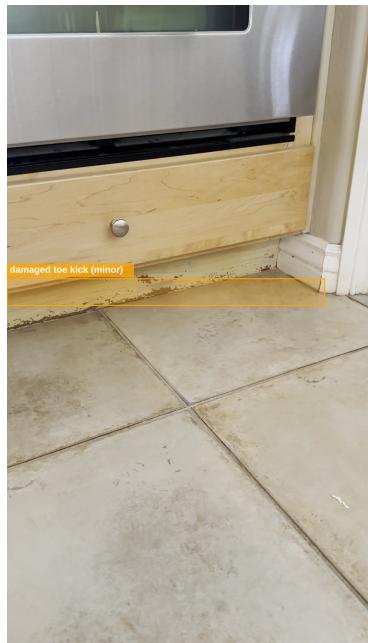
#### **3. Failing or Peeling Paint**

The paint finish exhibited signs of failure or peeling in one or more locations. It is recommended that a qualified contractor perform the necessary repairs.

*Original image: damaged toe kick at Kitchen*

*Annotated image: damaged toe kick at Kitchen*

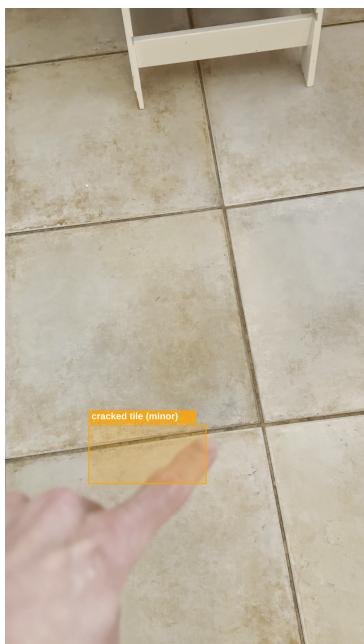
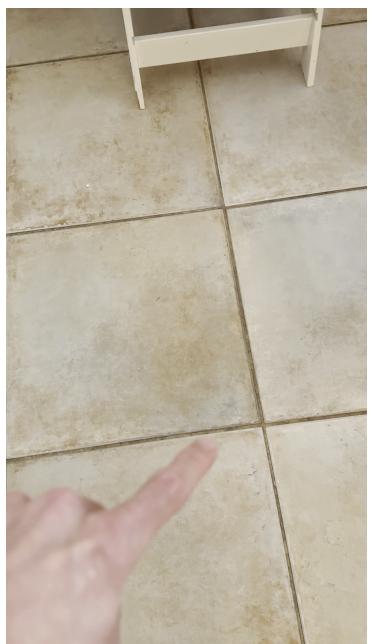
### **1. Cracked Floor Tile**

Two small cracks were observed in the kitchen floor tile. Cracked tile can allow moisture to penetrate the substrate and may deteriorate further over time. Recommend repair or replacement of the affected tile(s) by a qualified flooring contractor and verify the integrity of the surrounding substrate and grout. Obtain estimates as needed.

Annotated image: cracked tile at Kitchen

Original image: cracked tile at Kitchen

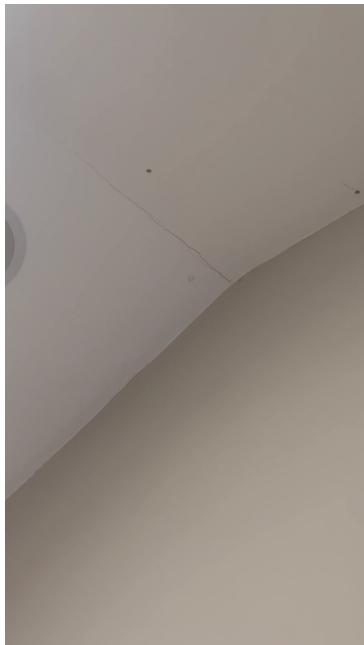
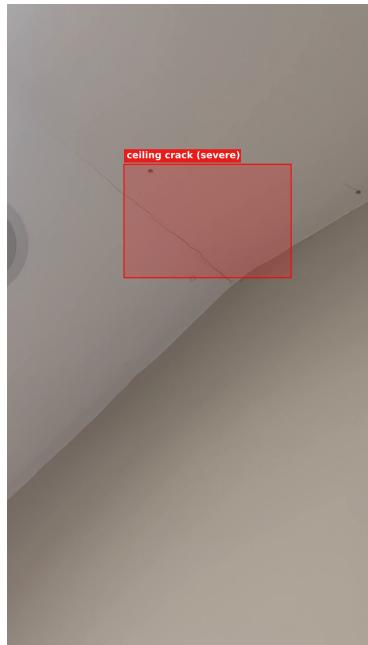
#### 1. Significant Drywall Cracking

Significant drywall imperfections, including damage, cracking, or inconsistencies, were noted in the referenced area(s). It is advisable to inquire with the current homeowner(s) regarding any past alterations. Repairs should be undertaken by a drywall contractor as desired.

*Original image: ceiling crack at Living Room*

*Annotated image: ceiling crack at Living Room*

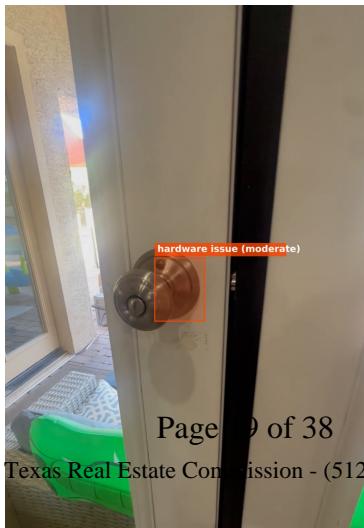
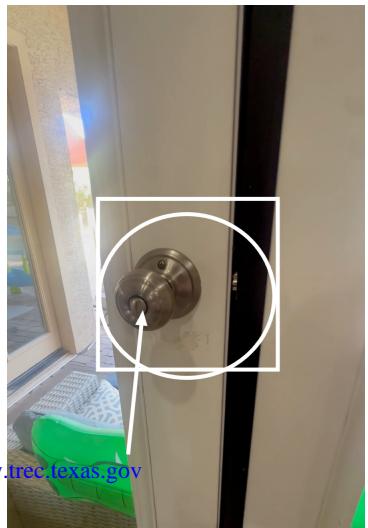
#### 1. Inoperable or Difficult Door Handle Lock

The handle lock on one or more exterior entryways was found to be inoperable or challenging to use. Replacement of the locking doorknob by a qualified professional is recommended.

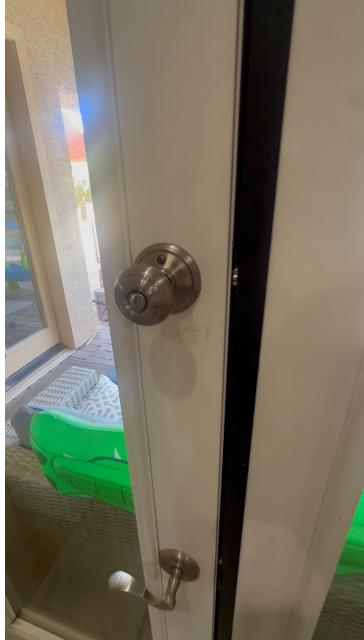
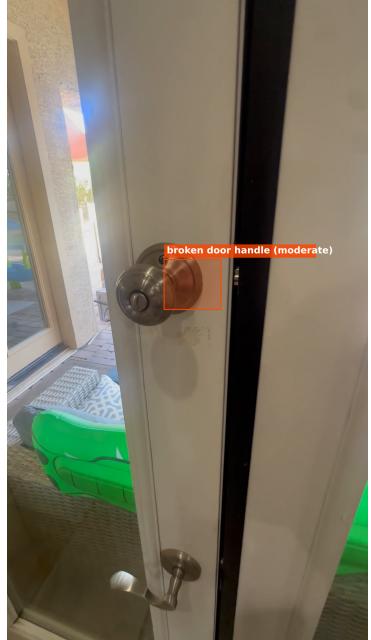
## 2. Loose, Damaged, or Missing Door Hardware

Various exterior door hardware components, including locksets, hinges, and pulls, were observed to be inoperable, damaged, loose, or absent. It is advised that a qualified contractor perform necessary repairs or replacements.

Original image: broken door handle at Living Room

Annotated image: broken door handle at Living Room

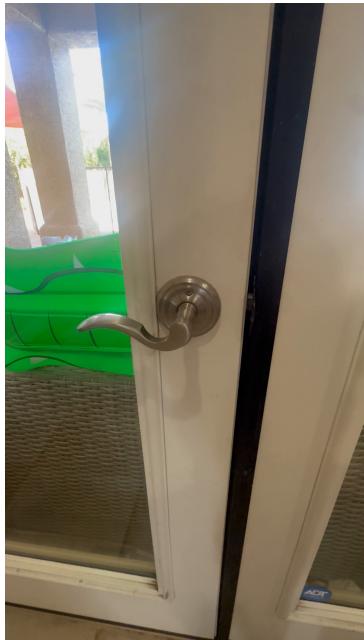
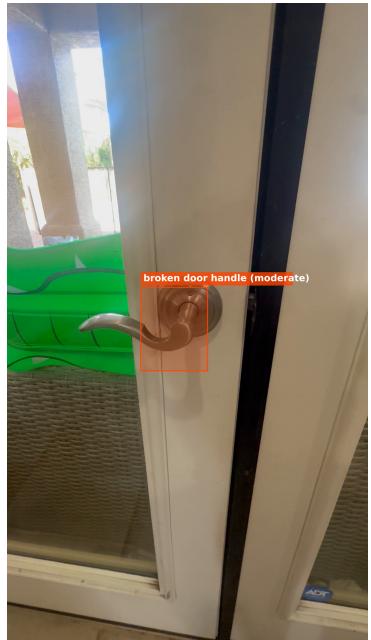
## 3. Damaged or Missing Door Hardware

The door handle is either damaged or missing. It is recommended that a qualified professional evaluate and repair or replace it as necessary.

Original image: broken door handle at Living Room

Annotated image: broken door handle at Living Room

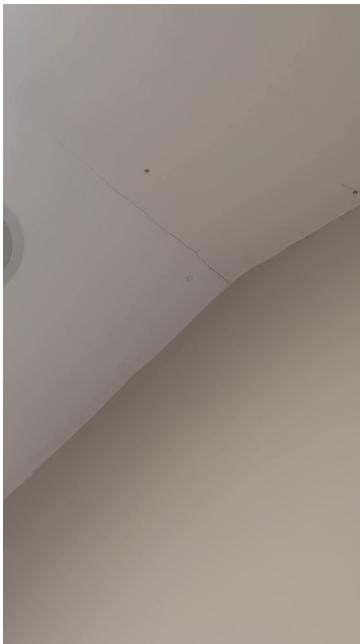
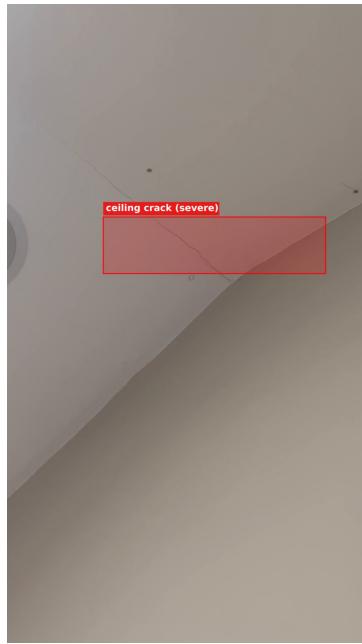
##### **1. Ceiling Crack — Possible Structural Concern**

Significant cracking was observed in the ceiling in the Living Room that may indicate underlying structural movement or damage. A licensed contractor or structural engineer should be engaged to evaluate the extent and cause of the cracking and to recommend necessary repairs. This condition may represent a safety risk and should be addressed promptly.

*Original image: ceiling crack at Living Room*

*Annotated image: ceiling crack at Living Room*

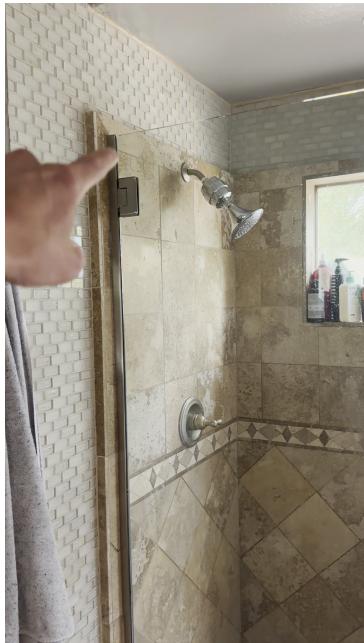
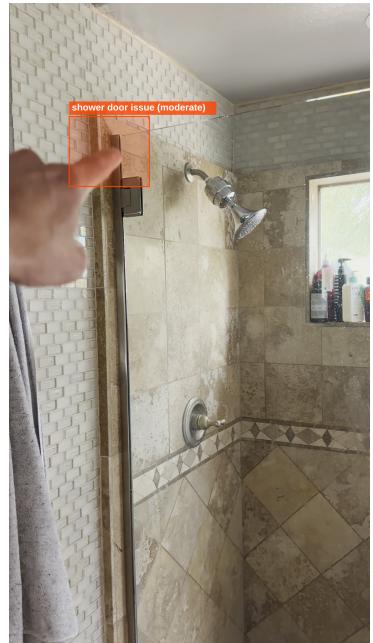
## 2. Shower Door Misalignment / Impacting Glass

The shower door was observed to be striking the adjoining glass and is misaligned. This condition can cause damage to the glass or hardware and may lead to failure if not corrected. It is recommended that a qualified glass/frameless-shower contractor or handyman evaluate the door alignment, adjust hinges or track, and install additional support or reinforcement as necessary to prevent further damage.

Original image: shower door issue at Master Bathroom Annotated image: shower door issue at Master Bathroom

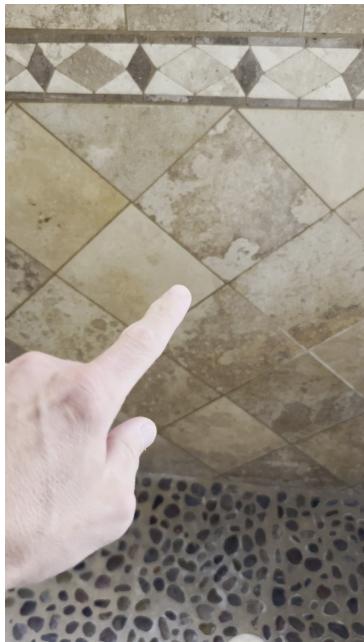
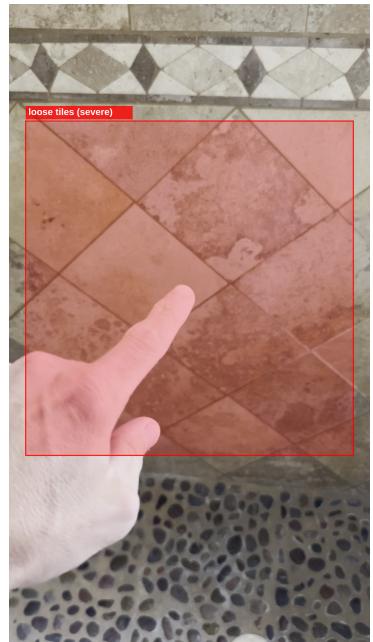
## 3. Loose Shower Wall Tiles — Safety Hazard

Loose tiles were observed in the master bathroom shower and were reported as a potential safety hazard. Loose or detached tiles can fall or create sharp edges and often indicate compromised substrate or prior water intrusion. It is recommended to discontinue use of the shower until a qualified tile contractor or licensed plumber assesses the condition, secures or replaces loose tiles, and evaluates the underlying substrate for moisture damage or continued leaks. Prompt repair is advised to prevent injury and further deterioration.

Original image: loose tiles at Master Bathroom Shower Annotated image: loose tiles at Master Bathroom Shower
