I Inspection Report Overview

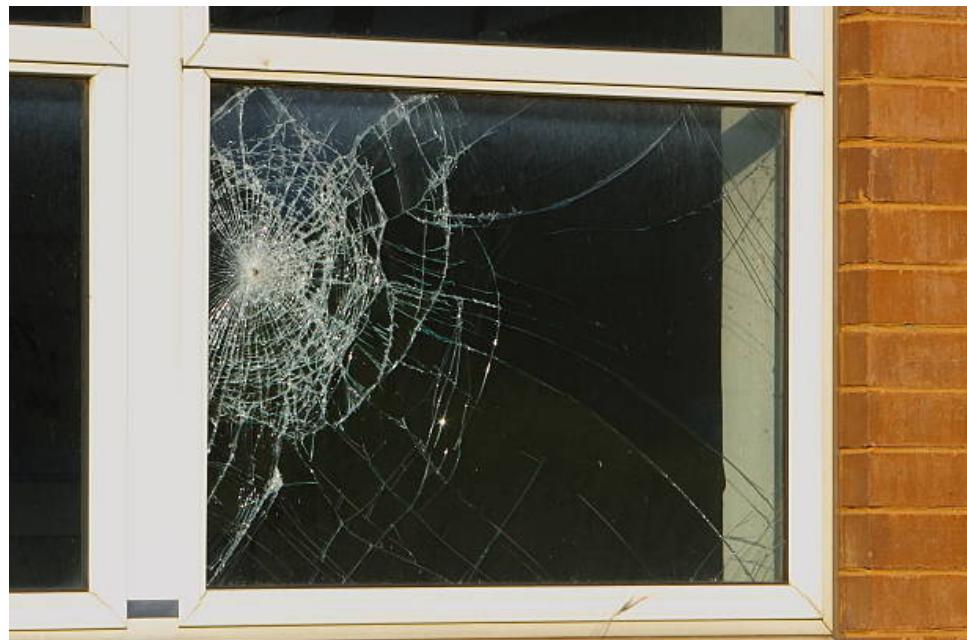
2. Cracked Window Pane

The damaged glass pane may expose sharp edges and reduce the thermal barrier against the elements. Further evaluation by a qualified contractor is recommended to repair or replace the damaged window as needed.

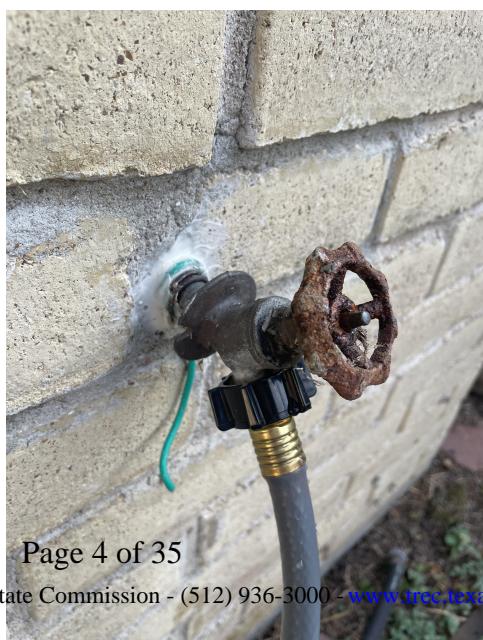
8. Hose Bib Repair / Replacement Recommended

Inspector recommends repairing or replacing the exterior hose bib to make it fully operational. Confirm functionality after repair and check for leaks. Obtain quotes from a licensed plumber or qualified contractor as needed.

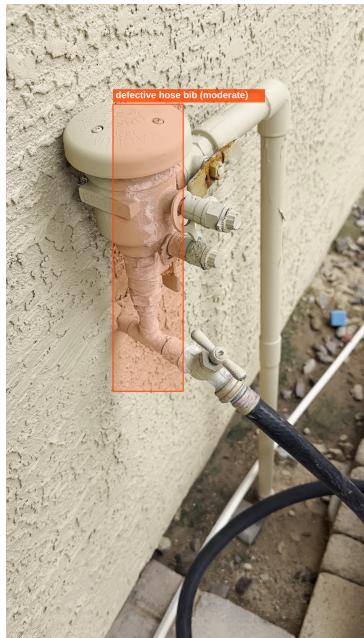
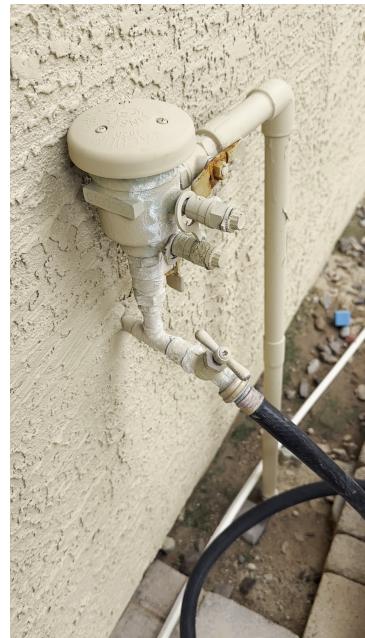
10. Hose Bib Handle Damaged or Missing

The handle for the exterior spigot was damaged or missing. Repairs or replacement as needed are recommended to be performed by a qualified individual to ensure proper operation.

Annotated image: defective hose bib at Back Yard

Original image: defective hose bib at Back Yard

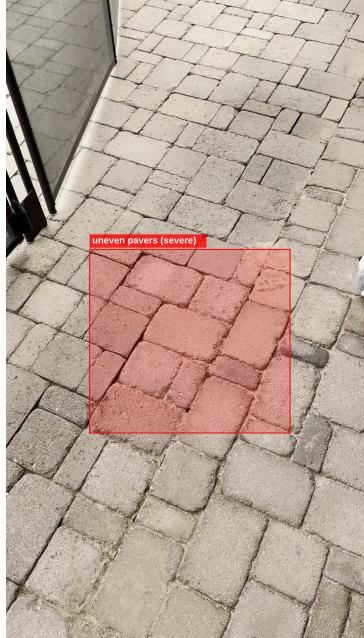
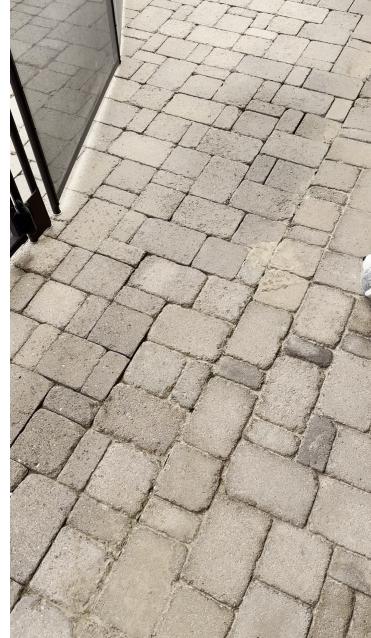
1. Uneven Pavers — Trip Hazard

Uneven paver stones were observed in the backyard, creating a potential trip hazard to occupants and visitors. This condition presents an immediate safety concern and should be corrected. Recommend evaluation and repair by a qualified hardscape contractor or landscaper to re-level, reset, or replace affected pavers to eliminate the trip hazard.

Annotated image: uneven pavers at Back Yard

Original image: uneven pavers at Back Yard

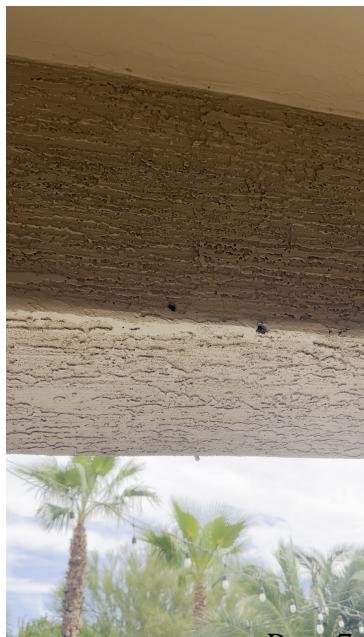
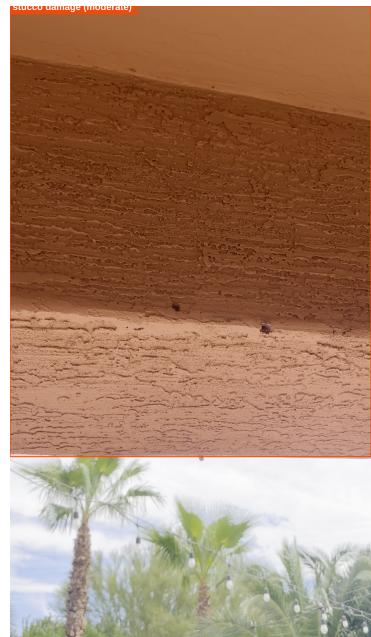
2. Stucco Cracks/Damage

Stucco damage was observed. Gaps or cracks in stucco can allow for moisture intrusion, accelerating deterioration. It is recommended that a qualified contractor evaluate and perform necessary repairs.

Original image: stucco damage at Back Yard

Annotated image: stucco damage at Back Yard

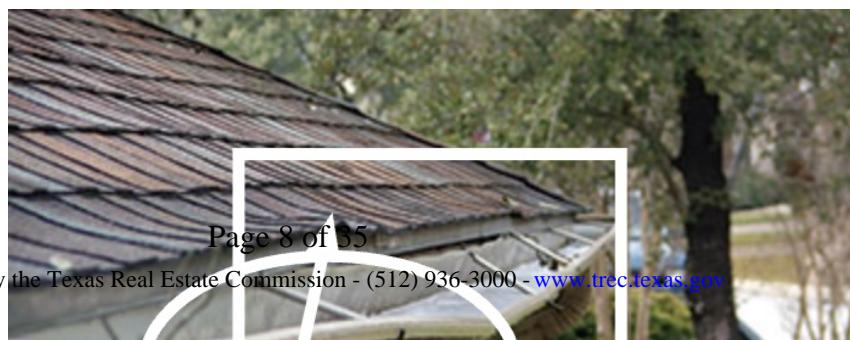
2. Missing or Damaged Gutter Hanger

A gutter hanger was observed to be missing or damaged. It is recommended to properly secure or replace the gutter hangers to ensure the intended stability and proper alignment of the gutter system.

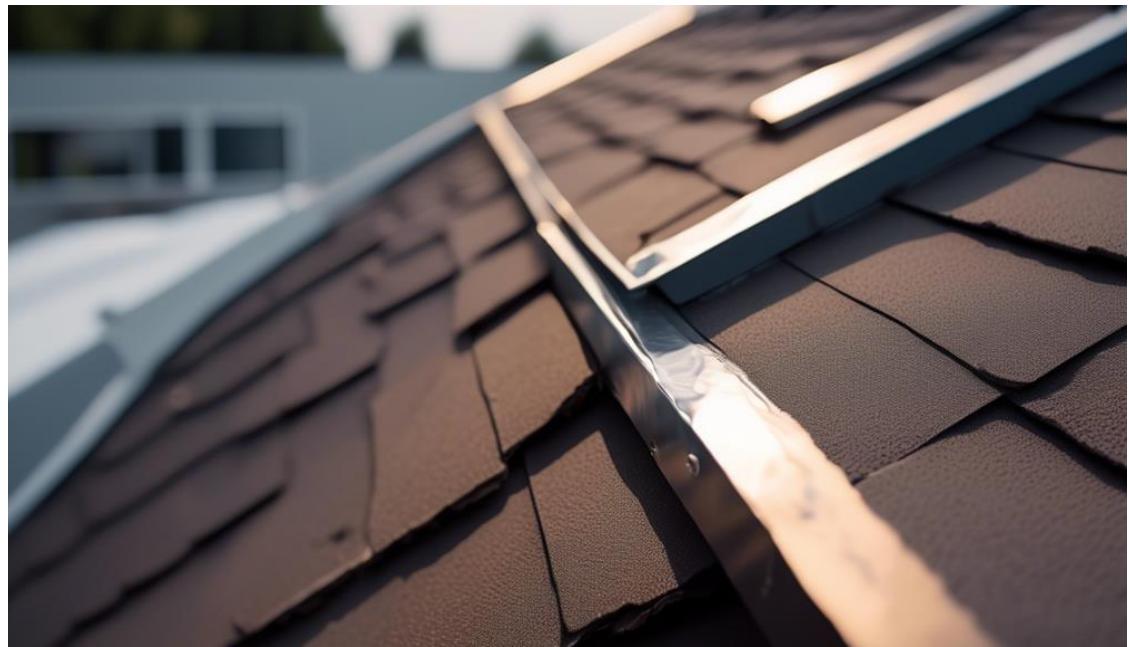
1. Compromised Flashing or Sealant Integrity

Observations indicate the presence of openings or gaps within the flashing or sealant materials. Such breaches can compromise the water-resistant barrier of the roof, potentially leading to water penetration. It is recommended to engage a certified roofing contractor to address and repair these areas to prevent future moisture intrusion.

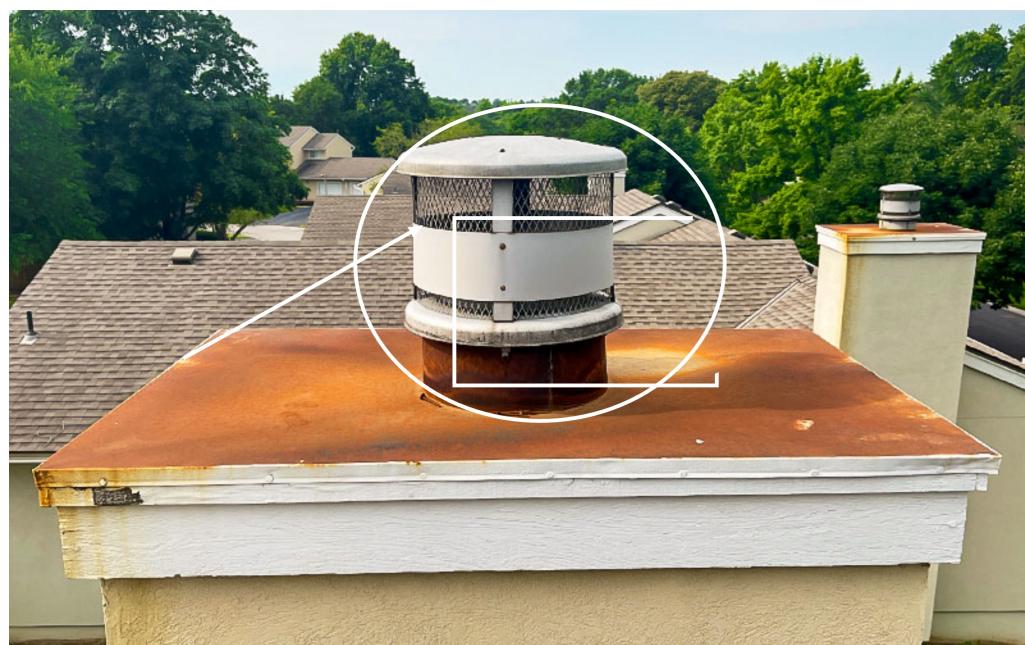
1. Vent Cover Damaged or Missing

A damaged or missing vent cover could allow debris and small pests to enter. It is recommended to repair or replace the vent cover to ensure proper operation.

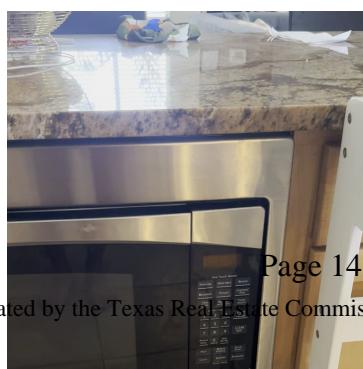
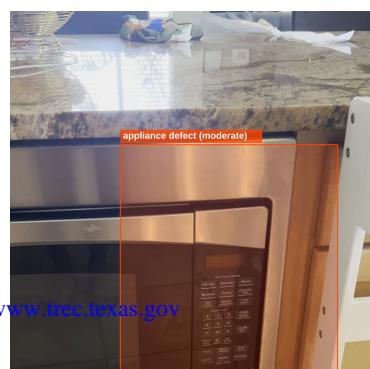
1. Unit Non-Functional or Malfunctioning

The microwave oven appeared to be non-operational or was malfunctioning. It is advised that a qualified appliance technician evaluate and perform necessary repairs or replacement.

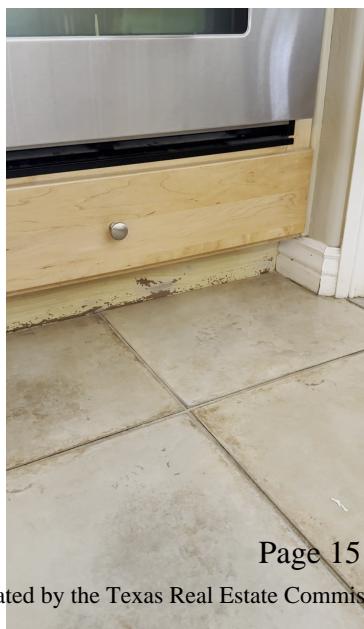
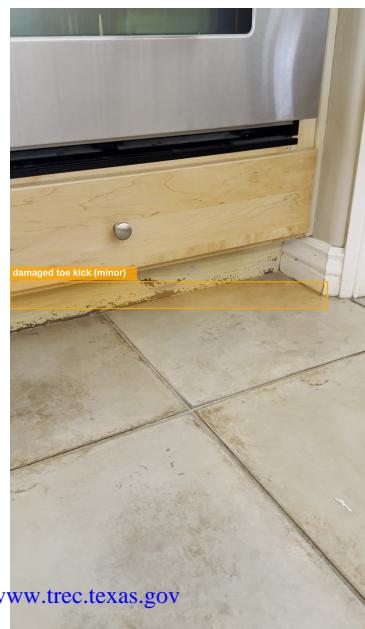
3. Failing or Peeling Paint

The paint finish exhibited signs of failure or peeling in one or more locations. It is recommended that a qualified contractor perform the necessary repairs.

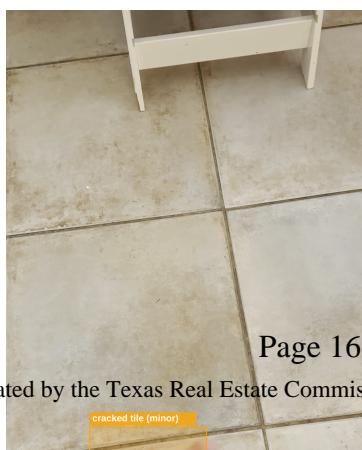
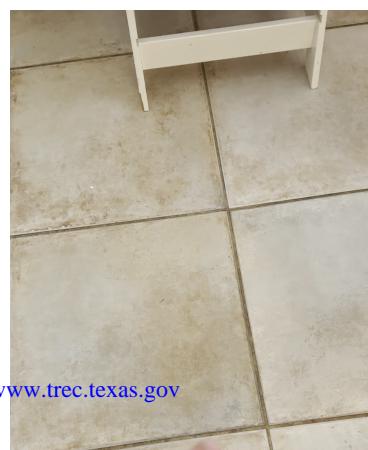
1. Cracked Floor Tile

Two small cracks were observed in the kitchen floor tile. Cracked tile can allow moisture to penetrate the substrate and may deteriorate further over time. Recommend repair or replacement of the affected tile(s) by a qualified flooring contractor and verify the integrity of the surrounding substrate and grout. Obtain estimates as needed.

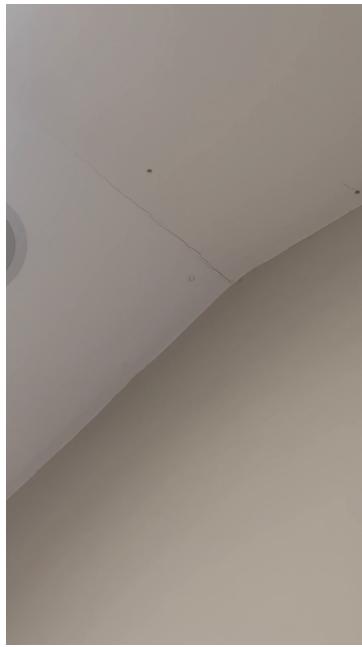
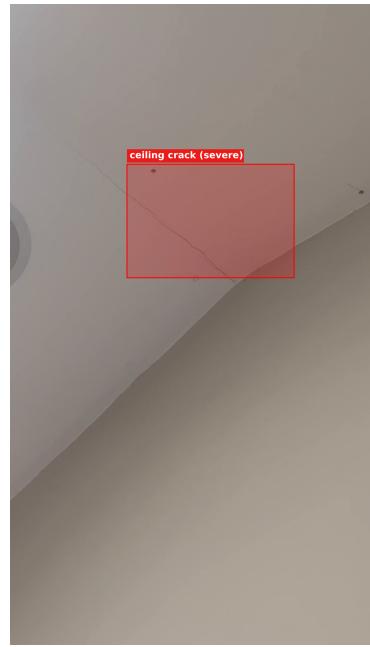
1. Significant Drywall Cracking

Significant drywall imperfections, including damage, cracking, or inconsistencies, were noted in the referenced area(s). It is advisable to inquire with the current homeowner(s) regarding any past alterations. Repairs should be undertaken by a drywall contractor as desired.

Original image: ceiling crack at Living Room

Annotated image: ceiling crack at Living Room

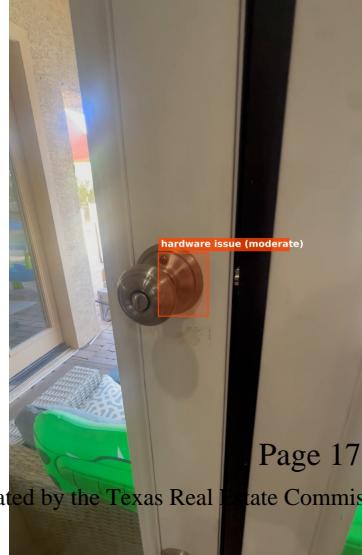
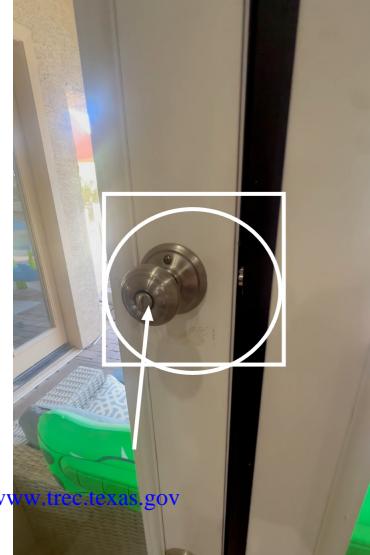
1. Inoperable or Difficult Door Handle Lock

The handle lock on one or more exterior entryways was found to be inoperable or challenging to use. Replacement of the locking doorknob by a qualified professional is recommended.

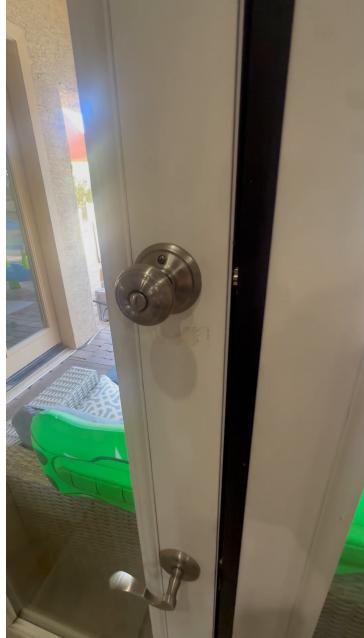
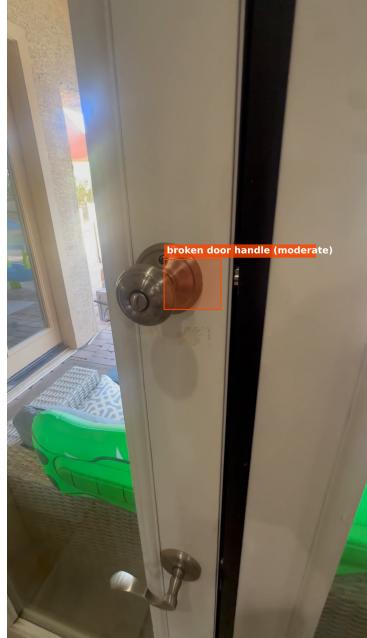
2. Loose, Damaged, or Missing Door Hardware

Various exterior door hardware components, including locksets, hinges, and pulls, were observed to be inoperable, damaged, loose, or absent. It is advised that a qualified contractor perform necessary repairs or replacements.

Original image: broken door handle at Living Room

Annotated image: broken door handle at Living Room

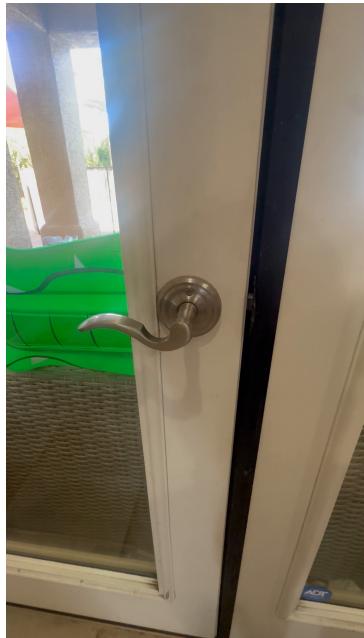
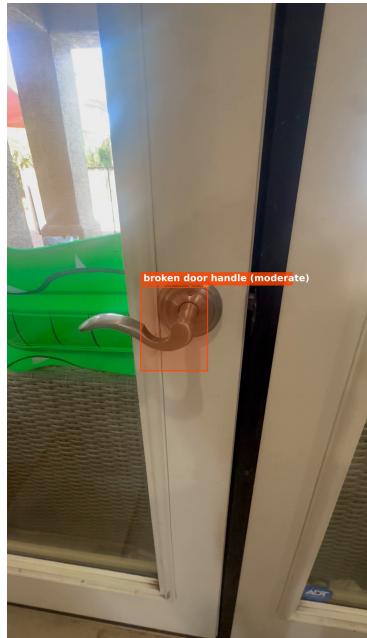
3. Damaged or Missing Door Hardware

The door handle is either damaged or missing. It is recommended that a qualified professional evaluate and repair or replace it as necessary.

Original image: broken door handle at Living Room

Annotated image: broken door handle at Living Room

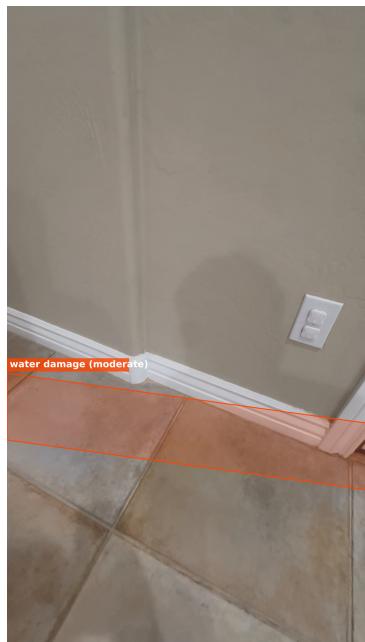
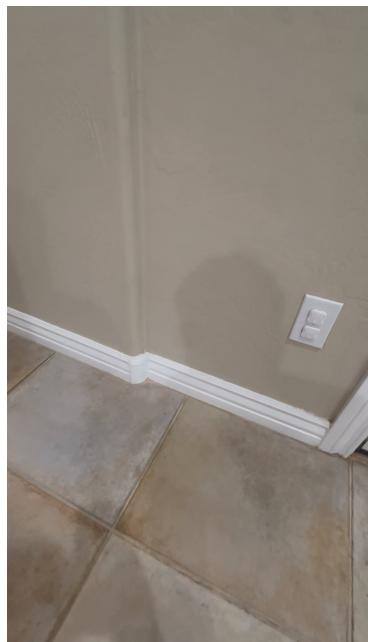
1. Subflooring Water Damage

Water damage was observed on the subflooring during the assessment. This damage may signify a historical or ongoing leak. It is advised to consult with the seller regarding the nature of the damage and any prior repairs. Alternatively, monitor the affected area for any subsequent deterioration.

Annotated image: water damage at Living Room

Original image: water damage at Living Room

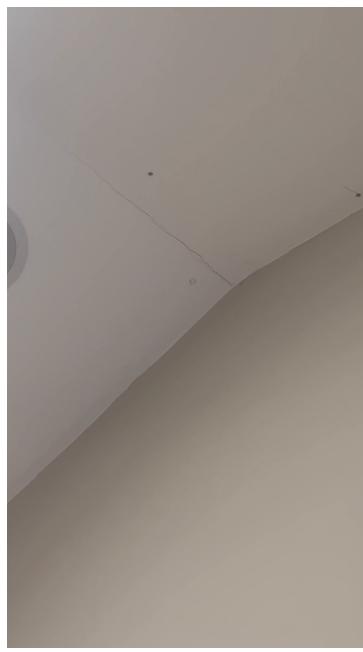
1. Ceiling Crack — Possible Structural Concern

Significant cracking was observed in the ceiling in the Living Room that may indicate underlying structural movement or damage. A licensed contractor or structural engineer should be engaged to evaluate the extent and cause of the cracking and to recommend necessary repairs. This condition may represent a safety risk and should be addressed promptly.

Original image: ceiling crack at Living Room

Annotated image: ceiling crack at Living Room

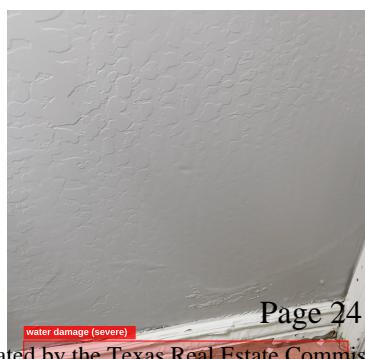
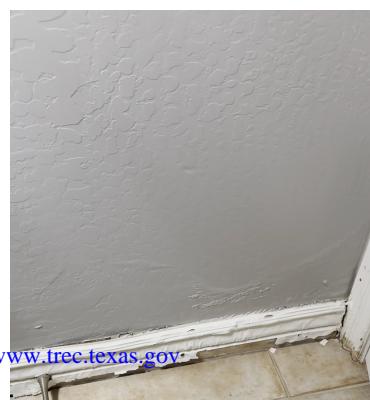
1. Evidence of Active Moisture Intrusion

The observed leakage could cause additional damage to the framing member and floor decking. Water staining and dampness were noted in one or more areas, as confirmed by a moisture meter. This condition increases the risk of insect infestation, mildew, and decay. It is recommended to consult a licensed contractor to identify and rectify the source of the dampness, which may involve improving exterior drainage, installing a waterproofing system, or sealing foundation cracks.

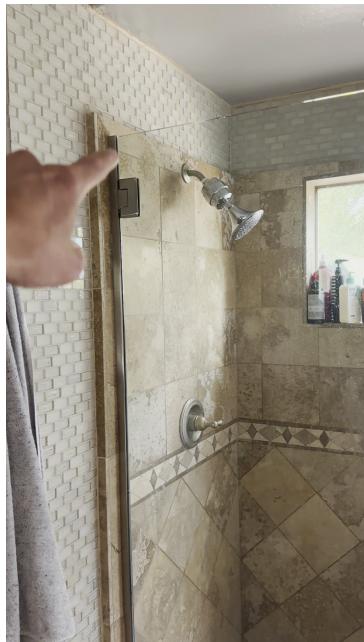
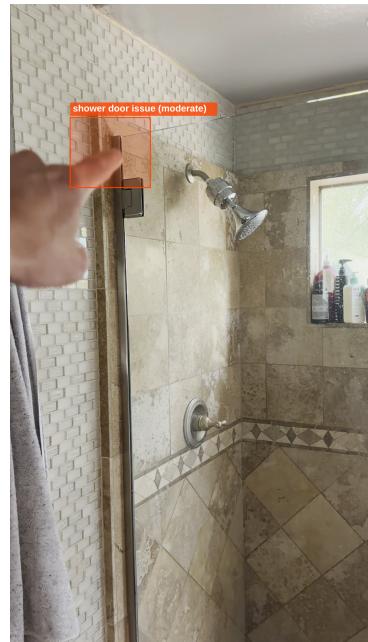
2. Shower Door Misalignment / Impacting Glass

The shower door was observed to be striking the adjoining glass and is misaligned. This condition can cause damage to the glass or hardware and may lead to failure if not corrected. It is recommended that a qualified glass/frameless-shower contractor or handyman evaluate the door alignment, adjust hinges or track, and install additional support or reinforcement as necessary to prevent further damage.

Original image: shower door issue at Master Bathroom

Annotated image: shower door issue at Master Bathroom

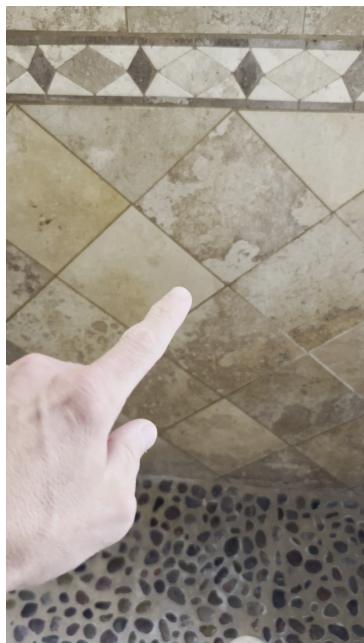
3. Loose Shower Wall Tiles — Safety Hazard

Loose tiles were observed in the master bathroom shower and were reported as a potential safety hazard. Loose or detached tiles can fall or create sharp edges and often indicate compromised substrate or prior water intrusion. It is recommended to discontinue use of the shower until a qualified tile contractor or licensed plumber assesses the condition, secures or replaces loose tiles, and evaluates the underlying substrate for moisture damage or continued leaks. Prompt repair is advised to prevent injury and further deterioration.

Original image: loose tiles at Master Bathroom Shower

Annotated image: loose tiles at Master Bathroom Shower
