I Inspection Report Overview

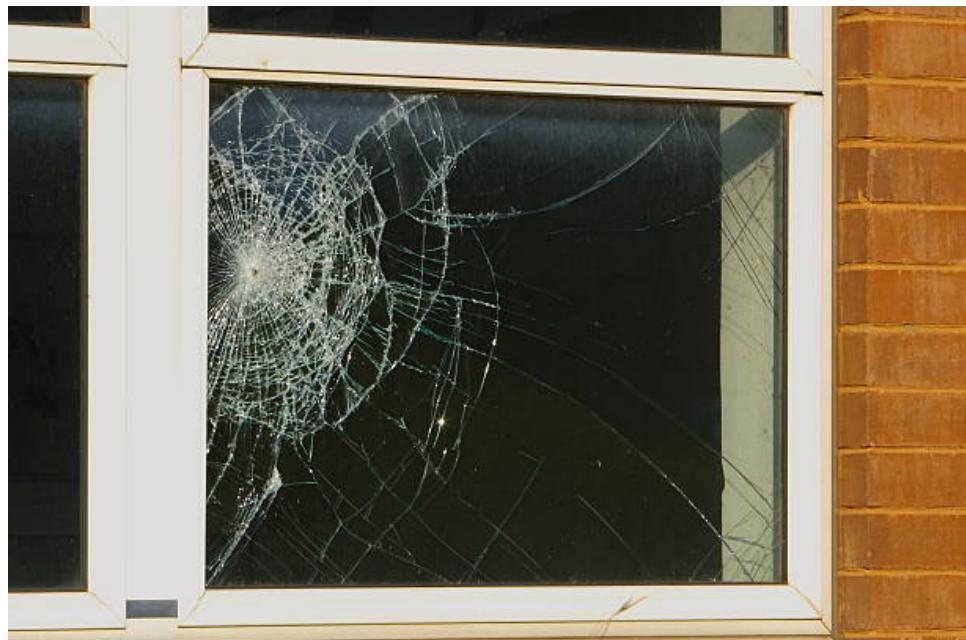
2. Cracked Window Pane

The damaged glass pane may expose sharp edges and reduce the thermal barrier against the elements. Further evaluation by a qualified contractor is recommended to repair or replace the damaged window as needed.

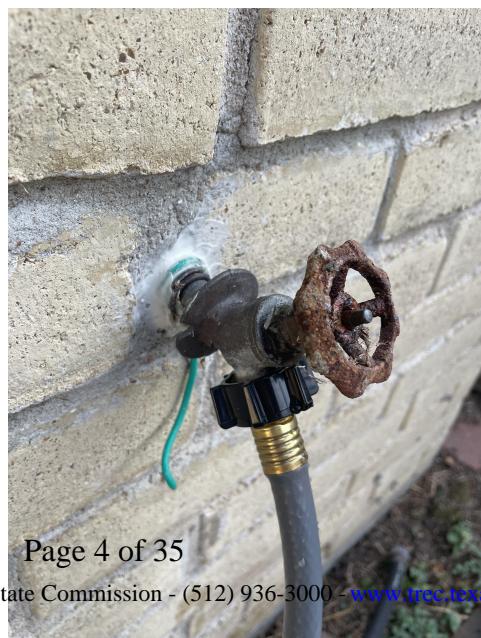
8. Hose Bib Repair / Replacement Recommended

Inspector recommends repairing or replacing the exterior hose bib to make it fully operational. Confirm functionality after repair and check for leaks. Obtain quotes from a licensed plumber or qualified contractor as needed.

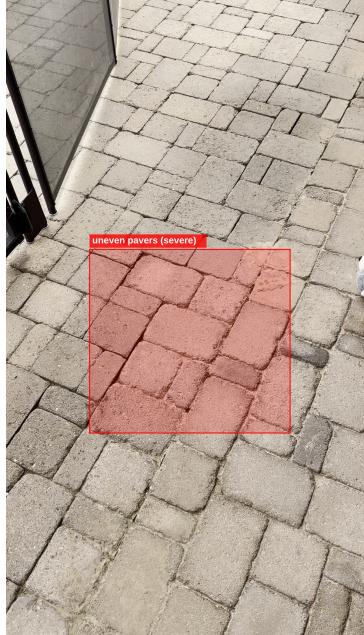
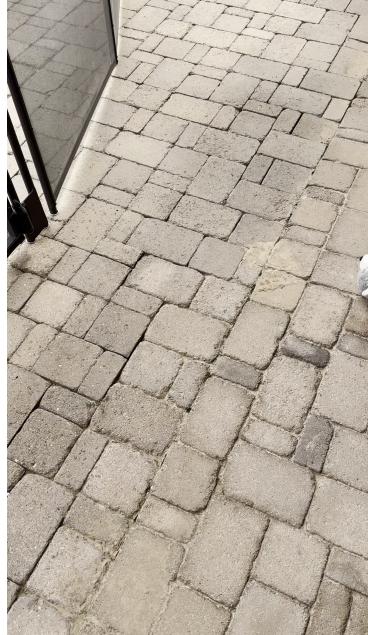
1. Uneven Pavers — Trip Hazard

Uneven paver stones were observed in the backyard, creating a potential trip hazard to occupants and visitors. This condition presents an immediate safety concern and should be corrected. Recommend evaluation and repair by a qualified hardscape contractor or landscaper to re-level, reset, or replace affected pavers to eliminate the trip hazard.

Annotated image: uneven pavers at Back Yard

Original image: uneven pavers at Back Yard

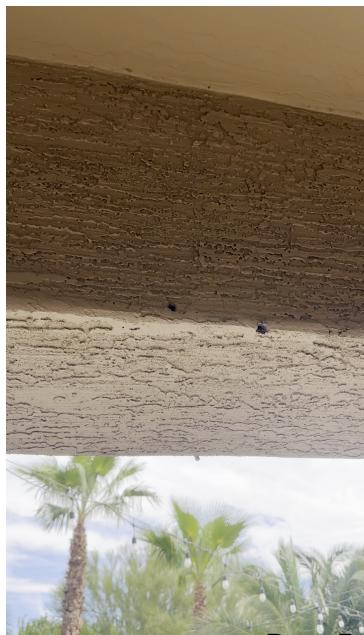
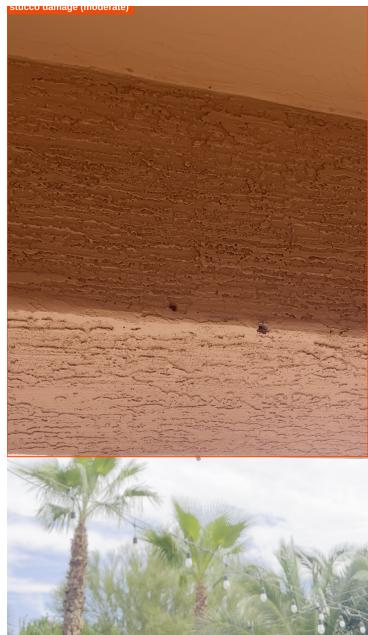
2. Stucco Cracks/Damage

Stucco damage was observed. Gaps or cracks in stucco can allow for moisture intrusion, accelerating deterioration. It is recommended that a qualified contractor evaluate and perform necessary repairs.

Original image: stucco damage at Back Yard

Annotated image: stucco damage at Back Yard

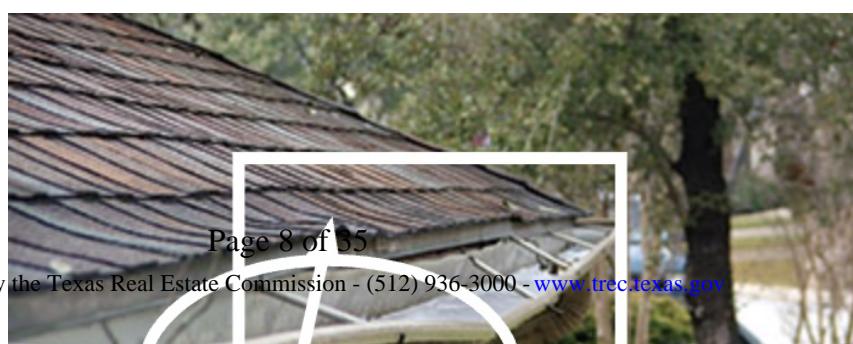
2. Missing or Damaged Gutter Hanger

A gutter hanger was observed to be missing or damaged. It is recommended to properly secure or replace the gutter hangers to ensure the intended stability and proper alignment of the gutter system.

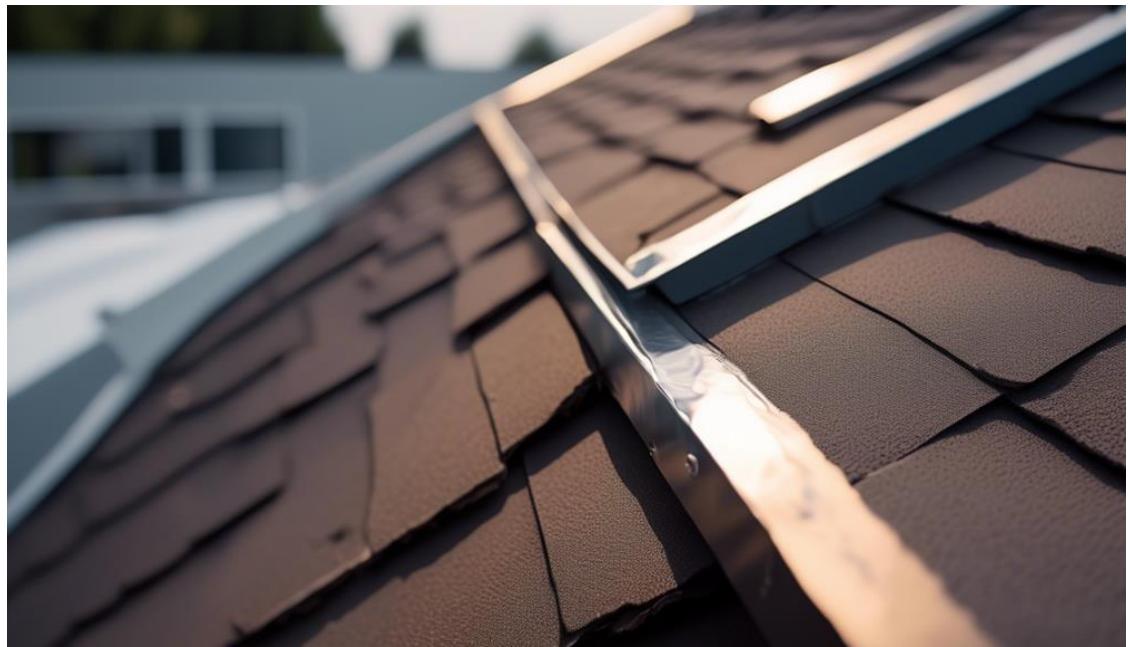
1. Compromised Flashing or Sealant Integrity

Observations indicate the presence of openings or gaps within the flashing or sealant materials. Such breaches can compromise the water-resistant barrier of the roof, potentially leading to water penetration. It is recommended to engage a certified roofing contractor to address and repair these areas to prevent future moisture intrusion.

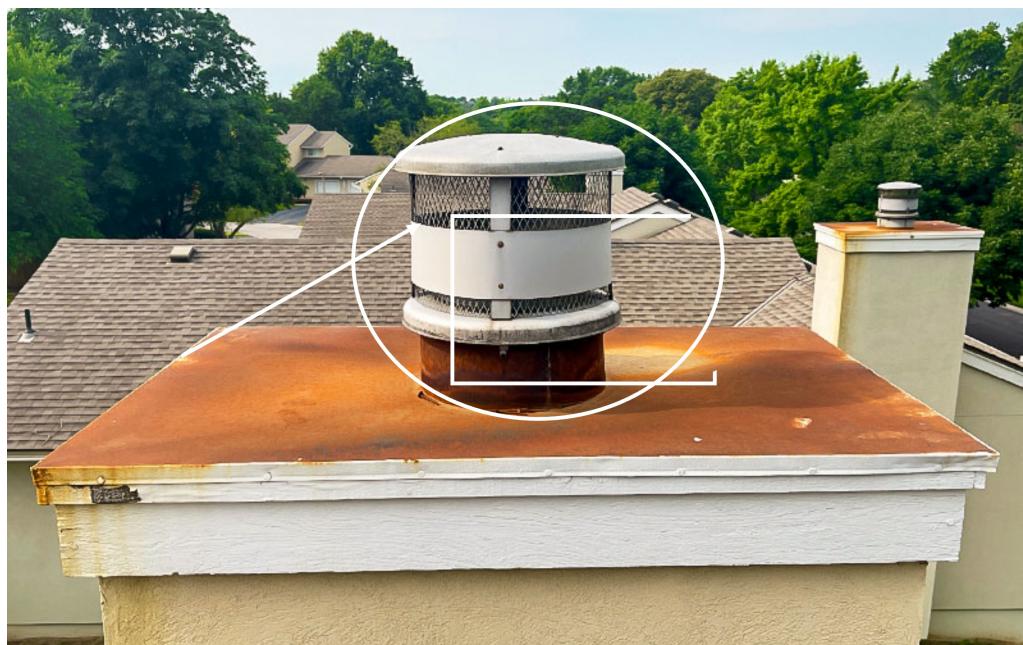
1. Vent Cover Damaged or Missing

A damaged or missing vent cover could allow debris and small pests to enter. It is recommended to repair or replace the vent cover to ensure proper operation.

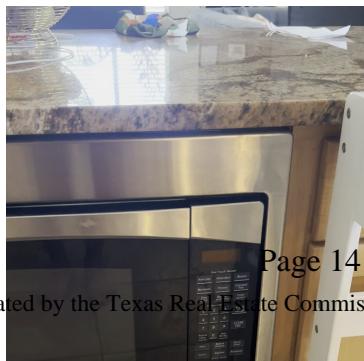
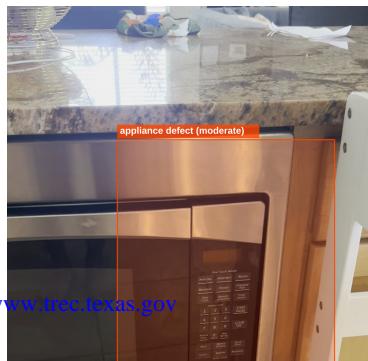
1. Unit Non-Functional or Malfunctioning

The microwave oven appeared to be non-operational or was malfunctioning. It is advised that a qualified appliance technician evaluate and perform necessary repairs or replacement.

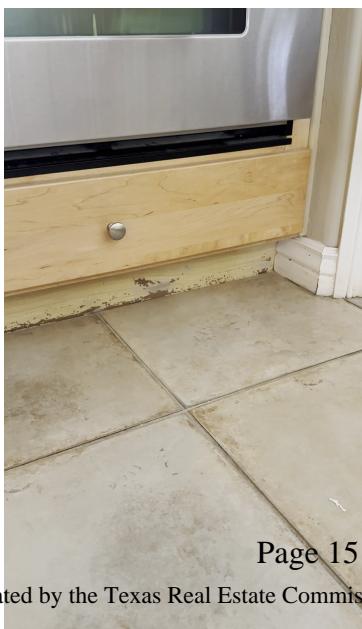
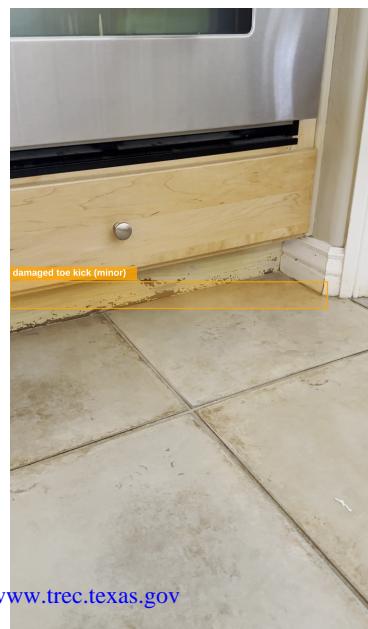
3. Failing or Peeling Paint

The paint finish exhibited signs of failure or peeling in one or more locations. It is recommended that a qualified contractor perform the necessary repairs.

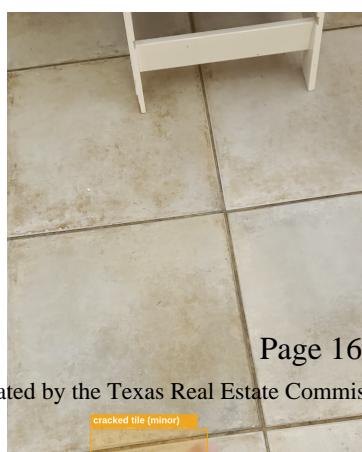
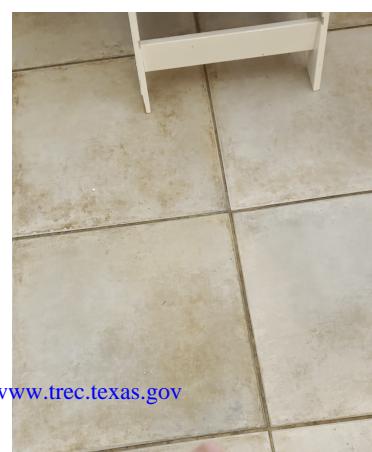
1. Cracked Floor Tile

Two small cracks were observed in the kitchen floor tile. Cracked tile can allow moisture to penetrate the substrate and may deteriorate further over time. Recommend repair or replacement of the affected tile(s) by a qualified flooring contractor and verify the integrity of the surrounding substrate and grout. Obtain estimates as needed.

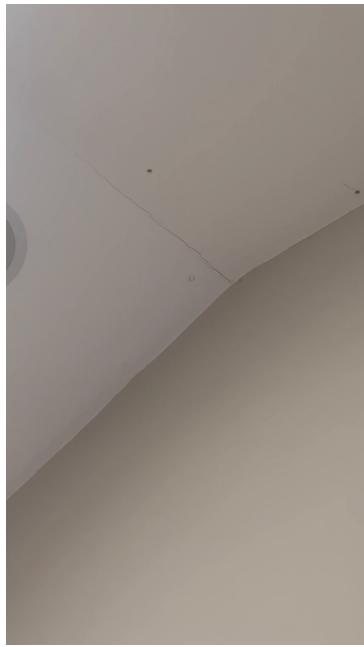
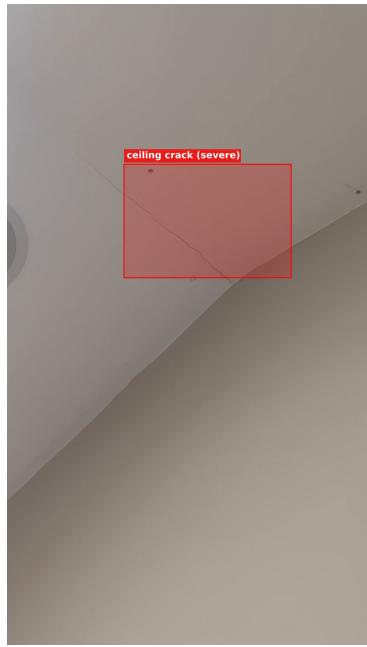
1. Significant Drywall Cracking

Significant drywall imperfections, including damage, cracking, or inconsistencies, were noted in the referenced area(s). It is advisable to inquire with the current homeowner(s) regarding any past alterations. Repairs should be undertaken by a drywall contractor as desired.

Original image: ceiling crack at Living Room

Annotated image: ceiling crack at Living Room

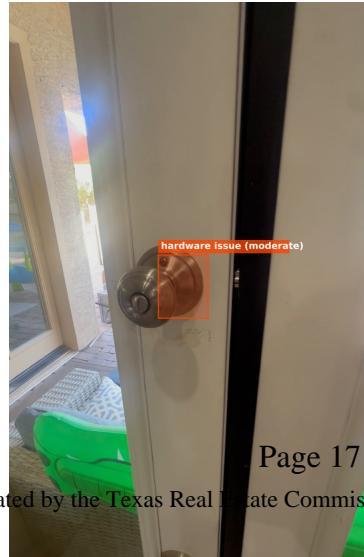
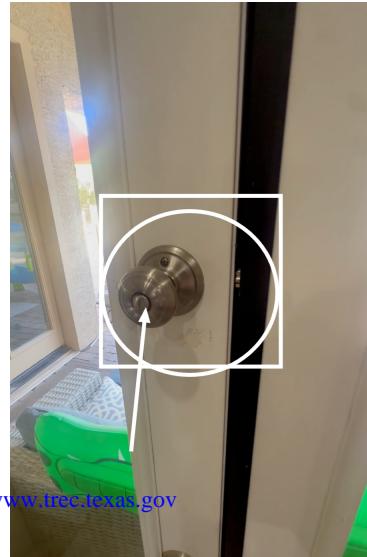
1. Inoperable or Difficult Door Handle Lock

The handle lock on one or more exterior entryways was found to be inoperable or challenging to use. Replacement of the locking doorknob by a qualified professional is recommended.

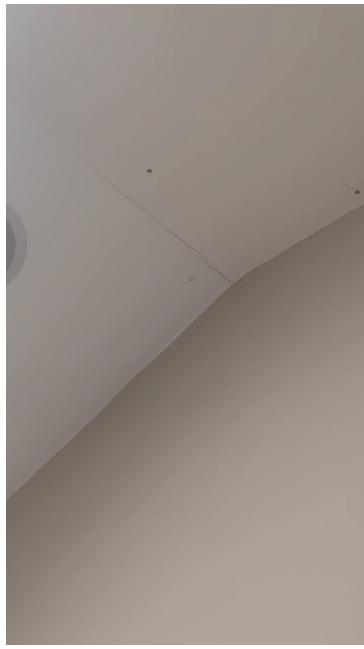
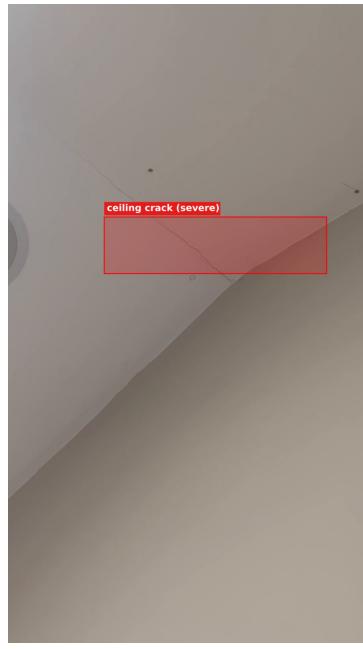
1. Ceiling Crack — Possible Structural Concern

Significant cracking was observed in the ceiling in the Living Room that may indicate underlying structural movement or damage. A licensed contractor or structural engineer should be engaged to evaluate the extent and cause of the cracking and to recommend necessary repairs. This condition may represent a safety risk and should be addressed promptly.

Original image: ceiling crack at Living Room

Annotated image: ceiling crack at Living Room

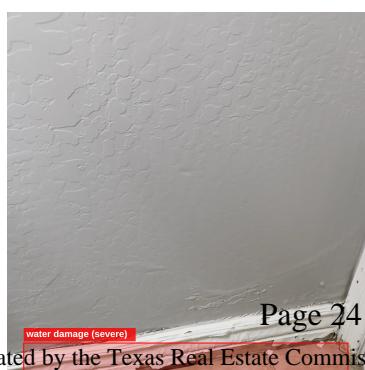
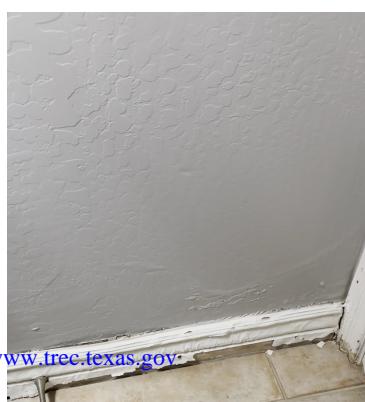
1. Evidence of Active Moisture Intrusion

The observed leakage could cause additional damage to the framing member and floor decking. Water staining and dampness were noted in one or more areas, as confirmed by a moisture meter. This condition increases the risk of insect infestation, mildew, and decay. It is recommended to consult a licensed contractor to identify and rectify the source of the dampness, which may involve improving exterior drainage, installing a waterproofing system, or sealing foundation cracks.

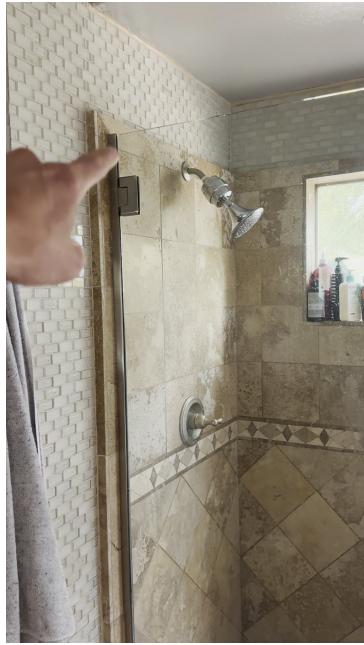
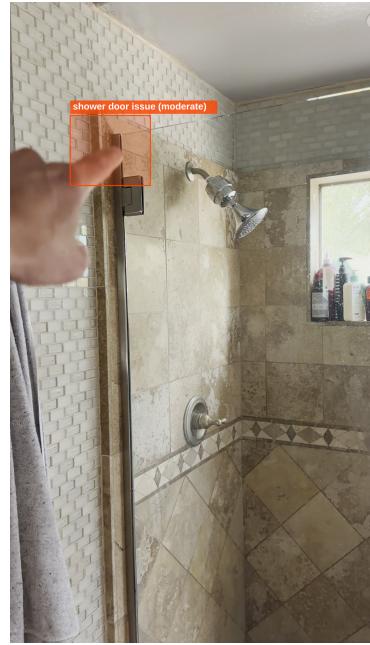
2. Shower Door Misalignment / Impacting Glass

The shower door was observed to be striking the adjoining glass and is misaligned. This condition can cause damage to the glass or hardware and may lead to failure if not corrected. It is recommended that a qualified glass/frameless-shower contractor or handyman evaluate the door alignment, adjust hinges or track, and install additional support or reinforcement as necessary to prevent further damage.

Original image: shower door issue at Master Bathroom

Annotated image: shower door issue at Master Bathroom

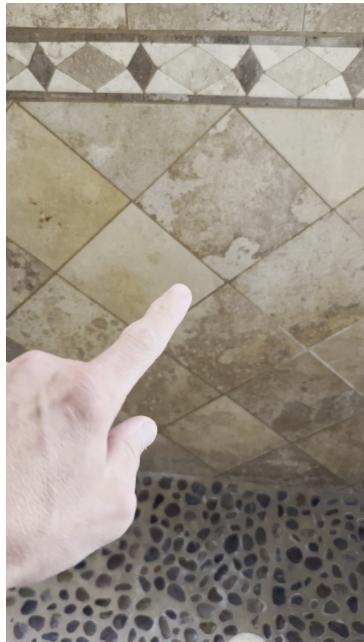
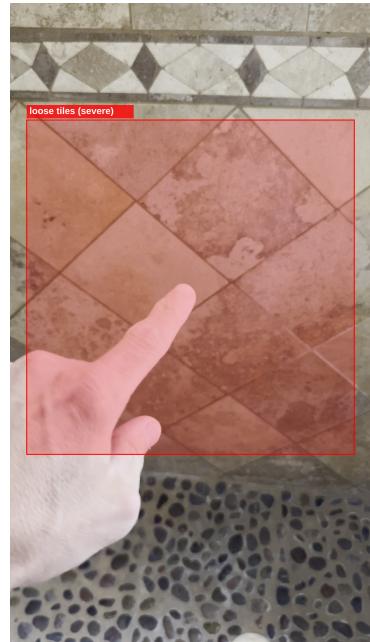
3. Loose Shower Wall Tiles — Safety Hazard

Loose tiles were observed in the master bathroom shower and were reported as a potential safety hazard. Loose or detached tiles can fall or create sharp edges and often indicate compromised substrate or prior water intrusion. It is recommended to discontinue use of the shower until a qualified tile contractor or licensed plumber assesses the condition, secures or replaces loose tiles, and evaluates the underlying substrate for moisture damage or continued leaks. Prompt repair is advised to prevent injury and further deterioration.

Original image: loose tiles at Master Bathroom Shower

Annotated image: loose tiles at Master Bathroom Shower
