PROPERTY INSPECTION REPORT

251 N Bristol Ave, Los Angeles, CA 90049

Inspection Date: August 13, 2025

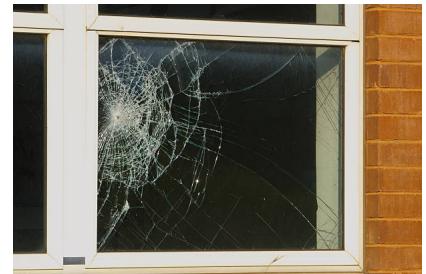
Photo 5.2

The damaged glass pane may expose sharp edges and reduce the thermal barrier against the elements. Further evaluation by a qualified contractor is recommended to repair or replace the damaged window as needed.

Recommendation: Contact window

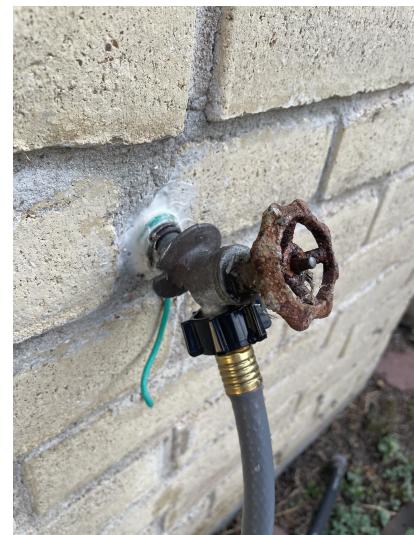
Photo 5.8

Inspector recommends repairing or replacing the exterior hose bib to make it fully operational. Confirm functionality after repair and check for leaks. Obtain quotes from a licensed plumber or qualified contractor as needed.

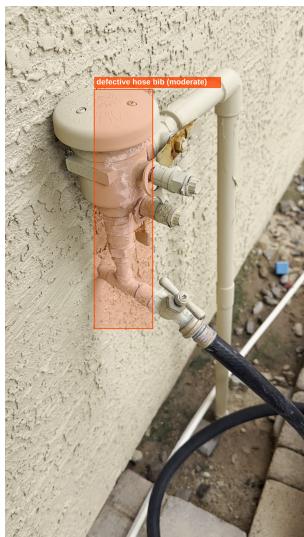
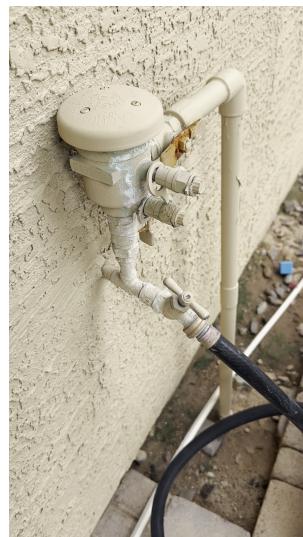
The handle for the exterior spigot was damaged or missing. Repairs or replacement as needed are recommended to be performed by a qualified individual to ensure proper operation.

Recommendation: Contact handyman-diy

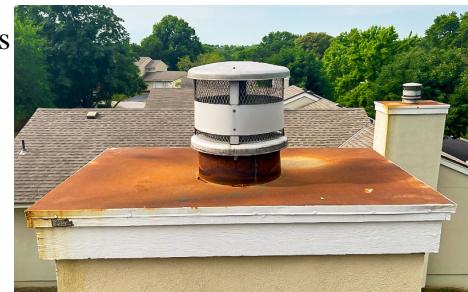
Photo 5.2

The chimney cap displayed signs of corrosion. Regular maintenance, such as sealing, is recommended to prevent further damage and extend its longevity.

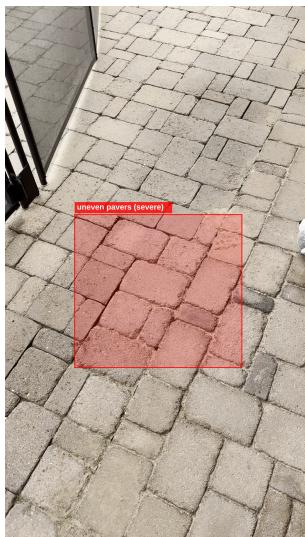
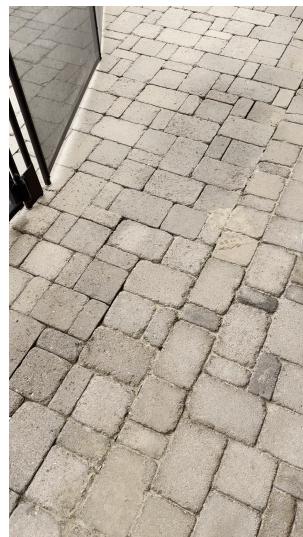
Uneven paver stones were observed in the backyard, creating a potential trip hazard to occupants and visitors. This condition presents an immediate safety concern and should be corrected. Recommend evaluation and repair by a qualified hardscape contractor or landscaper to re-level, reset, or replace affected pavers to eliminate the trip hazard.

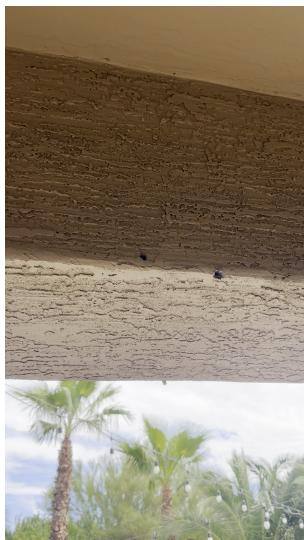
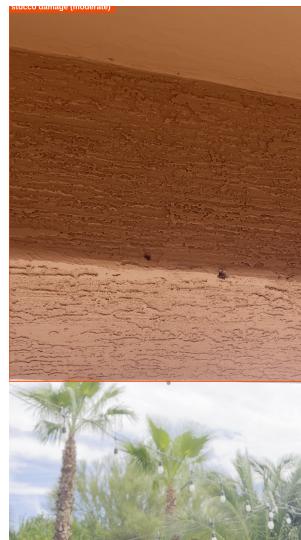
Stucco damage was observed. Gaps or cracks in stucco can allow for moisture intrusion, accelerating deterioration. It is recommended that a qualified contractor evaluate and perform necessary repairs.

Recommendation: Contact stucco

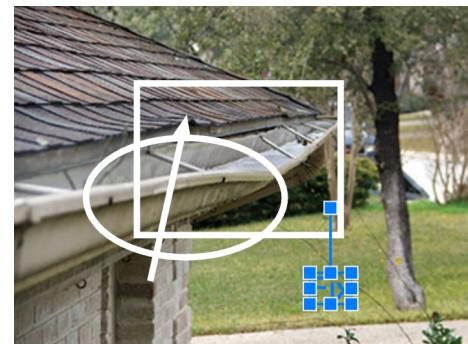
Photo 6.2

A gutter hanger was observed to be missing or damaged. It is recommended to properly secure or replace the gutter hangers to ensure the intended stability and proper alignment of the gutter system.

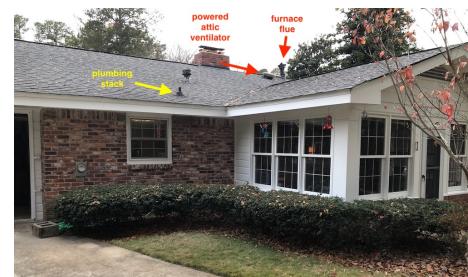
Photo 6.1

The plumbing vent displayed insufficient clearance from a rooftop deck. For proper ventilation and to prevent sewer gases from entering recreational areas, vents should typically extend at least 6 feet above a rooftop deck. It is recommended to consult with a licensed professional to ensure appropriate vent height and mitigate potential health concerns.

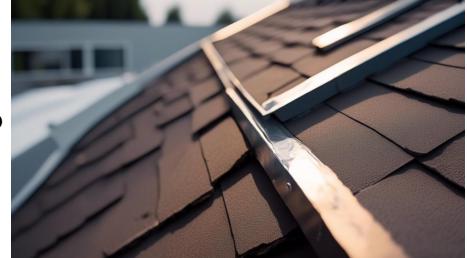
Photo 6.1

Observations indicate the presence of openings or gaps within the flashing or sealant materials. Such breaches can compromise the water-resistant barrier of the roof, potentially leading to water penetration. It is recommended to engage a certified roofing contractor to address and repair these areas to prevent future moisture intrusion.

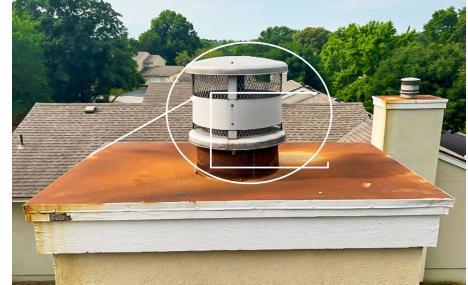
Photo 7.1

A damaged or missing vent cover could allow debris and small pests to enter. It is recommended to repair or replace the vent cover to ensure proper operation.

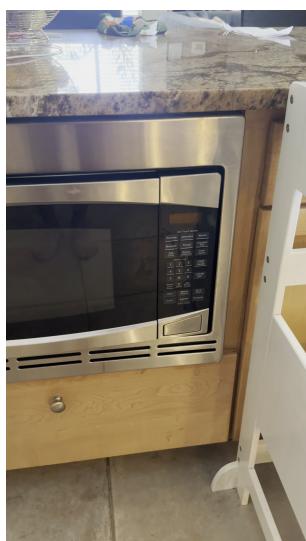
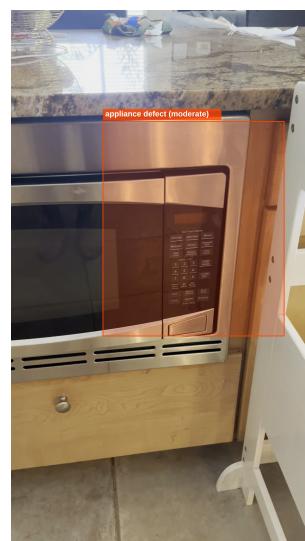
The microwave oven appeared to be non-operational or was malfunctioning. It is advised that a qualified appliance technician evaluate and perform necessary repairs or replacement.

Recommendation: Contact appliance

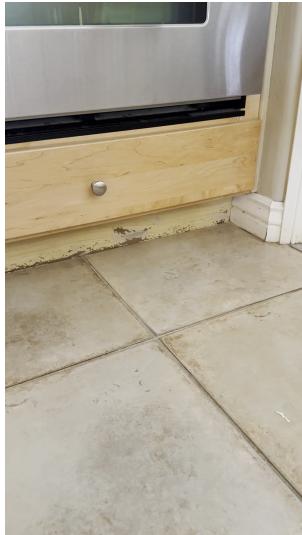
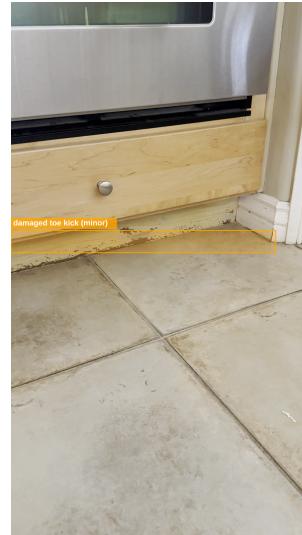
The paint finish exhibited signs of failure or peeling in one or more locations. It is recommended that a qualified contractor perform the necessary repairs.

Recommendation: Contact paint

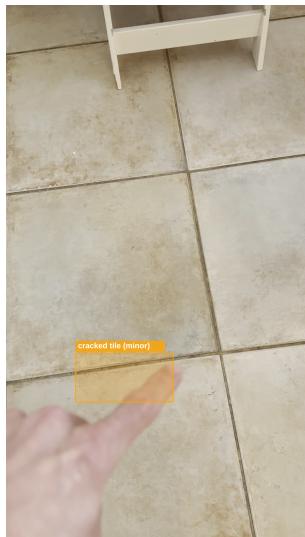
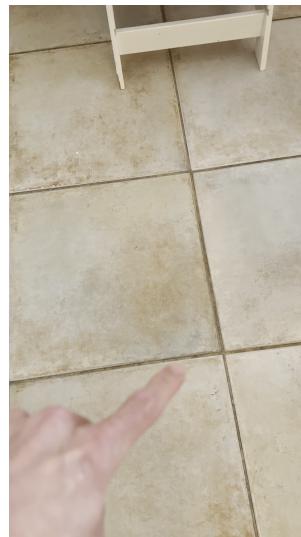
Two small cracks were observed in the kitchen floor tile. Cracked tile can allow moisture to penetrate the substrate and may deteriorate further over time. Recommend repair or replacement of the affected tile(s) by a qualified flooring contractor and verify the integrity of the surrounding substrate and grout. Obtain estimates as needed.

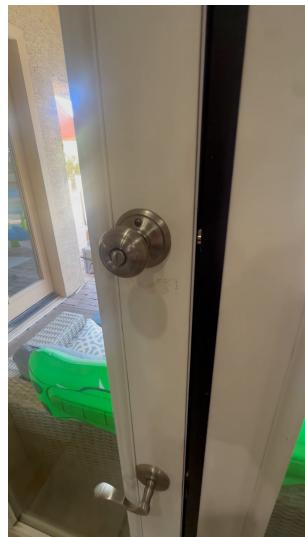
Various exterior door hardware components, including locksets, hinges, and pulls, were observed to be inoperable, damaged, loose, or absent. It is advised that a qualified contractor perform necessary repairs or replacements.

Recommendation: Contact handyman-diy

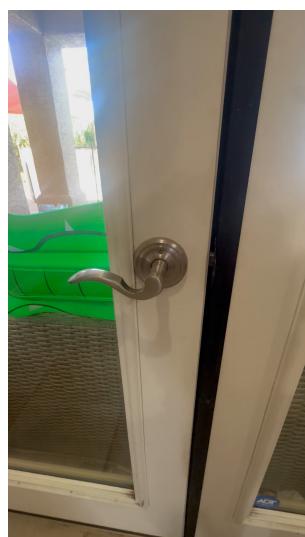
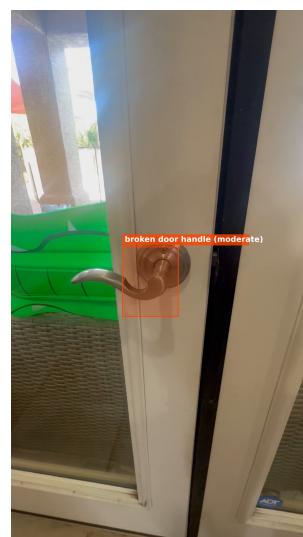
The door handle is either damaged or missing. It is recommended that a qualified professional evaluate and repair or replace it as necessary.

Recommendation: Contact gc

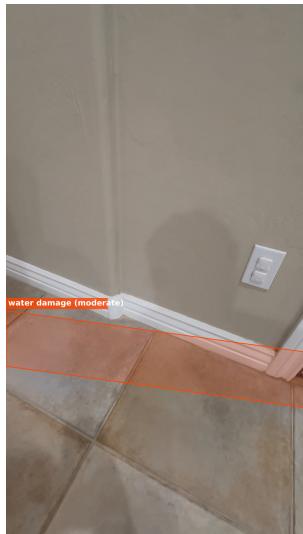
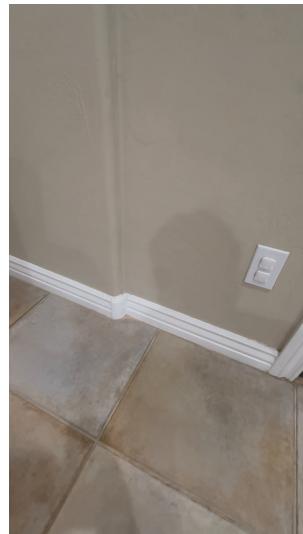
Water damage was observed on the subflooring during the assessment. This damage may signify a historical or ongoing leak. It is advised to consult with the seller regarding the nature of the damage and any prior repairs. Alternatively, monitor the affected area for any subsequent deterioration.

Recommendation: Contact pro

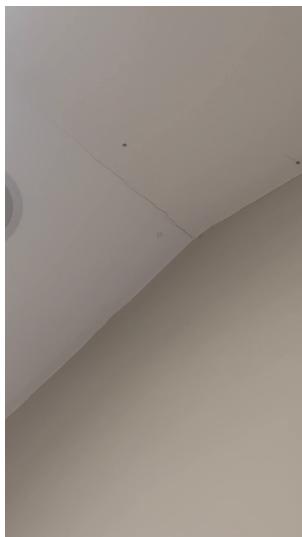
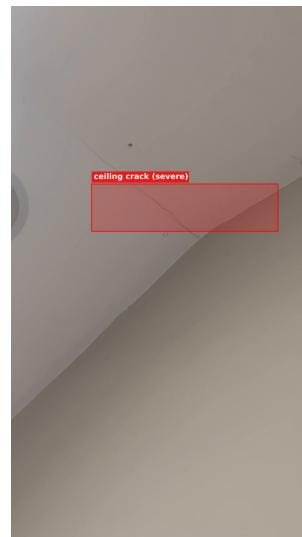
Significant cracking was observed in the ceiling in the Living Room that may indicate underlying structural movement or damage. A licensed contractor or structural engineer should be engaged to evaluate the extent and cause of the cracking and to recommend necessary repairs. This condition may represent a safety risk and should be addressed promptly.

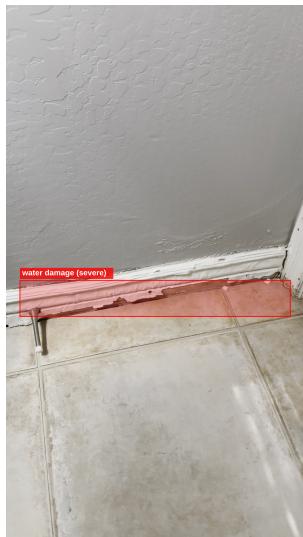
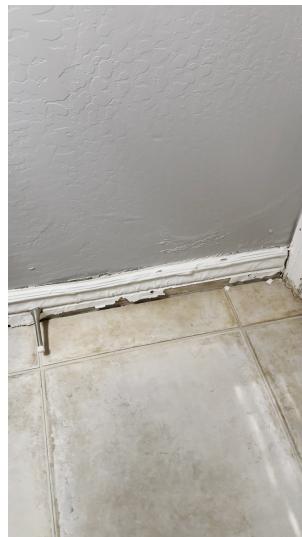
The observed leakage could cause additional damage to the framing member and floor decking. Water staining and dampness were noted in one or more areas, as confirmed by a moisture meter. This condition increases the risk of insect infestation, mildew, and decay. It is recommended to consult a licensed contractor to identify and rectify the source of the dampness, which may involve improving exterior drainage, installing a waterproofing system, or sealing foundation cracks.

Recommendation: Contact waterproof

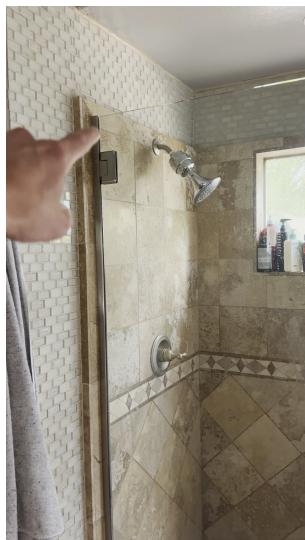
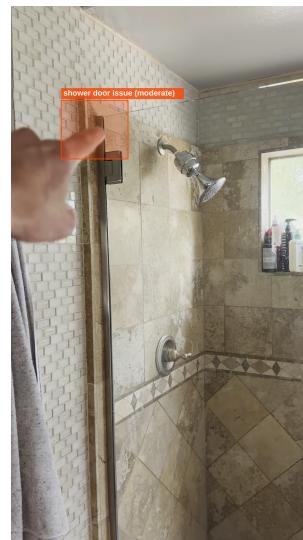
The shower door was observed to be striking the adjoining glass and is misaligned. This condition can cause damage to the glass or hardware and may lead to failure if not corrected. It is recommended that a qualified glass/frameless-shower contractor or handyman evaluate the door alignment, adjust hinges or track, and install additional support or reinforcement as necessary to prevent further damage.

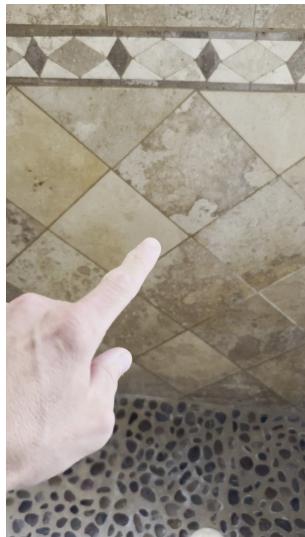
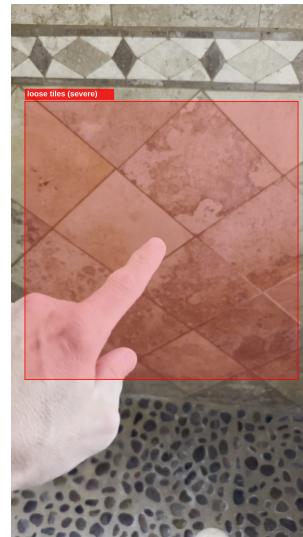
Loose tiles were observed in the master bathroom shower and were reported as a potential safety hazard. Loose or detached tiles can fall or create sharp edges and often indicate compromised substrate or prior water intrusion. It is recommended to discontinue use of the shower until a qualified tile contractor or licensed plumber assesses the condition, secures or replaces loose tiles, and evaluates the underlying substrate for moisture damage or continued leaks. Prompt repair is advised to prevent injury and further deterioration.
