# PROPERTY INSPECTION REPORT FORM

251 N Bristol Ave, Los Angeles, CA 90049  
Address of Inspected Property

08/13/2025, 6:00 AM  
Date of Inspection

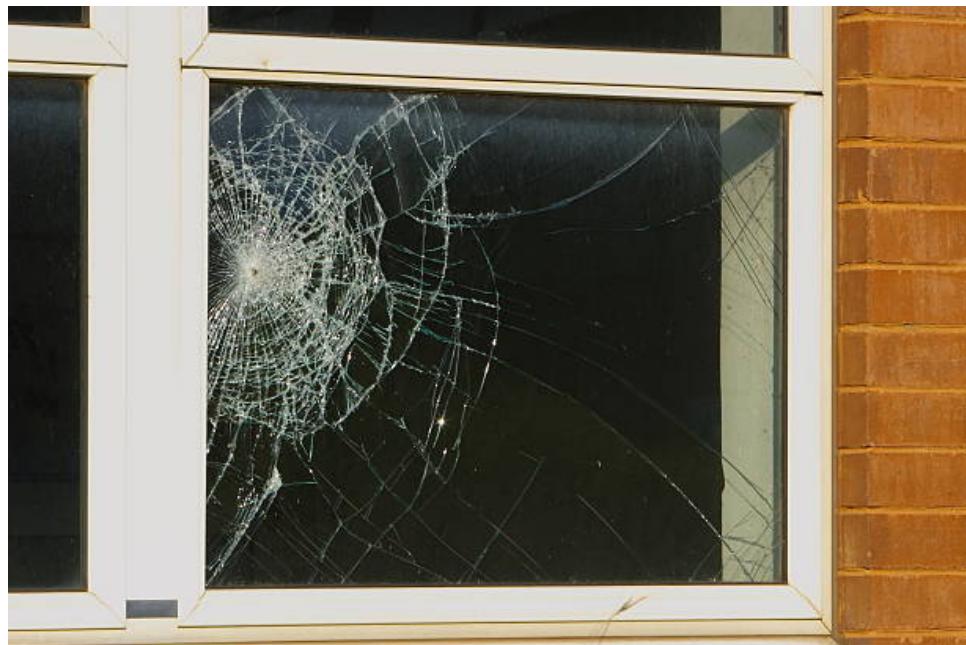
The damaged glass pane may expose sharp edges and reduce the thermal barrier against the elements. Further evaluation by a qualified contractor is recommended to repair or replace the damaged window as needed.

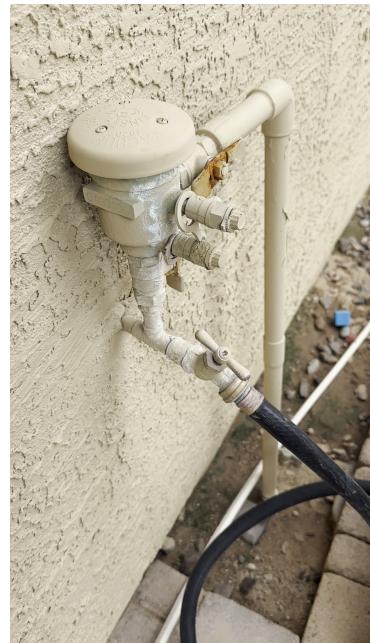
The handle for the exterior spigot was damaged or missing. Repairs or replacement as needed are recommended to be performed by a qualified individual to ensure proper operation.

Annotated image: defective hose bib at Back Yard

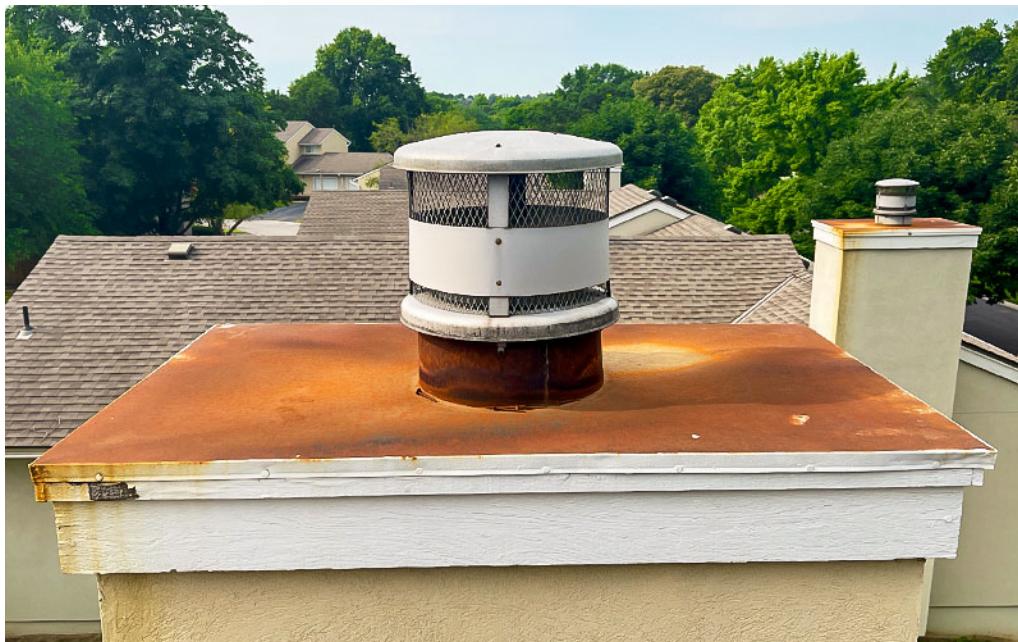
The chimney cap displayed signs of corrosion. Regular maintenance, such as sealing, is recommended to prevent further damage and extend its longevity.

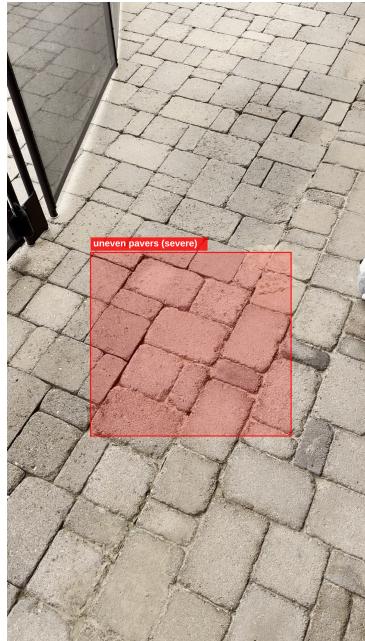
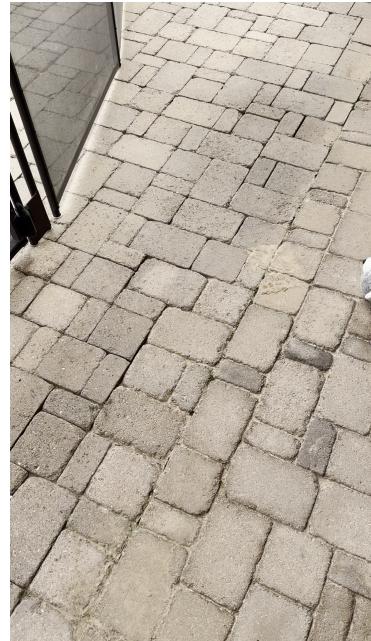
Uneven paver stones were observed in the backyard, creating a potential trip hazard to occupants and visitors. This condition presents an immediate safety concern and should be corrected. Recommend evaluation and repair by a qualified hardscape contractor or landscaper to re-level, reset, or replace affected pavers to eliminate the trip hazard.

Annotated image: uneven pavers at Back Yard

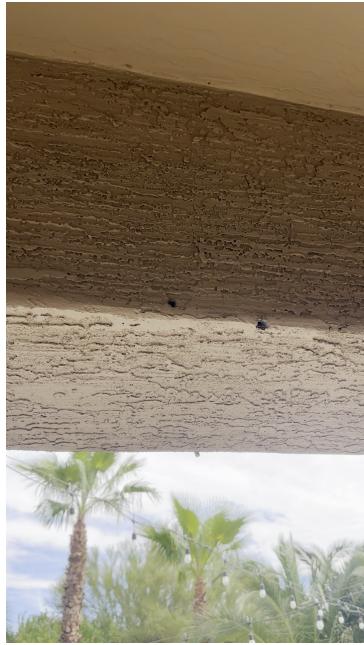
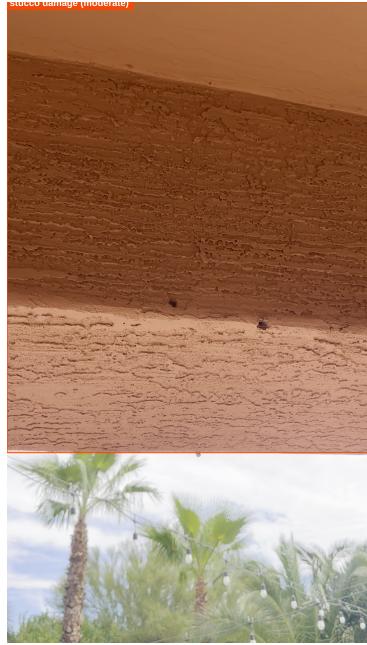
Stucco damage was observed. Gaps or cracks in stucco can allow for moisture intrusion, accelerating deterioration. It is recommended that a qualified contractor evaluate and perform necessary repairs.

Original image: stucco damage at Back Yard

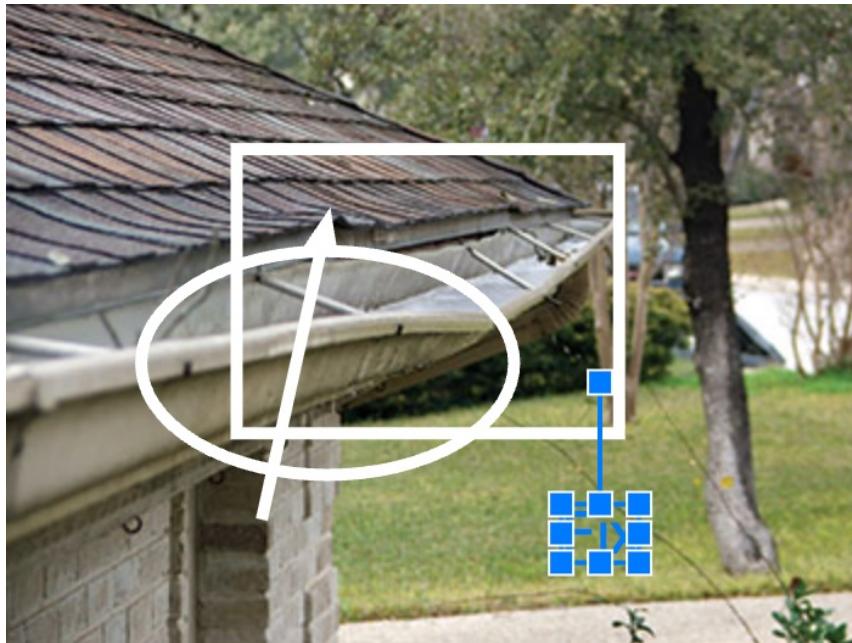
A gutter hanger was observed to be missing or damaged. It is recommended to properly secure or replace the gutter hangers to ensure the intended stability and proper alignment of the gutter system.

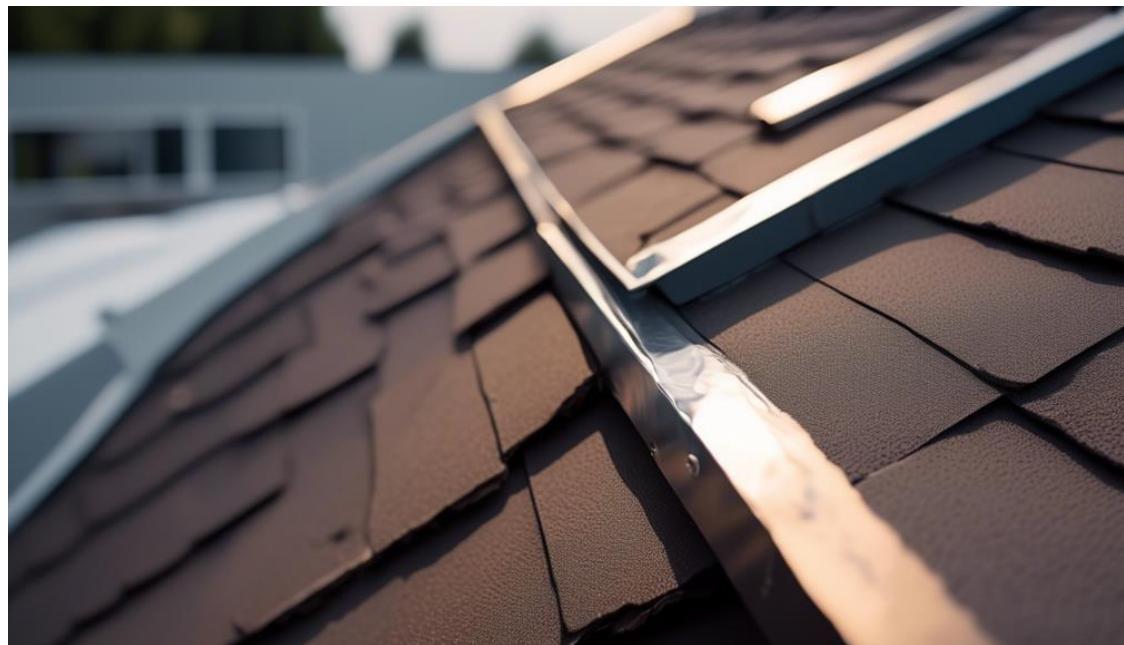
Observations indicate the presence of openings or gaps within the flashing or sealant materials. Such breaches can compromise the water-resistant barrier of the roof, potentially leading to water penetration. It is recommended to engage a certified roofing contractor to address and repair these areas to prevent future moisture intrusion.

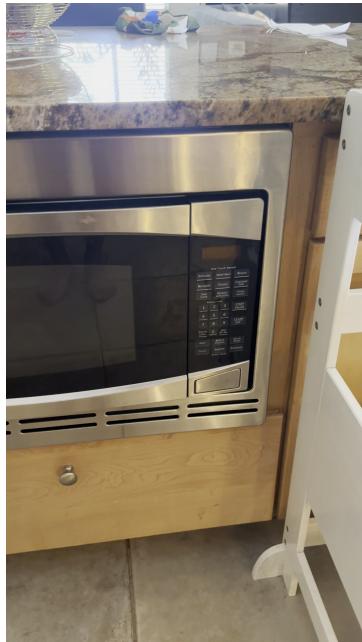
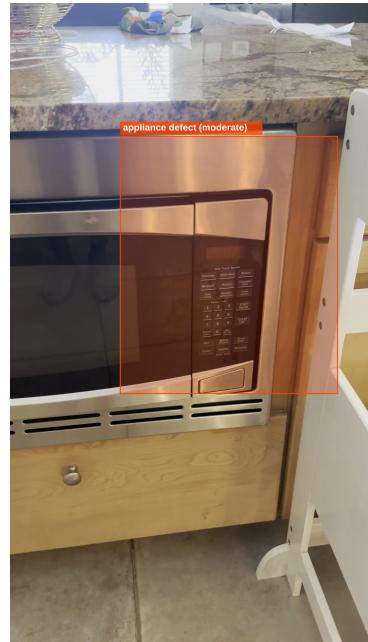
The microwave oven appeared to be non-operational or was malfunctioning. It is advised that a qualified appliance technician evaluate and perform necessary repairs or replacement.

Original image: appliance defect at Kitchen

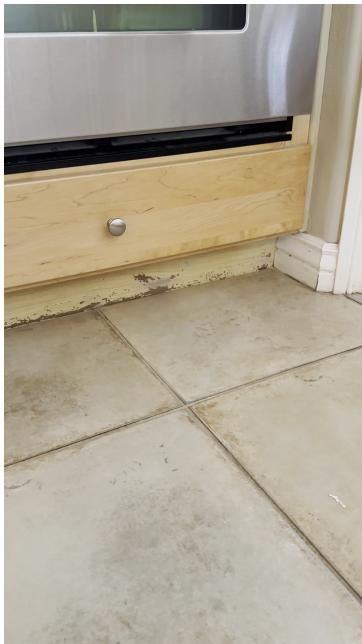
The paint finish exhibited signs of failure or peeling in one or more locations. It is recommended that a qualified contractor perform the necessary repairs.

Original image: damaged toe kick at Kitchen

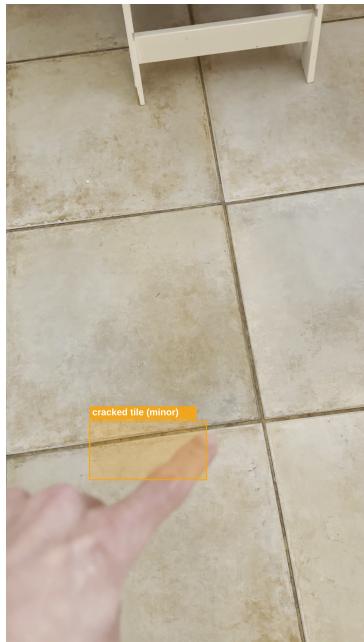
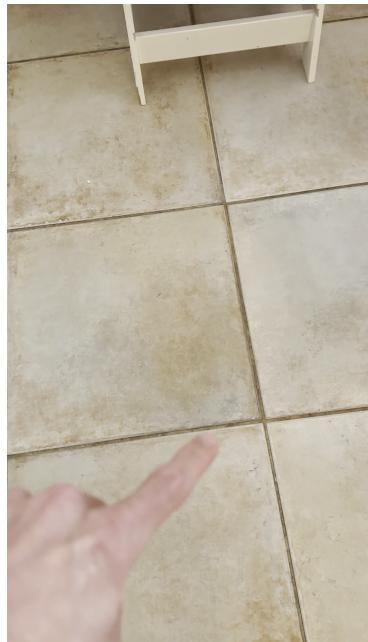
Two small cracks were observed in the kitchen floor tile. Cracked tile can allow moisture to penetrate the substrate and may deteriorate further over time. Recommend repair or replacement of the affected tile(s) by a qualified flooring contractor and verify the integrity of the surrounding substrate and grout. Obtain estimates as needed.

Annotated image: cracked tile at Kitchen

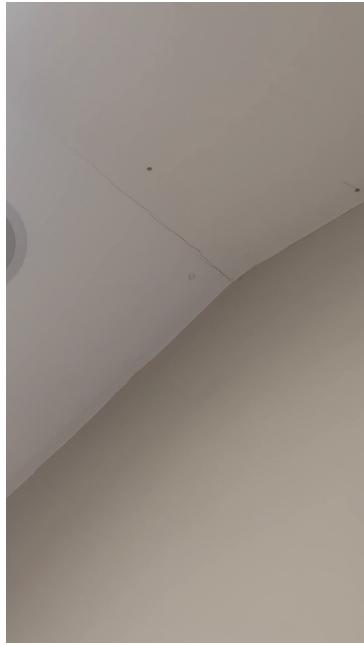
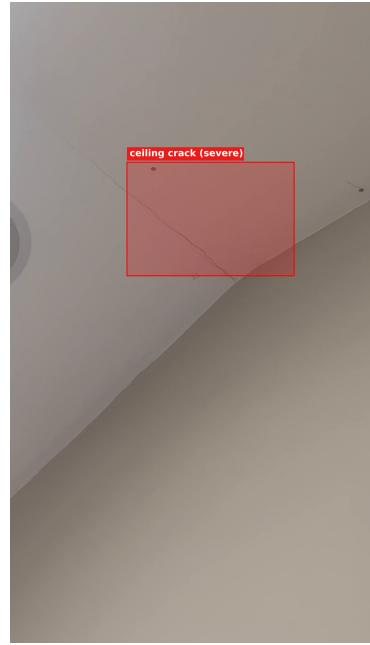
Significant drywall imperfections, including damage, cracking, or inconsistencies, were noted in the referenced area(s). It is advisable to inquire with the current homeowner(s) regarding any past alterations. Repairs should be undertaken by a drywall contractor as desired.

Original image: ceiling crack at Living Room

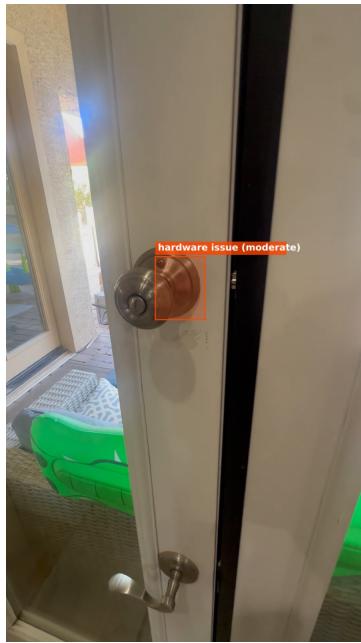
Annotated image: hardware issue at Living Room

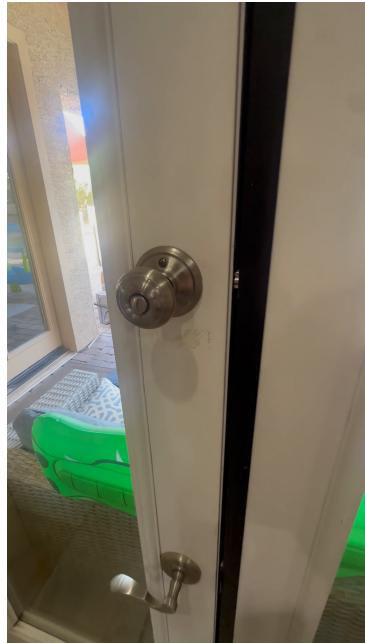
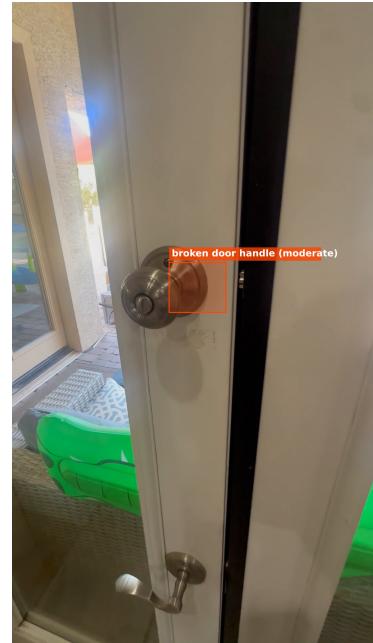
Original image: broken door handle at Living Room

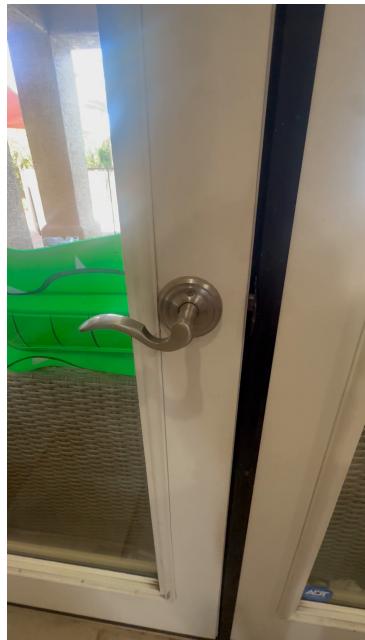
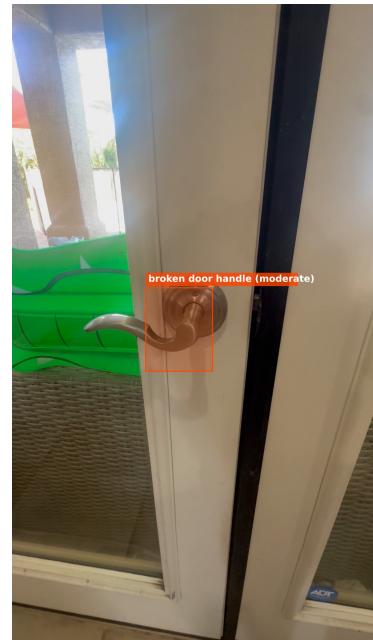
The door handle is either damaged or missing. It is recommended that a qualified professional evaluate and repair or replace it as necessary.

Original image: broken door handle at Living Room

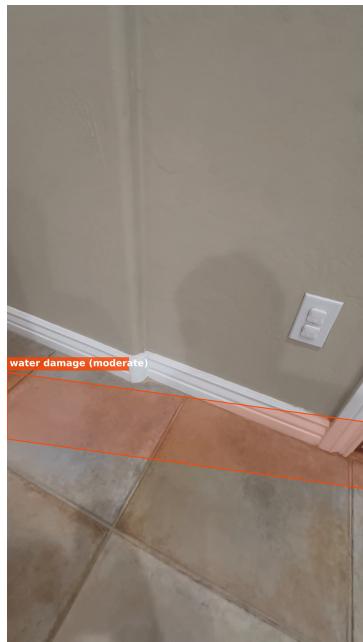
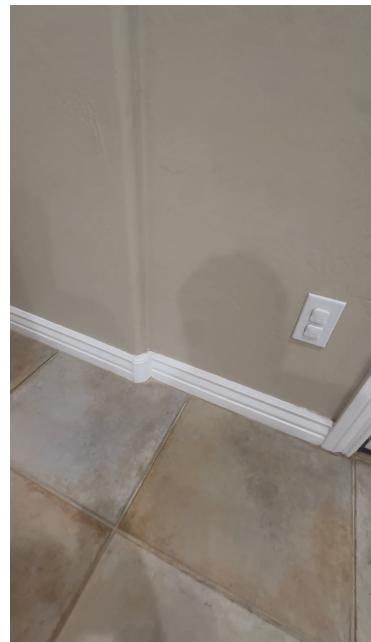
Water damage was observed on the subflooring during the assessment. This damage may signify a historical or ongoing leak. It is advised to consult with the seller regarding the nature of the damage and any prior repairs. Alternatively, monitor the affected area for any subsequent deterioration.

Annotated image: water damage at Living Room

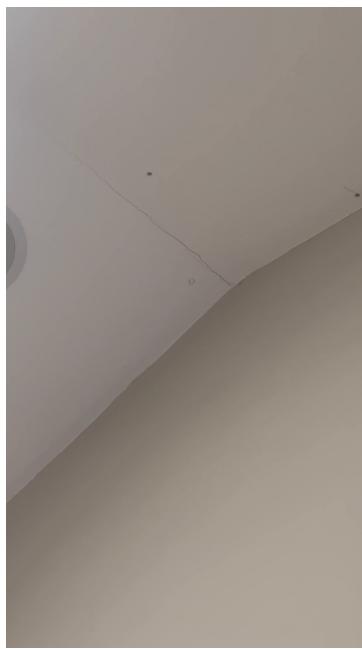
Significant cracking was observed in the ceiling in the Living Room that may indicate underlying structural movement or damage. A licensed contractor or structural engineer should be engaged to evaluate the extent and cause of the cracking and to recommend necessary repairs. This condition may represent a safety risk and should be addressed promptly.

Original image: ceiling crack at Living Room

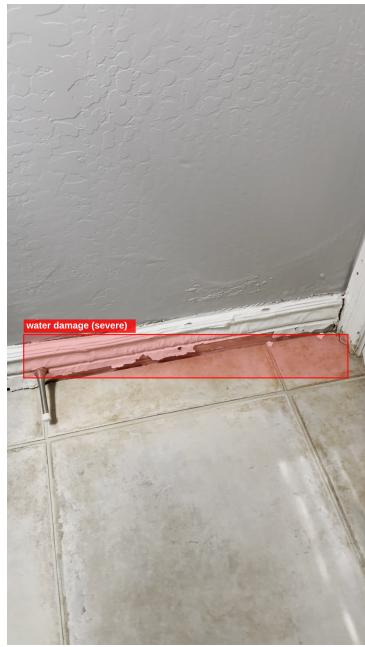
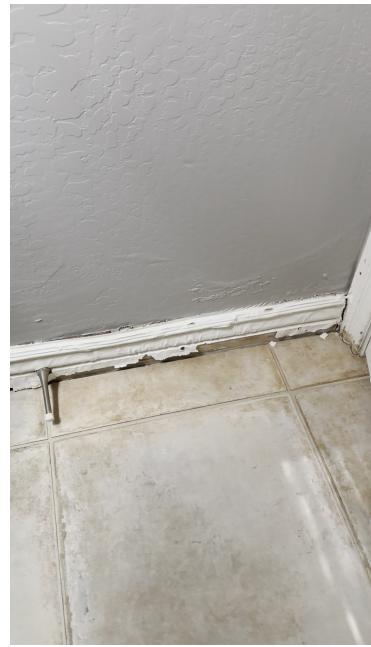
The observed leakage could cause additional damage to the framing member and floor decking. Water staining and dampness were noted in one or more areas, as confirmed by a moisture meter. This condition increases the risk of insect infestation, mildew, and decay. It is recommended to consult a licensed contractor to identify and rectify the source of the dampness, which may involve improving exterior drainage, installing a waterproofing system, or sealing foundation cracks.

Annotated image: water damage at Master Bathroom

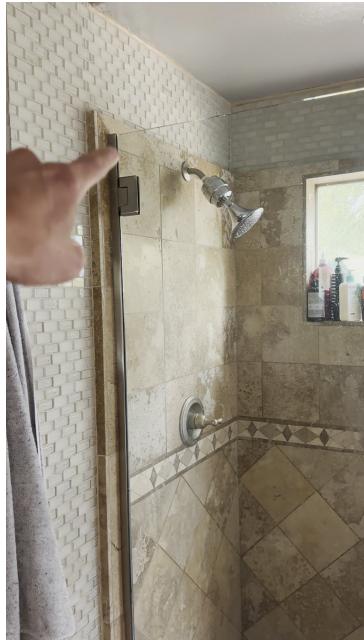
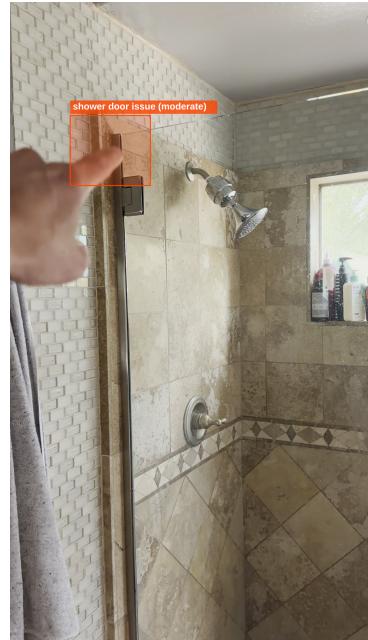
The shower door was observed to be striking the adjoining glass and is misaligned. This condition can cause damage to the glass or hardware and may lead to failure if not corrected. It is recommended that a qualified glass/frameless-shower contractor or handyman evaluate the door alignment, adjust hinges or track, and install additional support or reinforcement as necessary to prevent further damage.

Original image: shower door issue at Master Bathroom

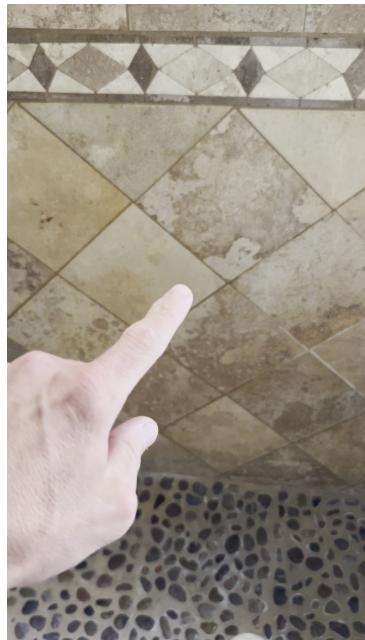
Loose tiles were observed in the master bathroom shower and were reported as a potential safety hazard. Loose or detached tiles can fall or create sharp edges and often indicate compromised substrate or prior water intrusion. It is recommended to discontinue use of the shower until a qualified tile contractor or licensed plumber assesses the condition, secures or replaces loose tiles, and evaluates the underlying substrate for moisture damage or continued leaks. Prompt repair is advised to prevent injury and further deterioration.

Original image: loose tiles at Master Bathroom Shower
