I Inspection Report Overview

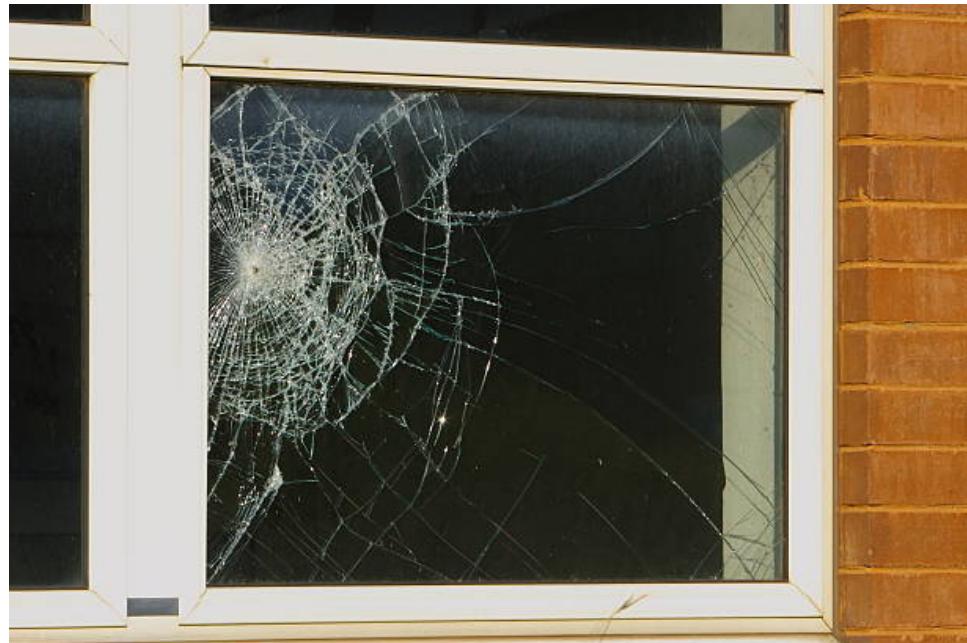
2. Cracked Window Pane

The damaged glass pane may expose sharp edges and reduce the thermal barrier against the elements. Further evaluation by a qualified contractor is recommended to repair or replace the damaged window as needed.

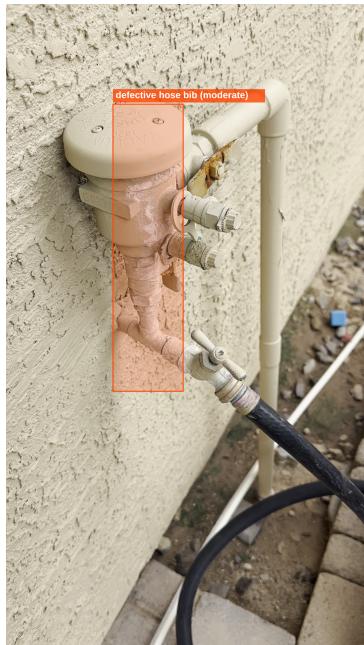
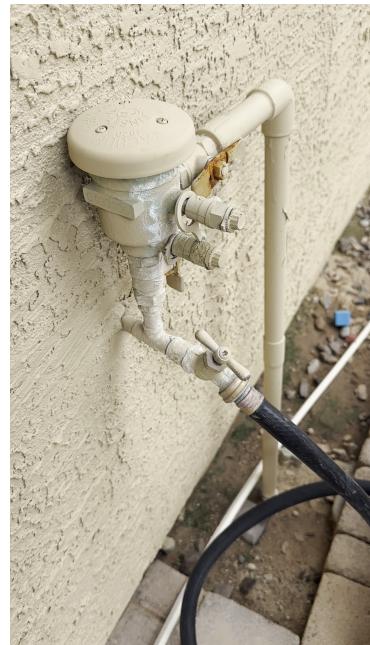
10. Hose Bib Handle Damaged or Missing

The handle for the exterior spigot was damaged or missing. Repairs or replacement as needed are recommended to be performed by a qualified individual to ensure proper operation.

Annotated image: defective hose bib at Back Yard

Original image: defective hose bib at Back Yard

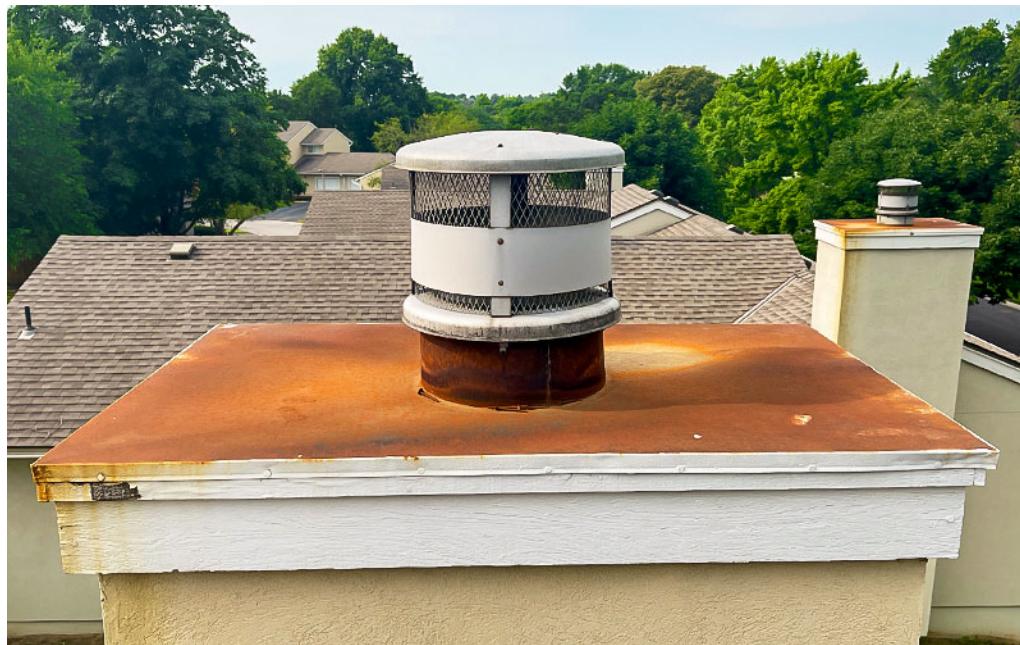
2. Corroded Chimney Cap

The chimney cap displayed signs of corrosion. Regular maintenance, such as sealing, is recommended to prevent further damage and extend its longevity.

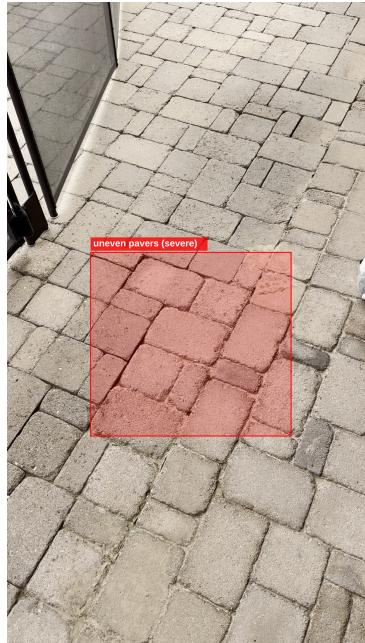
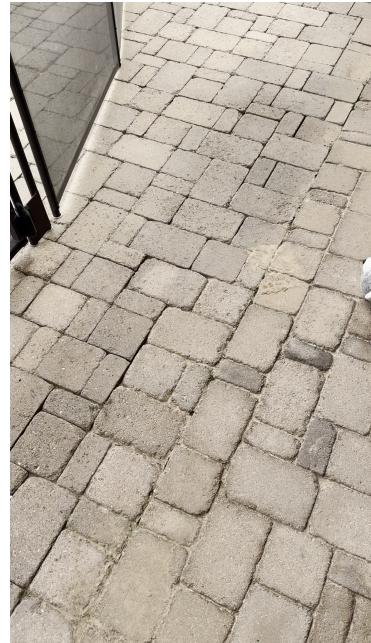
1. Uneven Pavers — Trip Hazard

Uneven paver stones were observed in the backyard, creating a potential trip hazard to occupants and visitors. This condition presents an immediate safety concern and should be corrected. Recommend evaluation and repair by a qualified hardscape contractor or landscaper to re-level, reset, or replace affected pavers to eliminate the trip hazard.

Annotated image: uneven pavers at Back Yard

Original image: uneven pavers at Back Yard

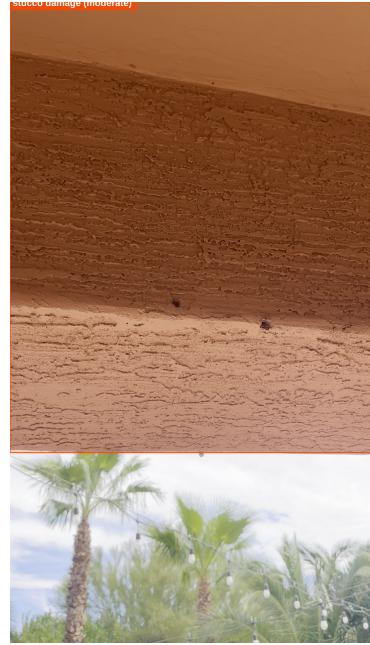
2. Stucco Cracks/Damage

Stucco damage was observed. Gaps or cracks in stucco can allow for moisture intrusion, accelerating deterioration. It is recommended that a qualified contractor evaluate and perform necessary repairs.

Original image: stucco damage at Back Yard

Annotated image: stucco damage at Back Yard

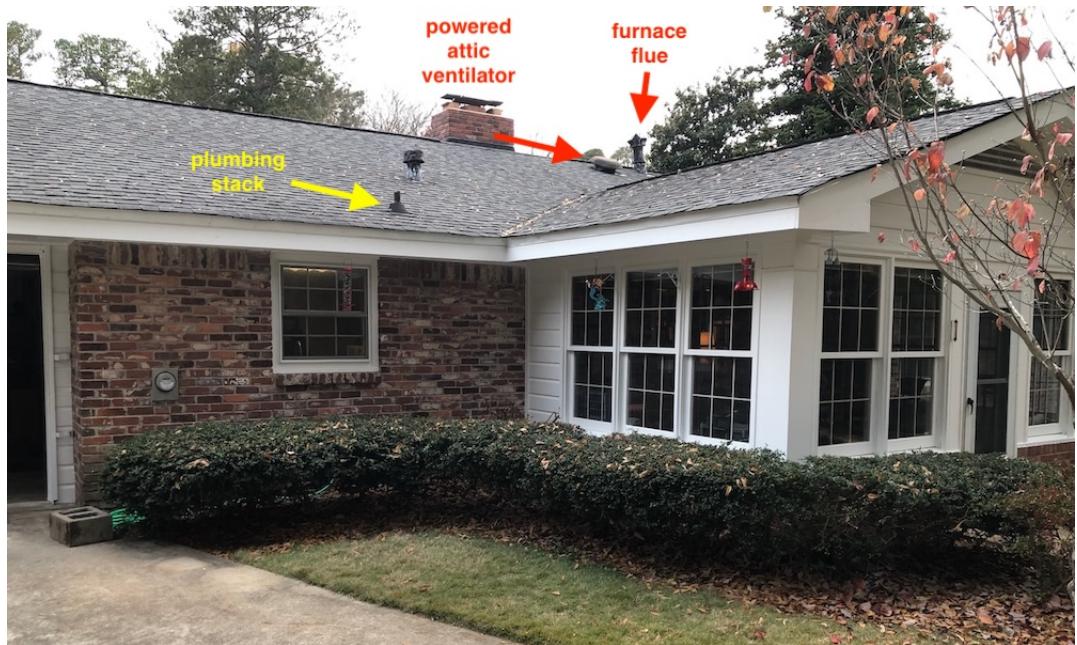
1. Inadequate Plumbing Vent Clearance near Rooftop Deck

The plumbing vent displayed insufficient clearance from a rooftop deck. For proper ventilation and to prevent sewer gases from entering recreational areas, vents should typically extend at least 6 feet above a rooftop deck. It is recommended to consult with a licensed professional to ensure appropriate vent height and mitigate potential health concerns.

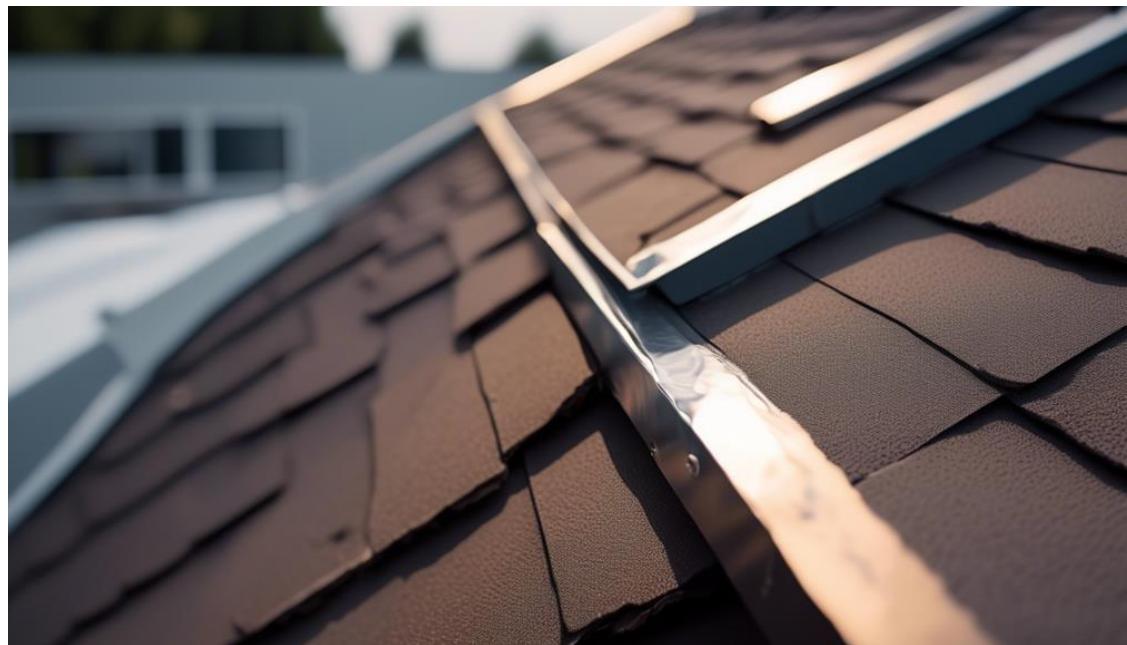
Observations indicate the presence of openings or gaps within the flashing or sealant materials. Such breaches can compromise the water-resistant barrier of the roof, potentially leading to water penetration. It is recommended to engage a certified roofing contractor to address and repair these areas to prevent future moisture intrusion.

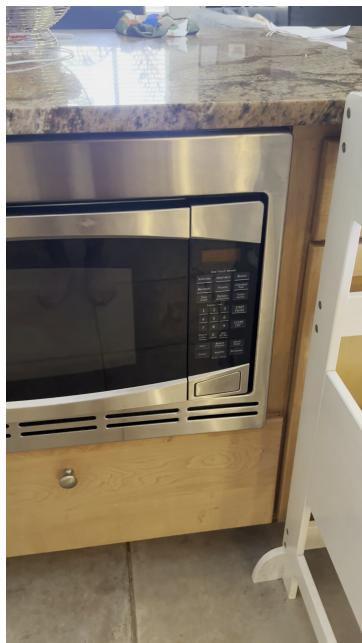
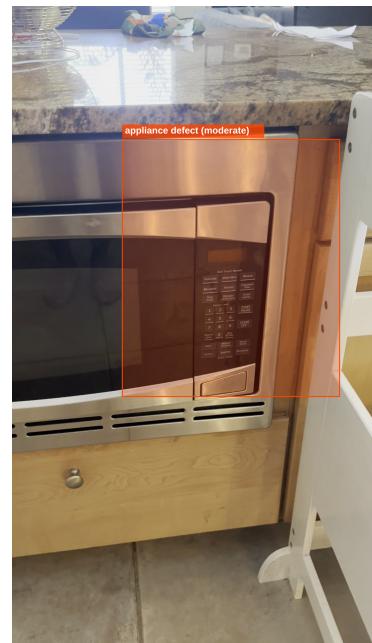
1. Unit Non-Functional or Malfunctioning

The microwave oven appeared to be non-operational or was malfunctioning. It is advised that a qualified appliance technician evaluate and perform necessary repairs or replacement.

Original image: appliance defect at Kitchen

Annotated image: appliance defect at Kitchen

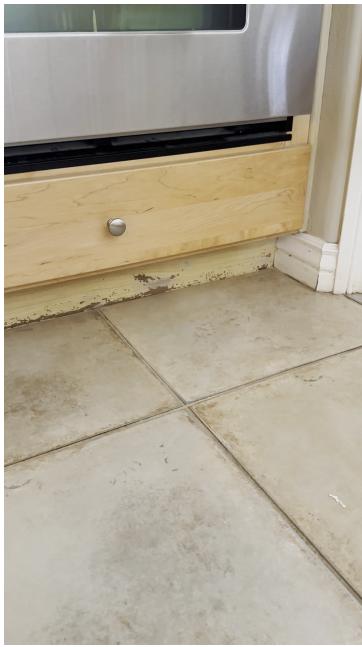
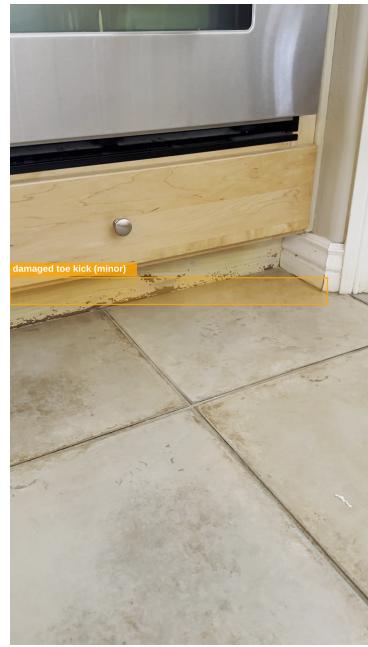
Original image: damaged toe kick at Kitchen

Annotated image: damaged toe kick at Kitchen

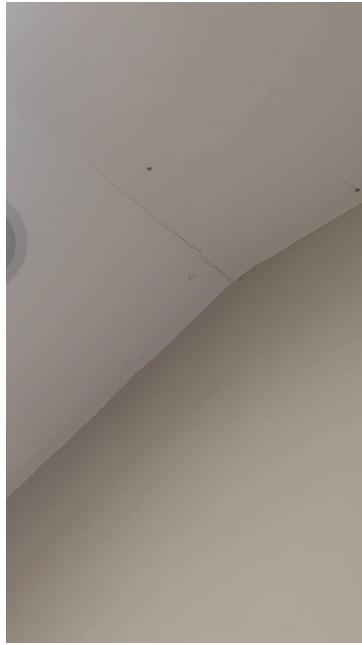
Significant drywall imperfections, including damage, cracking, or inconsistencies, were noted in the referenced area(s). It is advisable to inquire with the current homeowner(s) regarding any past alterations. Repairs should be undertaken by a drywall contractor as desired.

Original image: ceiling crack at Living Room

Annotated image: ceiling crack at Living Room

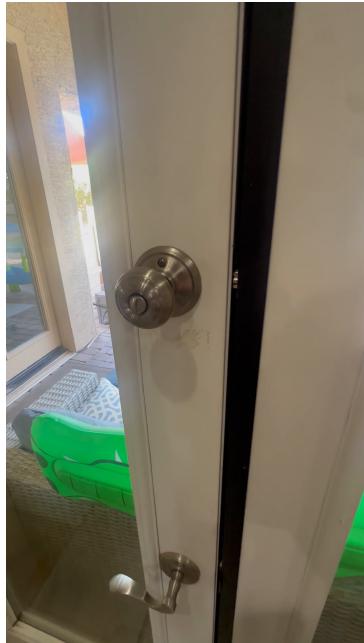
Original image: broken door handle at Living Room

Annotated image: broken door handle at Living Room

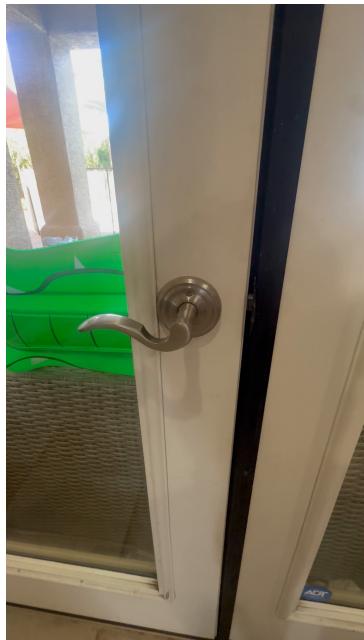
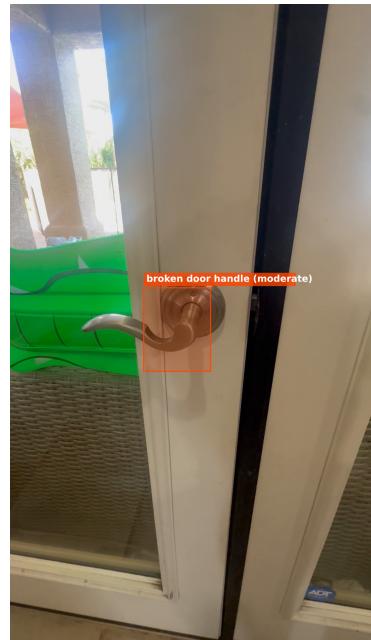
3. Damaged or Missing Door Hardware

The door handle is either damaged or missing. It is recommended that a qualified professional evaluate and repair or replace it as necessary.

Original image: broken door handle at Living Room

Annotated image: broken door handle at Living Room

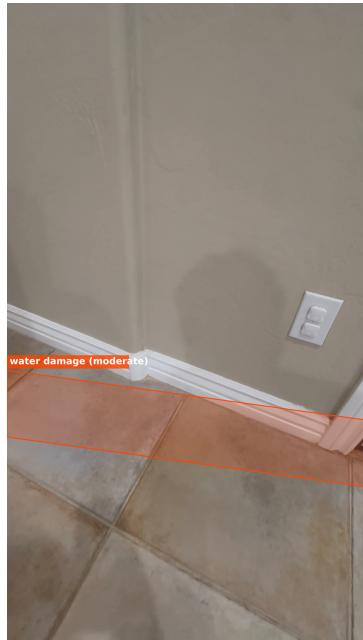
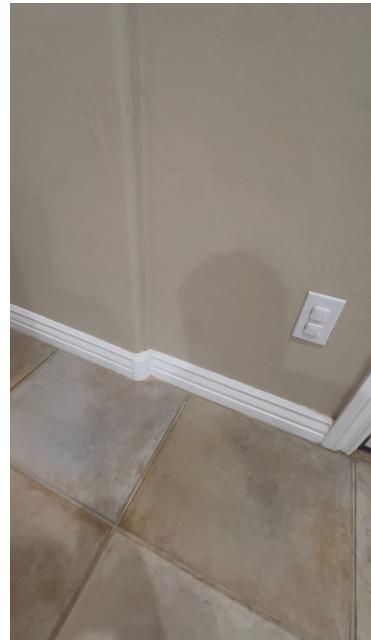
1. Subflooring Water Damage

Water damage was observed on the subflooring during the assessment. This damage may signify a historical or ongoing leak. It is advised to consult with the seller regarding the nature of the damage and any prior repairs. Alternatively, monitor the affected area for any subsequent deterioration.

Annotated image: water damage at Living Room

Original image: water damage at Living Room

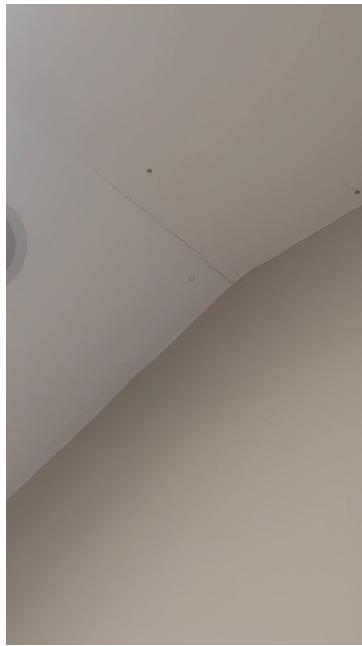
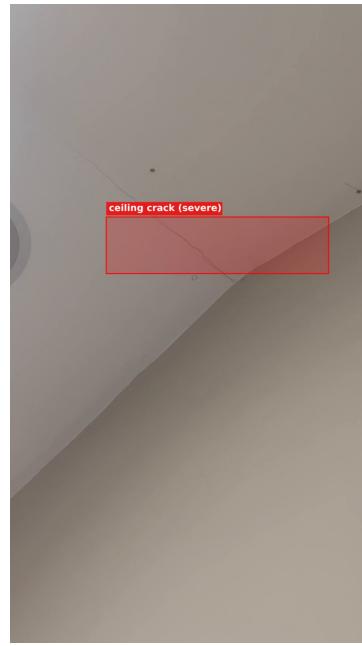
1. Ceiling Crack — Possible Structural Concern

Significant cracking was observed in the ceiling in the Living Room that may indicate underlying structural movement or damage. A licensed contractor or structural engineer should be engaged to evaluate the extent and cause of the cracking and to recommend necessary repairs. This condition may represent a safety risk and should be addressed promptly.

Original image: ceiling crack at Living Room

Annotated image: ceiling crack at Living Room

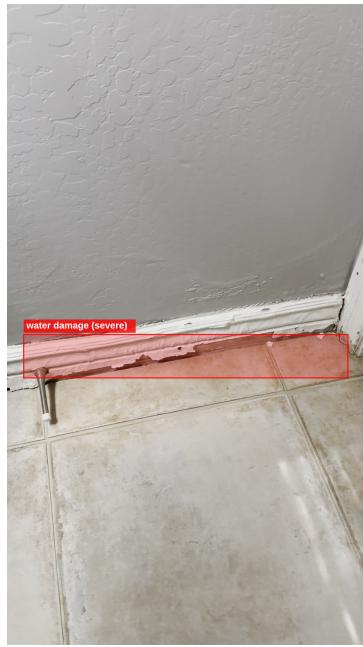
1. Evidence of Active Moisture Intrusion

The observed leakage could cause additional damage to the framing member and floor decking. Water staining and dampness were noted in one or more areas, as confirmed by a moisture meter. This condition increases the risk of insect infestation, mildew, and decay. It is recommended to consult a licensed contractor to identify and rectify the source of the dampness, which may involve improving exterior drainage, installing a waterproofing system, or sealing foundation cracks.

Annotated image: water damage at Master Bathroom

Original image: water damage at Master Bathroom

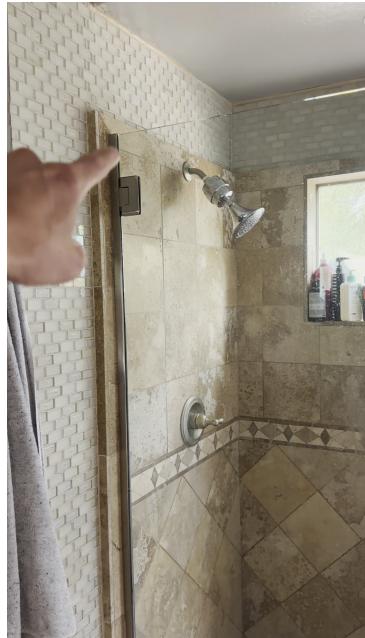
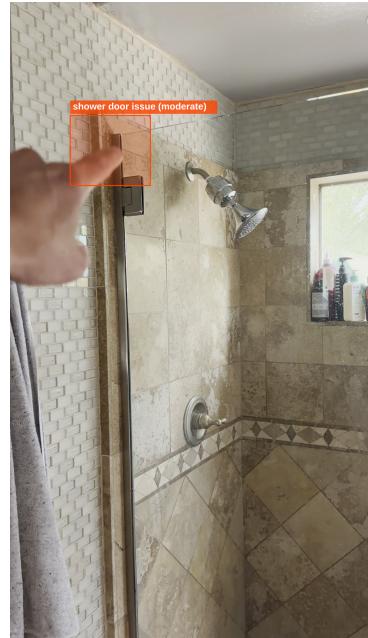
2. Shower Door Misalignment / Impacting Glass

The shower door was observed to be striking the adjoining glass and is misaligned. This condition can cause damage to the glass or hardware and may lead to failure if not corrected. It is recommended that a qualified glass/frameless-shower contractor or handyman evaluate the door alignment, adjust hinges or track, and install additional support or reinforcement as necessary to prevent further damage.

Original image: shower door issue at Master Bathroom

Annotated image: shower door issue at Master Bathroom
