# PROPERTY INSPECTION REPORT FORM

251 N Bristol Ave, Los Angeles, CA 90049  
Address of Inspected Property

08/13/2025, 6:00 AM  
Date of Inspection

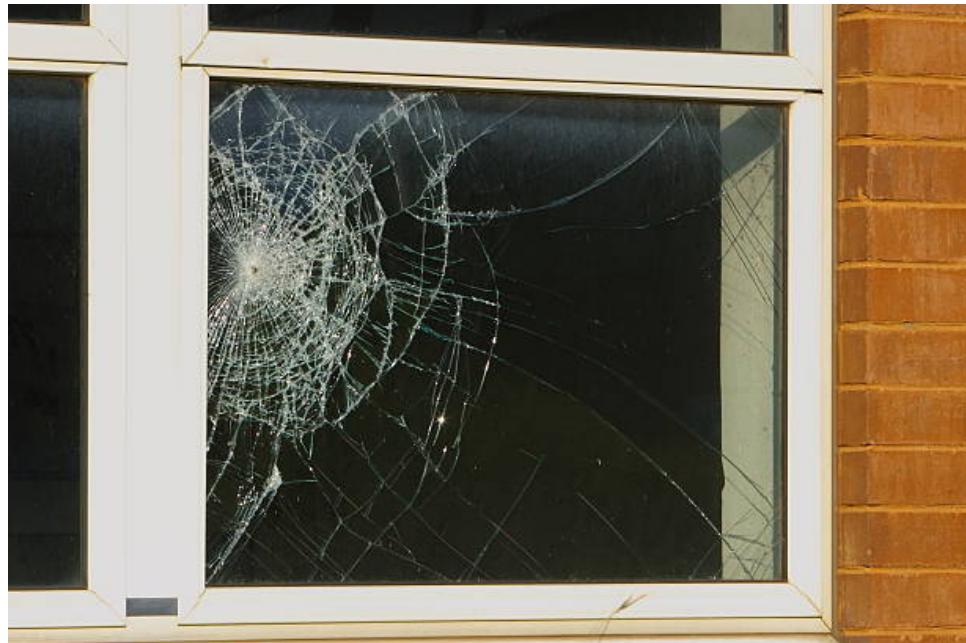
The damaged glass pane may expose sharp edges and reduce the thermal barrier against the elements. Further evaluation by a qualified contractor is recommended to repair or replace the damaged window as needed.

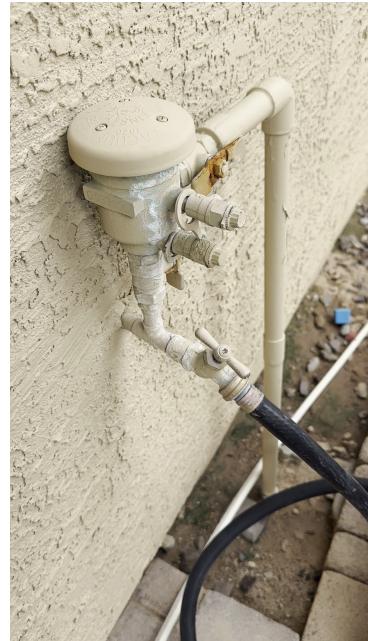
The handle for the exterior spigot was damaged or missing. Repairs or replacement as needed are recommended to be performed by a qualified individual to ensure proper operation.

Annotated image: defective hose bib at Back Yard

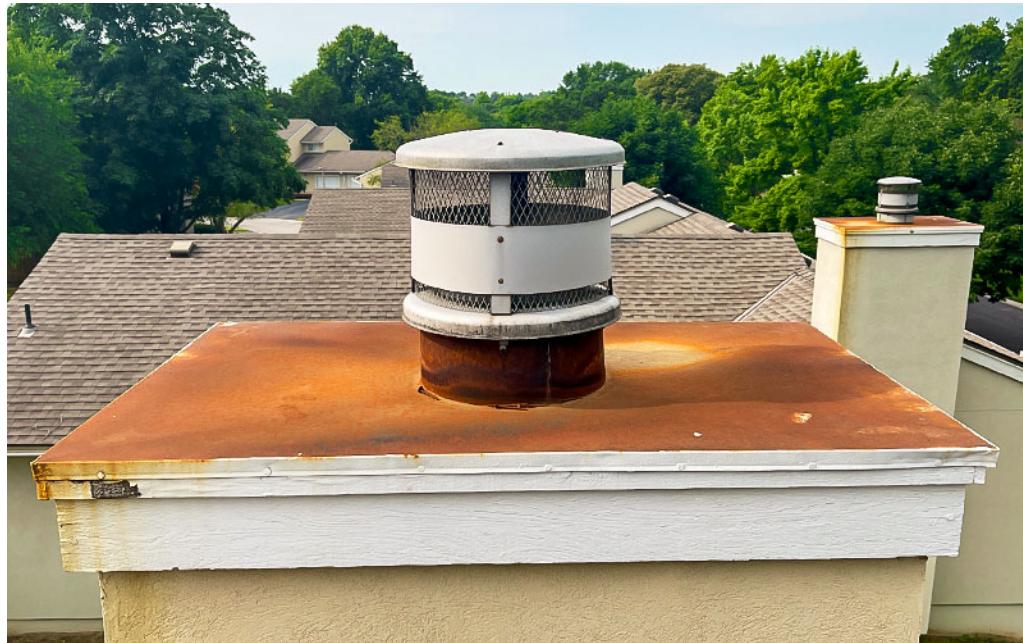
The chimney cap displayed signs of corrosion. Regular maintenance, such as sealing, is recommended to prevent further damage and extend its longevity.

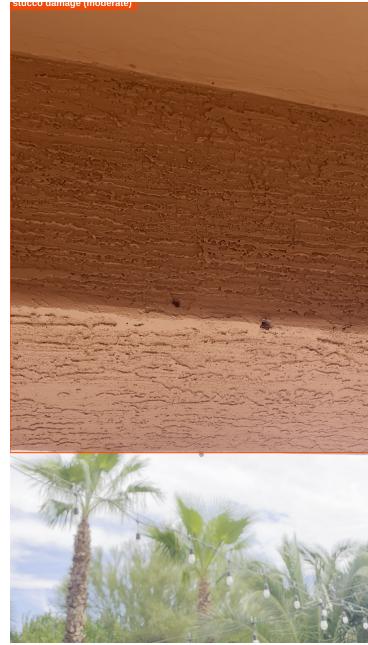
Stucco damage was observed. Gaps or cracks in stucco can allow for moisture intrusion, accelerating deterioration. It is recommended that a qualified contractor evaluate and perform necessary repairs.

Original image: stucco damage at Back Yard

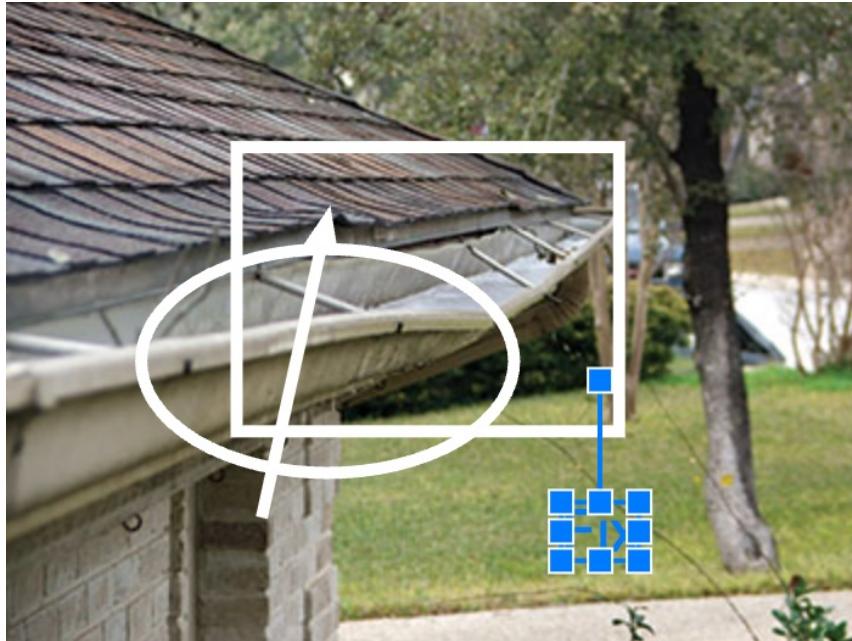
A gutter hanger was observed to be missing or damaged. It is recommended to properly secure or replace the gutter hangers to ensure the intended stability and proper alignment of the gutter system.

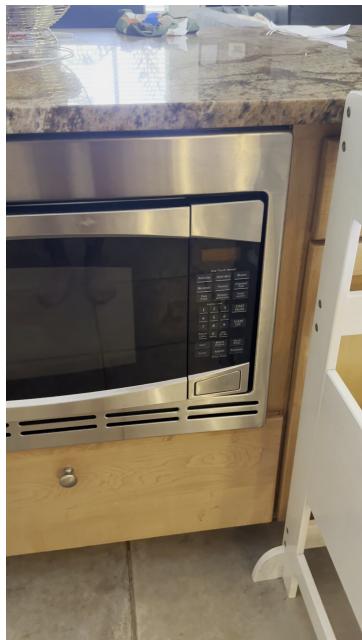
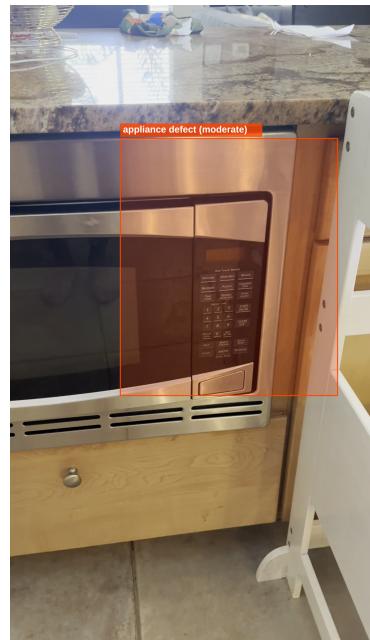
The microwave oven appeared to be non-operational or was malfunctioning. It is advised that a qualified appliance technician evaluate and perform necessary repairs or replacement.

Original image: appliance defect at Kitchen

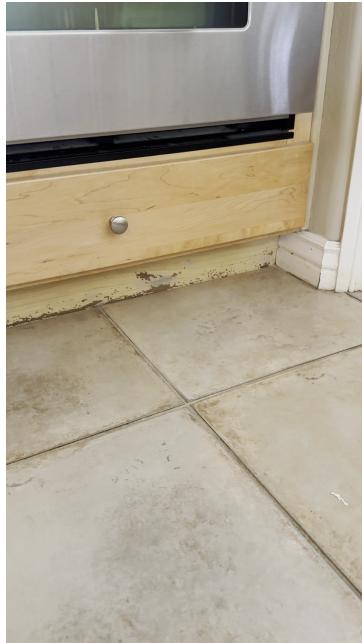
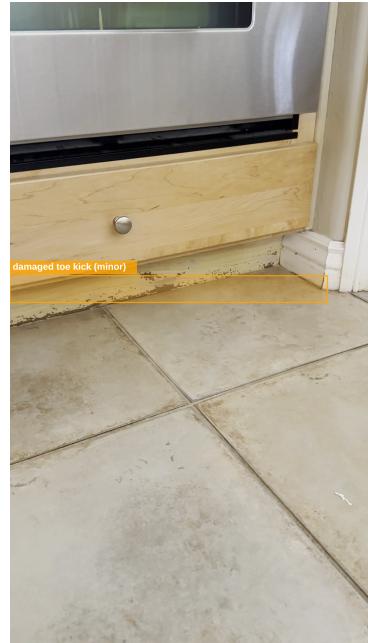
The paint finish exhibited signs of failure or peeling in one or more locations. It is recommended that a qualified contractor perform the necessary repairs.

Original image: damaged toe kick at Kitchen

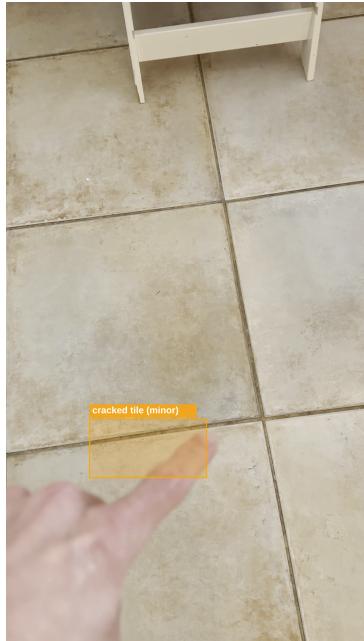
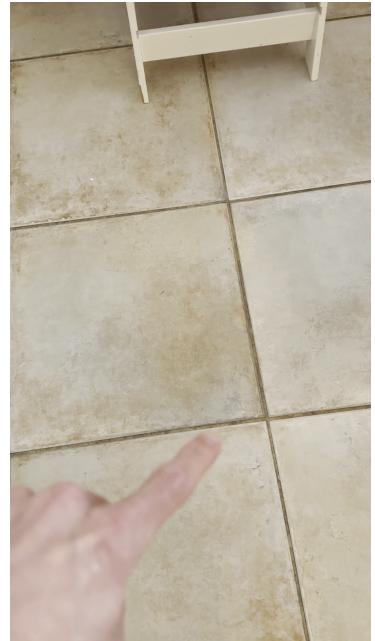
Annotated image: cracked tile at Kitchen

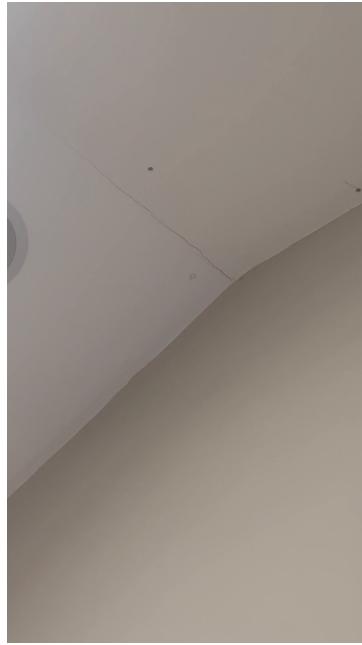
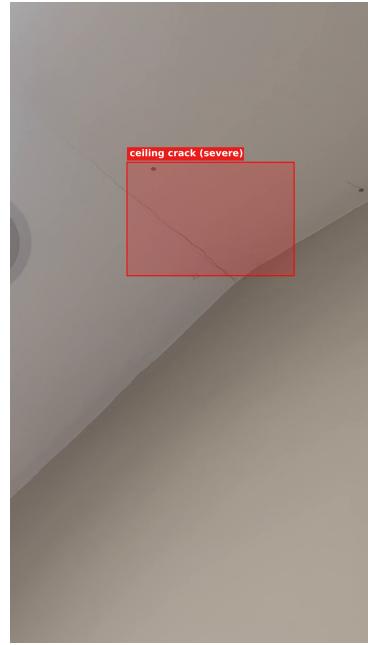
Significant drywall imperfections, including damage, cracking, or inconsistencies, were noted in the referenced area(s). It is advisable to inquire with the current homeowner(s) regarding any past alterations. Repairs should be undertaken by a drywall contractor as desired.

Original image: ceiling crack at Living Room

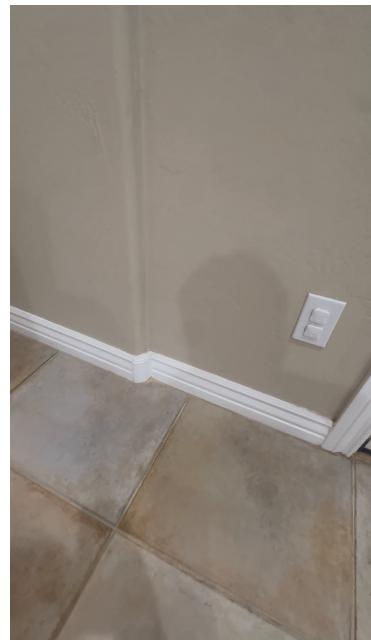
Water damage was observed on the subflooring during the assessment. This damage may signify a historical or ongoing leak. It is advised to consult with the seller regarding the nature of the damage and any prior repairs. Alternatively, monitor the affected area for any subsequent deterioration.

Annotated image: water damage at Living Room

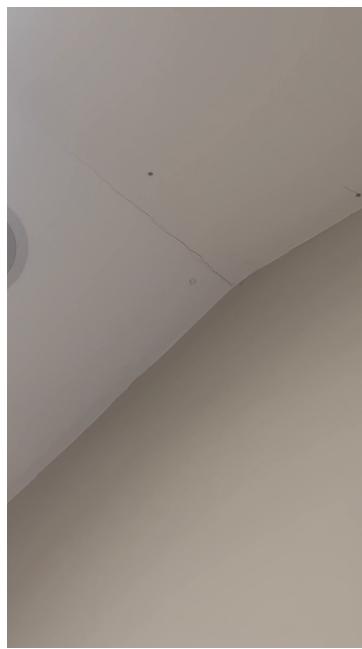
Significant cracking was observed in the ceiling in the Living Room that may indicate underlying structural movement or damage. A licensed contractor or structural engineer should be engaged to evaluate the extent and cause of the cracking and to recommend necessary repairs. This condition may represent a safety risk and should be addressed promptly.

Original image: ceiling crack at Living Room

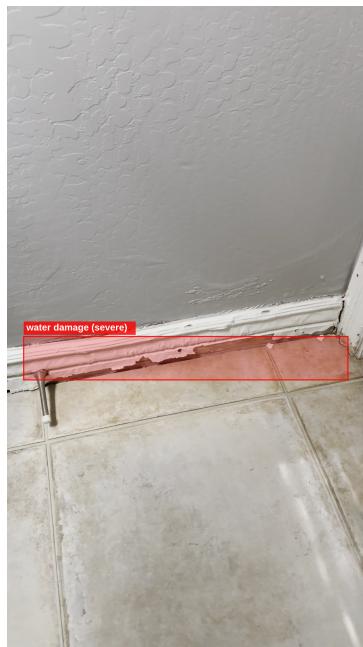
The observed leakage could cause additional damage to the framing member and floor decking. Water staining and dampness were noted in one or more areas, as confirmed by a moisture meter. This condition increases the risk of insect infestation, mildew, and decay. It is recommended to consult a licensed contractor to identify and rectify the source of the dampness, which may involve improving exterior drainage, installing a waterproofing system, or sealing foundation cracks.

Annotated image: water damage at Master Bathroom

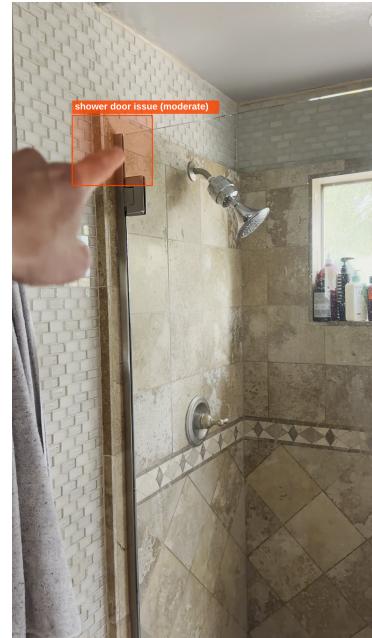
The shower door was observed to be striking the adjoining glass and is misaligned. This condition can cause damage to the glass or hardware and may lead to failure if not corrected. It is recommended that a qualified glass/frameless-shower contractor or handyman evaluate the door alignment, adjust hinges or track, and install additional support or reinforcement as necessary to prevent further damage.

Original image: shower door issue at Master Bathroom

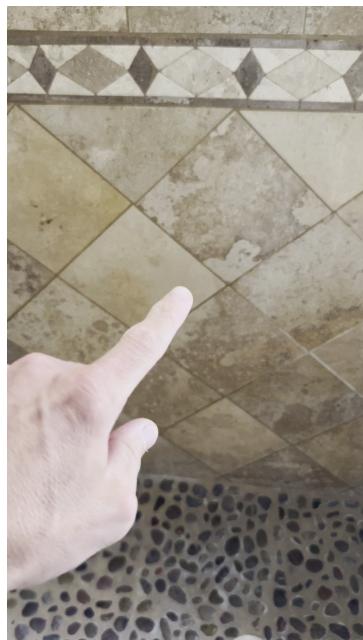
Loose tiles were observed in the master bathroom shower and were reported as a potential safety hazard. Loose or detached tiles can fall or create sharp edges and often indicate compromised substrate or prior water intrusion. It is recommended to discontinue use of the shower until a qualified tile contractor or licensed plumber assesses the condition, secures or replaces loose tiles, and evaluates the underlying substrate for moisture damage or continued leaks. Prompt repair is advised to prevent injury and further deterioration.

Original image: loose tiles at Master Bathroom Shower
