# PROPERTY INSPECTION REPORT FORM

251 N Bristol Ave, Los Angeles, CA 90049

08/13/2025, 6:00 AM

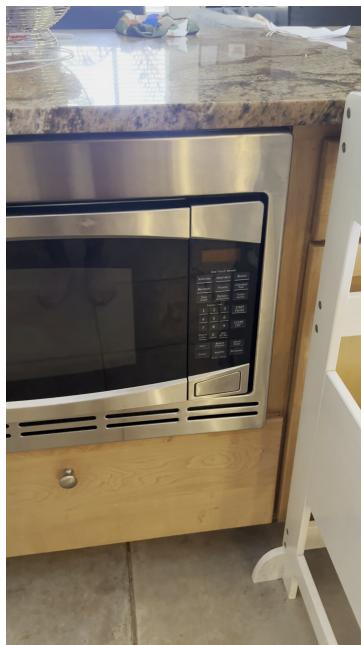
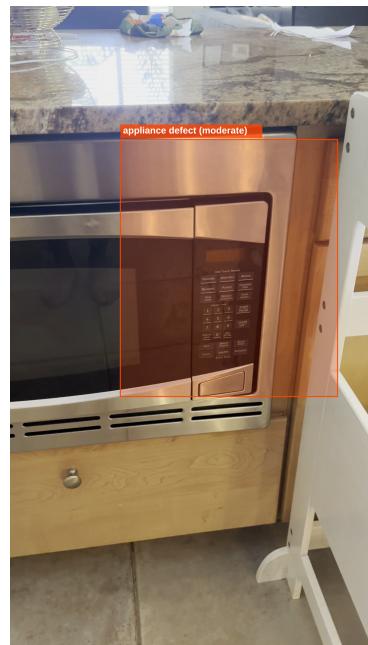
#### 1. Unit Non-Functional or Malfunctioning

The microwave oven appeared to be non-operational or was malfunctioning. It is advised that a qualified appliance technician evaluate and perform necessary repairs or replacement.

Original image: appliance defect at Kitchen

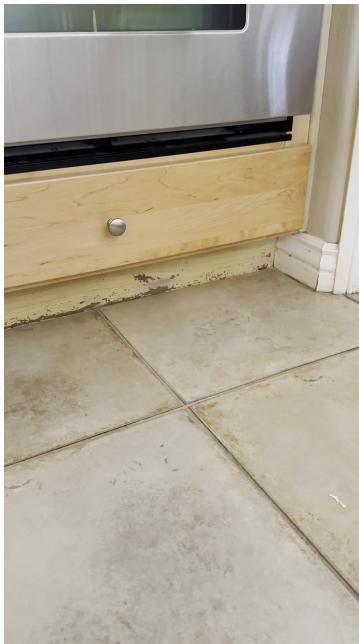
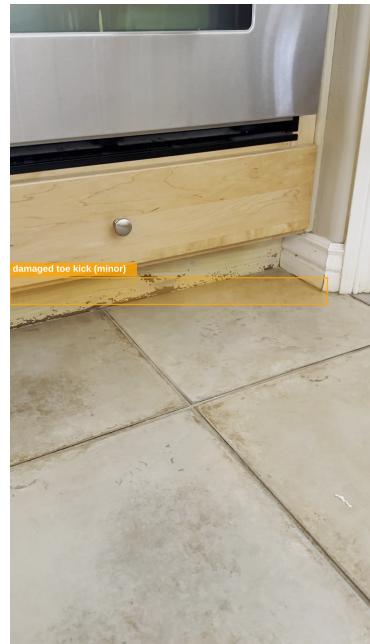
Original image: damaged toe kick at Kitchen

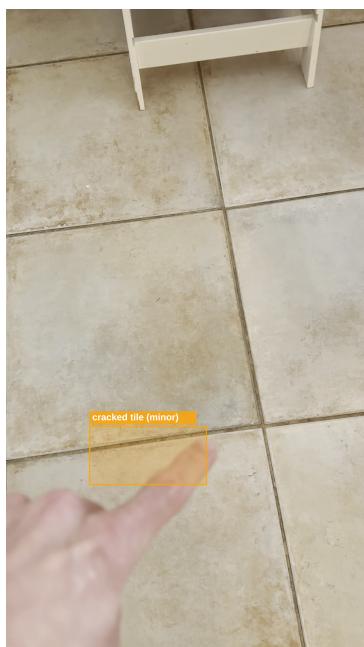
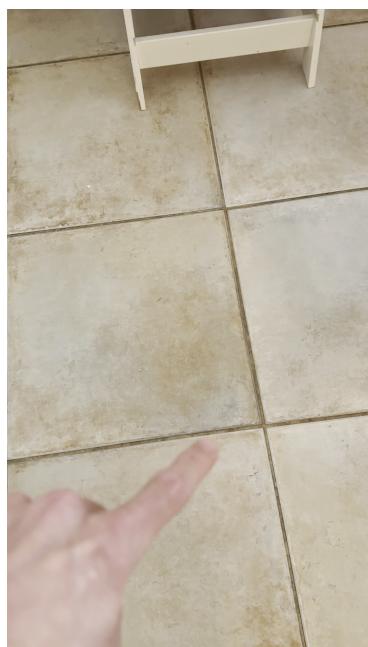
#### 1. Cracked Floor Tile

Two small cracks were observed in the kitchen floor tile. Cracked tile can allow moisture to penetrate the substrate and may deteriorate further over time. Recommend repair or replacement of the affected tile(s) by a qualified flooring contractor and verify the integrity of the surrounding substrate and grout. Obtain estimates as needed.

Annotated image: cracked tile at Kitchen

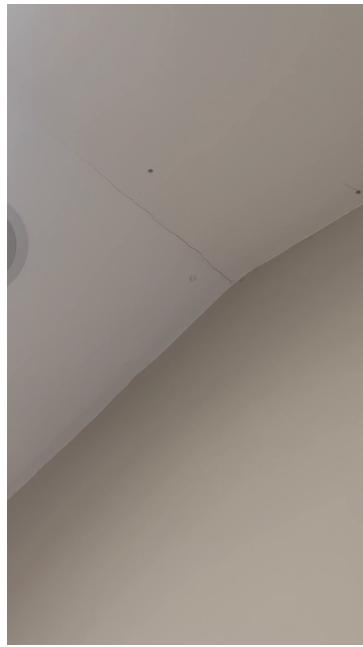
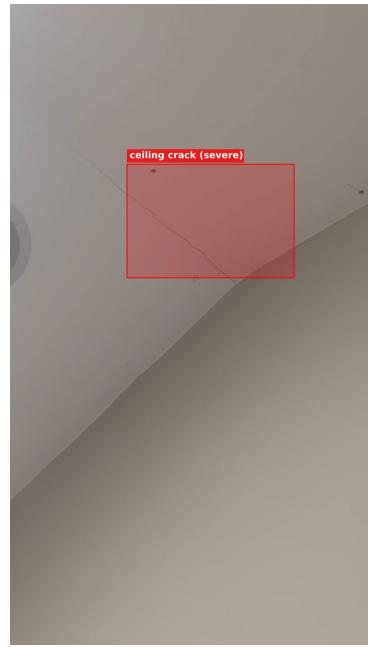
Significant drywall imperfections, including damage, cracking, or inconsistencies, were noted in the referenced area(s). It is advisable to inquire with the current homeowner(s) regarding any past alterations. Repairs should be undertaken by a drywall contractor as desired.

Original image: ceiling crack at Living Room

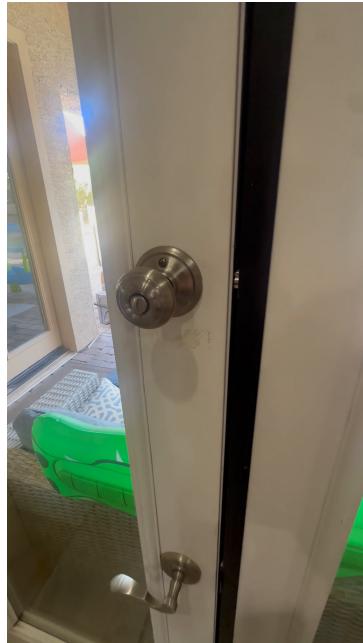
Original image: broken door handle at Living Room

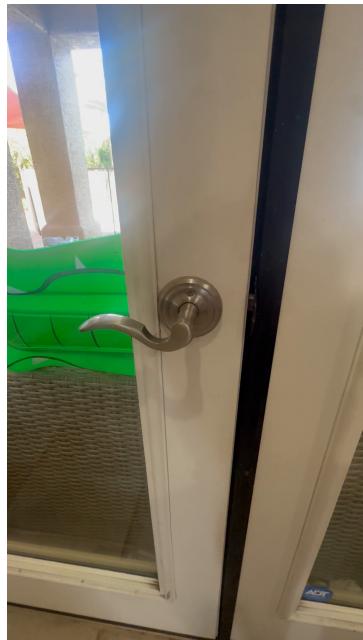
### 3. Damaged or Missing Door Hardware

The door handle is either damaged or missing. It is recommended that a qualified professional evaluate and repair or replace it as necessary.

Original image: broken door handle at Living Room

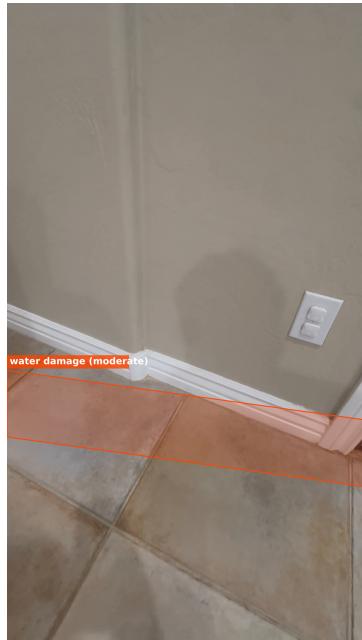
##### 1. Subflooring Water Damage

Water damage was observed on the subflooring during the assessment. This damage may signify a historical or ongoing leak. It is advised to consult with the seller regarding the nature of the damage and any prior repairs. Alternatively, monitor the affected area for any subsequent deterioration.

Annotated image: water damage at Living Room

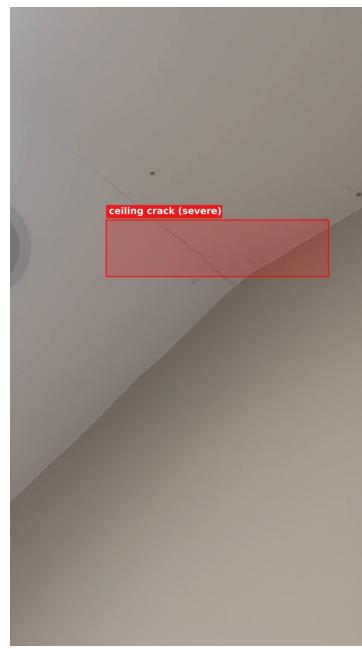
##### **1. Ceiling Crack — Possible Structural Concern**

Significant cracking was observed in the ceiling in the Living Room that may indicate underlying structural movement or damage. A licensed contractor or structural engineer should be engaged to evaluate the extent and cause of the cracking and to recommend necessary repairs. This condition may represent a safety risk and should be addressed promptly.

Original image: ceiling crack at Living Room

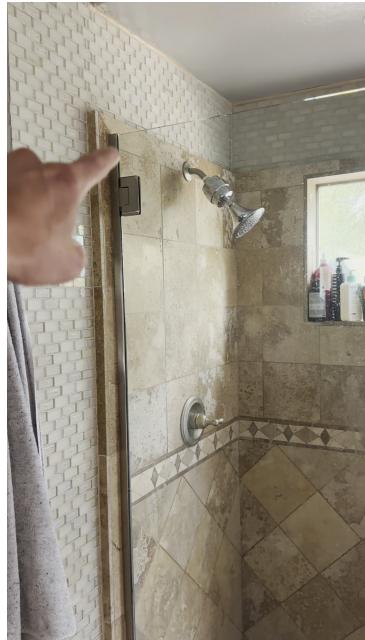
## 2. Shower Door Misalignment / Impacting Glass

The shower door was observed to be striking the adjoining glass and is misaligned. This condition can cause damage to the glass or hardware and may lead to failure if not corrected. It is recommended that a qualified glass/frameless-shower contractor or handyman evaluate the door alignment, adjust hinges or track, and install additional support or reinforcement as necessary to prevent further damage.

Original image: shower door issue at Master Bathroom

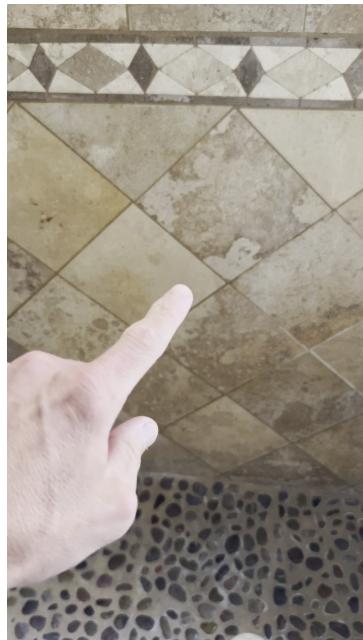
## 3. Loose Shower Wall Tiles — Safety Hazard

Loose tiles were observed in the master bathroom shower and were reported as a potential safety hazard. Loose or detached tiles can fall or create sharp edges and often indicate compromised substrate or prior water intrusion. It is recommended to discontinue use of the shower until a qualified tile contractor or licensed plumber assesses the condition, secures or replaces loose tiles, and evaluates the underlying substrate for moisture damage or continued leaks. Prompt repair is advised to prevent injury and further deterioration.

Original image: loose tiles at Master Bathroom Shower
