# PROPERTY INSPECTION REPORT

251 N Bristol Ave, Los Angeles, CA 90049

Inspection Date: August 13, 2025

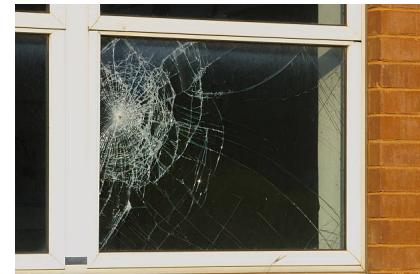
Photo 5.2

The damaged glass pane may expose sharp edges and reduce the thermal barrier against the elements. Further evaluation by a qualified contractor is recommended to repair or replace the damaged window as needed.

Recommendation: Contact window

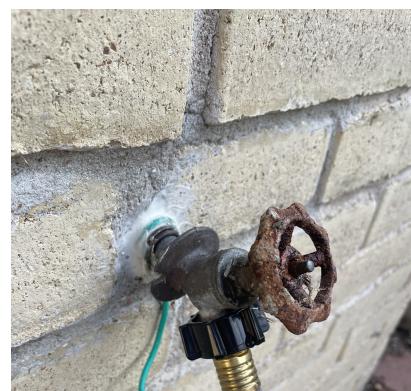
Inspector recommends repairing or replacing the exterior hose bib to make it fully operational. Confirm functionality after repair and check for leaks. Obtain quotes from a licensed plumber or qualified contractor as needed.

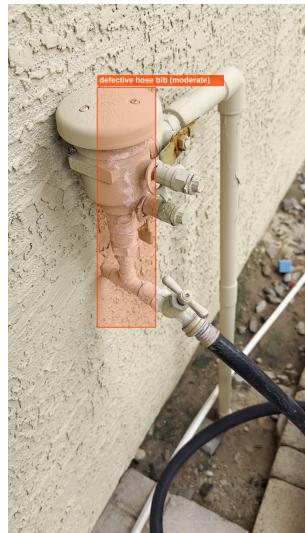
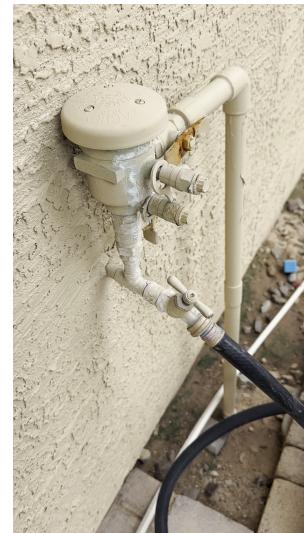
The handle for the exterior spigot was damaged or missing. Repairs or replacement as needed are recommended to be performed by a qualified individual to ensure proper operation.

Recommendation: Contact handyman-diy

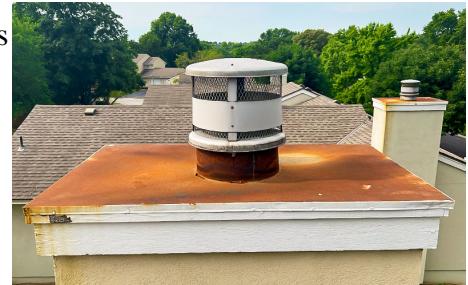
Photo 5.2

The chimney cap displayed signs of corrosion. Regular maintenance, such as sealing, is recommended to prevent further damage and extend its longevity.

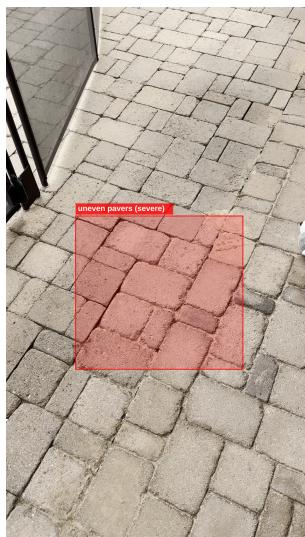
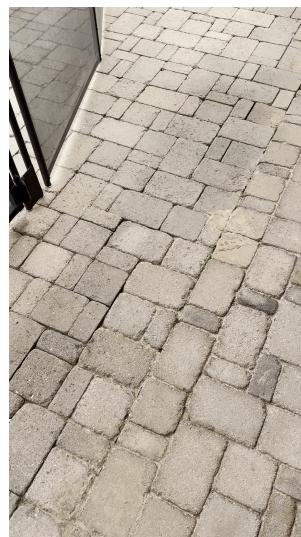
Uneven paver stones were observed in the backyard, creating a potential trip hazard to occupants and visitors. This condition presents an immediate safety concern and should be corrected. Recommend evaluation and repair by a qualified hardscape contractor or landscaper to re-level, reset, or replace affected pavers to eliminate the trip hazard.

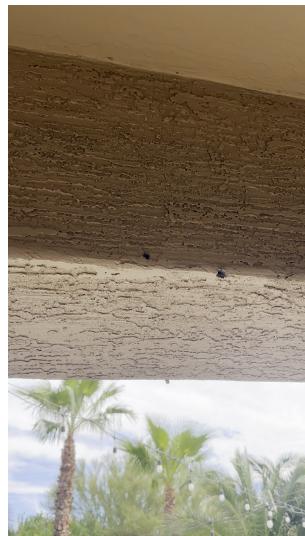
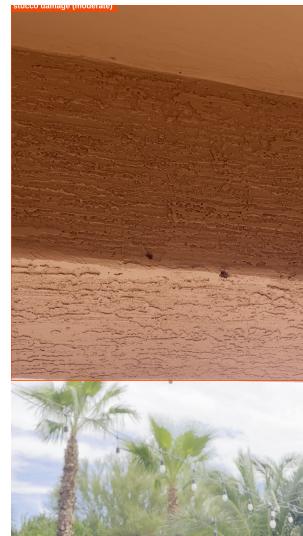
Stucco damage was observed. Gaps or cracks in stucco can allow for moisture intrusion, accelerating deterioration. It is recommended that a qualified contractor evaluate and perform necessary repairs.

Recommendation: Contact stucco

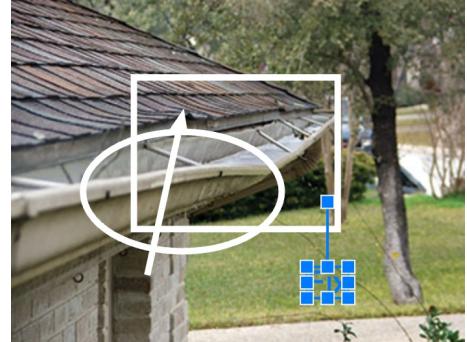
Photo 6.2

A gutter hanger was observed to be missing or damaged. It is recommended to properly secure or replace the gutter hangers to ensure the intended stability and proper alignment of the gutter system.

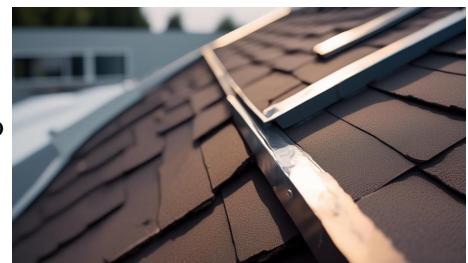
Photo 6.1

Observations indicate the presence of openings or gaps within the flashing or sealant materials. Such breaches can compromise the water-resistant barrier of the roof, potentially leading to water penetration. It is recommended to engage a certified roofing contractor to address and repair these areas to prevent future moisture intrusion.

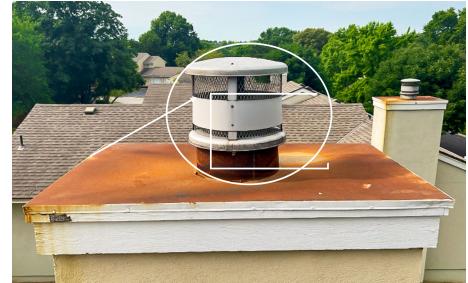
Photo 7.1

A damaged or missing vent cover could allow debris and small pests to enter. It is recommended to repair or replace the vent cover to ensure proper operation.

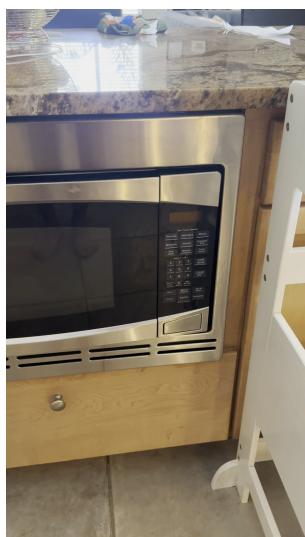
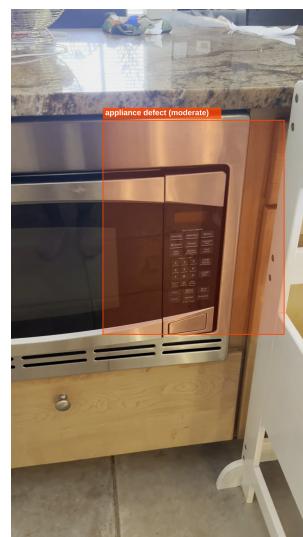
The microwave oven appeared to be non-operational or was malfunctioning. It is advised that a qualified appliance technician evaluate and perform necessary repairs or replacement.

Recommendation: Contact appliance

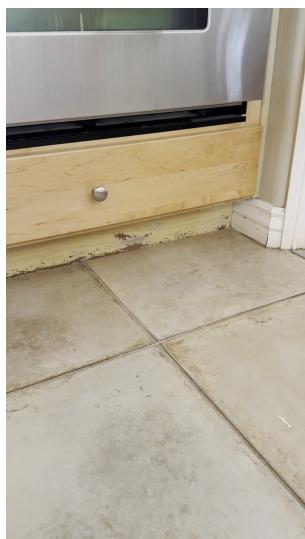
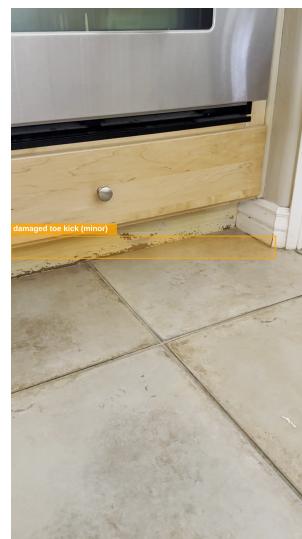
The paint finish exhibited signs of failure or peeling in one or more locations. It is recommended that a qualified contractor perform the necessary repairs.

Recommendation: Contact paint

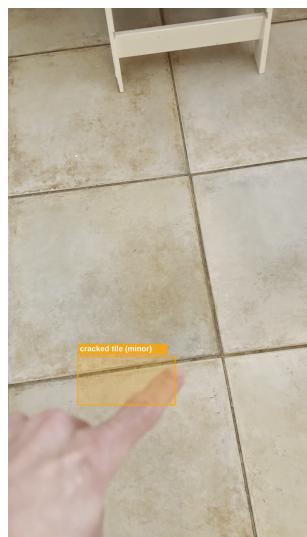
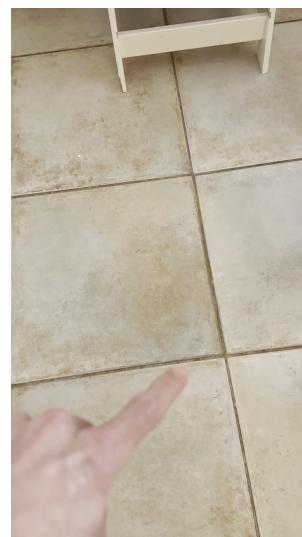
Two small cracks were observed in the kitchen floor tile. Cracked tile can allow moisture to penetrate the substrate and may deteriorate further over time. Recommend repair or replacement of the affected tile(s) by a qualified flooring contractor and verify the integrity of the surrounding substrate and grout. Obtain estimates as needed.

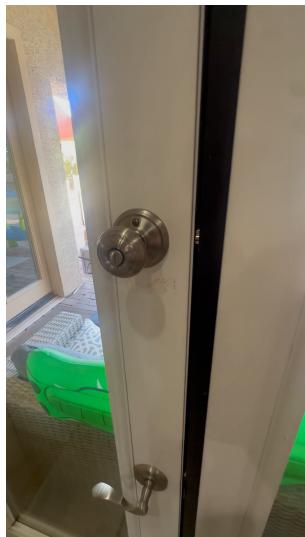
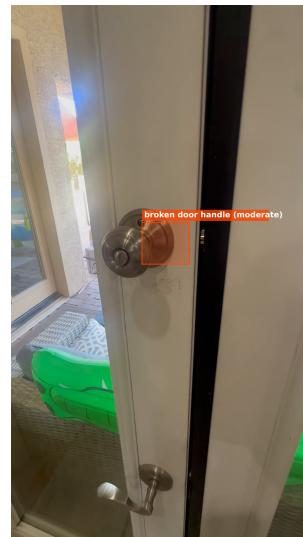
Various exterior door hardware components, including locksets, hinges, and pulls, were observed to be inoperable, damaged, loose, or absent. It is advised that a qualified contractor perform necessary repairs or replacements.

Recommendation: Contact handyman-diy

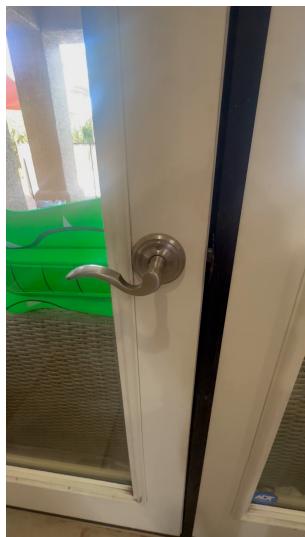
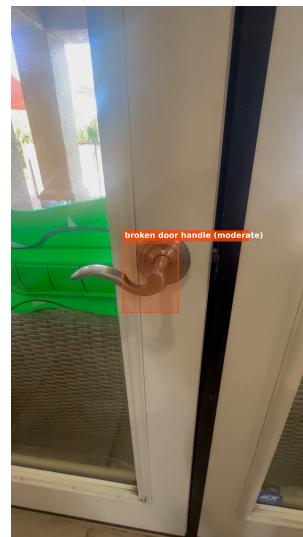
The door handle is either damaged or missing. It is recommended that a qualified professional evaluate and repair or replace it as necessary.

Recommendation: Contact gc

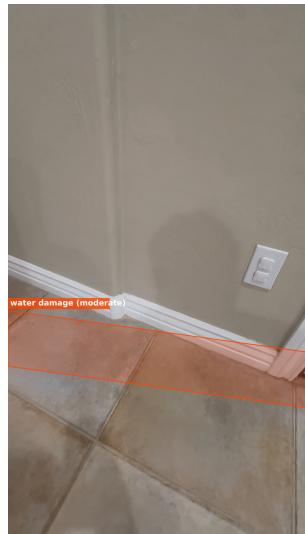
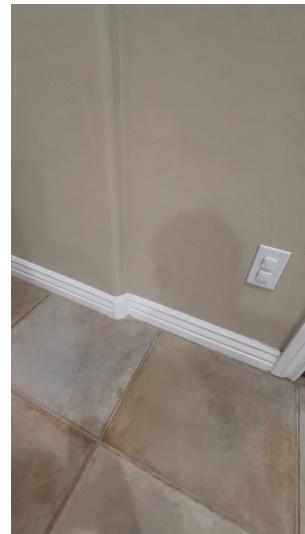
Water damage was observed on the subflooring during the assessment. This damage may signify a historical or ongoing leak. It is advised to consult with the seller regarding the nature of the damage and any prior repairs. Alternatively, monitor the affected area for any subsequent deterioration.

Recommendation: Contact pro

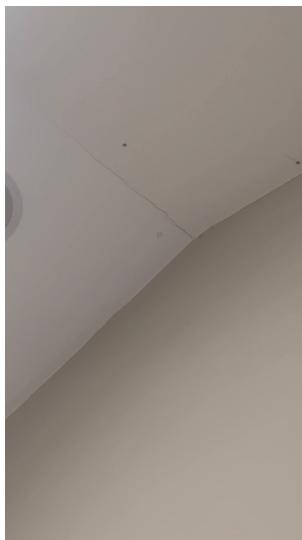
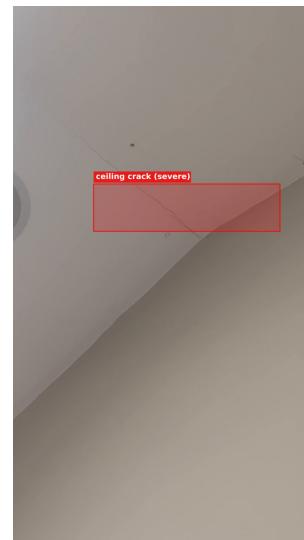
Significant cracking was observed in the ceiling in the Living Room that may indicate underlying structural movement or damage. A licensed contractor or structural engineer should be engaged to evaluate the extent and cause of the cracking and to recommend necessary repairs. This condition may represent a safety risk and should be addressed promptly.

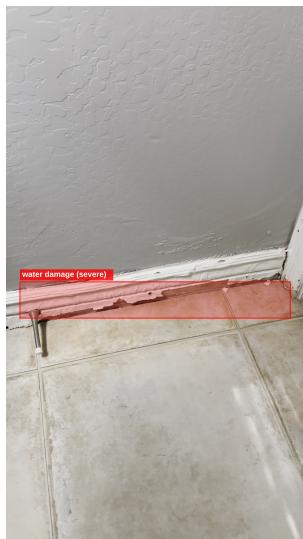
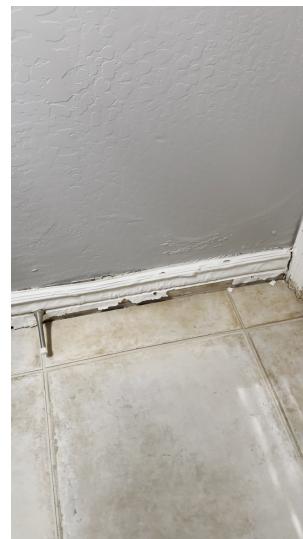
The observed leakage could cause additional damage to the framing member and floor decking. Water staining and dampness were noted in one or more areas, as confirmed by a moisture meter. This condition increases the risk of insect infestation, mildew, and decay. It is recommended to consult a licensed contractor to identify and rectify the source of the dampness, which may involve improving exterior drainage, installing a waterproofing system, or sealing foundation cracks.

Recommendation: Contact waterproof

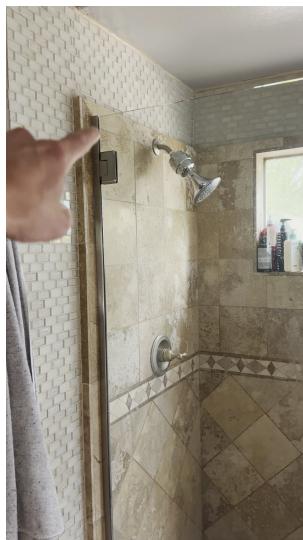
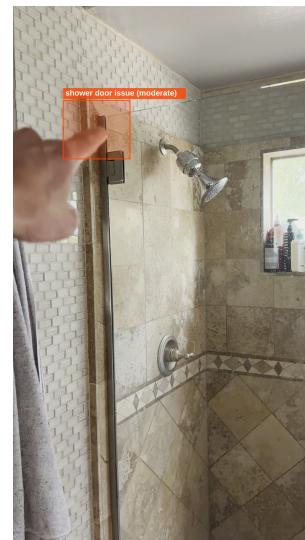
The shower door was observed to be striking the adjoining glass and is misaligned. This condition can cause damage to the glass or hardware and may lead to failure if not corrected. It is recommended that a qualified glass/frameless-shower contractor or handyman evaluate the door alignment, adjust hinges or track, and install additional support or reinforcement as necessary to prevent further damage.

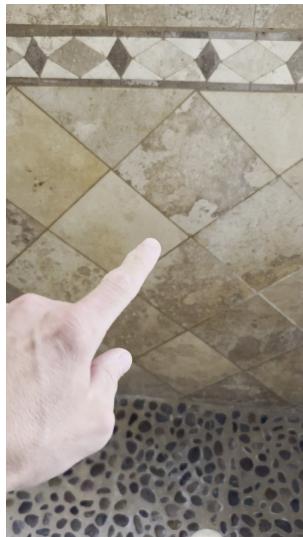
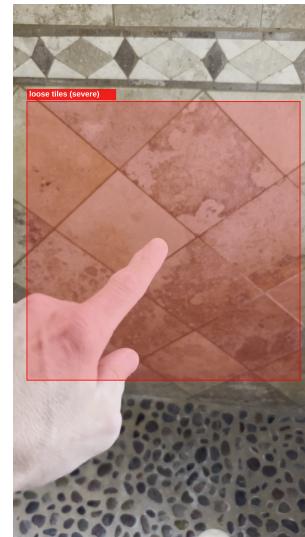
Loose tiles were observed in the master bathroom shower and were reported as a potential safety hazard. Loose or detached tiles can fall or create sharp edges and often indicate compromised substrate or prior water intrusion. It is recommended to discontinue use of the shower until a qualified tile contractor or licensed plumber assesses the condition, secures or replaces loose tiles, and evaluates the underlying substrate for moisture damage or continued leaks. Prompt repair is advised to prevent injury and further deterioration.
