SUBJECT : **FORMAL DENIAL OF LIABILITY – ALLEGED PORTSIDE DAMAGE INCIDENT.**

## FORMAL EXONERATION REPORT

Subject: Formal Rebuttal and Denial of Liability for Notice No. MSIF-21-01

**NOTICE OF DAMAGE BY STEVEDORE**  
**TO SHIP and/or SHIP'S EQUIPMENT and/or SHIP'S MACHINERY**  
装卸工人损坏通知书

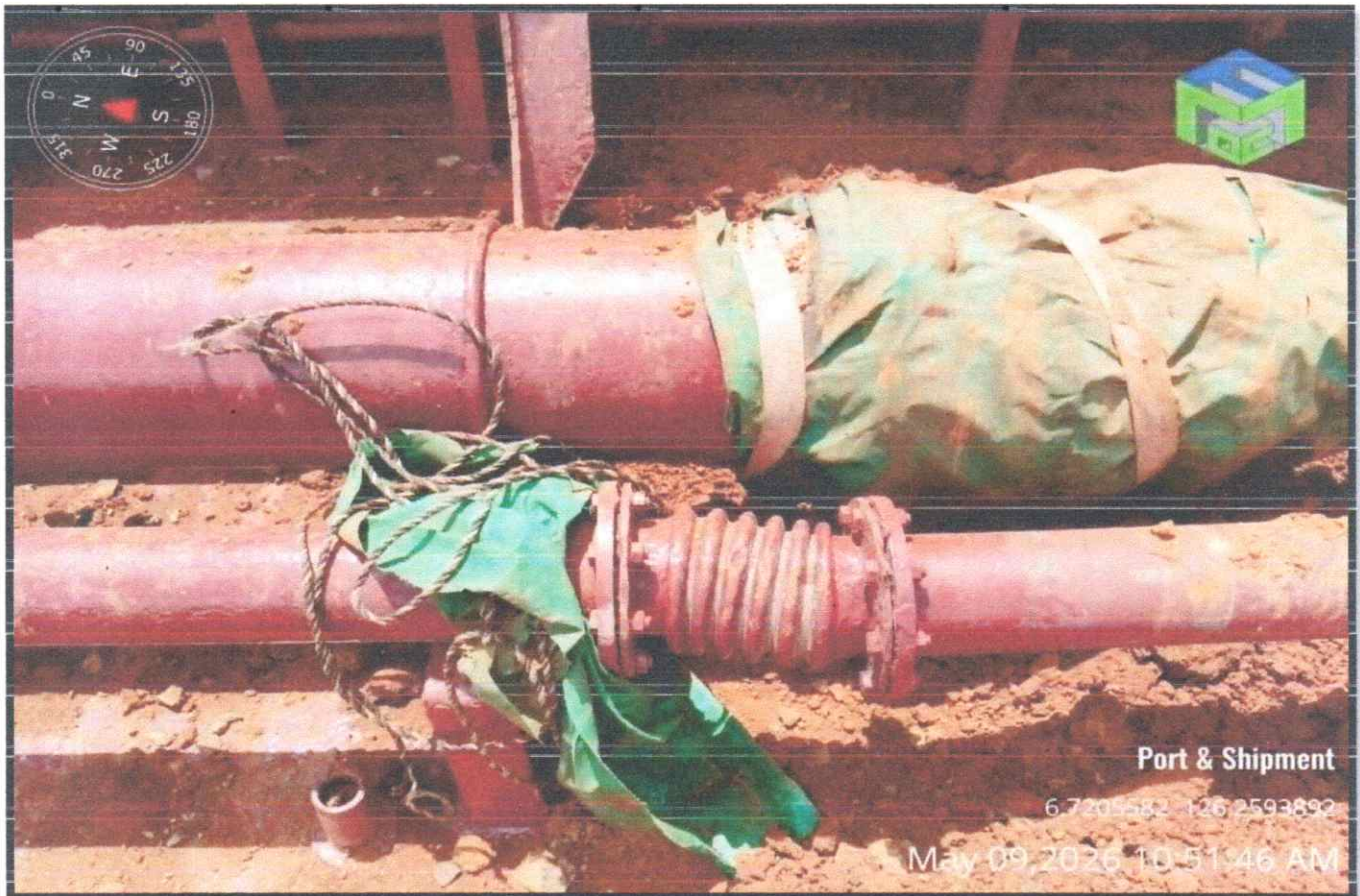
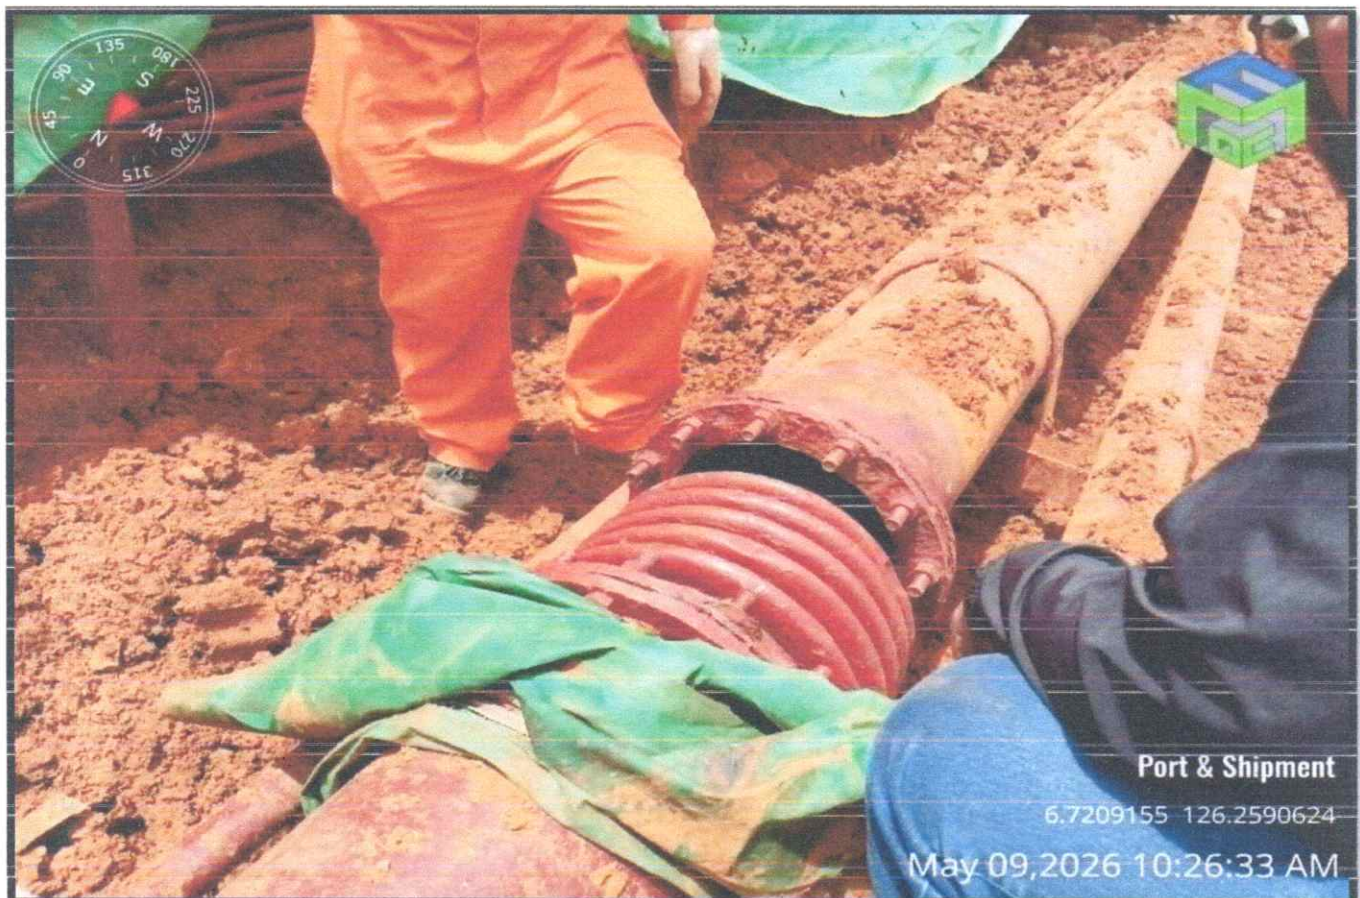
- The Pipe allegedly claimed to have been damaged.

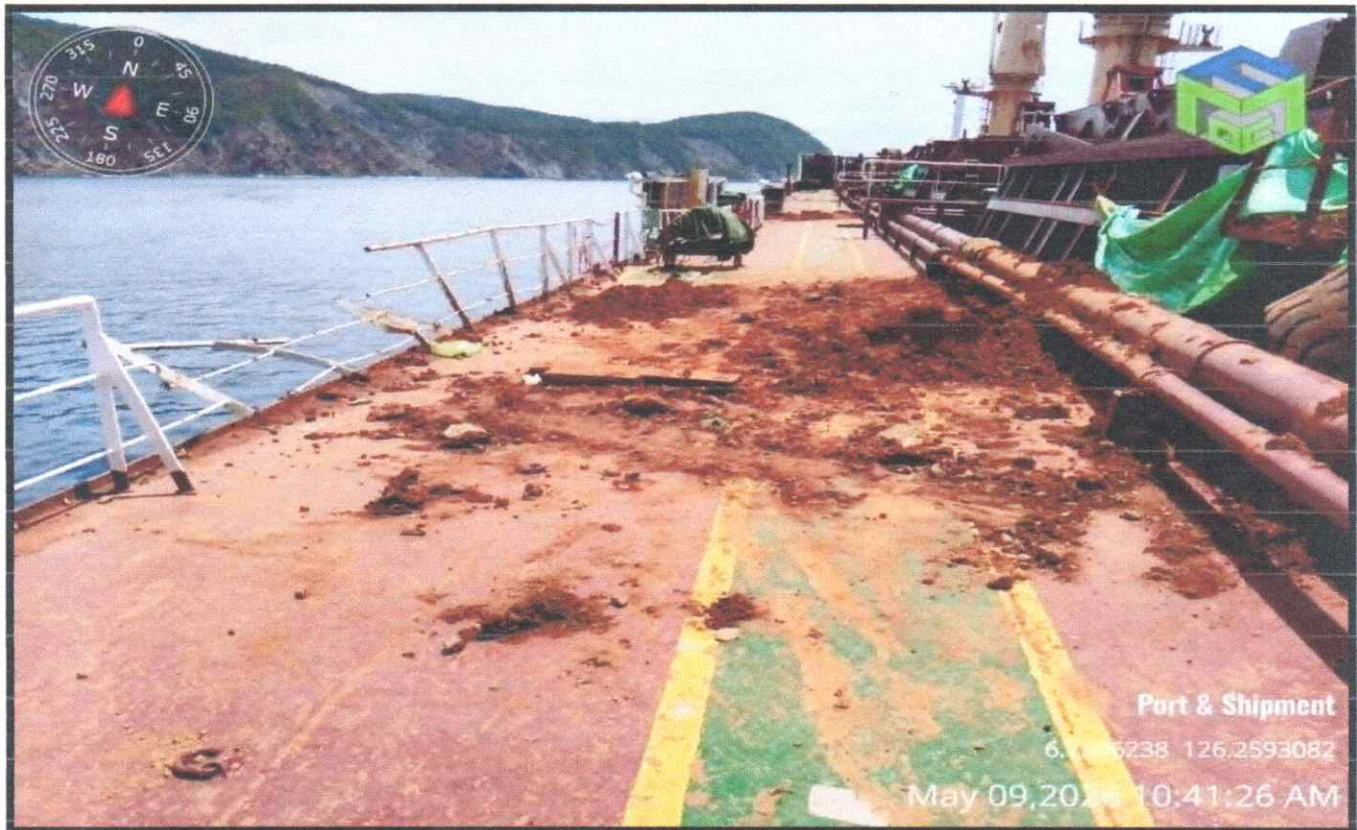
Rail 6 m<sup>2</sup> were broken on portside

No.4 crane grab on main deck out of position and unsecured effectively

1. No.4 Hold Rail 6 m<sup>2</sup> totally damaged on portside 2. No. 4 Hold Main Deck Cable Conduit 5M were bend on portside 3. angle iron brackets for cable conduit 3pcs damaged 4. bracket soleplate for cable conduit 6 pce damaged 5. conduit expansion joints broken by forced extrusion 2cable

- This is the area being claimed by MVZHE HAI 512 as alleged damaged by DUMSATO STEVEDORING

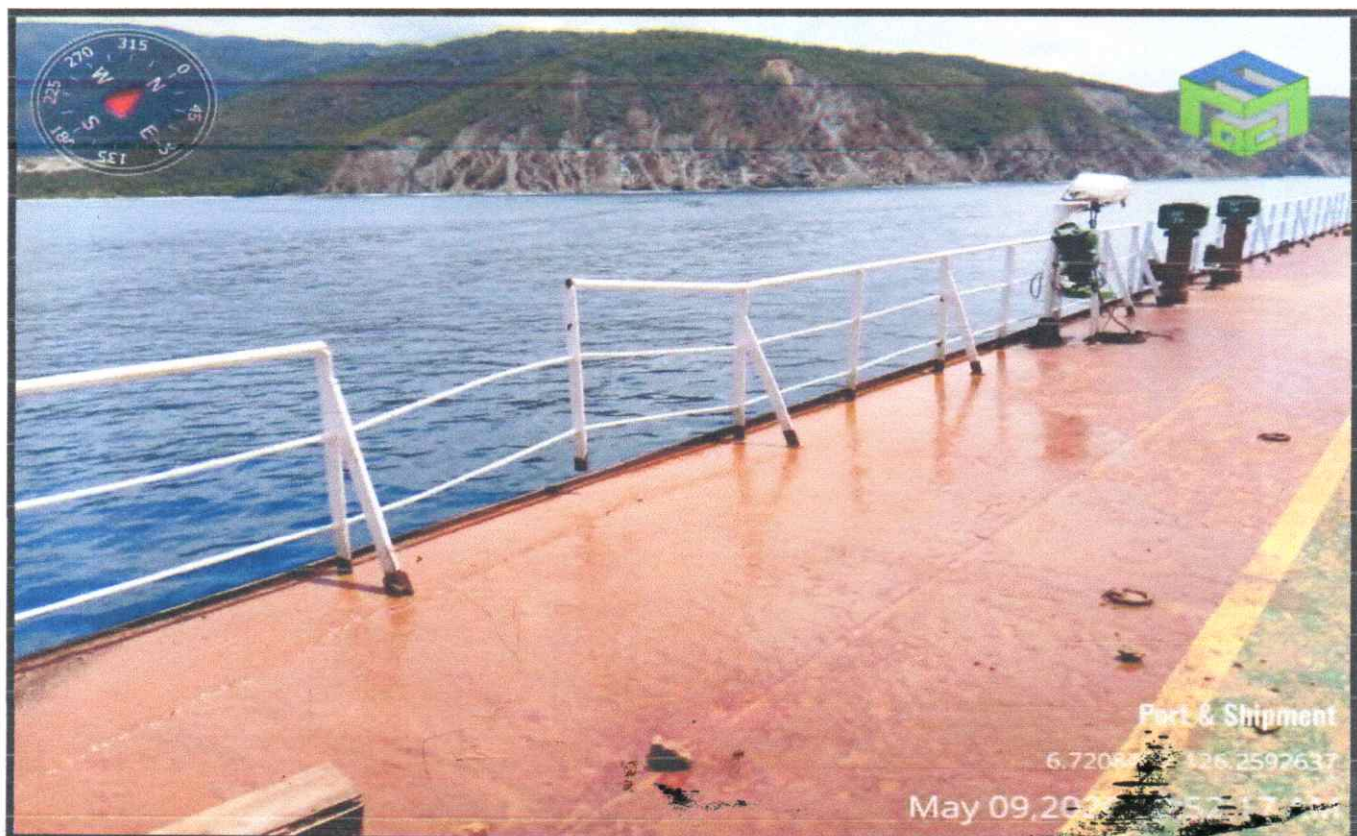
Findings further indicate that the probable cause of the damage was due to heavy swell and strong sea movement, which are considered external environmental factors beyond the control of **DUMSATO STEVEDORING** personnel. The damage was clearly accidental and unintentional in nature.

**The Incident Cause:** While the crane was at rest and the vessel was at anchorage, the vessel encountered a sudden and heavy swell. This unpredictable movement caused the crane grab to shift from its secured resting position.

- This area was acknowledged by the stevedore as the one they damaged, but the damage was unintentional.

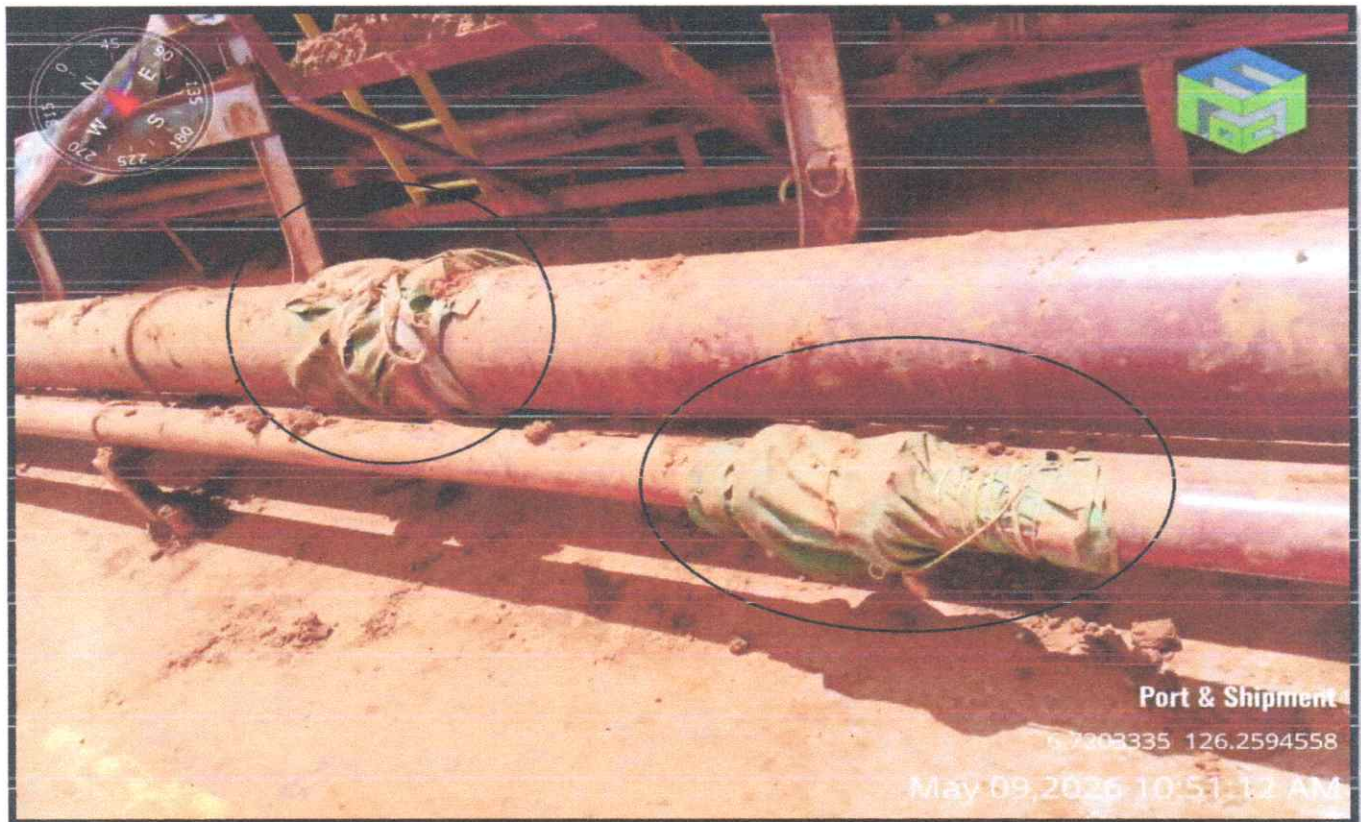
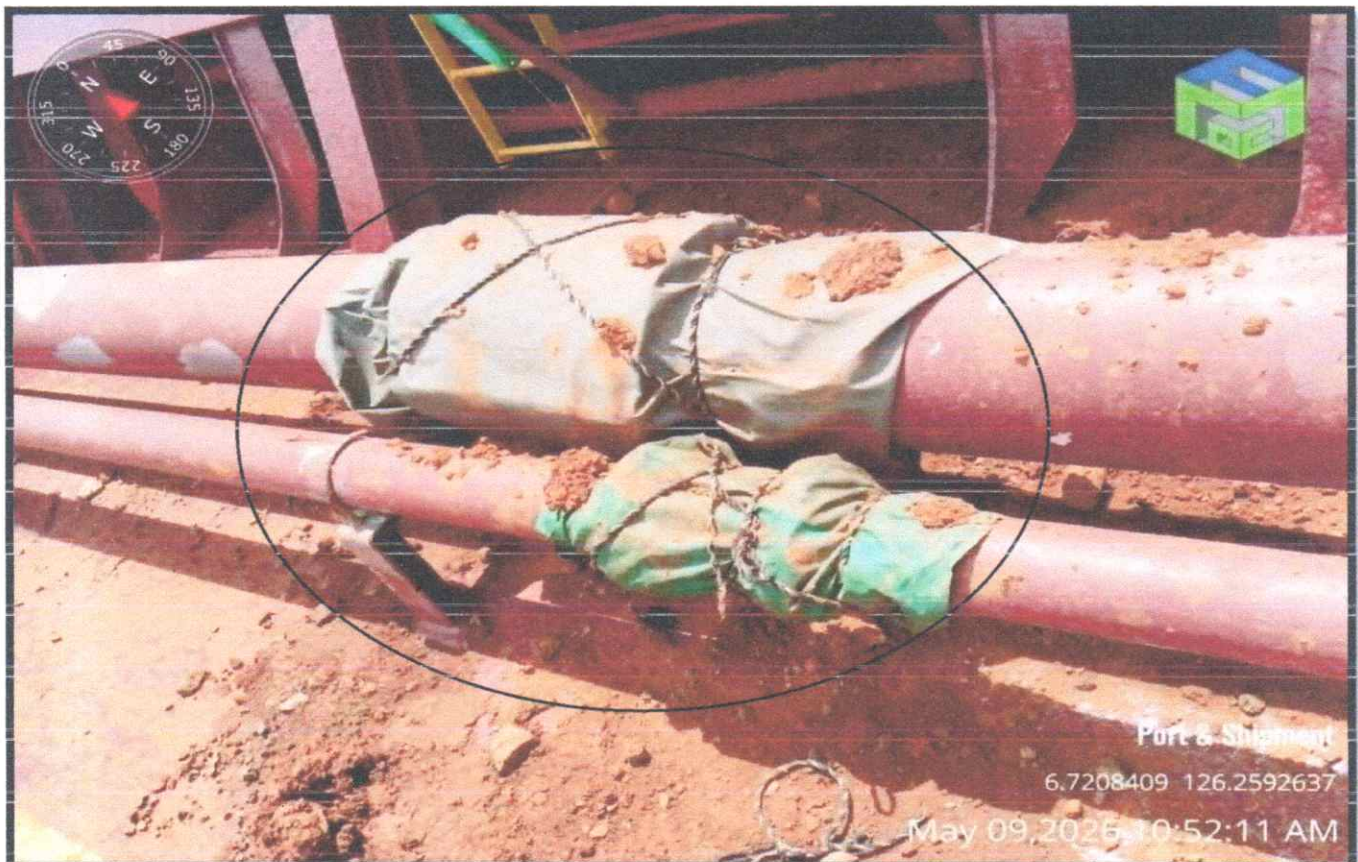
- The other pipes that were covered, we requested to have them uncovered but they refuse.
