EECE72545-24W DELIVERABLE

Project 2 – Hardware Testing Report

EECE72545-24W: Engineering Projects IV

Written by: Kyle Dick Date Completed: 1/04/2024 Instructor: Dr. So-Ra Chung Date Submitted: 1/04/2024

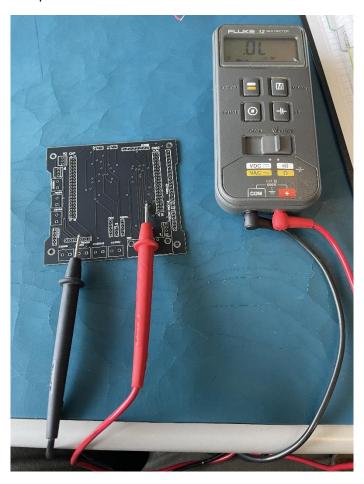
Continuity from the 5V input to output was measured along the expected signal paths along the designated power planes of PCB2 continuity to ground was also measured from relevant points including the RS232 IC, CANBUS, encoder and limit switch footprints. It was later determined that the signal path from MCU5V to the 5V pin of the MCU not continuous, this would later be remediated with a jumper wire.

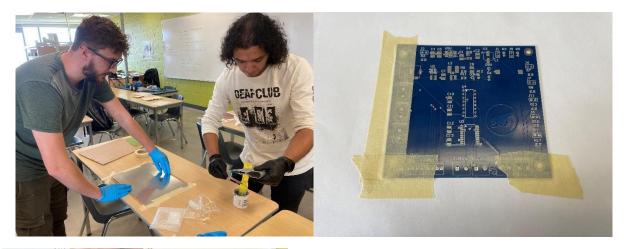
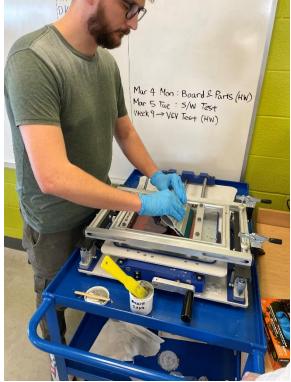
In the first image above, the student and their classmate are learning how to apply solder paste to PCB1 the traditional way where the stencil is positioned, aligned, and placed on top without the use of a jig other than some pieces of tape (image on the right). The reason he was doing it this way is due to the thickness of their PCB1. When he tried to apply solder paste to it using the jig they found that their board flexed and resulted in an inaccurate placement of paste to the pads. The second image above shows the result before placing SMD components and baking them.

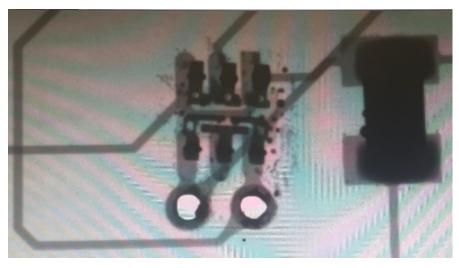
Above is an image of the 3V3 regulator; in this image it's clear to see that the fitment of the chip is off causing it to misbehave in the circuit. This chip was later replaced with a fresh IC with help from Dave Sulivan.
