Notice of breach of duty to residential rental provider of rented premises

Unit 168, 73 River Street, Richmond, Victoria

Non-Urgent Repairs Report in accordance with Section 74 (3c)
Residential Tenancies Act 1997

Case Number:	C2022/05/003437
Premises:	168/73 River Street Richmond
Renter:	Dr Kyle Peyton & Ms Sara LaBella
Rental Provider:	Mr S Ellis
Agent:	HSP REAL ESTATE PTY LTD t/a Hodges (South Melbourne)
Date Inspected:	16 May 2022

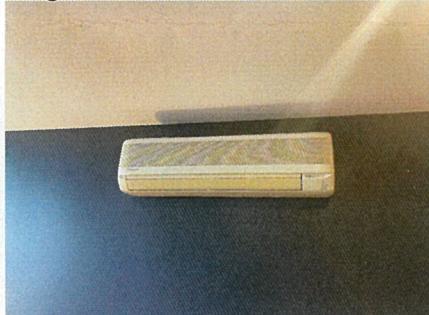
2.	Living area.	<p>The "Daikin" split system air-conditioner (Model RY60GAV1A) is in poor condition and is not supplying heat.</p> <p>Dr Peyton advised the system is approximately 15 years old and some of the components have decayed and corroded.</p> <p>I was unable to view the inside of the unit, due to the height/location.</p>

<p>This is an urgent repair which requires immediate repair/replacement.</p>

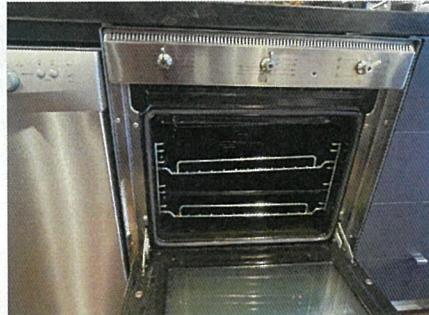
4.	Kitchen.	<p>The Oven light is not operational.</p> <p>Only one of the two Rangehood lights are operational.</p>

<p>Provide and install Oven light.</p> <p>Provide and install Rangehood light.</p>

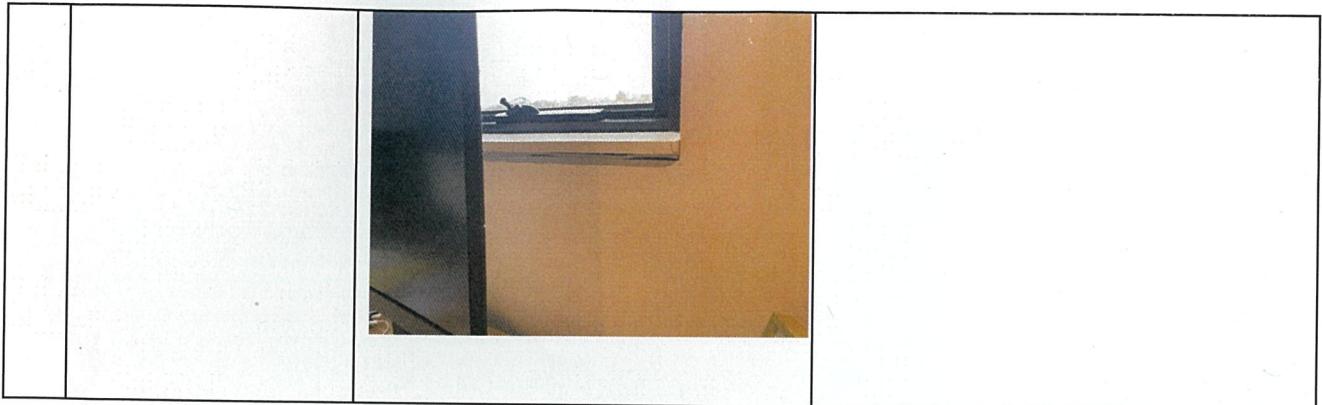
5.	Second bedroom.	<p>There is a gap between the wall and windowsill. This gap allows cold air to enter the room.</p>	<p>Inspect and seal the gap.</p>
