## Recent progress of physical failure analysis of GaN HEMTs

Xiaolong Cai, Chenglin Du, Zixuan Sun, Ran Ye, Haijun Liu, Yu Zhang, Xiangyang Duan, and Hai Lu

Citation: X L Cai, C L Du, Z X Sun, R Ye, H J Liu, Y Zhang, X Y Duan, and H Lu, Recent progress of physical failure analysis of GaN

HEMTs[J]. *J. Semicond.*, 2021, 42(5).

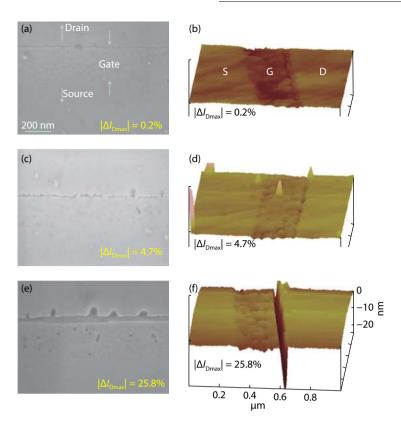
Fig. 7. (Color online) (a, c, e) SEM images and (b, d, f) AFM images of three devices with different stressed times[16].

In 2015, Wu *et al.*<sup>[16]</sup> reported a direct relation between structural and electrical degradations of GaN HEMTs under high-power and high-temperature direct current stresses. Under high electric stresses, the  $I_{\rm Dmax}$  degrades with stress time due to the structural deformation, as shown in Fig. 7. Shallow grooves appear along the drain-side gate metal fingers in the HEMTs with a mild  $I_{\rm Dmax}$  degradation. Deep pits are formed in the HEMTs with an obvious  $I_{\rm Dmax}$  degradation. As the drain current degradation rises from 0.2% to 25.8%, gate-edge damages develop from shallow grooves into distinct ravines which are deep enough to pierce through the buffer region and cause the final catastrophic failure.

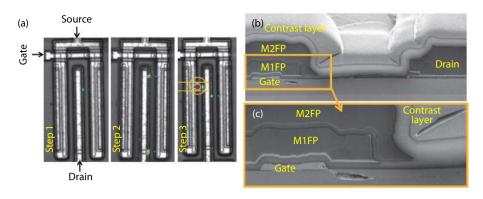
In 2016, Rossetto *et al.*<sup>[30]</sup> demonstrated that the drainside gate edge of GaN HEMTs under high electric stress is a weakness, where the electric field crowding in the passivation layer approaches the critical value of SiN<sub>x</sub>. They proved that the catastrophic failure is attributed to the formation of a short-circuit path between the gate-foot edge and the 2DEG in the drain-side. Small hot spots are detected in the EMMI system and their intensity rises as the stress time increases; a red spot can be clearly observed just before the catastrophic failure occurs, as shown in Fig. 8(a). The TEM images presents a path connecting the SiN<sub>x</sub> layer and the AlGaN layer, as shown in Figs. 8(b) and 8(c).

Fig. 8. (Color online) (a) EMMI images of the device at different stress times. (b, c) TEM image of the failure region depicted in (a)[30].

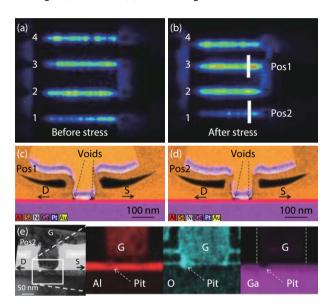
In 2017, the influence of gate metallizations on the reliability of SiC-based GaN HEMTs were investigated by Dammann et al.[31]. Ni voids and pits depicted by EMMI and TEM images near the gate-foot are regarded as the major failure reason of HEMTs with NiPtAu T-gates. Stressed devices are mapped by a high-resolution EDS system, where it is found that a local aluminium oxidation procedure leads to the formation of pits, as shown in Fig. 9. The interface between the AlGaN layer and the negatively charged pits is in the vicinity of the channel and, as a consequence, the conduction band slope and lateral electrical field near the gate-foot increases. This might cause a higher electric stress and trigger deformations at the location of the pit. Sin et al.[32] conducted similar tests on RF GaN HEMTs, and their results demonstrate that Pd-enriched pits/defects can also form at the interface between the Al-GaN layer and the spacer-gate-edge.

Fig. 9. (Color online) (a, b) EMMI images of the HEMT before and after ON-state DC-stress. (c, d) Cross-section EDS mapping of central T-gate finger showing the formation of Ni voids. (e) Aluminium oxidation at a pit<sup>[31]</sup>.

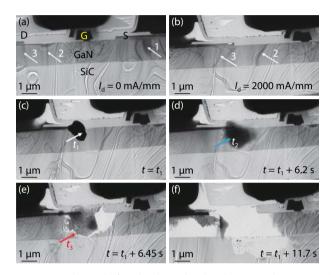
Fig. 11. (a) A device before loading. (b) The device at the on-set of source-drain leakage. (c) A metal inclusion appears at the drain region. (d) The metal inclusion penetrates the GaN layer. (e) The metal inclusion reaches the GaN-SiC interface. (f) The substrate is completely damaged at last<sup>[19]</sup>.

In 2018, Islam et al.[19] reported the real-time visualization of GaN HEMT failures by operating the devices inside a TEM. The in-situ TEM technique can characterize the lattice dislocations and metal diffusion and thus monitor the degradation of the epilayer quality during the whole failure process. Fig. 11(a) reveals a network of pre-existing dislocations which facilitate local charge accumulations and lower the breakdown strength, and catastrophic failures may occur through the dislocation percolation. As  $V_D$  increases,  $I_D$  becomes large enough to activate the dislocations (marked by arrows 2 and 3) that have moved towards the gate region, as shown in Fig. 11(b). The dislocation transformation leads to very large leakage current density, causing damages at the drain metal contacts and the subsequent epilayer and substrate, as shown in Figs. 11(c)-11(f). At first, a metal inclusion forms under the drain region (marked by arrow  $t_1$ ), which penetrates the GaN layer about 6.2 s later. It then takes less than a

second to reach the GaN-substrate interface and finally the substrate is completely damaged by the metal diffusion. The presented "seeing while measuring" in-situ TEM technique can be effective in finding out the dominant failure mechanisms and their fundamental origins.

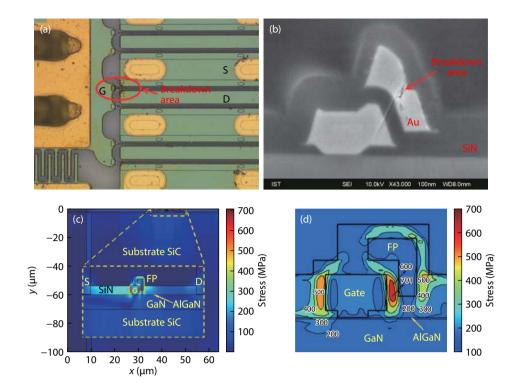
Fig. 15. (Color online) (a) Failure region of the GaN HEMT (CGH-27015, manufactured by Cree, Inc.). (b) FIB image of the breakdown area which is located in the FP. (c) Captured thermal stress distribution of the device. (d) Enlarged stress distribution near the gate<sup>[43]</sup>.

stress breakdown of GaN HEMTs under large microwave injected pulses. A burn mark is clearly seen in the failure region of the device, as shown in Fig. 15(a). The FIB cross section image [Fig. 15(b)] displays a crack in the field plate (FP). SiN<sub>x</sub> passivation layers are applied on the Au-made gate and its FP in order to decrease the current collapse of devices. According to the proposed thermal breakdown model and corresponding simulation results, the stress peak is located at the gate edge and the FP. The stress peak is lower than the critical yield strength of SiN<sub>x</sub> (2400 MPa), while the stress in the FP is larger than that of Au (200 MPa)[44, 45]. The FP with a large thermal expansion coefficient is greatly affected by the thermal stress, and therefore, the cracks start from the FP.

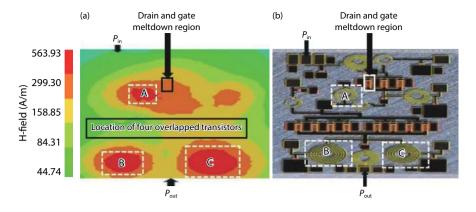
magnetic field of the failure region is about  $2.99 \times 10^2$  A/m, reaching the highest value among all the devices in the circuit. Once the total amount of the magnetic-induced eddy current and the operation current increase, remarkable Joule heatings in the drain and the gate metal regions occur and cause the observed failure of the device.

Fig. 17. (Color online) (a) Magnetic field distribution and (b) optical micrograph of the PA layout [46].

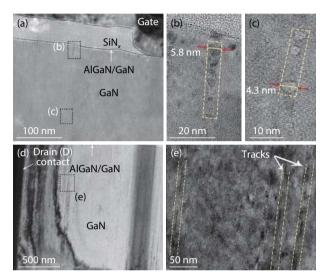
Fig. 18. TEM images of GaN HEMT device irradiated with 1540 MeV Bi ions at a fluence of  $1.7 \times 10^{11}$  ions/cm<sup>2[48]</sup>. (a) Cross-section of the gate areas. (b) High-resolution image of the tracks in heterogeneous junction areas as marked in (a). (c) High-resolution image of the tracks at a depth of about 500 nm as marked in (a). (d) Tracks formed in the drain area. (e) Tracks appearing at a depth of about 500 nm as marked in (d).

Figs. 18(b) and 18(c). The tracks through the whole epilayer in the HEMT is shown in Figs. 18(d) and 18(e). Further analyses indicate that the Bi-ions-irradiation-induced defects and disorders decrease the carrier density and mobility of 2DEG and finally lead to the degradation of the devices.
