Investigation and Differentiation of Degradation Modes Affecting Series Resistance in Photovoltaic Cells and Modules

Roopmati Meena , Humaid Mohammed Niyaz, and Rajesh Gupta

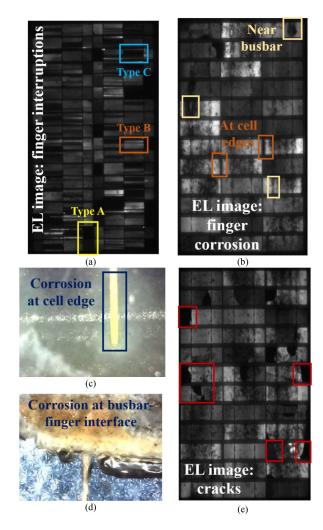
Fig. 4. (a) EL images of the module showing types of finger interruption. (b) EL image of module showing finger corrosion at the edges and around busbars, visual image showing (c) finger corrosion at cell edge, (d) corrosion at busbar-finger interface, and (e) EL image showing different crack orientations in solar cells.

The EL images showing spatial characteristics of different types of $R_{\text{deg,modes}}$ are given in Fig. 4. Metallization interruption has been further subclassified into finger interruption and interconnect-ribbon interruption. Three prime locations of finger interruptions along the busbar-finger interface have been observed as outlined in Fig. 4(a).

Type A interruption has been defined as breakage in the finger at the single-point connection with the busbar. Type B interruption has been defined for the fingers located between busbars and interrupted at any one finger-busbar interface. Type C interruption has also been defined for the fingers located between the busbars but disconnected from both the finger-busbar interface. Similarly, two cases have been considered for interconnect ribbon interruption, i.e., breakage of one ribbon and simultaneous breakage of any two ribbons. Furthermore, metallization corrosion has been identified at multiple locations in the EL images, as shown in Fig. 4(b). Dark regions at the edges of solar cells and around busbar regions have been identified, which can be attributed to corrosion of fingers, corrosion of

busbars, and solder bond failure, as shown in Fig. 4(c) and (d). In this work, based on the spatial location of observed degradations, uniform corrosion over metallization has been considered for simulation purposes. Moreover, based on the analysis of EL images and the study of existing literature, two prominent crack orientations have been identified, as shown in Fig. 4(e). Cracks parallel to the busbar are the most frequently observed crack orientation as also visible in EL image, followed by cracks diagonal to busbar [25]. The spatial characteristics of the aforementioned $R_{\rm deg,modes}$ have been modeled in DDM and their impact on the electrical performance of solar cells and modules has been analyzed.

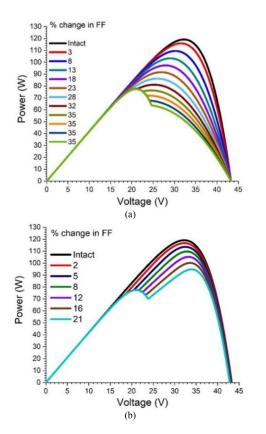
Fig. 12. Power–voltage (P-V) curves of the module with different extent of (a) metallization degradation and (b) cracked region in a string of the module.

1) Effect on Electrical Performance: For module level analysis, metallization corrosion and interruption have been analyzed under the umbrella term of metallization degradation. The severity of degradation has been changed in the simulation by varying $R_{\rm s}$ of the cells in a string. The P-V curves of the module for the varying extent of metallization degradation with change in FF are given in Fig. 12(a). The loss in FF has been high because of the additional mismatch loss in the cells of the module due to the nonuniform distribution of the degradation. Moreover, it can be observed that the change in FF has become constant with the activation of the bypass diode resulting in a constant global peak, characterized by the double peak in P-V curves. It occurs as the equivalent resistance experienced by the current en route to the external circuit becomes constant with activation of the bypass diode.

Similarly, the impact of cracks on the module has also been studied by introducing the cracks in the string of 24 cells of the module. The P–V curves for the varying extent of cracked areas are given in Fig. 12(b). Herein, the loss in the active area of up to 30% has been considered, which accounts for the simultaneous occurrence of two cracks parallel to the busbar. The loss in the active area has been simulated by systematically changing the value of I_{sc} in the SDM of cells. Herein, the reduction in global

peak/maxima has led to a permanent loss in $P_{\rm max}$ of the module, which has induced a permanent mismatch loss in the module strings. It must be noted that for metallization degradation, the change FF has become constant with activation of the bypass diode; however, for cracks, the reduction in FF persists even after bypass diode activation for 30% loss in the active cell area.
