# Barwood Condominiums - Building #5

## MILESTONE INSPECTION

28 APR 2023

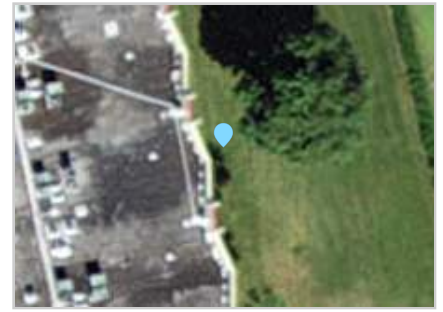
● **#80 - Balcony edge spalls**

Bldg 5, Barwood IV | Matt Duckstein | 5. Concrete Framing System

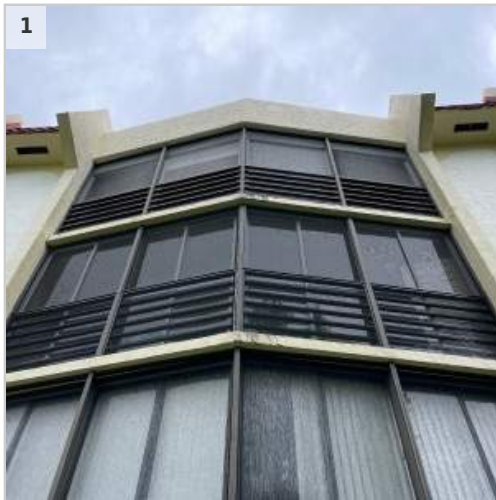
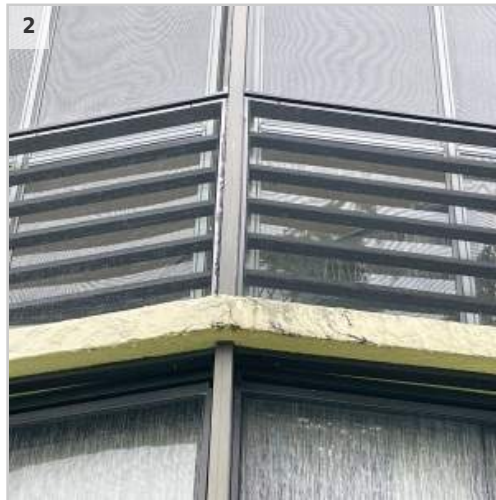
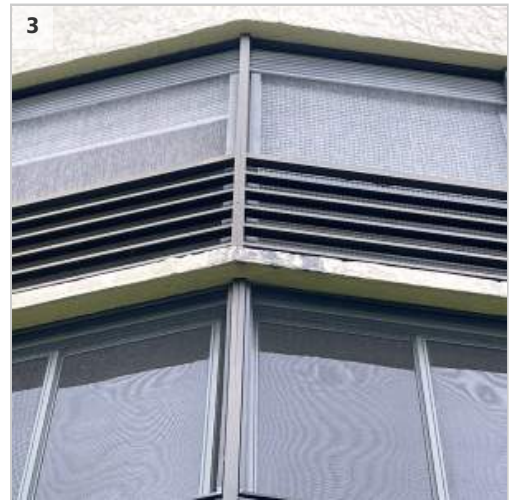
1) Multiple exterior balcony edge cracks and spalls.

- 1) Remove/replace roof membrane, terminations, flashing, etc., before the next review cycle.
- 2) Remove/replace cracked and unsound stucco areas from the exterior balcony edges, walls, and slab undersides.
- 3) Repaint and reseal the exterior unit windows as needed; consider installing building-wide upgraded impact resistant windows before the next review cycle.

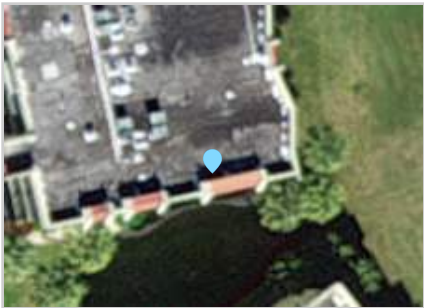
● **#79 - Stucco Cracks**

Bldg 5, Barwood IV | Matt Duckstein | 8. Building Facade  
Plan: Bldg 5 - Level 1 | Location: Bldg 5 - 23249 - Barwood IV > Elevations

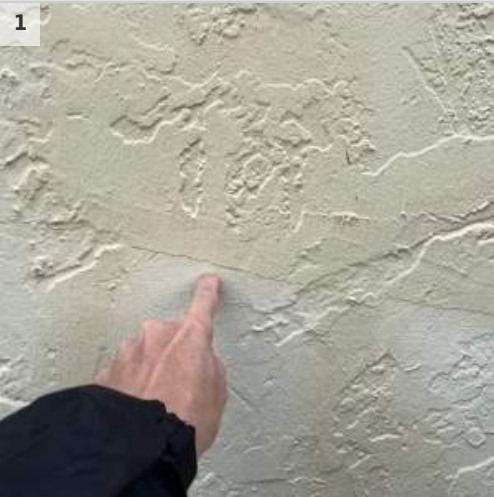
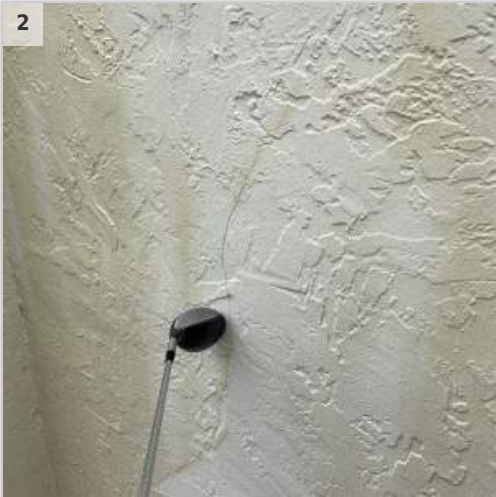
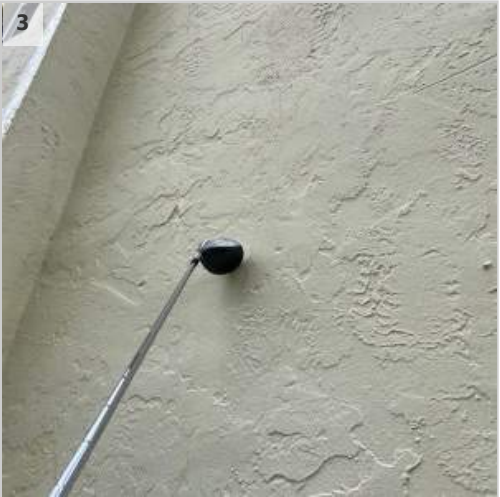
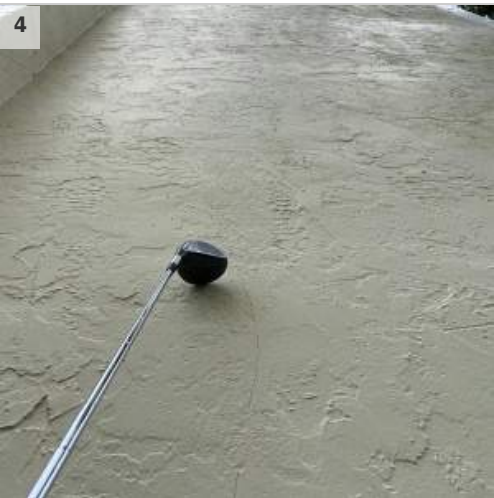
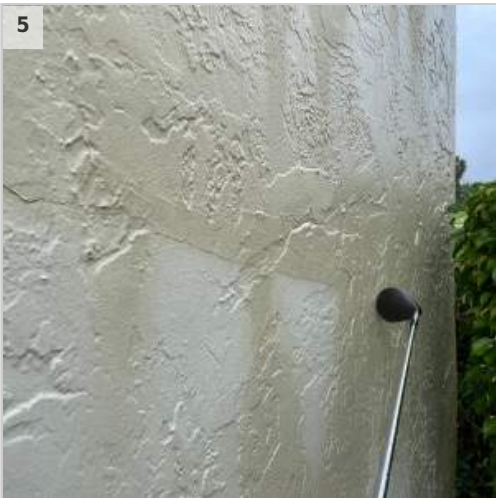
The building appears to have been recently painted, but has areas of cracked stucco and paint bubbling that require repair. The exterior is generally in good to fair condition with few previously repaired stucco cracks and a few requiring repair.

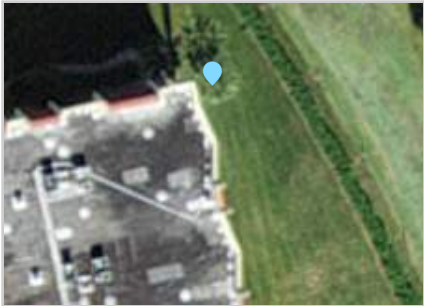
● **#82 - Stucco cracks**

Bldg 5, Barwood IV | Matt Duckstein | 8. Building Facade  
Plan: Bldg 5 - Level 1 | Location: Bldg 5 - 23249 - Barwood IV > Elevations

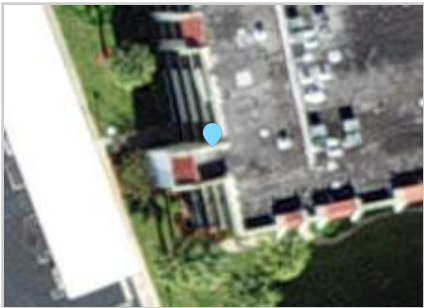
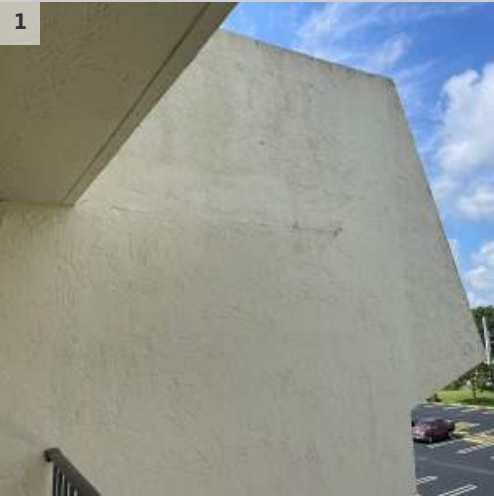
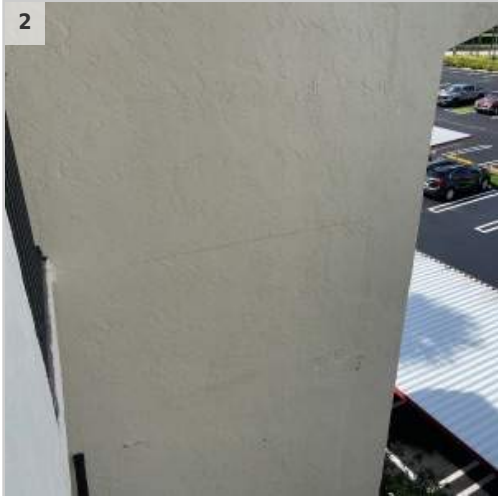
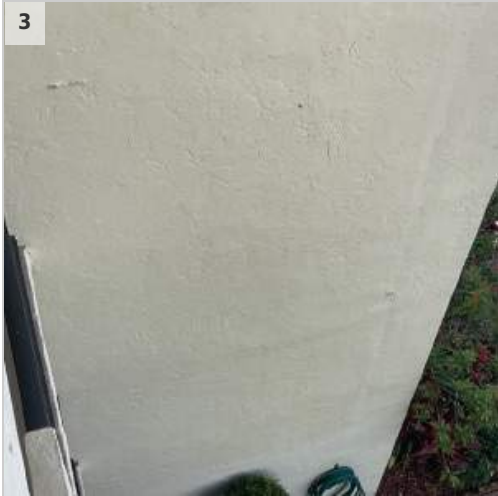
● **#95 - Stucco cracks**

Bldg 5, Barwood IV | Corey Pruneski | 0. General  
Plan: Bldg 5 - Level 4 | Location: Bldg 5 - 23249 - Barwood IV > Common Area

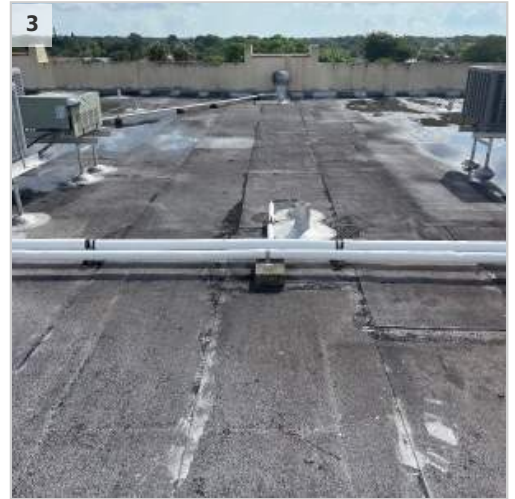
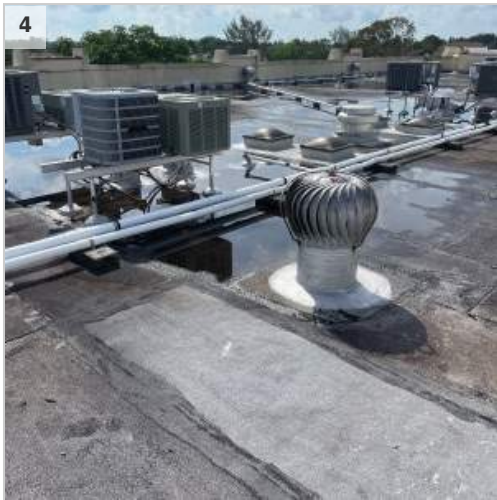
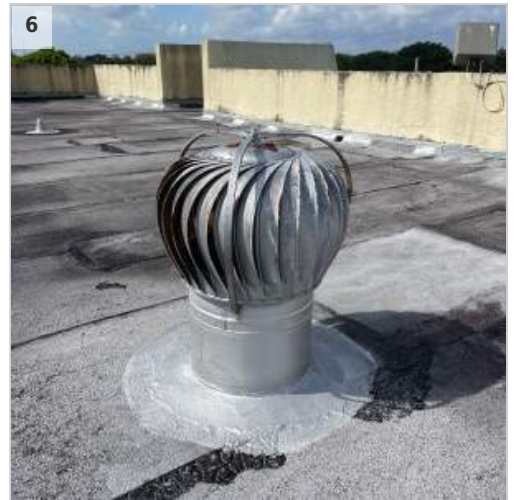
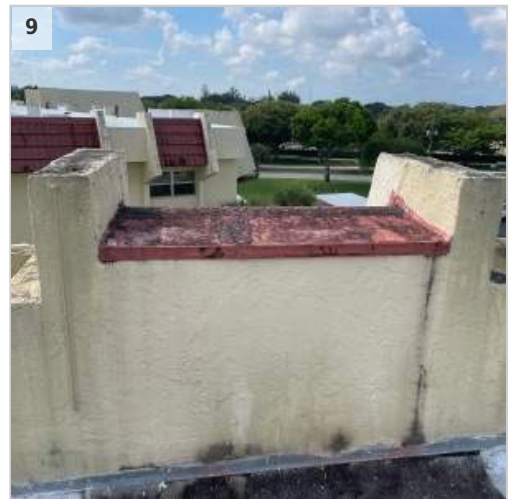
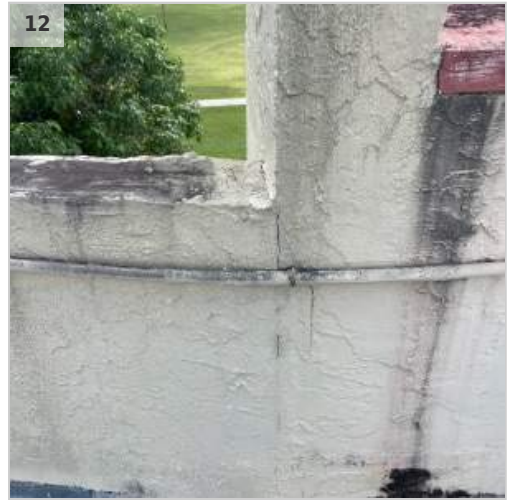
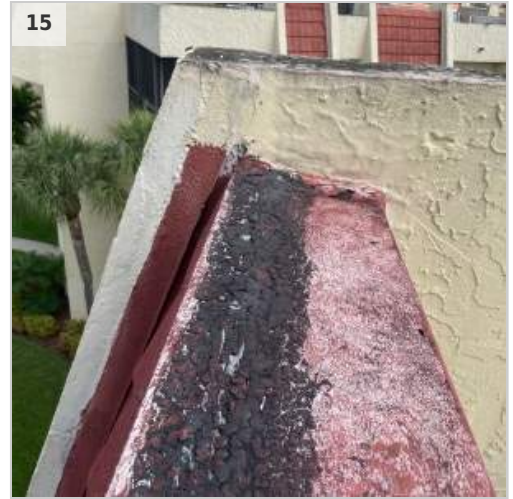
1. Beams: ☒ Good ☐ Fair ☐ Poor Significant (explain):  
No observed stress issues.
2. Columns: ☒ Good ☐ Fair ☐ Poor Significant (explain):  
No observed stress issues.
3. Struct. walls: ☒ Good ☐ Fair ☐ Poor Significant (explain):  
No observed stress issues.
4. Floors: ☒ Good ☐ Fair ☐ Poor Significant (explain):  
No observed stress issues.
5. Roof: ☐ Good ☒ Fair ☒ Poor Significant (explain):  
Widespread areas of standing water, corroded flashing, and cracked sealant, but no roof leaks reported.
6. Other: ☐ Good ☐ Fair ☐ Poor Significant (explain):  
N/A

● **#87 - Bldg 5 - roof**
