# Reserve Report

## St Tropez at Boca Golf Property Owners Association, Inc

17215 Boca Club Blvd  
Boca Raton, Florida 33487  
For Year 2023 (Ver 2.0 - 10/27/2022)

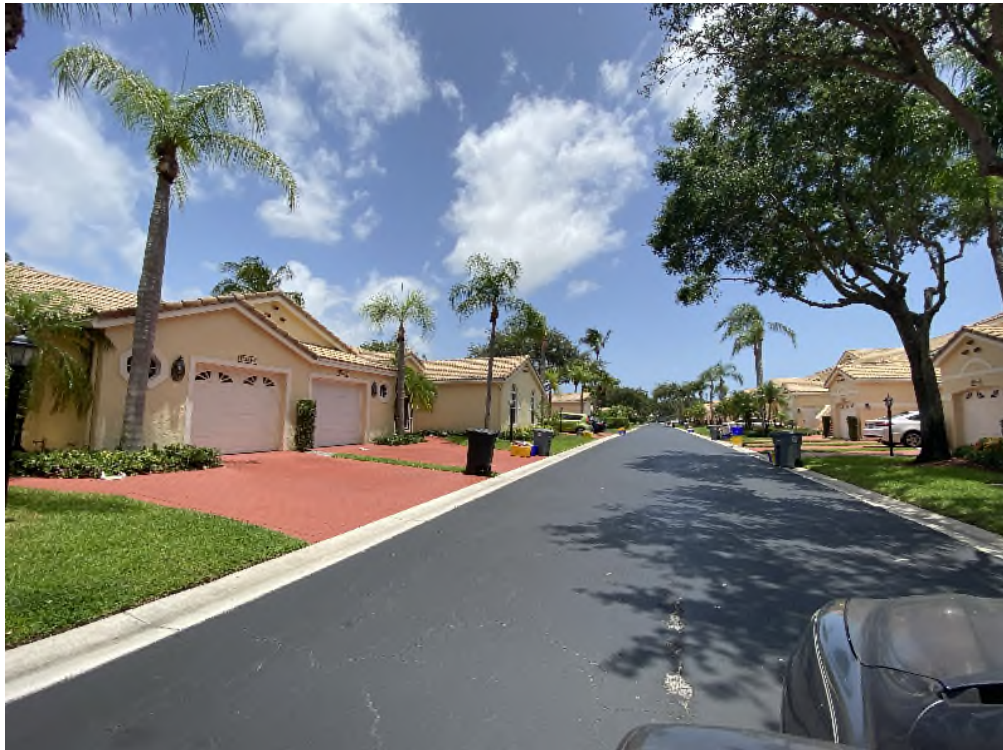
**Condition:** Average

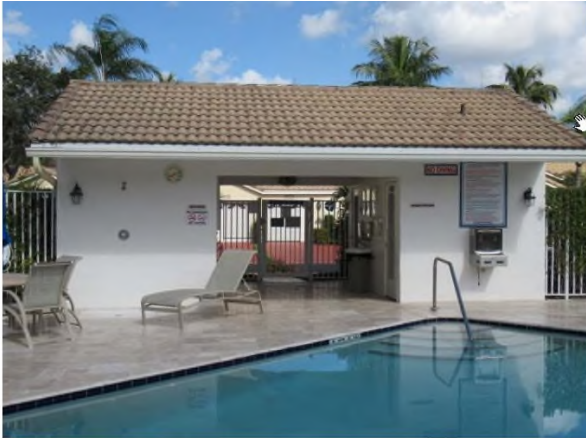
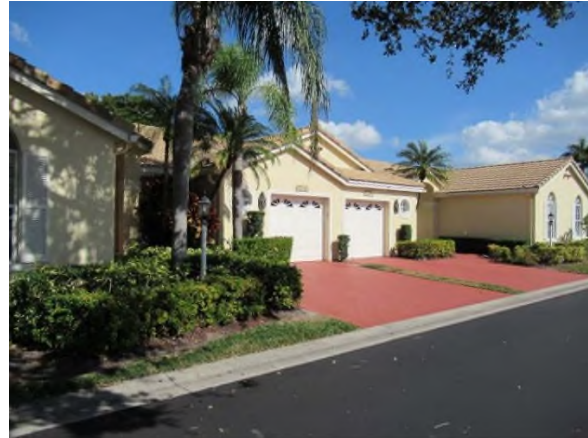
| Roofing | | Percent Replacement | 100% |

**Condition:** Average

**Remarks:** Roof covering is an S shaped multi color concrete tile. The Prostar February 2021 insurance valuation report reflects the roofs were resurfaced in 2006. This would indicated the current age of the roof is approximately 17 years old.. Many insurance carriers are requiring new roofs once they are 25 years old. **IT IS SUGGESTED THAT THIS REQUIREMENT BE REVIEWED WITH THE CURRENT INSURANCE CARRIER.** Based on the foregoing the projected replacement year is 2031. Marshal Valuation Services, and conversations with licensed roofers reflect the cost per square (100 SF) ranges from \$1,100 to \$2,000. For the purpose of this study \$2,205,500 was utilized since the report includes yearly increases for inflation, reserves and a contingency factor. Due to current inflation of roofing materials and that 7 buildings are 2 story, the amount of \$1,100 is at the lower range since this amount does not reflect any hidden damaged wood decking, trusses or fascia boards. Prestar Insurance Vaaluation reflects cost to replace at \$1,226,014 or \$612/SQ, which base on my analysis is very low and I suggest obtaining bis fro at least 3 other roofing contractors.

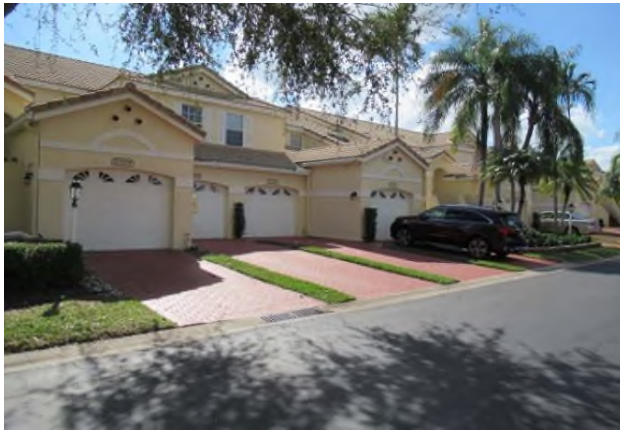
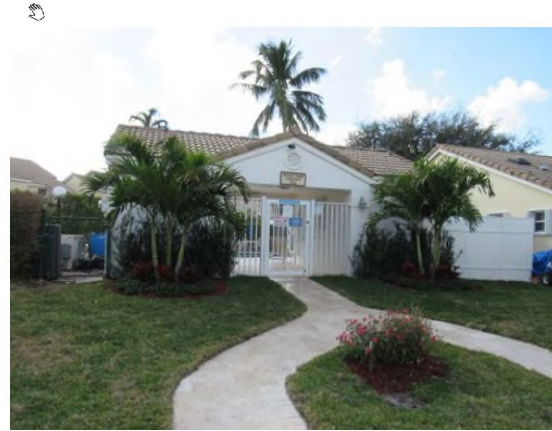
| Painting | | Percent Replacement | 100% |

**Salvage Value:** \$0.00  
**Condition:** Average to Good  
**Service Contract:** N/A

**Remarks:** Painting was reported to have been done in 2017 by PD Painting for \$109,450. The current amount is based on multiplying the \$109,450 by 1.03% for the last 5 years. The Financial Statement reflect the estimated remaining life as 6 years or repainting every 10 years which includes painting of all the units, pool building and replacing the gutters. Based on the foregoing, and utilizing a useful life of 10 years, and based on the 2022 financial statement it is projected the buildings will be repainted and gutters replaced in 2027.

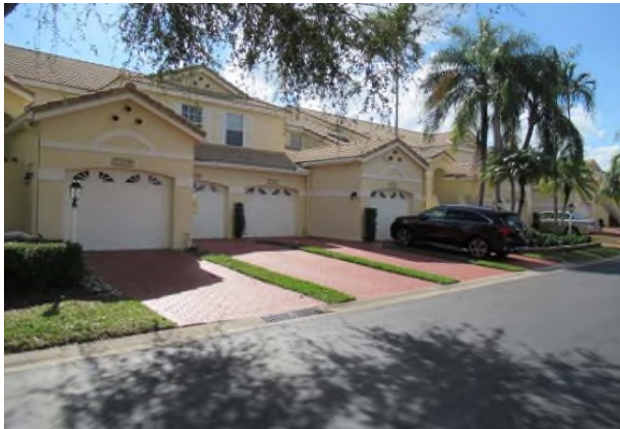
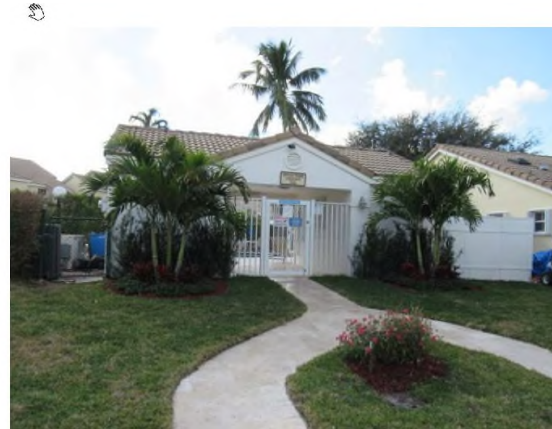
| Painting | | Percent Replacement | 100% |

**Salvage Value:** \$0.00  
**Condition:** Average to Good  
**Service Contract:** N/A

**Remarks:** Painting was reported to have been done in 2017 by PD Painting for \$109,450. The current amount is based on multiplying the \$109,450 by 1.03% for the last 5 years. The Financial Statement reflect the estimated remaining life as 6 years or repainting every 10 years which includes painting of all the units, pool building and replacing the gutters. Based on the foregoing, and utilizing a useful life of 10 years, and based on the 2022 financial statement it is projected the buildings will be repainted and gutters replaced in 2027.

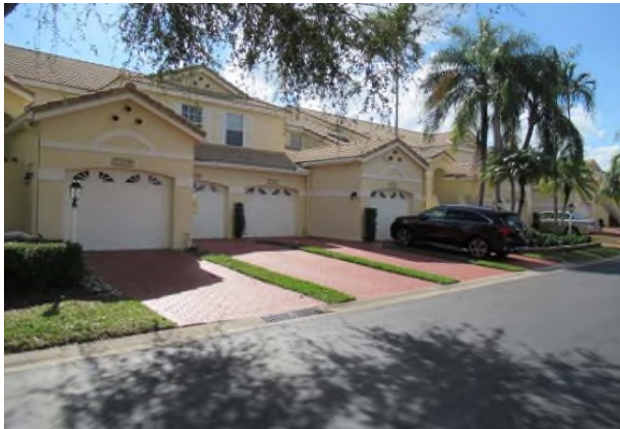
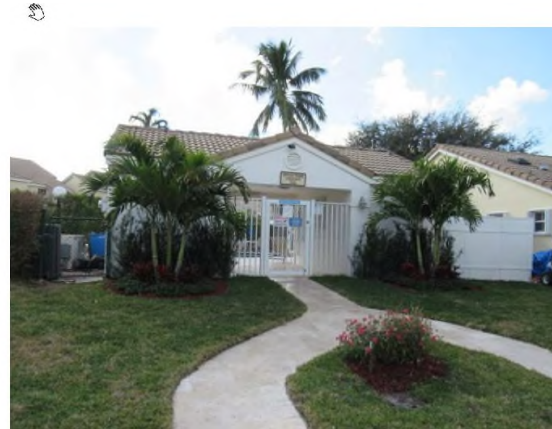
| Painting | | Percent Replacement | 100% |

**Salvage Value:** \$0.00  
**Condition:** Average to Good  
**Service Contract:** N/A

**Remarks:** Painting was reported to have been done in 2017 by PD Painting for \$109,450. The current amount is based on multiplying the \$109,450 by 1.03% for the last 5 years. The Financial Statement reflect the estimated remaining life as 6 years or repainting every 10 years which includes painting of all the units, pool building and replacing the gutters. Based on the foregoing, and utilizing a useful life of 10 years, and based on the 2022 financial statement it is projected the buildings will be repainted and gutters replaced in 2027.

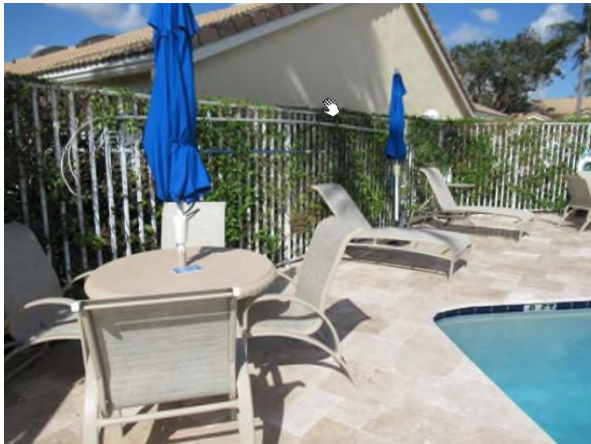
| Fencing/Security | | Percent Replacement | 100% |

**Condition:** Average, based on limited visual inspection not covered by vegetation.

**Remarks:** The date in service was not provided. The Financial Statement reflects the estimated remaining life in 2022 as 4 years indicating replacement in 2026.. The Prestar Services Insurance valuation does not reflect the pool's metal fence or its useful life. A maintained metal fence's useful life can range from 30 to 40+ years. Utilizing a 30 year useful life +4 year life adjustment do to my limited viewing, and a date in service of 1992 4 year estimated remaining life and \$25,000 estimated replacement cost as reflected in the financial statement was utilized.

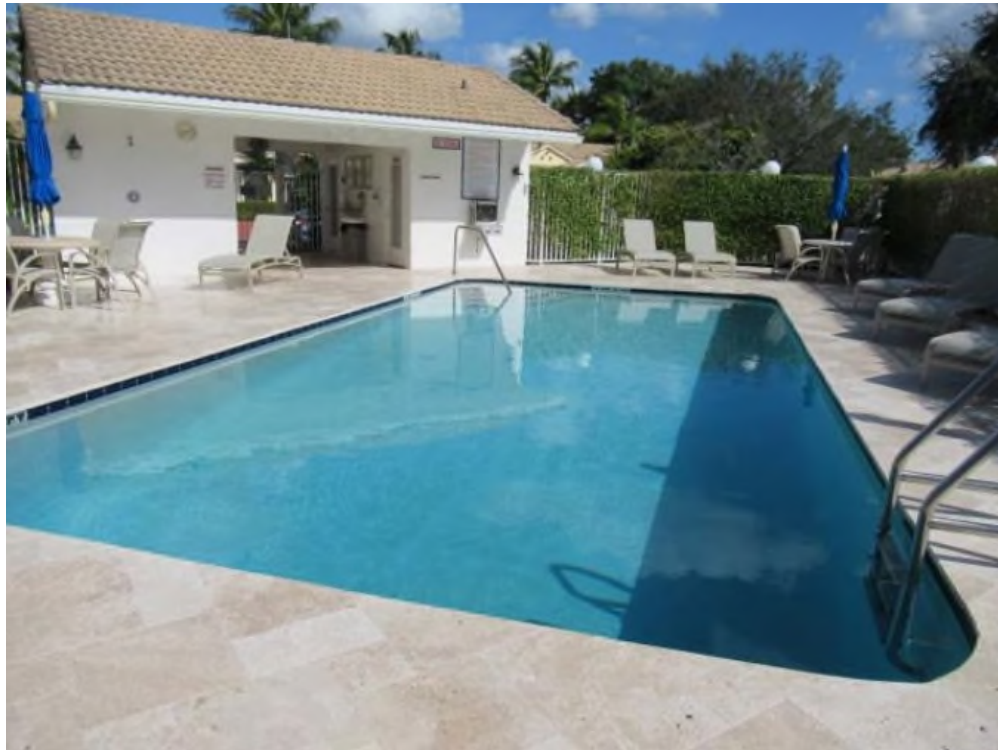
| Recreation/Pool | | Percent Replacement | 100% |

**Condition:** Average to Good

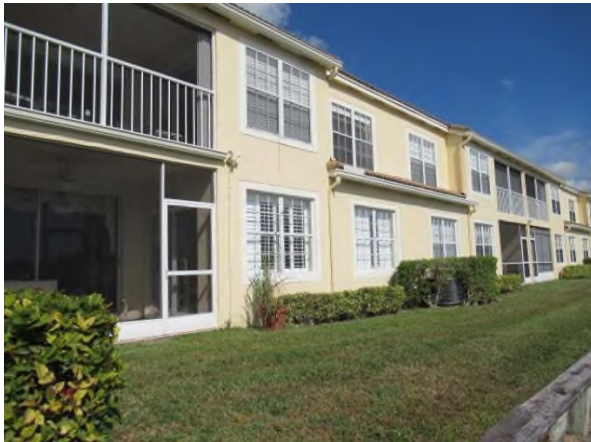
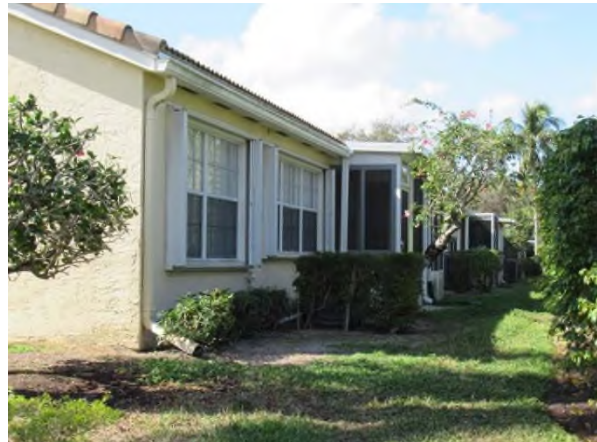
| Gutters and Downspouts | | Percent Replacement | 100% |

**Salvage Value:** \$0.00  
**Condition:** Average  
**Service Contract:** N/A

**Remarks:** The gutters are attached to the fascia board and below the drip edge of the tile roofs. The Financial Statement reflect the estimated remaining life as 6 years, which indicates painting of all the units, pool building and gutters was done in 2018 and the estimated current cost for the gutters is \$20,000. Based on the foregoing, and utilizing a useful life of 10 years, and based on the 2022 financial statement it is projected the buildings and gutters will be repainted and gutters replaced in 2028.

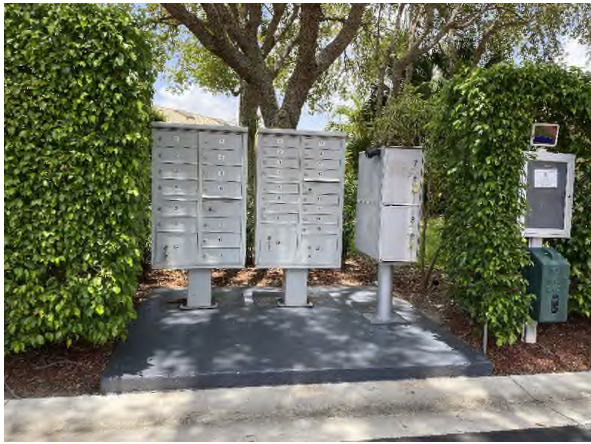
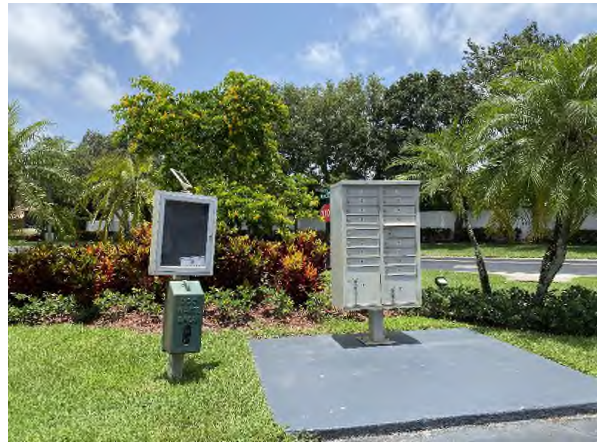
| Mailboxes | | Percent Replacement | 100% |

**Salvage Value:** \$0.00  
**Condition:** Average to Good  
**Service Contract:** None  
**Remarks:** Existing pedestal mailboxe are in average to good condition.  
 Repair or replacement of doors are paid from the maintenance budget. .

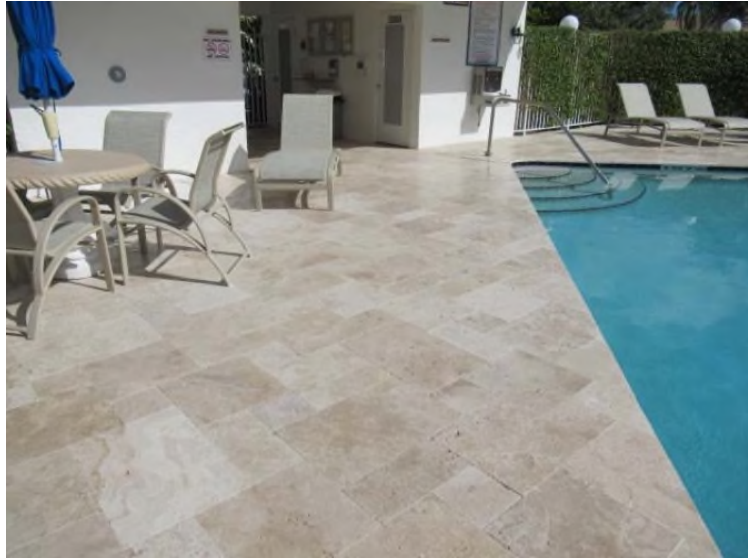
| Pavers | | Percent Replacement | 100% |

**Salvage Value:** \$0.00  
**Condition:** Average to Good  
**Service Contract:** N/A

**Remarks:** The date of installation was not provided. The Financial Statement reflects the estimated remaining life as 14 years, a current estimated replacement cost of \$15,000. The Prestar Services Insurance valuation does not reflect the pavers, cost or useful life. Pavers useful life can range from 20 to 40+ years based on numerous factor.. Utilizing a 20 year useful life, 14 year remaining life, calculates to a date in service of 2016. The \$15,000 amount in the financial statement is deemed a reasonable amount for reserves.
