## State of Washington Department of Ecology

The Good Neighbor Village project is covered under the State of Washington's Construction Stormwater General Permit (CSWGP). The CSWGP is a National Pollutant Discharge Elimination System (NPDES) and a State Waste Discharge permit for discharge of construction-related stormwater. The purpose of this inspection is to conduct a compliance inspection and to provide technical assistance as appropriate.

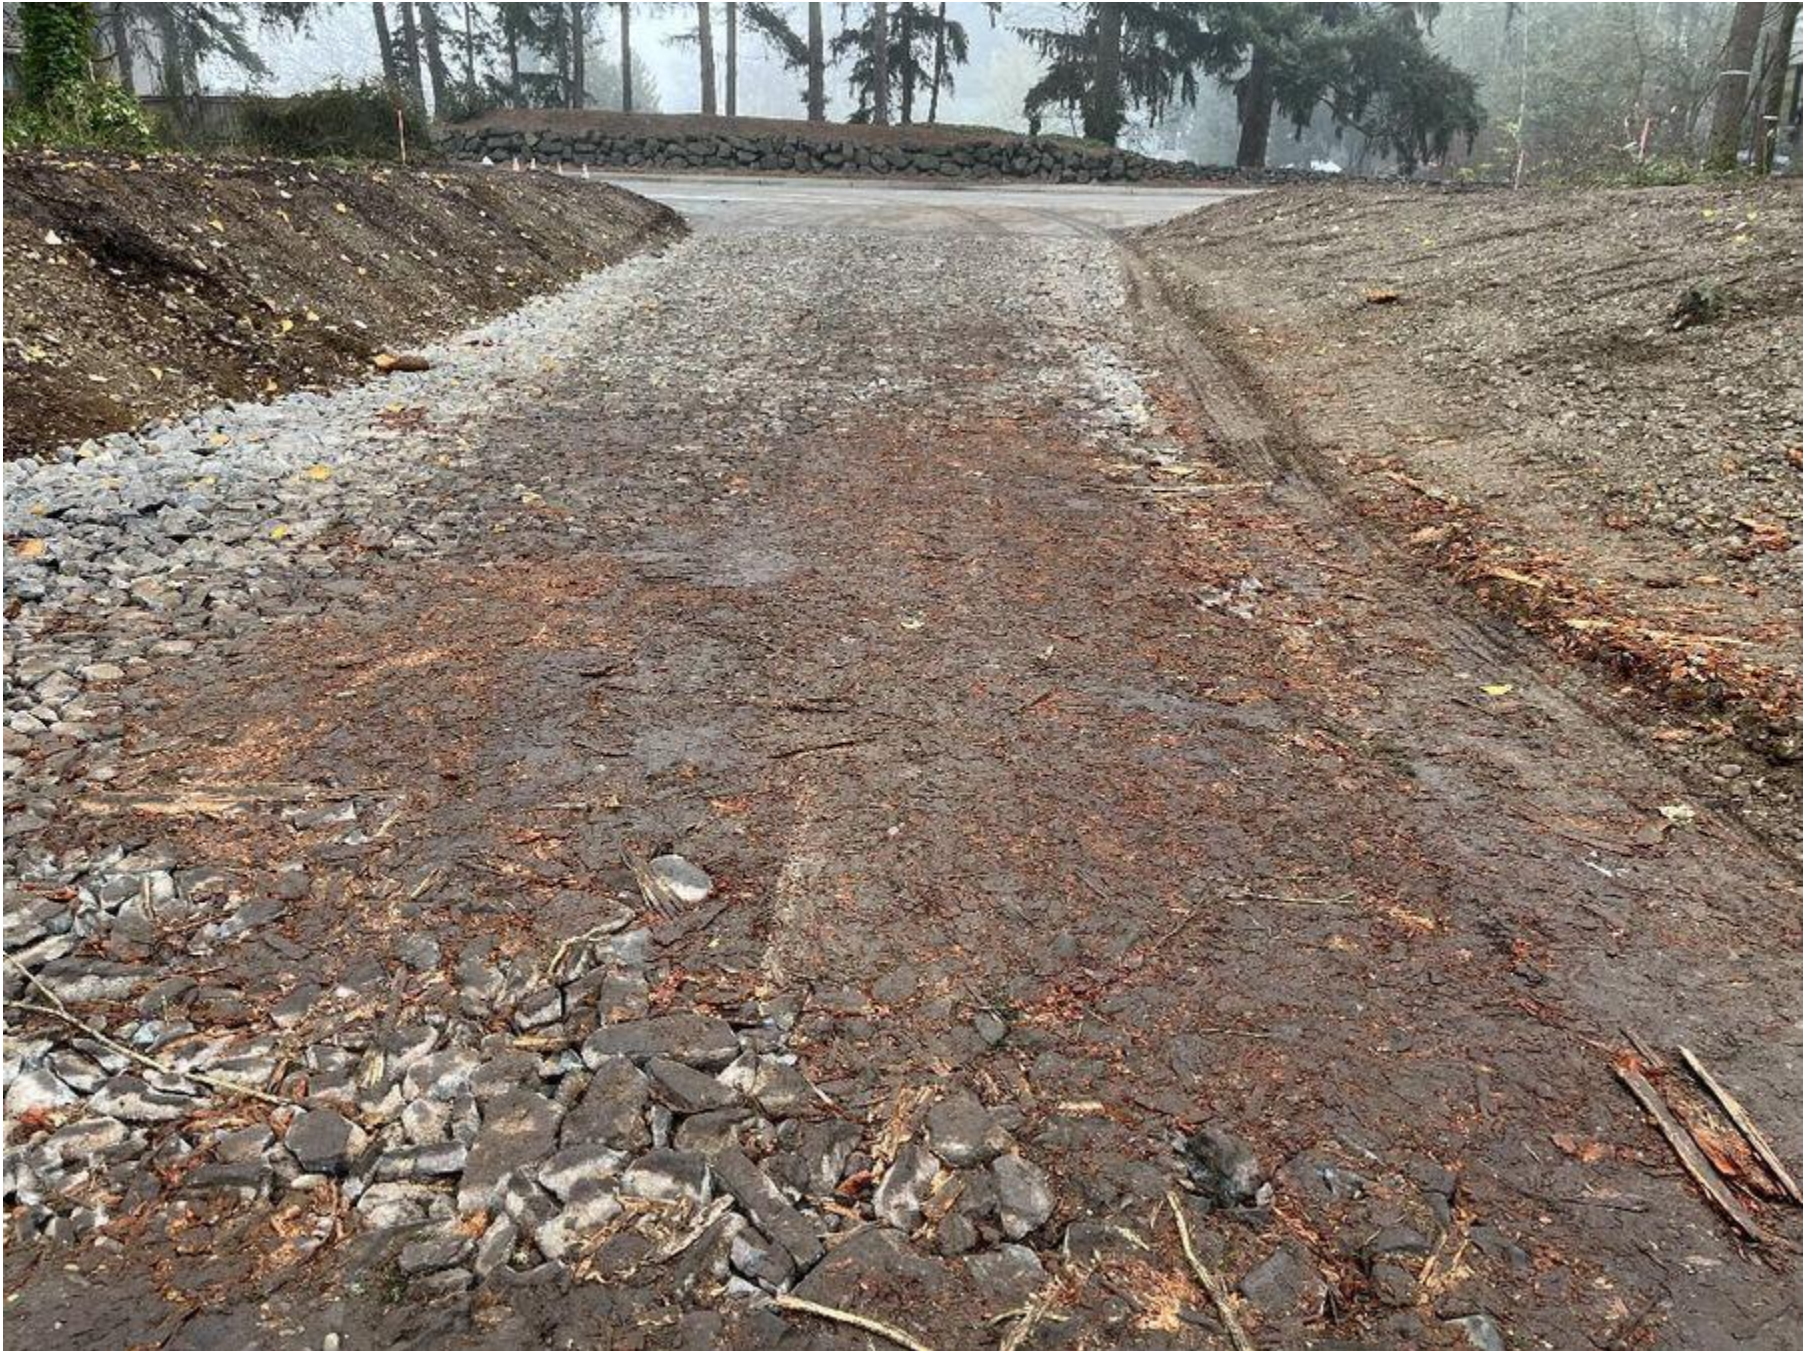
**Photo 1**

| Section C: Compliance | | |
|---|---|---|
| <p><u>S9.D.11 Maintain BMPs</u><br/> <b>BMP C105: Stabilized Construction Access requires maintenance where debris has filled the voids within the quarry spalls. Organic material/debris were observed within the quarry spill access. Maintain BMP C105: Stabilized Construction Access when the access is not preventing sediments from being tracked off site.</b><br/> <b>Failure to meet S9.D.11.a:</b> Permittee must maintain and repair all temporary and permanent erosion and sediment control BMPs as needed to assure continued performance of their intended function in accordance with BMP specifications. Maintain and repair all temporary and permanent BMPs, as set forth in permit condition S9.D.11.a.</p> | <p>Immediately begin. Address the problems <b>no later than 10 days</b> from the date of this inspection.</p> <p><b>12/20/2024</b></p> | <p>SWMMWW, Chapter II-3 <a href="#">Construction Stormwater BMPs</a>, <a href="#">C150</a>, <a href="#">C160</a>, <a href="#">C105</a></p> |

Photo Description: BMP C105: Stabilized Construction Access requires maintenance where organic debris/sediments have filled the voids within spalls.

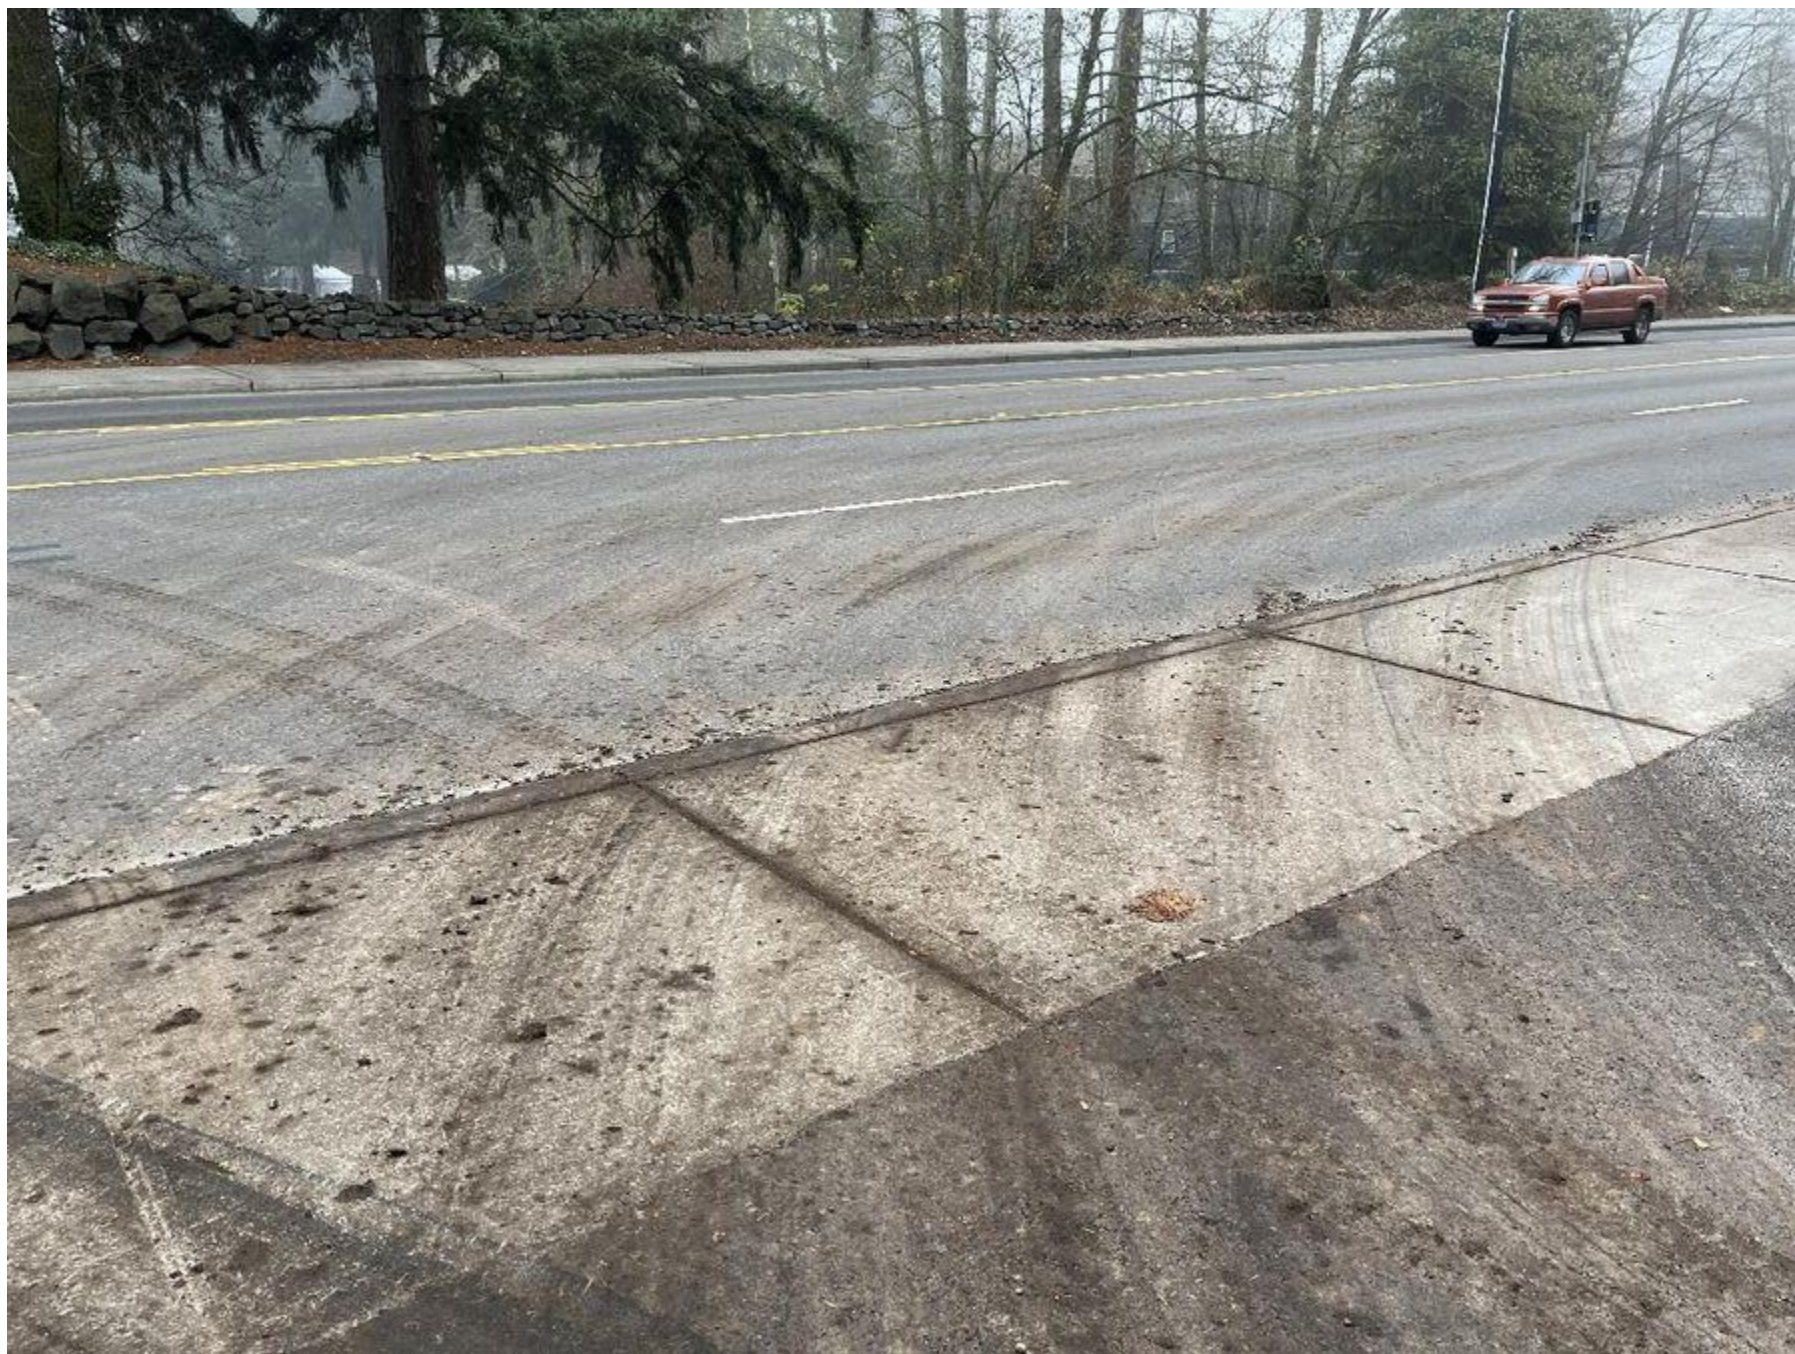
**Photo 2**

| Section C: Compliance | | |
|---|---|---|
| <p><u>S9.D.2 Establish Construction Access</u><br/> <b>Track out was observed on Spanaway Loop Road S. BMP C105: Stabilized Construction Access requires maintenance where debris has filled the voids within the quarry spalls.</b><br/> <b>Failure to meet S9.D.2.d:</b> If sediment is tracked off site, clean the affected roadway thoroughly at the end of each day, or more frequently as necessary (for example, during wet weather). Remove sediment from roads by shoveling, sweeping, or pickup and transport of the sediment to a controlled sediment disposal area. Install and maintain adequate construction access to prevent track-out off-site.</p> | <p>Clean the affected roadway thoroughly <b>at the end of each day</b>, or more frequently <b>as necessary</b></p> | <p><a href="#">BMP C105</a>, <a href="#">BMP C106</a>, <a href="#">BMP C107</a></p> |

Photo Description: Track was observed traveling both directions on Spanaway Loop Road S.

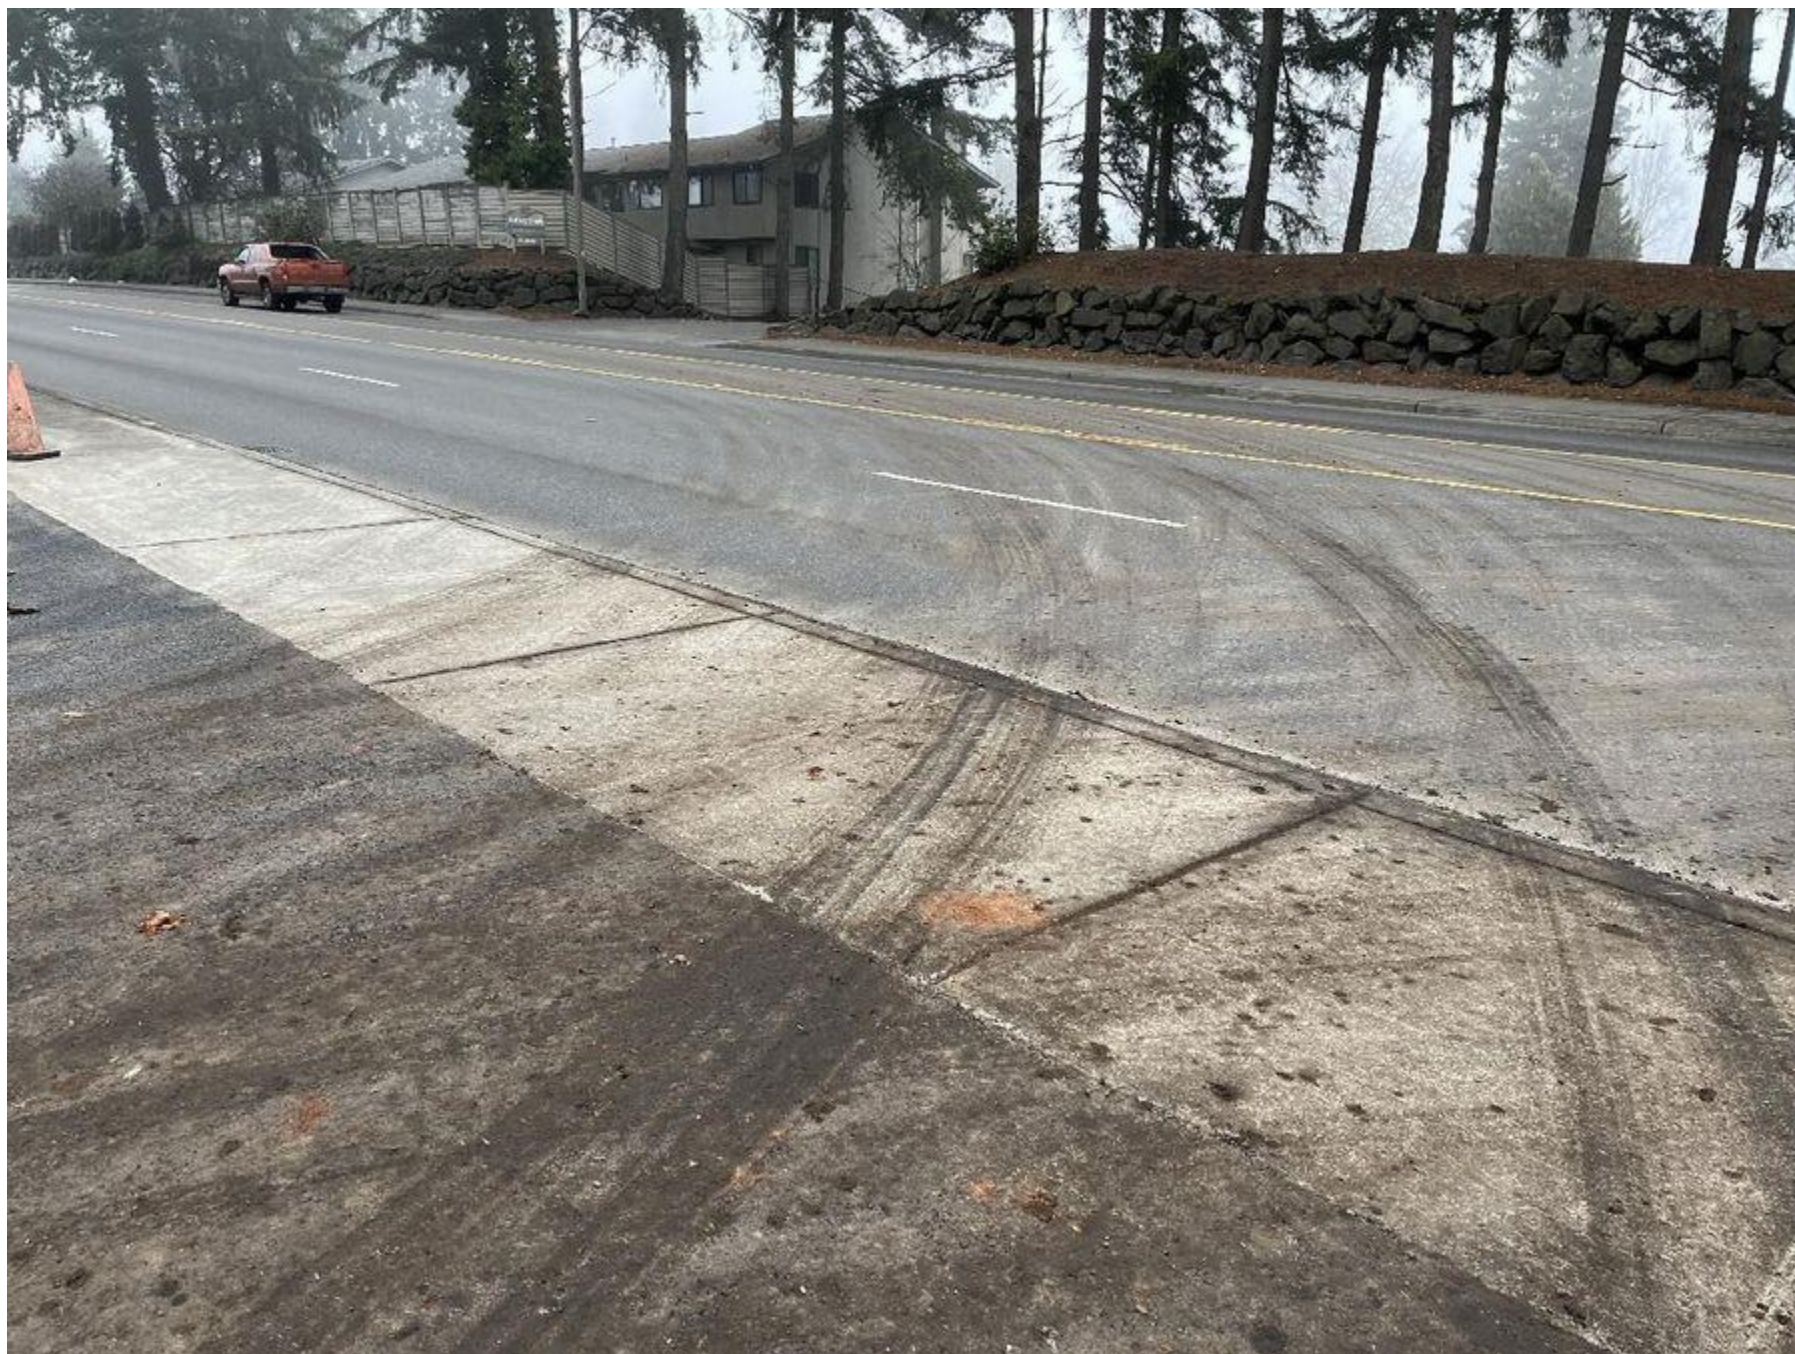
**Photo 3**

Photo Description: Track was observed traveling both directions on Spanaway Loop Road S.

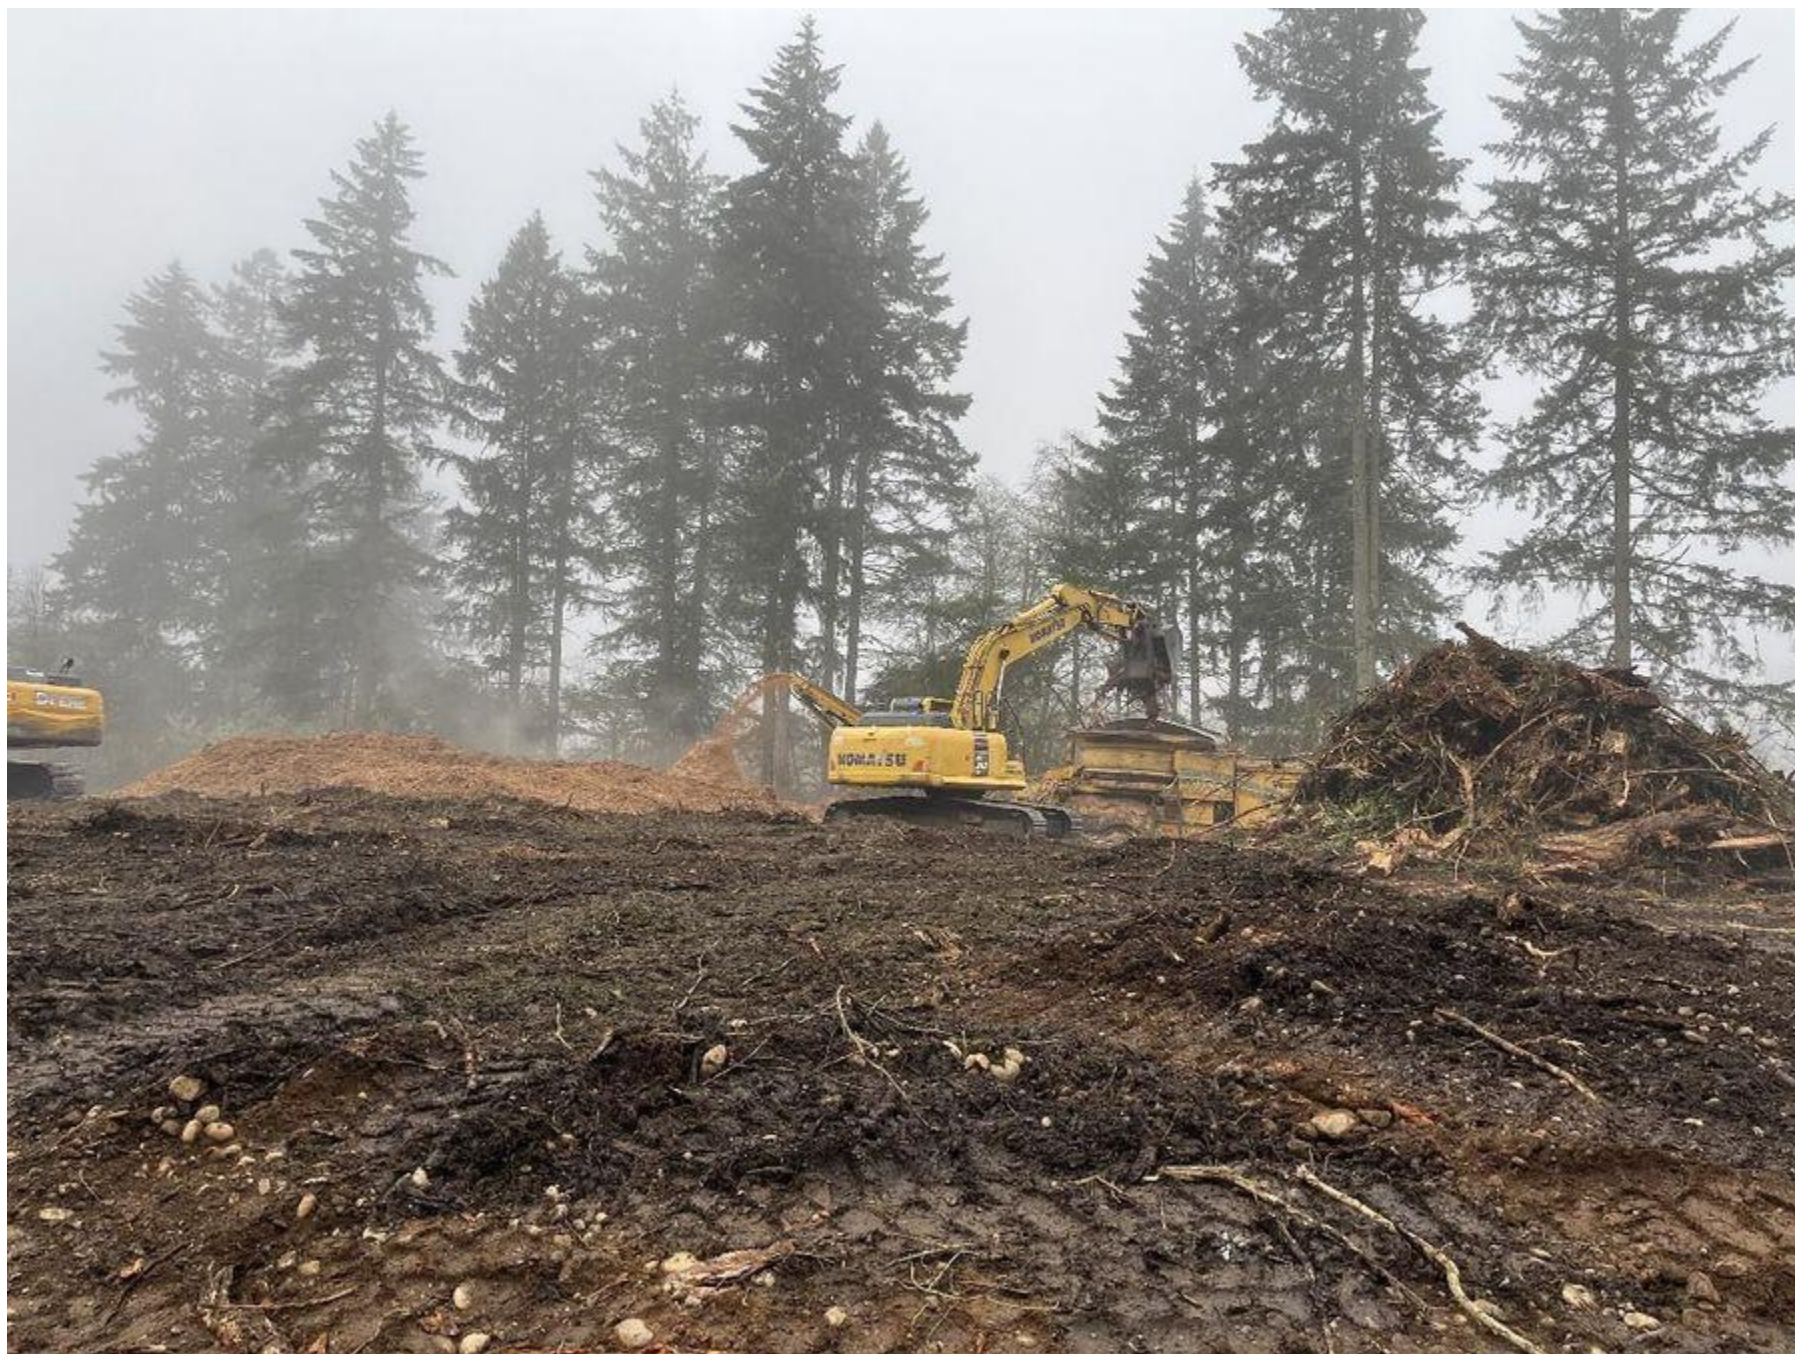
**Photo 4**

Photo Description: Onsite operations observed during inspection were importing material and grinding organic material into hog fuel mulch.
