| Builder | DRB Group |
| Community | Campbell Ridge SF (NC)(RAL) |
| Street Address | 113 Alden Way |
| Date | 5/15/2026 |

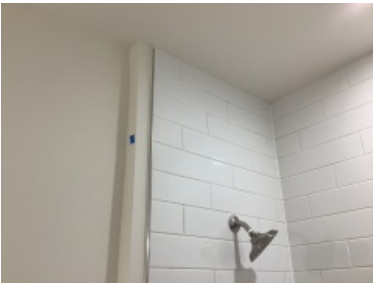
| Room | Trade | Item | Description | Points | Initials | |
|---|---|---|---|---|---|--|
| Bath - 1st Floor Full | Drywall | 1400 - Miscellaneous | Bow in drywall at ceiling above showerhead | 0.25 | | |

Bath - 1st Floor Full  
1400 - Miscellaneous  
Bow in drywall at ceiling above showerhead

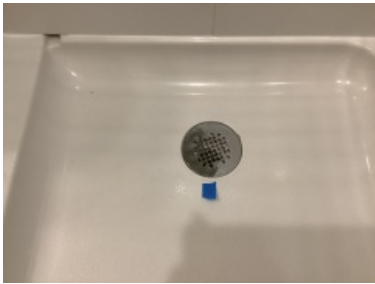
| Room | Trade | Item | Description | Points | Initials | |
|---|---|---|---|---|---|--|
| Bath - 1st Floor Full | Plumbing | 700D - Damage | Drain cover tarnished | 0.25 | | |

Bath - 1st Floor Full  
700D - Damage  
Drain cover tarnished

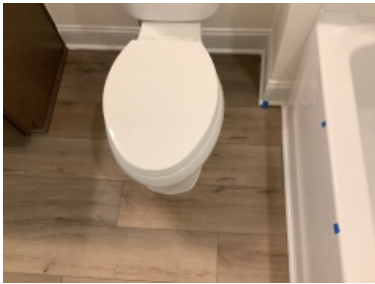
| Room | Trade | Item | Description | Points | Initials | |
|---|---|---|---|---|---|--|
| Bath - Hall | Framing | 1030 - Out of Square/Level | At hall bath top floor trim is out of square at floor right of toilet | 0.25 | | |

Bath - Hall  
1030 - Out of Square/Level  
At hall bath top floor trim is out of square at floor right of toilet

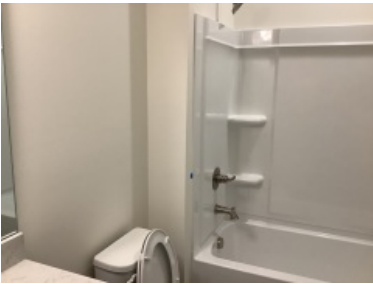
| Room | Trade | Item | Description | Points | Initials | |
|---|---|---|---|---|---|--|
| Bath - Hall | Drywall | 1400 - Miscellaneous | At top floor hall bath Bow in drywall at wall with shower next to toilet | 0.25 | | |

Bath - Hall  
1400 - Miscellaneous  
At top floor hall bath Bow in drywall at wall with shower next to toilet

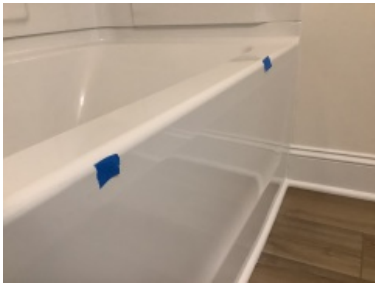
| Room | Trade | Item | Description | Points | Initials | |
|---|---|---|---|---|---|--|
| Bath - Hall | Plumbing | 700D - Damage | At top floor hall bath, scuffs and scratches at edge of tub across from toilet | 0.25 | | |

Bath - Hall  
700D - Damage  
At top floor hall bath, scuffs and scratches at edge of tub across from toilet

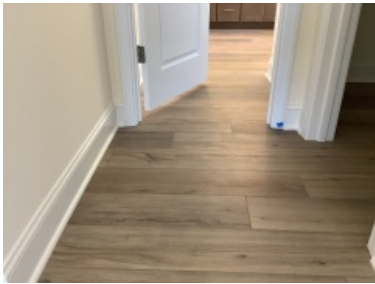
| Room | Trade | Item | Description | Points | Initials | |
|---|---|---|---|---|---|--|
| Bath - Owner's | Interior_Trim | 1510 - Not Pieced Together Well | Inconsistent gap between jamb/casing and floor between left and right side | 0.25 | | |

Bath - Owner's  
1510 - Not Pieced Together Well  
Inconsistent gap between jamb/casing and floor between left and right side

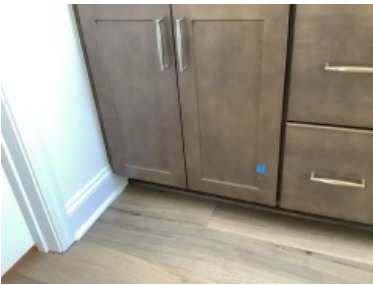
| Room | Trade | Item | Description | Points | Initials | |
|---|---|---|---|---|---|--|
| Bath - Owner's | Cabinets | 1600D - Damage | Chip in left vanity cabinet right door | 0.25 | | |

Bath - Owner's  
1600D - Damage  
Chip in left vanity cabinet right door

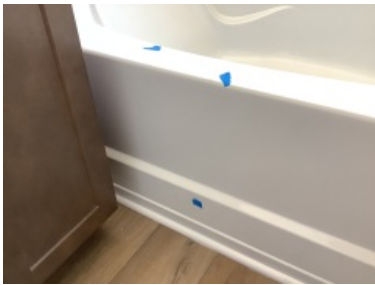
| Room | Trade | Item | Description | Points | Initials | |
|---|---|---|---|---|---|--|
| Bath - Owner's | Plumbing | 700D - Damage | Scuffs,scratches on front of tub next to vanity | 0.25 | | |

Bath - Owner's  
700D - Damage  
Scuffs, scratches on front of tub next to vanity

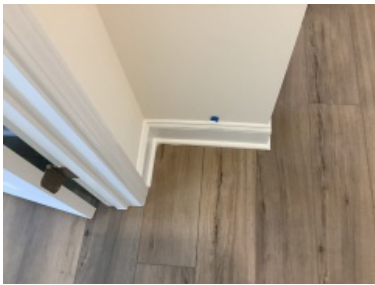
| Room | Trade | Item | Description | Points | Initials | |
|---|---|---|---|---|---|--|
| Bedroom - Owner's | Interior_Trim | 1500D - Damage | Baseboard damaged next to hinges outside owners bedroom | 0.25 | | |

Bedroom - Owner's  
1500D - Damage  
Baseboard damaged next to hinges outside owners bedroom

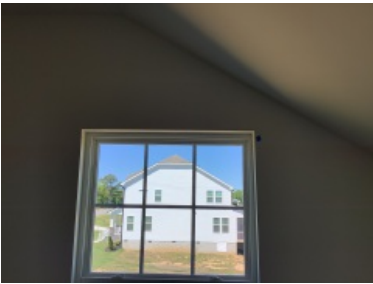
| Room | Trade | Item | Description | Points | Initials | |
|---|---|---|---|---|---|--|
| Bedroom 2 | Drywall | 1410 - Major Drywal Issue | Bow in drywall at bedroom across from loft at top of stairs | 0.25 | | |

Bedroom 2  
1410 - Major Drywal Issue  
Bow in drywall at bedroom across from loft at top of stairs

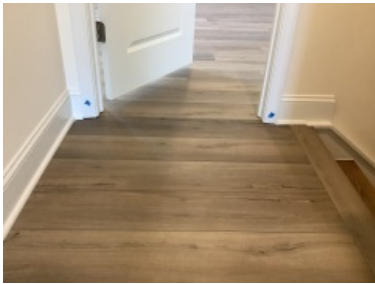
| Room | Trade | Item | Description | Points | Initials | |
|---|---|---|---|---|---|--|
| Bedroom 2 | Interior_Trim | 1510 - Not Pieced Together Well | Inconsistent gap between jamb/casing and floor between left and right side at BR at top of stairs | 0.25 | | |

Bedroom 2  
1510 - Not Pieced Together Well  
Inconsistent gap between jamb/casing and floor between left and right side at BR at top of stairs

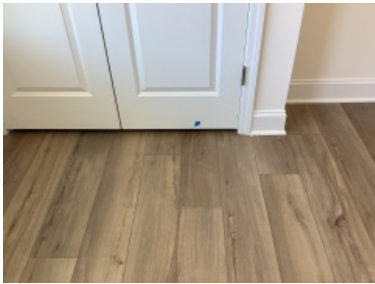
| Room | Trade | Item | Description | Points | Initials | |
|---|---|---|---|---|---|--|
| Bedroom 3 | Doors | 50000D - Damage | FR bedroom closet door damaged , right door at bottom | 0.25 | | |

Bedroom 3  
50000D - Damage  
FR bedroom closet door damaged , right door at bottom

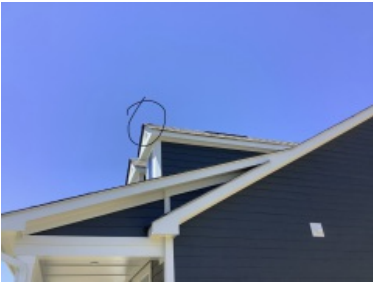
| Room | Trade | Item | Description | Points | Initials | |
|---|---|---|---|---|---|--|
| Exterior | Roofing | 2000 - Miscellaneous | Lifted shingle at front of right dormer | 0.25 | | |

Exterior  
2000 - Miscellaneous  
Lifted shingle at front of right dormer

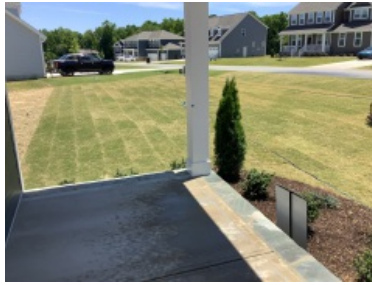
| Room | Trade | Item | Description | Points | Initials | |
|---|---|---|---|---|---|--|
| Exterior | Stairs_and_Rails | 21005 - Missing Pieces | Railings not present at front porch, inconsistent with the rest of community | 0.25 | | |

Exterior  
21005 - Missing Pieces  
Railings not present at front porch, inconsistent with the rest of community

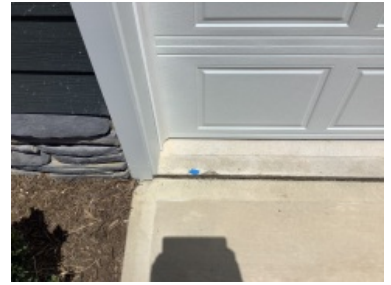
| Room | Trade | Item | Description | Points | Initials | |
|---|---|---|---|---|---|--|
| Exterior | Concrete_Flatwork | 500D - Damage | Chip in garage slab outside of overhead door left side | 0.25 | | |

Exterior  
500D - Damage  
Chip in garage slab outside of overhead door left side

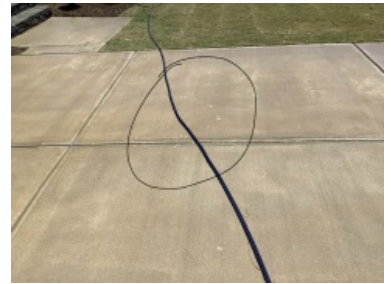
| Room | Trade | Item | Description | Points | Initials | |
|---|---|---|---|---|---|--|
| Exterior | Concrete_Flatwork | 520 - Stain | Paint stains on right side of driveway | 0.25 | | |

Exterior  
520 - Stain  
Paint stains on right side of driveway

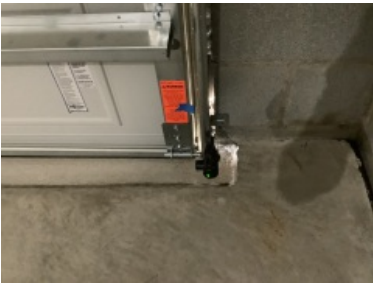
| Room | Trade | Item | Description | Points | Initials | |
|---|---|---|---|---|---|--|
| Garage | Exterior_Trim | 20000 - Miscellaneous | Gap between foundation and garage door, trim, exterior visible from inside garage | 0.25 | | |

Garage  
20000 - Miscellaneous  
Gap between foundation and garage door, trim, exterior visible from inside garage

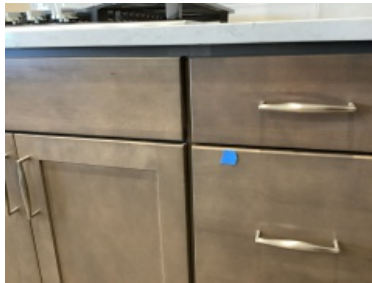
| Room | Trade | Item | Description | Points | Initials | |
|---|---|---|---|---|---|--|
| Kitchen/Dinette | Cabinets | 1600D - Damage | Middle drawer face right of cooktop scratched | 0.25 | | |

Kitchen/Dinette  
1600D - Damage  
Middle drawer face right of cooktop scratched

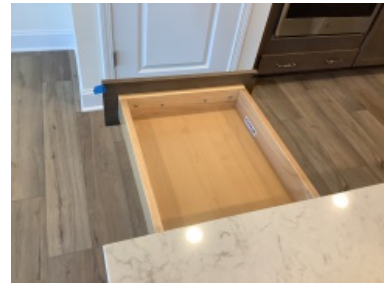
| Room | Trade | Item | Description | Points | Initials | |
|---|---|---|---|---|---|--|
| Kitchen/Dinette | Cabinets | 1620 - Missing Bumps | Missing bump for drawer across from pantry at Island | 0.25 | | |

Kitchen/Dinette  
1620 - Missing Bumps  
Missing bump for drawer across from pantry at Island

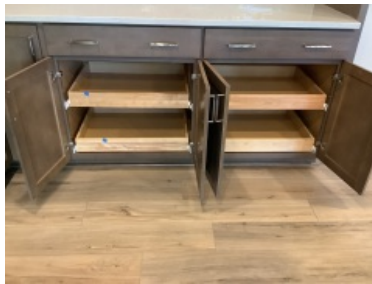
| Room | Trade | Item | Description | Points | Initials | |
|---|---|---|---|---|---|--|
| Kitchen/Dinette | Cabinets | 1630 - Drawer/Door Issue | Pull out shelves left of fridge, left cabinet binding, inconsistent operation with adjacent set | 0.25 | | |

Kitchen/Dinette  
1630 - Drawer/Door Issue  
Pull out shelves left of fridge, left cabinet binding, inconsistent operation with adjacent set

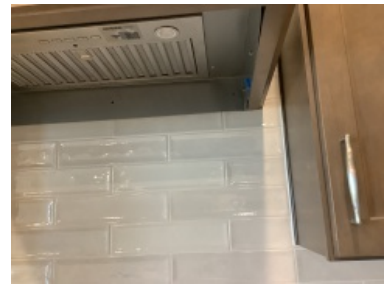
| Room | Trade | Item | Description | Points | Initials | |
|---|---|---|---|---|---|--|
| Kitchen/Dinette | Appliances | 1800D - Damage | Bend in rear corner, inconsistent gap between hood vent and wood surround right side | 0.25 | | |

Kitchen/Dinette  
1800D - Damage  
Bend in rear corner, inconsistent gap between hood vent and wood surround right side

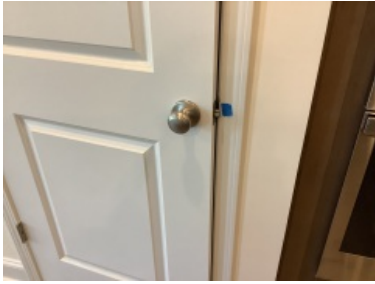
| Room | Trade | Item | Description | Points | Initials | |
|---|---|---|---|---|---|--|
| Kitchen/Dinette | Doors | 50040 - Door Rubs | Metal rubbing at strike plate for pantry door in kitchen | 0.25 | | |

Kitchen/Dinette  
50040 - Door Rubs  
Metal rubbing at strike plate for pantry door in kitchen

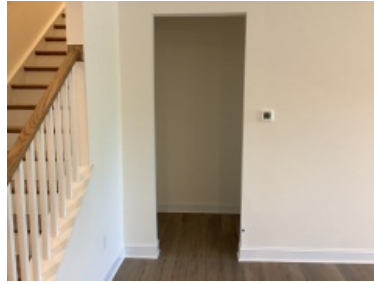
| Room | Trade | Item | Description | Points | Initials | |
|---|---|---|---|---|---|--|
| Living | Framing | 1020 - Out of Plumb | Wall at Cased opening to owners BR next to thermostat crooked | 0.25 | | |

Living  
1020 - Out of Plumb  
Wall at Cased opening to owners BR next to thermostat crooked

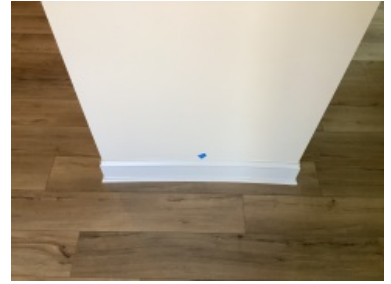
| Room | Trade | Item | Description | Points | Initials | |
|---|---|---|---|---|---|--|
| Stairs/Hall | Framing | 1050 - Bowed Wall | Bow in wall across from front door, next to entry to first floor bedrooms | 0.25 | | |

Stairs/Hall  
1050 - Bowed Wall  
Bow in wall across from front door, next to entry to first floor bedrooms

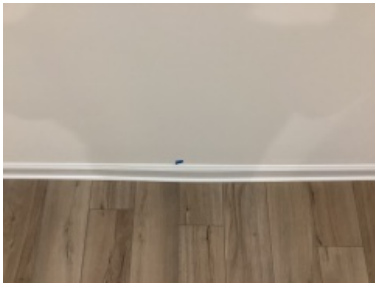
| Room | Trade | Item | Description | Points | Initials | |
|---|---|---|---|---|---|--|
| Stairs/Hall | Framing | 1050 - Bowed Wall | Bow in wall between front door and stairs , midway between | 0.25 | | |

Stairs/Hall  
1050 - Bowed Wall  
Bow in wall between front door and stairs , midway between

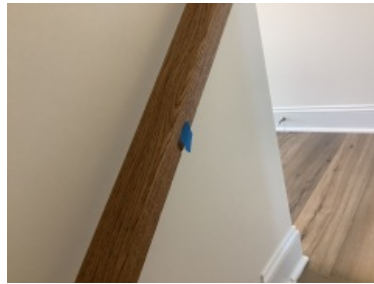
| Stairs/Hall | Stairs_and_Rails | 21040 - Rough Finish | Chip , rough edge in bottom of handrail at top of stairs | 0.25 | | |

Stairs/Hall  
21040 - Rough Finish  
Chip , rough edge in bottom of handrail at top of stairs

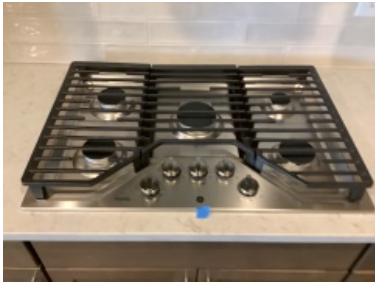
| Room | Trade | Item | Description | Adjustment | Initials | |
|---|---|---|---|---|---|--|
| Kitchen/Dinette | Appliances | 1835 - Inoperable Appliance | DNS per Doug: customer provides propane for gas appliances | | | |

Kitchen/Dinette  
1835 - Inoperable Appliance  
DNS per Doug: customer provides propane for gas appliances

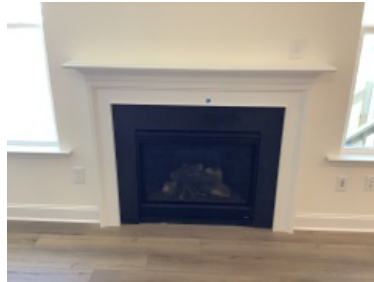
| Room | Trade | Item | Description | Adjustment | Initials | |
|---|---|---|---|---|---|--|
| Living | HVAC | 600 - Miscellaneous | DNS per Doug: customer provides propane for gas appliances, fireplace not operating | | | |

Living  
600 - Miscellaneous  
DNS per Doug: customer provides propane for gas appliances, fireplace not operating
