| Builder | DRB Group |
| Community | Essex Village SF (NC)(RAL) |
| Street Address | 30 Gerrard St |
| Type | New Review |

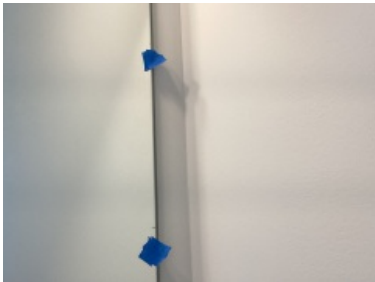
| Room | Trade | Item | Description | Points | Initials | |
|---|---|---|---|---|---|--|
| Bath - Hall | Bath_Accessories | 18050D - Damage | Scratches in right edge of mirror | 0.25 | | |

Bath - Hall  
18050D - Damage  
Scratches in right edge of mirror

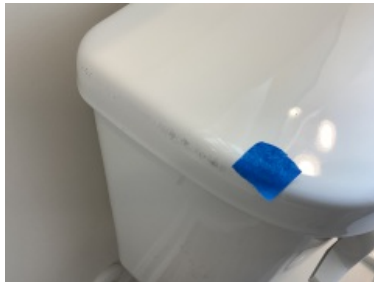
| Room | Trade | Item | Description | Points | Initials | |
|---|---|---|---|---|---|--|
| Bath - Hall | Plumbing | 700D - Damage | Black marks on side of toilet tank cover | 0.25 | | |

Bath - Hall  
700D - Damage  
Black marks on side of toilet tank cover

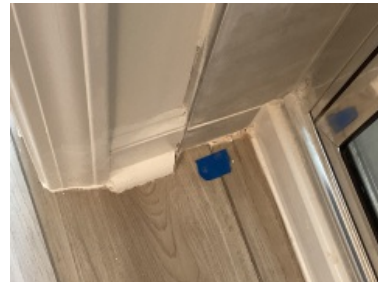
| Room | Trade | Item | Description | Points | Initials | |
|---|---|---|---|---|---|--|
| Bath - Owner's | Flooring | 1300 - Miscellaneous | Inconsistent gap at bottom left of shower door, grout is used for half | 0.25 | | |

Bath - Owner's  
1300 - Miscellaneous  
Inconsistent gap at bottom left of shower door, grout is used for half

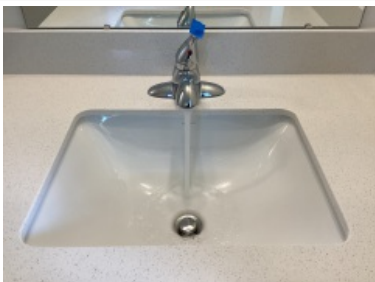
| Room | Trade | Item | Description | Points | Initials | |
|---|---|---|---|---|---|--|
| Bath - Owner's | Plumbing | 740 - Hot/Cold Reversed | Hot and cold reversed at right sink | 0.25 | | |

Bath - Owner's  
740 - Hot/Cold Reversed  
Hot and cold reversed at right sink

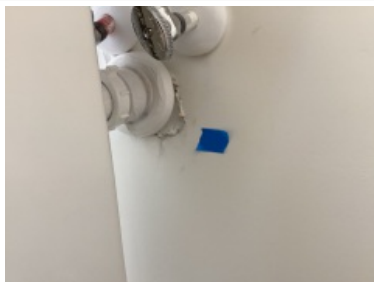
| Room | Trade | Item | Description | Points | Initials | |
|---|---|---|---|---|---|--|
| Bath - Powder | Drywall | 1400D -Damage | Damage to drywall under sink | 0.25 | | |

Bath - Powder  
1400D -Damage  
Damage to drywall under sink

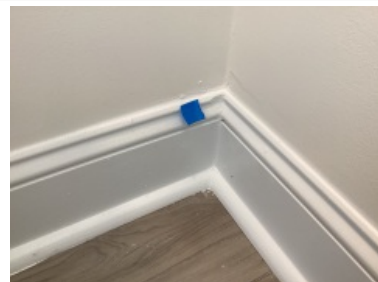
| Room | Trade | Item | Description | Points | Initials | |
|---|---|---|---|---|---|--|
| Bath - Powder | Interior_Trim | 1500D - Damage | Damage to baseboard to right of sink | 0.25 | | |

Bath - Powder  
1500D - Damage  
Damage to baseboard to right of sink

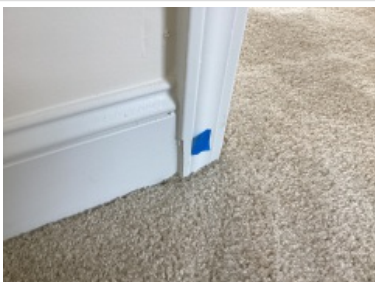
| Room | Trade | Item | Description | Points | Initials | |
|---|---|---|---|---|---|--|
| Bedroom 2 | Interior_Trim | 1500D - Damage | Damage to door trim at bottom strike side of entry door, middle left bedroom | 0.25 | | |

Bedroom 2  
1500D - Damage  
Damage to door trim at bottom strike side of entry door, middle left bedroom

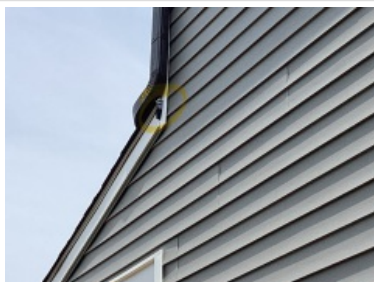
| Room | Trade | Item | Description | Points | Initials | |
|---|---|---|---|---|---|--|
| Exterior | Roofing | 2020 - Plastic Wrappers Left On | Tape visible on flashing at right side of house at front porch roof | 0.25 | | |

Exterior  
2020 - Plastic Wrappers Left On  
Tape visible on flashing at right side of house at front porch roof

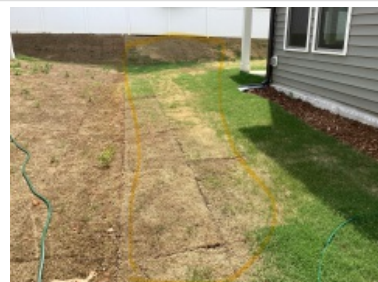
| Room | Trade | Item | Description | Points | Initials | |
|---|---|---|---|---|---|--|
| Exterior | Landscaping | 330 - Dying Sod/Seed/Shrubs/Tree | Dying sod in left and back yard | 0.25 | | |

Exterior  
330 - Dying Sod/Seed/Shrubs/Tree  
Dying sod in left and back yard

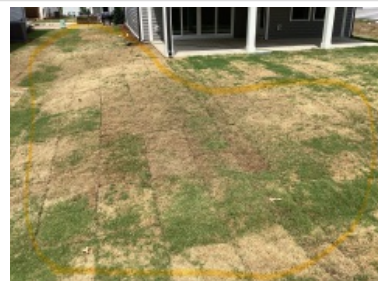
| Room | Trade | Item | Description | Points | Initials | |
|---|---|---|---|---|---|--|
| Exterior | Landscaping | 330 - Dying Sod/Seed/Shrubs/Tree | Dying sod in right and back yard | 0.25 | | |

Exterior  
330 - Dying Sod/Seed/Shrubs/Tree  
Dying sod in right and back yard

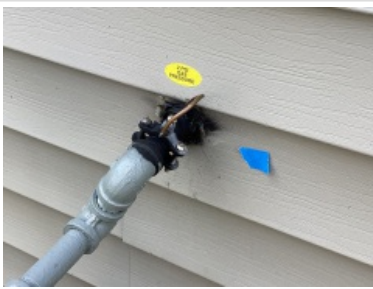
| Room | Trade | Item | Description | Points | Initials | |
|---|---|---|---|---|---|--|
| Exterior | Siding | 4000D - Damage | Stains on siding at gas line, left side of house | 0.25 | | |

Exterior  
4000D - Damage  
Stains on siding at gas line, left side of house

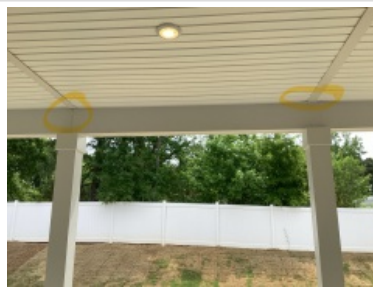
| Room | Trade | Item | Description | Points | Initials | |
|---|---|---|---|---|---|--|
| Exterior | Siding | 4030 - Soffit/Fascia Issues | Gap in soffit above middle columns at back porch | 0.25 | | |

Exterior  
4030 - Soffit/Fascia Issues  
Gap in soffit above middle columns at back porch

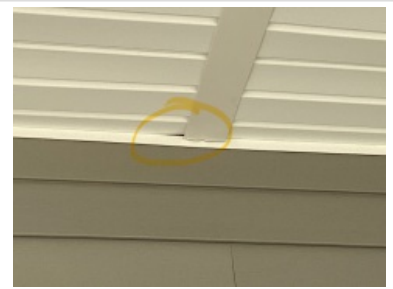
| Room | Trade | Item | Description | Points | Initials | |
|---|---|---|---|---|---|--|
| Exterior | Siding | 4030 - Soffit/Fascia Issues | Gap in soffit above SGD at back porch | 0.25 | | |

Exterior  
4030 - Soffit/Fascia Issues  
Gap in soffit above SGD at back porch

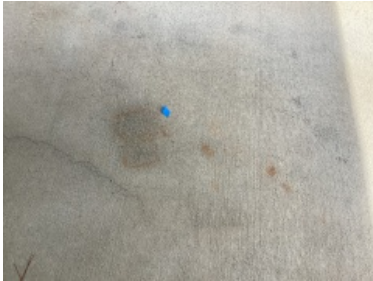
| Room | Trade | Item | Description | Points | Initials | |
|---|---|---|---|---|---|--|
| Exterior | Concrete_Flatwork | 520 - Stain | Stains on back patio | 0.25 | | |

Exterior  
520 - Stain  
Stains on back patio

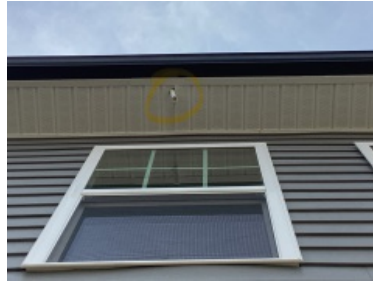
| Room | Trade | Item | Description | Points | Initials | |
|---|---|---|---|---|---|--|
| Exterior | Plumbing | 770 - House Penetrations Not Sealed | Penetration not sealed at soffit pipe on left side of house | 0.25 | | |

Exterior  
770 - House Penetrations Not Sealed  
Penetration not sealed at soffit pipe on left side of house

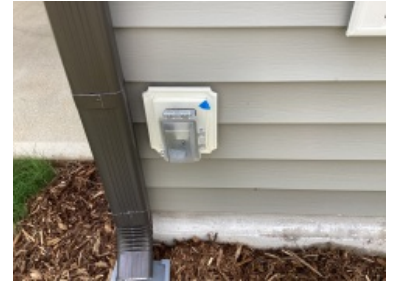
| Room | Trade | Item | Description | Points | Initials | |
|---|---|---|---|---|---|--|
| Exterior | Electric | 852 - Exterior Penetrations Not Sealed | Outlet not sealed at left side of house at back | 0.25 | | |

Exterior  
852 - Exterior Penetrations Not Sealed  
Outlet not sealed at left side of house at back

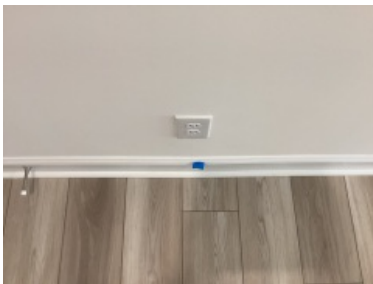
| Room | Trade | Item | Description | Points | Initials | |
|---|---|---|---|---|---|--|
| Foyer | Framing | 1050 - Bowed Wall | Wall bows under outlet | 0.25 | | |

Foyer  
1050 - Bowed Wall  
Wall bows under outlet

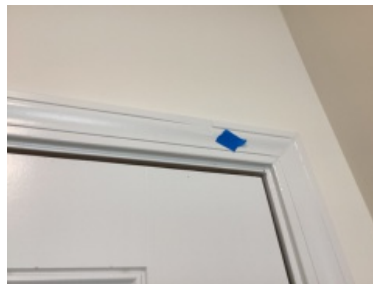
| Room | Trade | Item | Description | Points | Initials | |
|---|---|---|---|---|---|--|
| Foyer | Interior_Trim | 1500D - Damage | Damage to door trim above front door | 0.25 | | |

Foyer  
1500D - Damage  
Damage to door trim above front door

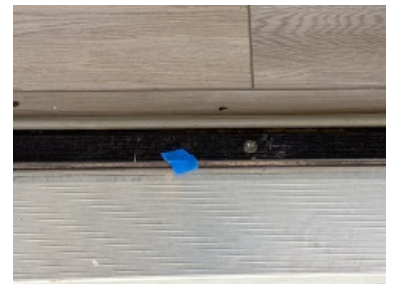
| Room | Trade | Item | Description | Points | Initials | |
|---|---|---|---|---|---|--|
| Foyer | Doors | 50000D - Damage | Scratches in threshold at front door | 0.25 | | |

Foyer  
50000D - Damage  
Scratches in threshold at front door

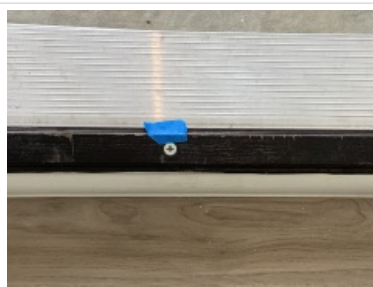
| Room | Trade | Item | Description | Points | Initials | |
|---|---|---|---|---|---|--|
| Garage | Doors | 50000D - Damage | Scratches in threshold at garage door | 0.25 | | |

Garage  
50000D - Damage  
Scratches in threshold at garage door

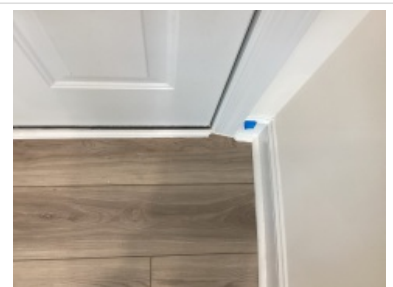
| Room | Trade | Item | Description | Points | Initials | |
|---|---|---|---|---|---|--|
| Kitchen/Dinette | Interior_Trim | 1560 - Out of plumb/square | Trim not square at bottom right of garage door | 0.25 | | |

Kitchen/Dinette  
1560 - Out of plumb/square  
Trim not square at bottom right of garage door

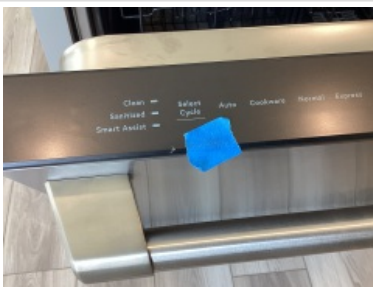
| Room | Trade | Item | Description | Points | Initials | |
|---|---|---|---|---|---|--|
| Kitchen/Dinette | Appliances | 1800D - Damage | Scratch in top of dishwasher | 0.25 | | |

Kitchen/Dinette  
1800D - Damage  
Scratch in top of dishwasher

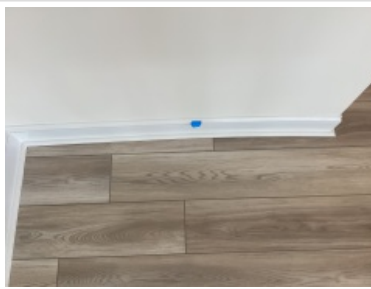
| Room | Trade | Item | Description | Points | Initials | |
|---|---|---|---|---|---|--|
| Living | Framing | 1050 - Bowed Wall | Wall bows, left of font hall way | 0.25 | | |

Living  
1050 - Bowed Wall  
Wall bows, left of front hall way

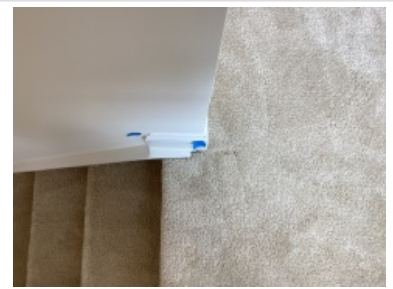
| Room | Trade | Item | Description | Points | Initials | |
|---|---|---|---|---|---|--|
| Stairs/Hall | Interior_Trim | 1560 - Out of plumb/square | Out of square at top of stairs at knee wall | 0.25 | | |

Stairs/Hall  
1560 - Out of plumb/square  
Out of square at top of stairs at knee wall
