| Builder | DRB Group |
| Community | Essex Village SF (NC)(RAL) |
| Street Address | 27 Gerrard St |
| Type | New Review |

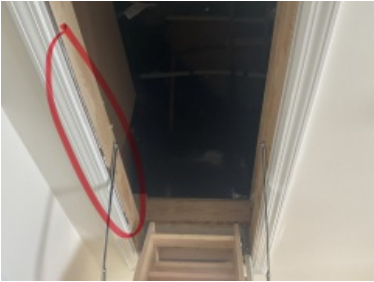
| Room | Trade | Item | Description | Points | Initials | |
|---|---|---|---|---|---|---|
| Attic | Doors | 5000D - Damage | Weatherstripping on attic door is partially painted on left side and fully painted on right side | 0.25 | | |

Attic  
50000D - Damage  
Weatherstripping on attic door is partially painted on left side and fully painted on right side

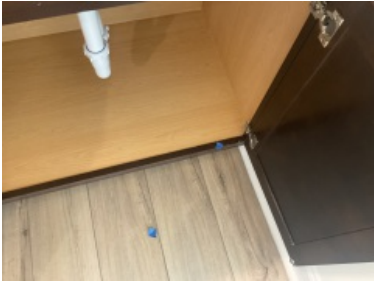
| Room | Trade | Item | Description | Points | Initials | |
|---|---|---|---|---|---|---|
| Bath - Owner's | Cabinets | 1600D - Damage | Top edge lower rail of cabinet under right sink is scratched near the right side | 0.25 | | |

Bath - Owner's  
1600D - Damage  
Top edge lower rail of cabinet under right sink is scratched near the right side

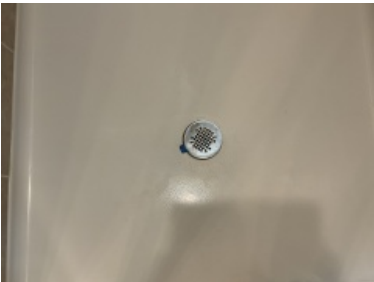
| Room | Trade | Item | Description | Points | Initials | |
|---|---|---|---|---|---|---|
| Bath - Owner's | Plumbing | 701 - Fixture Improperly Installed | Drain cover is set crooked in shower | 0.25 | | |

Bath - Owner's  
701 - Fixture Improperly Installed  
Drain cover is set crooked in shower

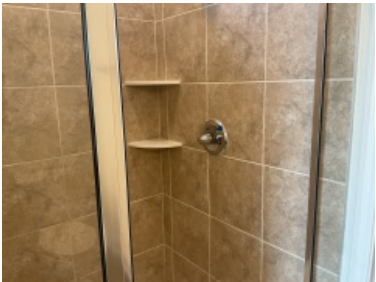
| Room | Trade | Item | Description | Points | Initials | |
|---|---|---|---|---|---|---|
| Bath - Owner's | Plumbing | 740 - Hot/Cold Reversed | Hot and cold are reversed on the shower | 0.25 | | |

Bath - Owner's  
740 - Hot/Cold Reversed  
Hot and cold are reversed on the shower

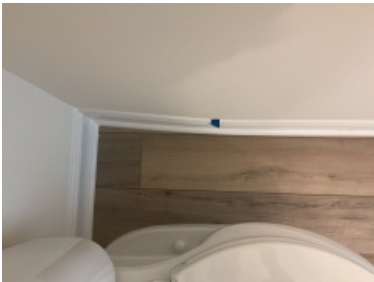
| Room | Trade | Item | Description | Points | Initials | |
|---|---|---|---|---|---|---|
| Bath - Powder | Interior_Trim | 1560 - Out of plumb/square | The baseboard on the right side of the toilet is bowed | 0.25 | | |

Bath - Powder  
1560 - Out of plumb/square  
The baseboard on the right side of the toilet is bowed

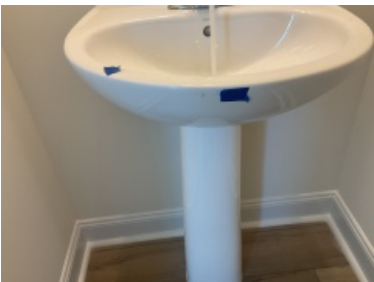
| Room | Trade | Item | Description | Points | Initials | |
|---|---|---|---|---|---|---|
| Bath - Powder | Plumbing | 700D - Damage | Marks or scratches on the front edge of the sink in the middle | 0.25 | | |

Bath - Powder  
700D - Damage  
Marks or scratches on the front edge of the sink in the middle

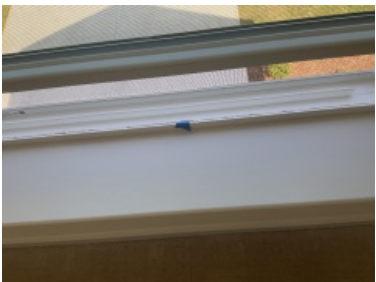
| Room | Trade | Item | Description | Points | Initials | |
|---|---|---|---|---|---|---|
| Bedroom 1 | Windows | 13000D - Damage | Lower rail is gouged on right window in the middle in front right bedroom | 0.25 | | |

Bedroom 1  
13000D - Damage  
Lower rail is gouged on right window in the middle in front right bedroom

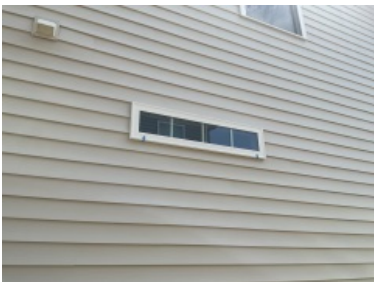
| Room | Trade | Item | Description | Points | Initials | |
|---|---|---|---|---|---|---|
| Exterior | Cleaning | 1915 - Exterior Presentation | Tape left over weep holes of transom window on the right side of home | 0.25 | | |

Exterior  
1915 - Exterior Presentation  
Tape left over weep holes of transom window on the right side of home

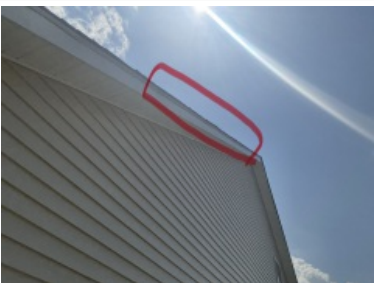
| Room | Trade | Item | Description | Points | Initials | |
|---|---|---|---|---|---|---|
| Exterior | Roofing | 2000D - Damage | Bent drip edge on right side of home left of the apex of the roof line | 0.25 | | |

Exterior  
2000D - Damage  
Bent drip edge on right side of home left of the apex of the roof line

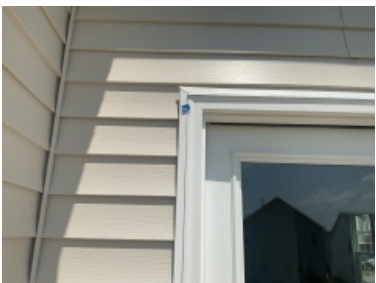
| Room | Trade | Item | Description | Points | Initials | |
|---|---|---|---|---|---|---|
| Exterior | Siding | 4000 - Miscellaneous | J channel over cut on top left corner of patio door | 0.25 | | |

Exterior  
4000 - Miscellaneous  
J channel over cut on top left corner of patio door

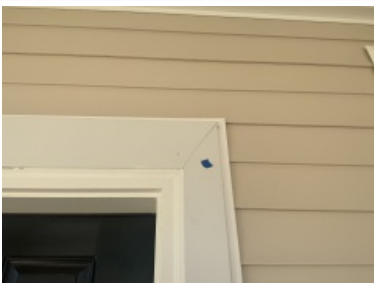
| Room | Trade | Item | Description | Points | Initials | |
|---|---|---|---|---|---|---|
| Exterior | Siding | 4000D - Damage | Metal wrap has sharp edge at top right corner over the front door | 0.25 | | |

Exterior  
4000D - Damage  
Metal wrap has sharp edge at top right corner over the front door

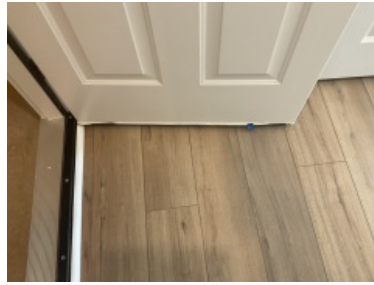
| Room | Trade | Item | Description | Points | Initials | |
|---|---|---|---|---|---|---|
| Garage | Doors | 50000D - Damage | Door sweep for fire door entry is partially painted | 0.25 | | |

Garage  
50000D - Damage  
Door sweep for fire door entry is partially painted

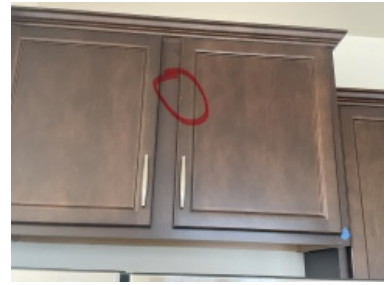
| Room | Trade | Item | Description | Points | Initials | |
|---|---|---|---|---|---|---|
| Kitchen/Dinette | Cabinets | 1600D - Damage | Scratch on cabinet door of upper cabinet over refrigerator right door, scratch on left side over handle | 0.25 | | |

Kitchen/Dinette  
1600D - Damage  
Scratch on cabinet door of upper cabinet over refrigerator right door, scratch on left side over handle

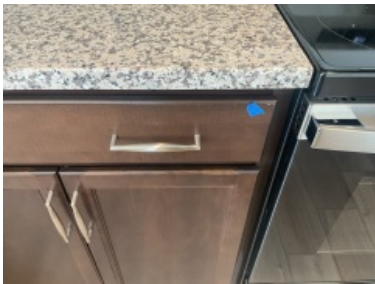
| Room | Trade | Item | Description | Points | Initials | |
|---|---|---|---|---|---|---|
| Kitchen/Dinette | Cabinets | 1600D - Damage | The top right corner of the drawer left of stove. The finish is rubbed off. | | JW | 7/2/2026 |

Kitchen/Dinette  
1600D - Damage  
The top right corner of the drawer left of stove. The finish is rubbed off.

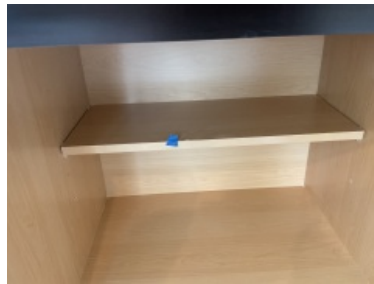
| Room | Trade | Item | Description | Points | Initials | |
|---|---|---|---|---|---|---|
| Kitchen/Dinette | Cabinets | 1600D - Damage | The front edge of shelf in lower cabinet right of stove is damaged | 0.25 | | |

Kitchen/Dinette  
1600D - Damage  
The front edge of shelf in lower cabinet right of stove is damaged

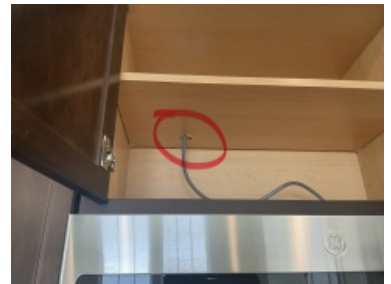
| Room | Trade | Item | Description | Points | Initials | |
|---|---|---|---|---|---|---|
| Kitchen/Dinette | Cabinets | 1600D - Damage | The hole cut through the shelf in cabinet above microwave has rough edges around the hole | 0.25 | | |

Kitchen/Dinette  
1600D - Damage  
The hole cut through the shelf in cabinet above microwave has rough edges around the hole

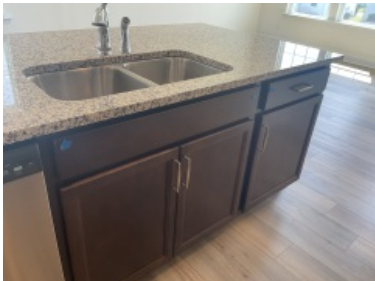
| Room | Trade | Item | Description | Points | Initials | |
|---|---|---|---|---|---|---|
| Kitchen/Dinette | Cabinets | 1600D - Damage | The top corner edges of the false front under the sink and the top left corner of the the drawer to the right has the finish rubbed off | 0.25 | | |

Kitchen/Dinette  
1600D - Damage  
The top left corner of the false front under the sink and the top left corner of the drawer to the right has the finish rubbed off

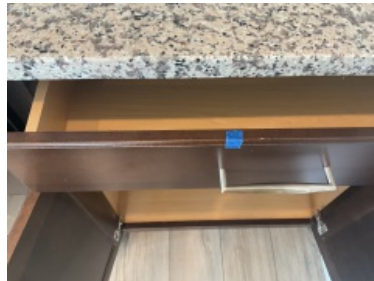
| Room | Trade | Item | Description | Points | Initials | |
|---|---|---|---|---|---|---|
| Kitchen/Dinette | Cabinets | 1600D - Damage | The top edge of the drawer, right of the stove is scratched above handle | 0.25 | | |

Kitchen/Dinette  
1600D - Damage  
The top edge of the drawer, right of the stove is scratched above handle

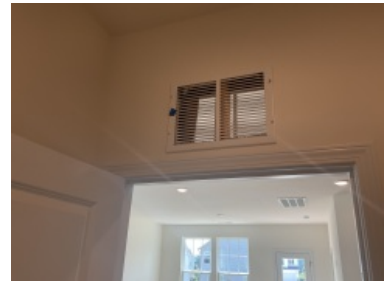
| Room | Trade | Item | Description | Points | Initials | |
|---|---|---|---|---|---|---|
| Laundry Room | HVAC | 660 - Ragged Drywall Visible Through Grate | Visible damaged drywall can be seen behind vent over laundry door on the laundry room side | 0.25 | | |

Laundry Room  
660 - Ragged Drywall Visible Through Grate  
Visible damaged drywall can be seen behind vent over laundry door on the laundry room side
