New Review - Home Quality Review

| Builder | DRB Group |
|---|---|
| Community | Essex Village TH (NC)(RAL) |
| Lot | 00.0140 |
| Street Address | 218 Alberta Drive |

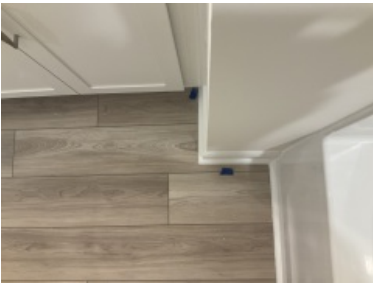
| Room | Trade | Item | Description | Points | Initials | |
|---|---|---|---|---|---|--|
| Bath - Hall | Interior_Trim | 1560 - Out of plumb/square | Shoe mould at right side of vanity not square with floor | 0.25 | | |

Bath - Hall  
1560 - Out of plumb/square  
Shoe mould at right side of vanity not square with floor

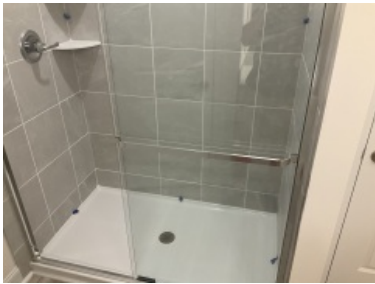
| Room | Trade | Item | Description | Points | Initials | |
|---|---|---|---|---|---|--|
| Bath - Owner's | Ceramic | 1220 - Tile Installation Issue | Corners and bottom edges of tile not sealed in shower | 0.25 | | |

Bath - Owner's  
1220 - Tile Installation Issue  
Comers and bottom edges of tile not sealed in shower

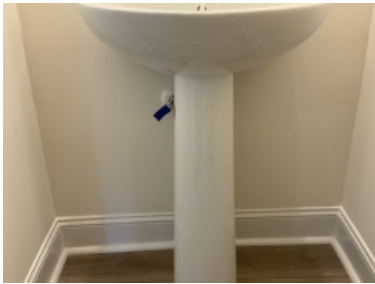
| Room | Trade | Item | Description | Points | Initials | |
|---|---|---|---|---|---|--|
| Bath - Powder | Plumbing | 721 - Pedastal Sink Water Lines Visible | Water line visible on left side of pedestal sink | 0.25 | | |

Bath - Powder  
721 - Pedastal Sink Water Lines Visible  
Water line visible on left side of pedestal sink

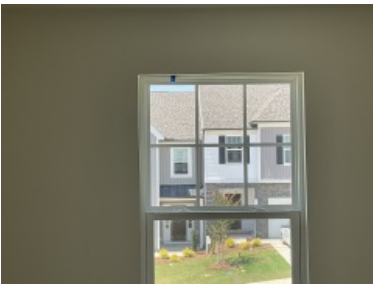
| Room | Trade | Item | Description | Points | Initials | |
|---|---|---|---|---|---|--|
| Bedroom 1 | Drywall | 1400 - Miscellaneous | Left front bedroom, drywall return above front window uneven | 0.25 | | |

Bedroom 1  
1400 - Miscellaneous  
Left front bedroom, drywall return above front window uneven

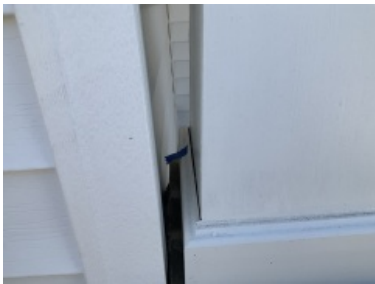
| Room | Trade | Item | Description | Points | Initials | |
|---|---|---|---|---|---|--|
| Exterior | Exterior_Appointments | 12000 - Miscellaneous | Gap between column and back side bottom trim | 0.25 | | |

Exterior  
12000 - Miscellaneous  
Gap between column and back side bottom trim

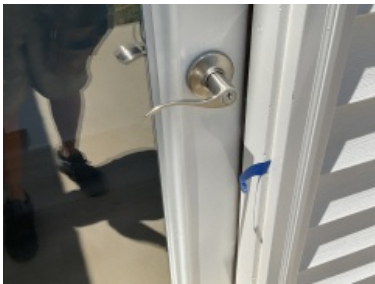
| Room | Trade | Item | Description | Points | Initials | |
|---|---|---|---|---|---|--|
| Exterior | Exterior_Trim | 20000D - Damage | Jamb at back door chipped below strike plate | 0.25 | | |

Exterior  
20000D - Damage  
Jamb at back door chipped below strike plate

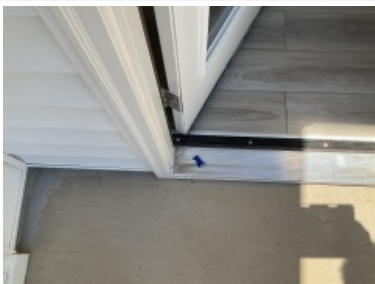
| Room | Trade | Item | Description | Points | Initials | |
|---|---|---|---|---|---|--|
| Exterior | Exterior_Trim | 20070 - Tamished Threshold | Back door threshold tarnished | 0.25 | | |

Exterior  
20070 - Tarnished Threshold  
Back door threshold tarnished

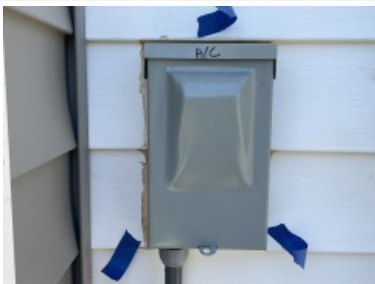
| Room | Trade | Item | Description | Points | Initials | |
|---|---|---|---|---|---|--|
| Exterior | Siding | 4000D - Damage | Siding above and on each side of service disconnect stained | 0.25 | | |

Exterior  
4000D - Damage  
Siding above and on each side of service disconnect stained

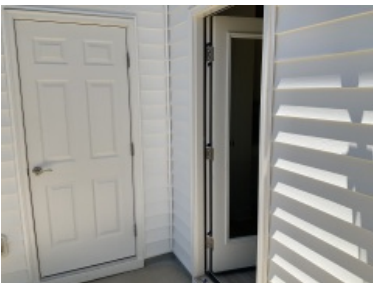
| Room | Trade | Item | Description | Points | Initials | |
|---|---|---|---|---|---|--|
| Exterior | Doors | 50000D - Damage | Paint on all hinges of back door | 0.25 | | |

Exterior  
50000D - Damage  
Paint on all hinges of back door

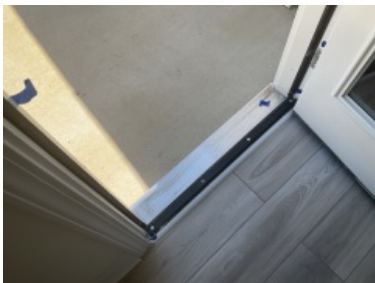
| Room | Trade | Item | Description | Points | Initials | |
|---|---|---|---|---|---|--|
| Exterior | Doors | 50007 - Exterior Doors Missing Schlaggle | Schlagel pads missing at back door | 0.25 | | |

Exterior  
50007 - Exterior Doors Missing Schlagggle  
Schlagel pads missing at back door

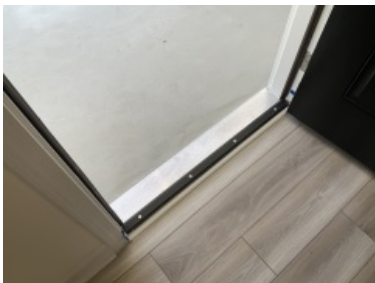
| Room | Trade | Item | Description | Points | Initials | |
|---|---|---|---|---|---|--|
| Exterior | Doors | 50007 - Exterior Doors Missing Schlaggle | Schlagel pads missing at front door | 0.25 | | |

Exterior  
50007 - Exterior Doors Missing Schlagggle  
Schlagel pads missing at front door

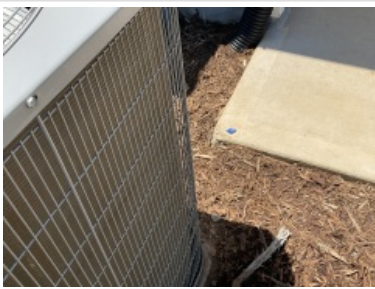
| Room | Trade | Item | Description | Points | Initials | |
|---|---|---|---|---|---|--|
| Exterior | Concrete_Flatwork | 500D - Damage | Corner of patio broken behind hvac unit | 0.25 | | |

Exterior  
500D - Damage  
Comer of patio broken behind hvac unit

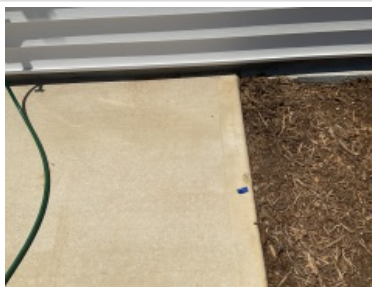
| Room | Trade | Item | Description | Points | Initials | |
|---|---|---|---|---|---|--|
| Exterior | Concrete_Flatwork | 500D - Damage | Looking at home right edge of patio chipped near back wall | 0.25 | | |

Exterior  
500D - Damage  
Looking at home right edge of patio chipped near back wall

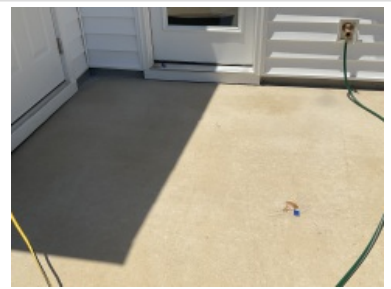
| Room | Trade | Item | Description | Points | Initials | |
|---|---|---|---|---|---|--|
| Exterior | Concrete_Flatwork | 520 - Stain | Stain on patio in middle of slab | 0.25 | | |

Exterior  
520 - Stain  
Stain on patio in middle of slab

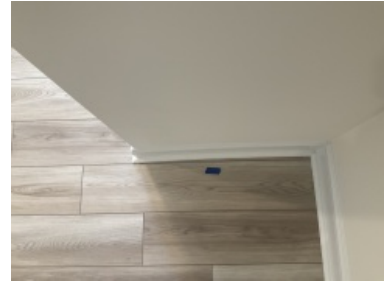
| Room | Trade | Item | Description | Points | Initials | |
|---|---|---|---|---|---|--|
| Family Room | Interior_Trim | 1560 - Out of plumb/square | Shoe mould on wall that is common with refrigerator space not square with floor | 0.25 | | |

Family Room  
1560 - Out of plumb/square  
Shoe mould on wall that is common with refrigerator space not square with floor

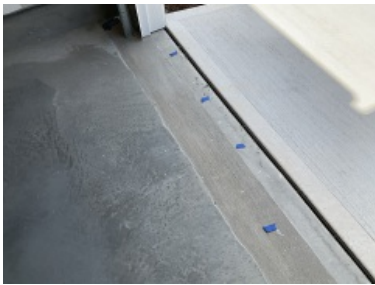
| Room | Trade | Item | Description | Points | Initials | |
|---|---|---|---|---|---|--|
| Garage | Concrete_Flatwork | 520 - Stain | Concrete splatter and paint on right side of slab at entrance | 0.25 | | |

Garage  
520 - Stain  
Concrete splatter and paint on right side of slab at entrance

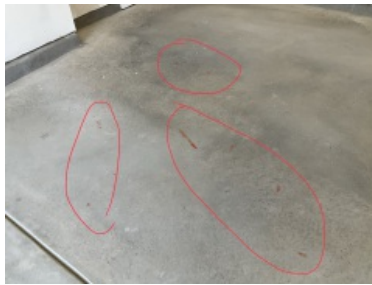
| Room | Trade | Item | Description | Points | Initials | |
|---|---|---|---|---|---|--|
| Garage | Concrete_Flatwork | 520 - Stain | Orange stains on slab in middle of rear section | 0.25 | | |

Garage  
520 - Stain  
Orange stains on slab in middle of rear section

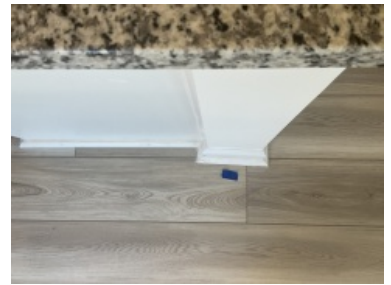
| Room | Trade | Item | Description | Points | Initials | |
|---|---|---|---|---|---|--|
| Kitchen/Dinette | Interior_Trim | 1560 - Out of plumb/square | Shoe mould on end of island near back door not square with floor | 0.25 | | |

Kitchen/Dinette  
1560 - Out of plumb/square  
Shoe mould on end of island near back door not square with floor

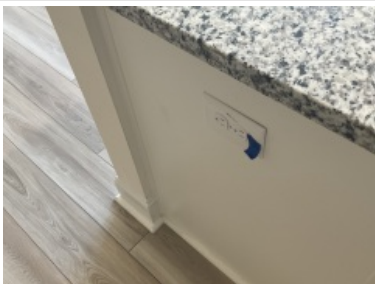
| Room | Trade | Item | Description | Points | Initials | |
|---|---|---|---|---|---|--|
| Kitchen/Dinette | Electric | 810 - Crooked Outlet/Switch | On family room end of island, gap between receptacle plate and island panel | 0.25 | | |

Kitchen/Dinette  
810 - Crooked Outlet/Switch  
On family room end of island, gap between receptacle plate and island panel

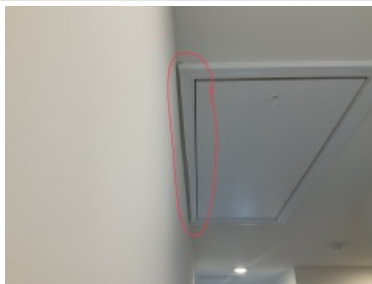
| Room | Trade | Item | Description | Points | Initials | |
|---|---|---|---|---|---|--|
| Stairs/Hall | Interior_Trim | 1520 - Miscut | Ripped trim on side of attic stairs panel is uneven in width | 0.25 | | |

Stairs/Hall  
1520 - Miscut  
Ripped trim on side of attic stairs panel is uneven in width

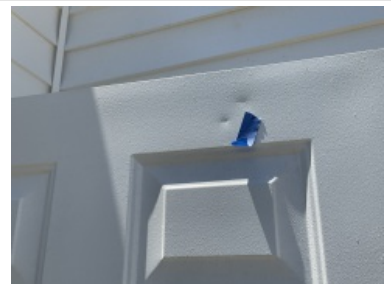
| Room | Trade | Item | Description | Points | Initials | |
|---|---|---|---|---|---|--|
| Utility Room | Doors | 50000D - Damage | Top of door dented | 0.25 | | |

Utility Room  
50000D - Damage  
Top of door dented
