New Review - Home Quality Review

| Builder | DRB Group |
|---|---|
| Community | Jaspers Landing SF (NC)(RAL) |
| Lot | 00.0040 |
| Street Address | 53 Juniper Branch Trail |

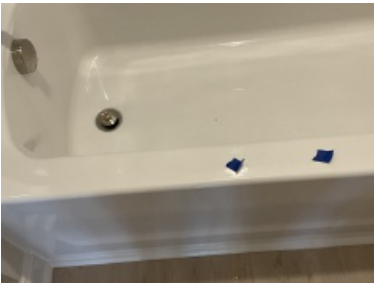
| Room | Trade | Item | Description | Points | Initials | |
|---|---|---|---|---|---|--|
| Bath - Hall | Plumbing | 700D - Damage | Top edge of tub scratched near middle | 0.25 | | |

Bath - Hall  
700D - Damage  
Top edge of tub scratched near middle

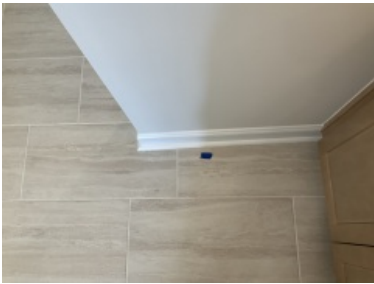
| Room | Trade | Item | Description | Points | Initials | |
|---|---|---|---|---|---|--|
| Bath - Owner's | Interior_Trim | 1560 - Out of plumb/square | Shoe mould at left side sink bowed | 0.25 | | |

Bath - Owner's  
1560 - Out of plumb/square  
Shoe mould at left side sink bowed

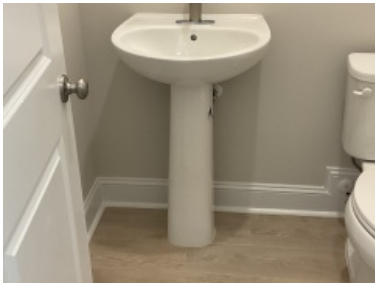
| Room | Trade | Item | Description | Points | Initials | |
|---|---|---|---|---|---|--|
| Bath - Powder | Plumbing | 721 - Pedastal Sink Water Lines Visible | Water line visible on right side of pedestal sink | 0.25 | | |

Bath - Powder  
721 - Pedestal Sink Water Lines Visible  
Water line visible on right side of pedestal sink

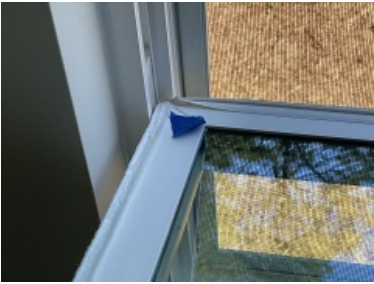
| Room | Trade | Item | Description | Points | Initials | |
|---|---|---|---|---|---|--|
| Bedroom 1 | Windows | 13000D - Damage | Left rear bedroom bottom weather strip at rear window damaged on left side | 0.25 | | |

Bedroom 1  
13000D - Damage  
Left rear bedroom bottom weather strip at rear window damaged on left side

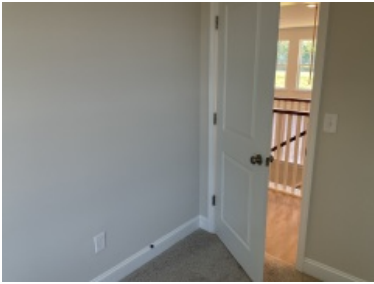
| Room | Trade | Item | Description | Points | Initials | |
|---|---|---|---|---|---|--|
| Bedroom 2 | Doors | 50005 - Missing Pieces | Left middle bedroom, door stop missing at entry door | 0.25 | | |

Bedroom 2  
50005 - Missing Pieces  
Left middle bedroom, door stop missing at entry door

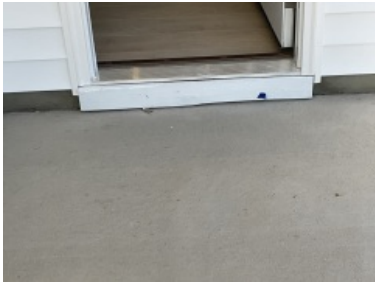
| Room | Trade | Item | Description | Points | Initials | |
|---|---|---|---|---|---|--|
| Exterior | Exterior_Trim | 20050 - Ext. Trim Miscut | Kick board under back door miscut | 0.25 | | |

Exterior  
20050 - Ext. Trim Miscut  
Kick board under back door miscut

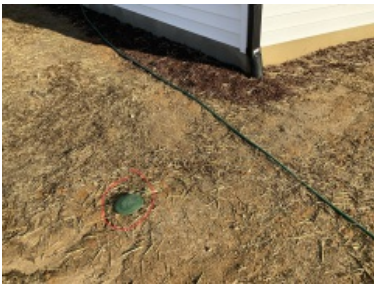
| Room | Trade | Item | Description | Points | Initials | |
|---|---|---|---|---|---|--|
| Exterior | Gutters_and_Downspout | 3000 - Miscellaneous | Discharge outlet for right rear downspout above grade | 0.25 | | |

Exterior  
3000 - Miscellaneous  
Discharge outlet for right rear downspout above grade

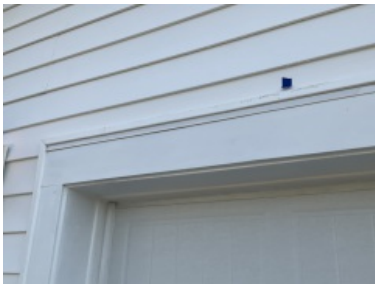
| Room | Trade | Item | Description | Points | Initials | |
|---|---|---|---|---|---|--|
| Exterior | Siding | 4000D - Damage | J channel above left side of garage door scuffed | 0.25 | | |

Exterior  
4000D - Damage  
J channel above left side of garage door scuffed

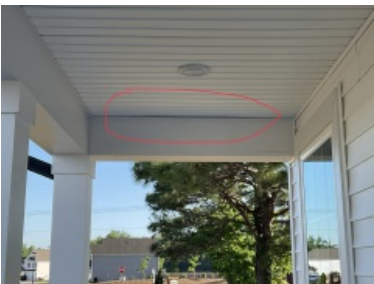
| Room | Trade | Item | Description | Points | Initials | |
|---|---|---|---|---|---|--|
| Exterior | Siding | 4030 - Soffit/Fascia Issues | Gap between left side front porch soffit and metal trim | 0.25 | | |

Exterior  
4030 - Soffit/Fascia Issues  
Gap between left side front porch soffit and metal trim

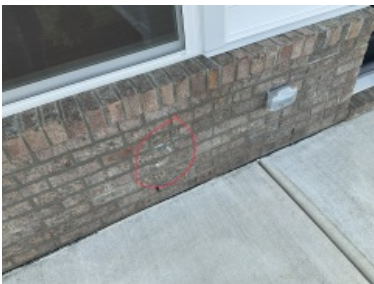
| Room | Trade | Item | Description | Points | Initials | |
|---|---|---|---|---|---|--|
| Exterior | Brick_Stone_Stucco | 5000 - Miscellaneous | Excess mortar on brick left of front porch outlet | 0.25 | | |

Exterior  
5000 - Miscellaneous  
Excess mortar on brick left of front porch outlet

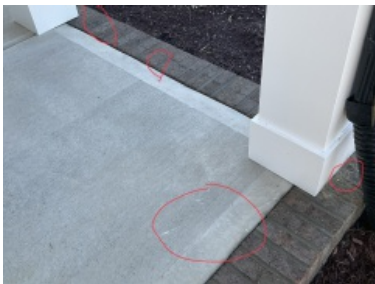
| Room | Trade | Item | Description | Points | Initials | |
|---|---|---|---|---|---|--|
| Exterior | Brick_Stone_Stucco | 5000 - Miscellaneous | Paint on brick and front porch slab in front and on left side | 0.25 | | |

Exterior  
5000 - Miscellaneous  
Paint on brick and front porch slab in front and on left side

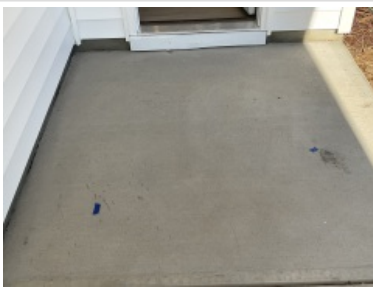
| Room | Trade | Item | Description | Points | Initials | |
|---|---|---|---|---|---|--|
| Exterior | Concrete_Flatwork | 520 - Stain | Patio stained in front of back door | 0.25 | | |

Exterior  
520 - Stain  
Patio stained in front of back door

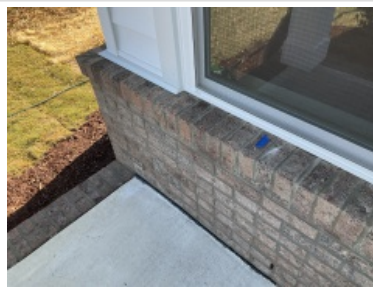
| Room | Trade | Item | Description | Points | Initials | |
|---|---|---|---|---|---|--|
| Exterior | Cleaning | TIC | White mark on brick at left window of front porch | 0 | | |

Exterior  
TIC  
White mark on brick at left window of front porch

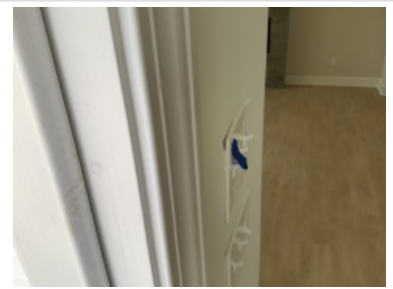
| Room | Trade | Item | Description | Points | Initials | |
|---|---|---|---|---|---|--|
| Family Room | Electric | 810 - Crooked Outlet/Switch | Gap between wall and switch plate at back door | 0.25 | | |

Family Room  
810 - Crooked Outlet/Switch  
Gap between wall and switch plate at back door

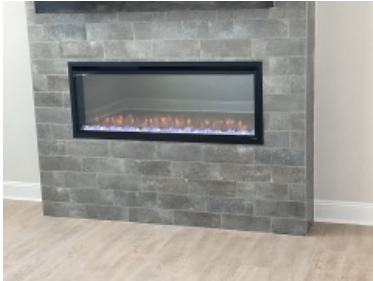
| Room | Trade | Item | Description | Points | Initials | |
|---|---|---|---|---|---|--|
| Family Room | Low_Voltage | 900 - Miscellaneous | Pulsing sound coming from fireplace | 0.25 | | |

Family Room  
900 - Miscellaneous  
Pulsing sound coming from fireplace

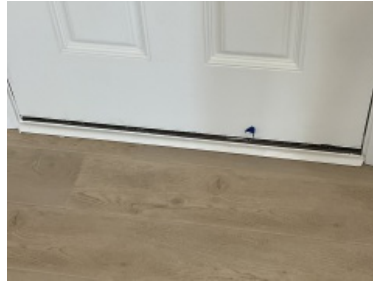
| Room | Trade | Item | Description | Points | Initials | |
|---|---|---|---|---|---|--|
| Foyer | Cleaning | TIC | Paint on bottom weather strip at front door | 0 | | |

Foyer  
TIC  
Paint on bottom weather strip at front door

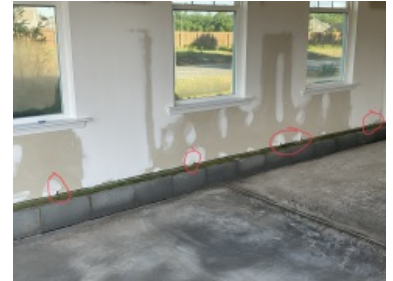
| Room | Trade | Item | Description | Points | Initials | |
|---|---|---|---|---|---|--|
| Garage | Framing | 1000 - Miscellaneous | Anchor bolts exposed on front wall | 0.25 | | |

Garage  
1000 - Miscellaneous  
Anchor bolts exposed on front wall

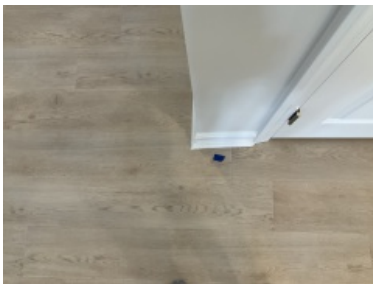
| Room | Trade | Item | Description | Points | Initials | |
|---|---|---|---|---|---|--|
| Kitchen/Dinette | Interior_Trim | 1560 - Out of plumb/square | Shoe mould left of pantry closet bowed | 0.25 | | |

Kitchen/Dinette  
1560 - Out of plumb/square  
Shoe mould left of pantry closet bowed

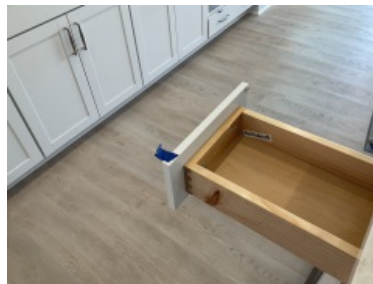
| Room | Trade | Item | Description | Points | Initials | |
|---|---|---|---|---|---|--|
| Kitchen/Dinette | Cabinets | 1620 - Missing Bumps | Bump missing at drawer right of dishwasher | 0.25 | | |

Kitchen/Dinette  
1620 - Missing Bumps  
Bump missing at drawer right of dishwasher

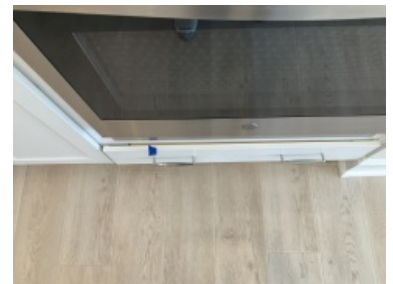
| Room | Trade | Item | Description | Points | Initials | |
|---|---|---|---|---|---|--|
| Kitchen/Dinette | Cabinets | 1630 - Drawer/Door Issue | Drawer under oven not self closing tight to frame on left side | 0.25 | | |

Kitchen/Dinette  
1630 - Drawer/Door Issue  
Drawer under oven not self closing tight to frame on left side

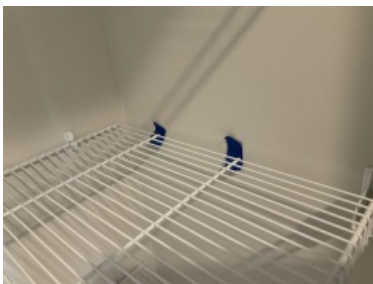
| Room | Trade | Item | Description | Points | Initials | |
|---|---|---|---|---|---|--|
| Kitchen/Dinette | Closet_Shelving | 17005- Missing Pieces | In pantry closet, caps missing on right side of 2nd shelf from top | 0.25 | | |

Kitchen/Dinette  
17005- Missing Pieces  
In pantry closet, caps missing on right side of 2nd shelf from top

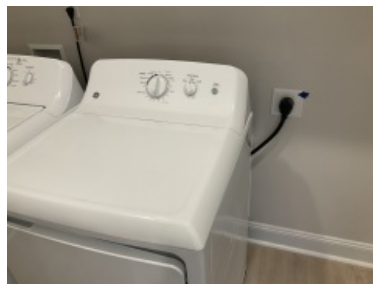
| Room | Trade | Item | Description | Points | Initials | |
|---|---|---|---|---|---|--|
| Laundry Room | Electric | 850 - Improper Switch/Outlet Location | Outlet for dryer not behind appliance | 0.25 | | |

Laundry Room  
850 - Improper Switch/Outlet Location  
Outlet for dryer not behind appliance

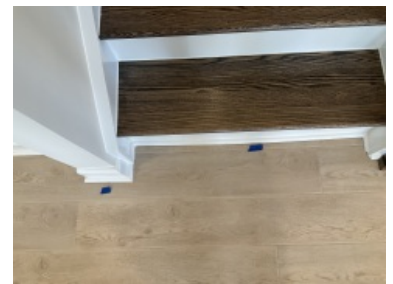
| Room | Trade | Item | Description | Points | Initials | |
|---|---|---|---|---|---|--|
| Stairs/Hall | Interior_Trim | 1560 - Out of plumb/square | Shoe mould on left side wall and shoe mould at bottom step not square with floor | 0.25 | | |

Stairs/Hall  
1560 - Out of plumb/square  
Shoe mould on left side wall and shoe mould at bottom step not square with floor

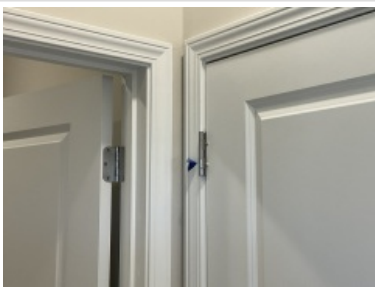
| Room | Trade | Item | Description | Points | Initials | |
|---|---|---|---|---|---|--|
| Stairs/Hall | Doors | 50005 - Missing Pieces | Hinge bump missing at garage door | 0.25 | | |

Stairs/Hall  
50005 - Missing Pieces  
Hinge bump missing at garage door

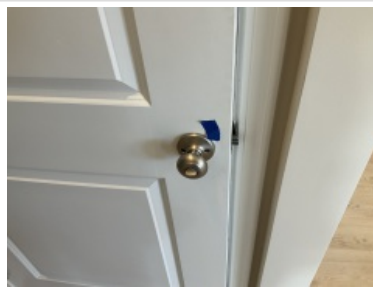
| Room | Trade | Item | Description | Points | Initials | |
|---|---|---|---|---|---|--|
| Stairs/Hall | Doors | 50040 - Door Rubs | Garage door rubs jamb at strike plate | 0.25 | | |

Stairs/Hall  
50040 - Door Rubs  
Garage door rubs jamb at strike plate

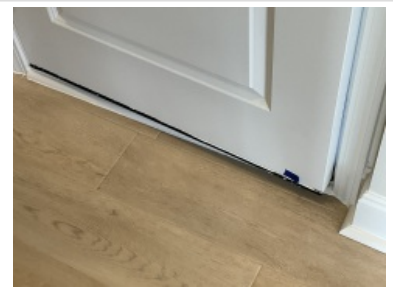
| Room | Trade | Item | Description | Points | Initials | |
|---|---|---|---|---|---|--|
| Stairs/Hall | Cleaning | TIC | Paint on bottom weather strip at garage door | 0 | | |

Stairs/Hall  
TIC  
Paint on bottom weather strip at garage door
