| Builder | DRB Group |
| Community | Kensley Grove TH (NC)(RAL) |
| Street Address | 959 Kensley Grove Ln |
| Type | New Review |

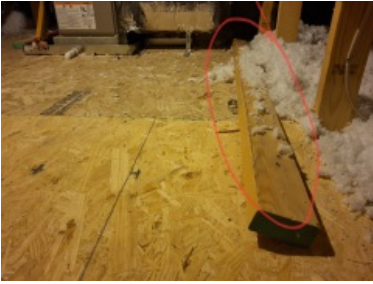
| Room | Trade | Item | Description | Points | Initials | |
|---|---|---|---|---|---|--|
| Attic | Cleaning | 1910 - Construction Items Left Behind | on attic platform, left behind 2X4 | 0.25 | | |

Attic  
1910 - Construction Items Left Behind  
on attic platform, left behind 2X4

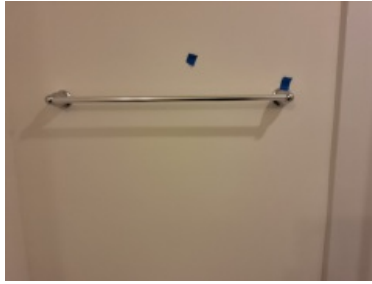
| Room | Trade | Item | Description | Points | Initials | |
|---|---|---|---|---|---|--|
| Bath - Hall | Bath_Accessories | 18020 - Towel Bar Loose | at right wall connection, towel bar loose | 0.25 | | |

Bath - Hall  
18020 - Towel Bar Loose  
at right wall connection, towel bar loose

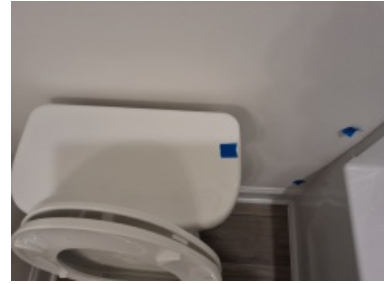
| Room | Trade | Item | Description | Points | Initials | |
|---|---|---|---|---|---|--|
| Bath - Hall | Plumbing | 700D - Damage | top of toilet tank cover porcelain is scuffed | 0.25 | | |

Bath - Hall  
700D - Damage  
top of toilet tank cover porcelain is scuffed

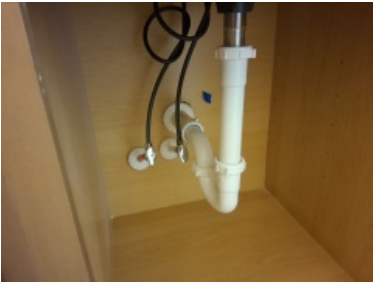
| Room | Trade | Item | Description | Points | Initials | |
|---|---|---|---|---|---|--|
| Bath - Owner's | Cabinets | 1670 - Overcut Hole for Pipes | at right vanity, overcut for drain line | 0.25 | | |

Bath - Owner's  
1670 - Overcut Hole for Pipes  
at right vanity, overcut for drain line

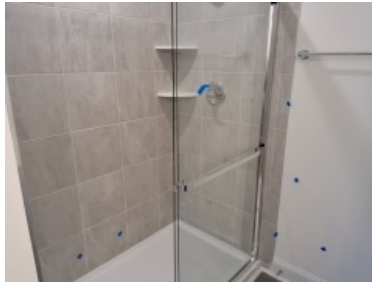
| Room | Trade | Item | Description | Points | Initials | |
|---|---|---|---|---|---|--|
| Bath - Owner's | Bath_Accessories | 18060 - Shower Enclosure Not Operating Properly | exterior door-with horizontal handle- is hard to operate in track | 0.25 | | |

Bath - Owner's  
18060 - Shower Enclosure Not Operating Properly  
exterior door- with horizontal handle- is hard to operate  
in track

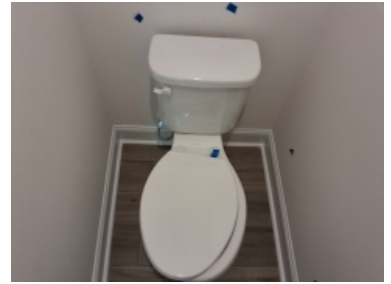
| Room | Trade | Item | Description | Points | Initials | |
|---|---|---|---|---|---|--|
| Bath - Owner's | Plumbing | 701 - Fixture Improperly Installed (ex: not square) | in water closet, toilet seat is not secured | 0.25 | | |

Bath - Owner's  
701 - Fixture Improperly Installed (ex: not square)  
in water closet, toilet seat is not secured

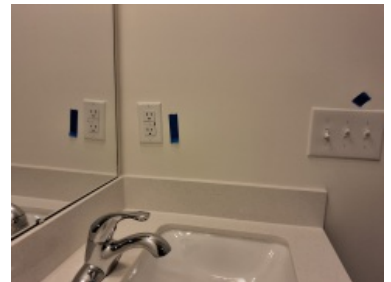
| Room | Trade | Item | Description | Points | Initials | |
|---|---|---|---|---|---|--|
| Bath - Owner's | Electric | 810 - Crooked Outlet/Switch | GFCI right of mirror is not square/ level with mirror or splash block | 0.25 | | |

Bath - Owner's  
810 - Crooked Outlet/Switch  
GFCI right of mirror is not square/ level with mirror or  
splash block

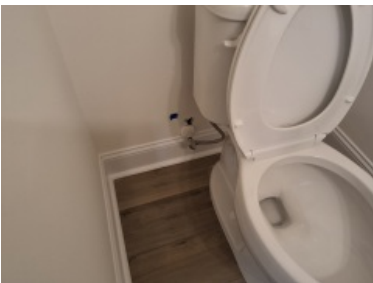
| Room | Trade | Item | Description | Points | Initials | |
|---|---|---|---|---|---|--|
| Bath - Powder | Drywall | 1400D -Damage | damage to drywall at supply line behind toilet | 0.25 | | |

Bath - Powder  
1400D - Damage  
damage to drywall at supply line behind toilet

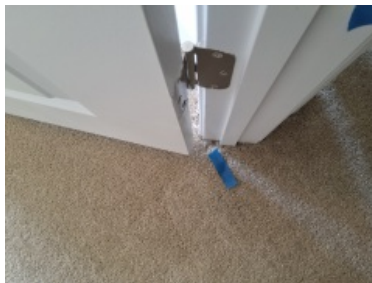
| Room | Trade | Item | Description | Points | Initials | |
|---|---|---|---|---|---|--|
| Bedroom 2 | Flooring | 1350 - Carpet Installation | front right bedroom entry, hinges side jamb, carpet comes short and visible subfloor | 0.25 | | |

Bedroom 2  
1350 - Carpet Installation  
front right bedroom entry, hinges side jamb, carpet comes  
short and visible subfloor

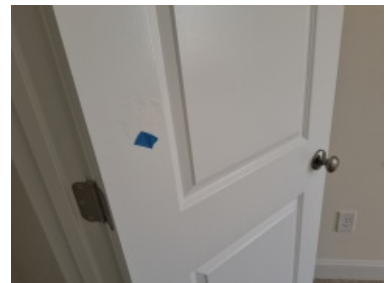
| Room | Trade | Item | Description | Points | Initials | |
|---|---|---|---|---|---|--|
| Bedroom 2 | Doors | 50000D - Damage | front right bedroom, closet door damaged and repair effort made which is noticeable at top panel, interior hinge side | 0.25 | | |

Bedroom 2  
50000D - Damage  
front right bedroom, closet door damaged and repair  
effort made which is noticeable at top panel, interior  
hinge side

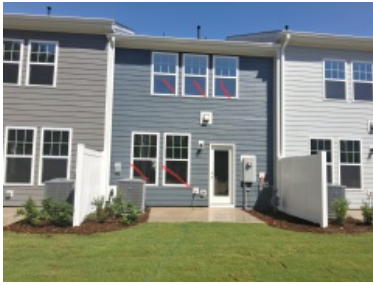
| Room | Trade | Item | Description | Points | Initials | |
|---|---|---|---|---|---|--|
| Exterior | Windows | 13005 - Missing Pieces | whole home is missing screen install- is the only unit in whole building with no screens- not consistent for neighborhood | 0.25 | | |

Exterior  
13005 - Missing Pieces  
whole home is missing screen install- is the only unit in whole building with no screens- not consistent for neighborhood

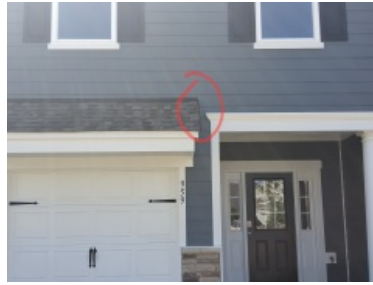
| Room | Trade | Item | Description | Points | Initials | |
|---|---|---|---|---|---|--|
| Exterior | Roofing | 2000 - Miscellaneous | at garage detail roof, shingles at right side come short of starter strip | 0.25 | | |

Exterior  
2000 - Miscellaneous  
at garage detail roof, shingles at right side come short of starter strip

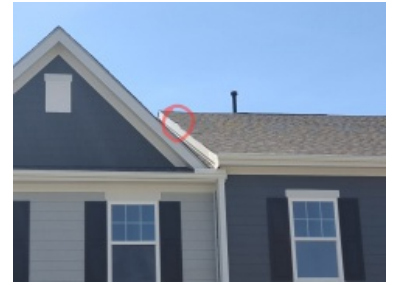
| Room | Trade | Item | Description | Points | Initials | |
|---|---|---|---|---|---|--|
| Exterior | Roofing | 2000 - Miscellaneous | left side of home, upper gable, raised shingles at overhang | 0.25 | | |

Exterior  
2000 - Miscellaneous  
left side of home, upper gable, raised shingles at overhang

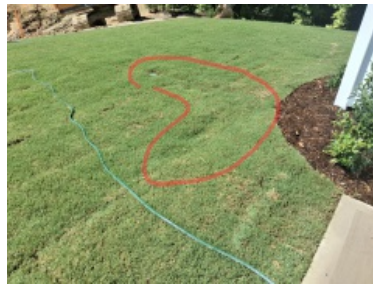
| Room | Trade | Item | Description | Points | Initials | |
|---|---|---|---|---|---|--|
| Exterior | Landscaping | 300 - Miscellaneous | at rear, negative grade/ sinkage mid yard just off the nose of rear patio | 0.25 | | |

Exterior  
300 - Miscellaneous  
at rear, negative grade/ sinkage mid yard just off the nose of rear patio

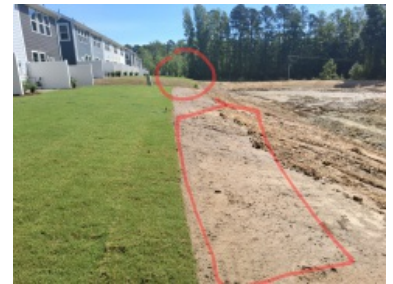
| Room | Trade | Item | Description | Points | Initials | |
|---|---|---|---|---|---|--|
| Exterior | Landscaping | 300 - Miscellaneous | whole back of unit building, sod is not terminated where neighboring units have termination of sod | 0.25 | | |

Exterior  
300 - Miscellaneous  
whole back of unit building, sod is not terminated where neighboring units have termination of sod

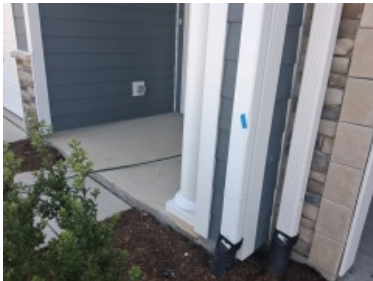
| Room | Trade | Item | Description | Points | Initials | |
|---|---|---|---|---|---|--|
| Exterior | Gutters_and_Downspout | 3000D - Damage | right of front porch, gutter is damaged near bottom 3 ft | 0.25 | | |

Exterior  
3000D - Damage  
right of front porch, gutter is damaged near bottom 3 ft

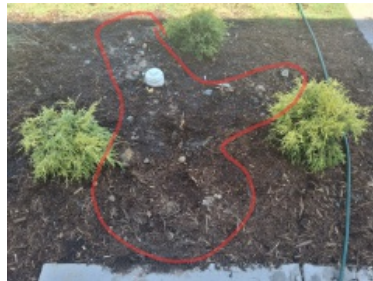
| Room | Trade | Item | Description | Points | Initials | |
|---|---|---|---|---|---|--|
| Exterior | Landscaping | 300D - Damage | front mulch disturbed at flower bed with cleanout | 0.25 | | |

Exterior  
300D - Damage  
front mulch disturbed at flower bed with cleanout

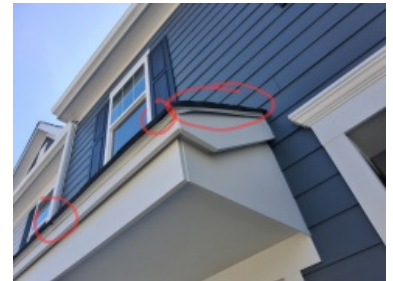
| Room | Trade | Item | Description | Points | Initials | |
|---|---|---|---|---|---|--|
| Exterior | Siding | 4000D - Damage | at front, lower roof, the drip edge on front and right of garage roof detail has poor joints and is dented/ bent | 0.25 | | |

Exterior  
4000D - Damage  
at front, lower roof, the drip edge on front and right of garage roof detail has poor joints and is dented/ bent

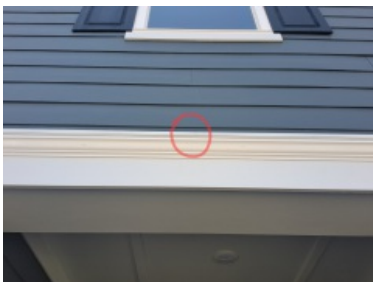
| Room | Trade | Item | Description | Points | Initials | |
|---|---|---|---|---|---|--|
| Exterior | Siding | 4000D - Damage | over front porch portal, flashing mid run of header is damaged | 0.25 | | |

Exterior  
4000D - Damage  
over front porch portal, flashing mid run of header is damaged

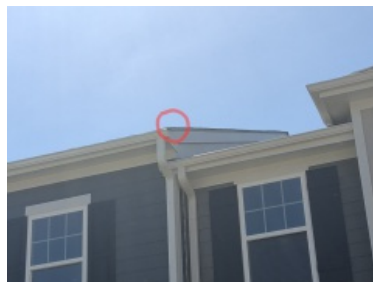
| Room | Trade | Item | Description | Points | Initials | |
|---|---|---|---|---|---|--|
| Exterior | Siding | 4040 - Drip Edge | at front of home, top gable drip edge right side is bent out of placement at gutter junction | 0.25 | | |

Exterior  
4040 - Drip Edge  
at front of home, top gable drip edge right side is bent out of placement at gutter junction

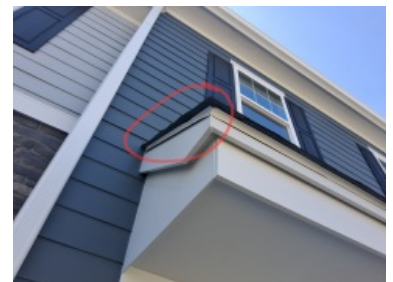
| Room | Trade | Item | Description | Points | Initials | |
|---|---|---|---|---|---|--|
| Exterior | Siding | 4040 - Drip Edge | left side of garge roof detail drip edge is bent and has poor joint at front corner | 0.25 | | |

Exterior  
4040 - Drip Edge  
left side of garge roof detail drip edge is bent and has poor joint at front corner

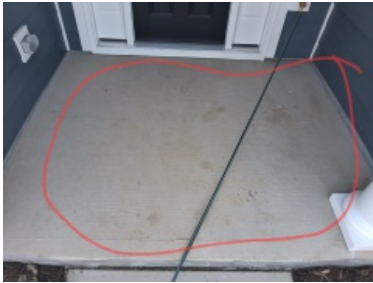
| Room | Trade | Item | Description | Points | Initials | |
|---|---|---|---|---|---|--|
| Exterior | Concrete_Flatwork | 520 - Stain | front porch of home has staining present- foot prints, mud, other materials | 0.25 | | |

Exterior  
520 - Stain  
front porch of home has staining present- foot prints, mud, other materials

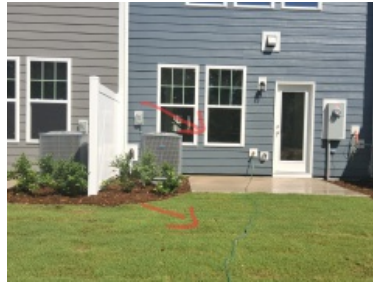
| Room | Trade | Item | Description | Points | Initials | |
|---|---|---|---|---|---|--|
| Exterior | HVAC | 600 - Miscellaneous | at rear, condenser unit lot level | 0.25 | | |

Exterior  
600 - Miscellaneous  
at rear, condenser unit lot level

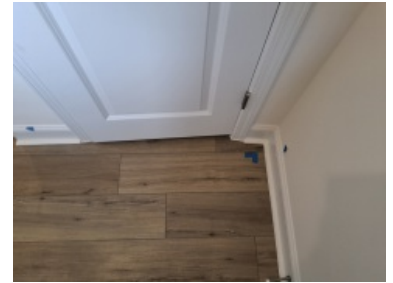
| Room | Trade | Item | Description | Points | Initials | |
|---|---|---|---|---|---|--|
| Foyer | Interior_Trim | 1560 - Out of plumb/square | at foyer coat closet, short wall, right side, trim and wall noticeably not square with flooring | 0.25 | | |

Foyer  
1560 - Out of plumb/square  
at foyer coat closet, short wall, right side, trim and wall noticeably not square with flooring

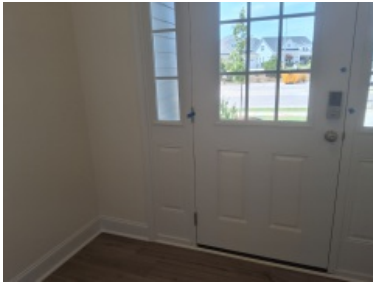
| Room | Trade | Item | Description | Points | Initials | |
|---|---|---|---|---|---|--|
| Foyer | Doors | 50010 - Hinge Screw/Pin Issues | at front door, noisy hinges | 0.25 | | |

Foyer  
50010 - Hinge Screw/Pin Issues  
at front door, noisy hinges

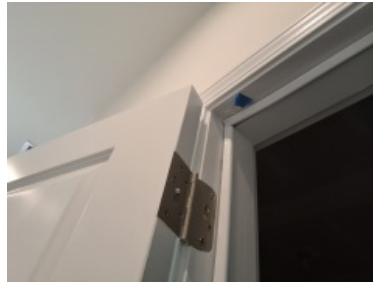
| Garage | Interior_Trim | 1510 - Not Pieced Together Well | at entry from garage, casing nails in top corner hinge side of door | 0.25 | | |

Garage  
1510 - Not Pieced Together Well  
at entry from garage, casing nails in top corner hinge side of door

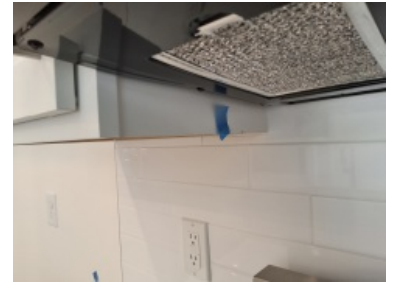
| Kitchen/Dinette | Cabinets | 1600D - Damage | left side of microwave, cabinet box is damaged | 0.25 | | |

Kitchen/Dinette  
1600D - Damage  
left side of microwave, cabinet box is damaged

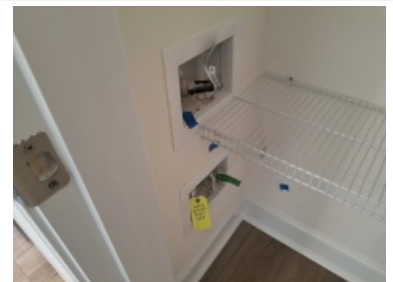
| Kitchen/Dinette | Cleaning | 1920 - Trash and Debris | inside pantry closet, both plumbing boxes are not clean | 0.25 | | |

Kitchen/Dinette  
1920 - Trash and Debris  
inside pantry closet, both plumbing boxes are not clean

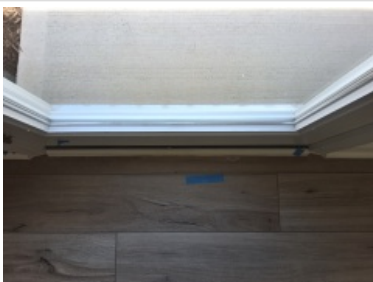
| Kitchen/Dinette | Doors | 50030 - Daylight Through Exterior Door Edge | at rear entry to home, water from sprinklers got into home under door sweep | 0.25 | | |

Kitchen/Dinette  
50030 - Daylight Through Exterior Door Edge  
at rear entry to home, water from sprinklers got into home under door sweep

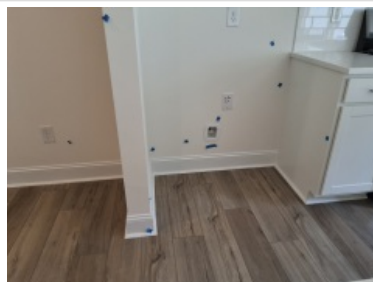
| Kitchen/Dinette | Plumbing | 701 - Fixture Improperly Installed (ex: not square) | fridge line trim box not square with base board/ crooked | 0.25 | | |

Kitchen/Dinette  
701 - Fixture Improperly Installed (ex: not square)  
fridge line trim box not square with base board/ crooked

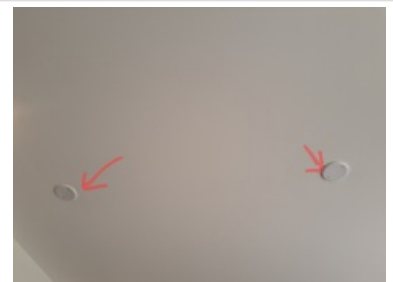
| Kitchen/Dinette | Electric | 855 - Other Installation Issue | prewire caps have differing screws each cap | 0.25 | | |

Kitchen/Dinette  
855 - Other Installation Issue  
prewire caps have differing screws each cap

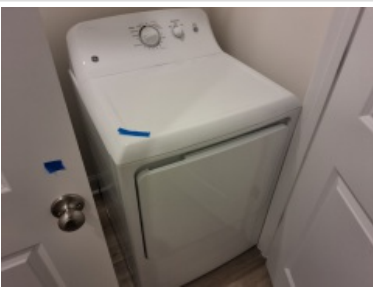
| Laundry Room | Appliances | 1830 - Installed Incorrectly | dryer is not leveled- rocks when operating | 0.25 | | |

Laundry Room  
1830 - Installed Incorrectly  
dryer is not leveled- rocks when operating

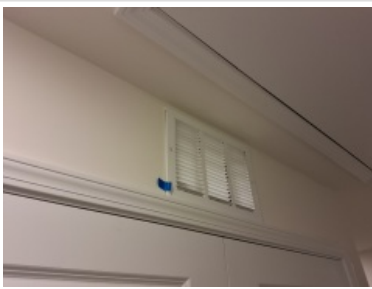
| Laundry Room | HVAC | 660 - Ragged Drywall Visible Through Grate | visible drywall in transfer grill over doors | 0.25 | | |

Laundry Room  
660 - Ragged Drywall Visible Through Grate  
visible drywall in transfer grill over doors

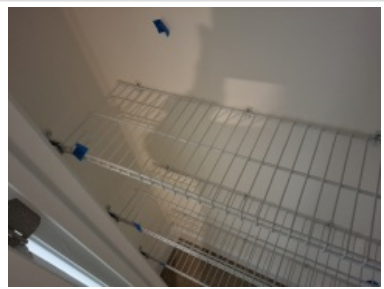
| Stairs/Hall | Closet_Shelving | 17010 - Installation | linen closet in hall by front bedrooms, all shelves cut short- not full weight bearing of 1 | 0.25 | | |

Stairs/Hall  
17010 - Installation  
linen closet in hall by front bedrooms, all shelves cut  
short- not full weight bearing of 1

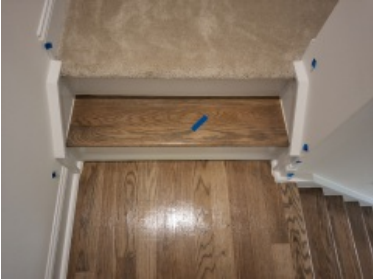
| Stairs/Hall | Stairs_and_Rails | 21000 - Miscellaneous | at second floor landing, the single step to second floor has a negative slope in towards riser | 0.25 | | |

Stairs/Hall  
21000 - Miscellaneous  
at second floor landing, the single step to second floor  
has a negative slope in towards riser
