New Review - Home Quality Review

| Builder | DRB Group |
|---|---|
| Community | Kensley Grove TH (NC)(RAL) |
| Lot | 00.0053 |
| Street Address | 950 Kensley Grove Ln |

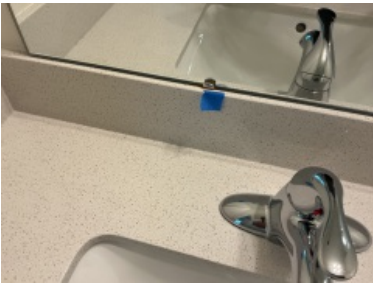
| Room | Trade | Item | Description | Points | Initials | |
|---|---|---|---|---|---|--|
| Bath - Hall | Bath_Accessories | 18050D - Damage | Hall bath mirror bracket is rusty, bottom left of mirror | 0.25 | | |

Bath - Hall  
18050D - Damage  
Hall bath mirror bracket is rusty, bottom left of mirror

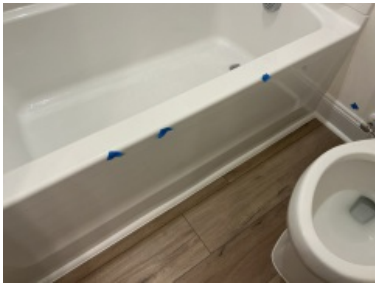
| Room | Trade | Item | Description | Points | Initials | |
|---|---|---|---|---|---|--|
| Bath - Hall | Plumbing | 700D - Damage | Front edge of hall bath tub is scratched | 0.25 | | |

Bath - Hall  
700D - Damage  
Front edge of hall bath tub is scratched

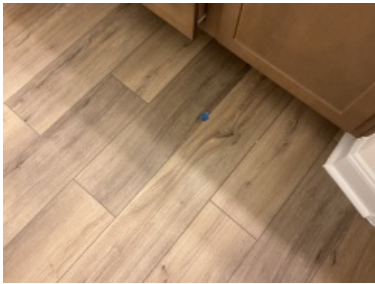
| Room | Trade | Item | Description | Points | Initials | |
|---|---|---|---|---|---|--|
| Bath - Owner's | Flooring | 1300D - Damage | Scratch on flooring front of master vanity cabinet | 0.25 | | |

Bath - Owner's  
1300D - Damage  
Scratch on flooring front of master vanity cabinet

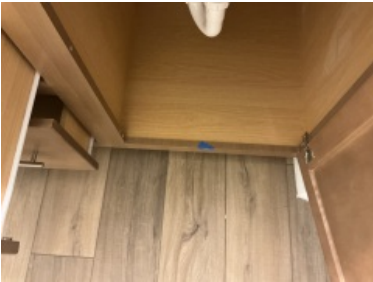
| Room | Trade | Item | Description | Points | Initials | |
|---|---|---|---|---|---|--|
| Bath - Owner's | Cabinets | 1600D - Damage | Chip in master bath vanity cabinet, front edge right side | 0.25 | | |

Bath - Owner's  
1600D - Damage  
Chip in master bath vanity cabinet, front edge right side

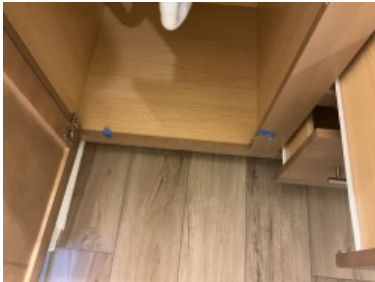
| Room | Trade | Item | Description | Points | Initials | |
|---|---|---|---|---|---|--|
| Bath - Owner's | Cabinets | 1600D - Damage | Master bath vanity cabinet is chipped, front edge, left side | 0.25 | | |

Bath - Owner's  
1600D - Damage  
Master bath vanity cabinet is chipped, front edge, left side

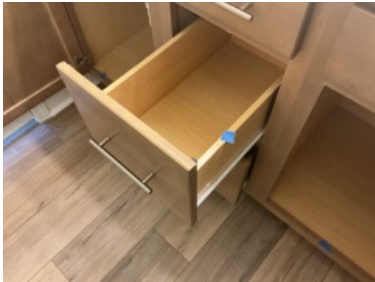
| Room | Trade | Item | Description | Points | Initials | |
|---|---|---|---|---|---|--|
| Bath - Owner's | Cabinets | 1600D - Damage | Right rail of middle drawer is chipped, master vanity cabinet | 0.25 | | |

Bath - Owner's  
1600D - Damage  
Right rail of middle drawer is chipped, master vanity cabinet

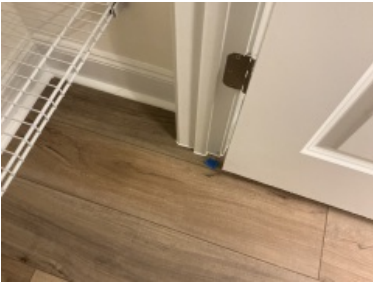
| Room | Trade | Item | Description | Points | Initials | |
|---|---|---|---|---|---|--|
| Bath - Owner's | Doors | 50000D - Damage | Bottom right of master bath linen closet door jamb is chipped | 0.25 | | |

Bath - Owner's  
50000D - Damage  
Bottom right of master bath linen closet door jamb is chipped

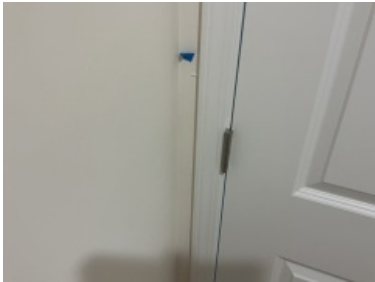
| Room | Trade | Item | Description | Points | Initials | |
|---|---|---|---|---|---|--|
| Bedroom - Owner's | Interior_Trim | 1500D - Damage | Master bedroom closet door has nail protruding out, left middle side, closet side | 0.25 | | |

Bedroom - Owner's  
1500D - Damage  
Master bedroom closet door has nail protruding out, left middle side, closet side

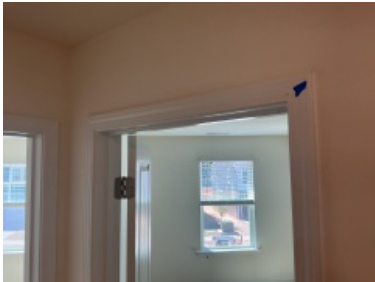
| Room | Trade | Item | Description | Points | Initials | |
|---|---|---|---|---|---|--|
| Bedroom 2 | Interior_Trim | 1500D - Damage | Top right of front left bedroom door casing is chipped, hallway side | 0.25 | | |

Bedroom 2  
1500D - Damage  
Top right of front left bedroom door casing is chipped, hallway side

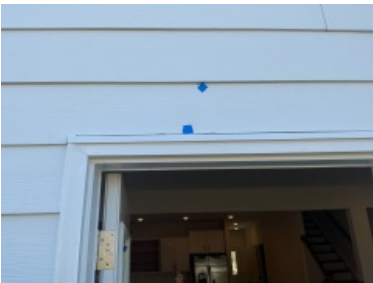
| Room | Trade | Item | Description | Points | Initials | |
|---|---|---|---|---|---|--|
| Exterior | Siding | 4000D - Damage | Siding miscut, wavy line above back entry door and screw hole visible | 0.25 | | |

Exterior  
4000D - Damage  
Siding miscut, wavy line above back entry door and screw hole visible

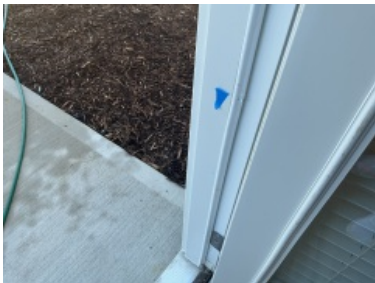
| Room | Trade | Item | Description | Points | Initials | |
|---|---|---|---|---|---|--|
| Exterior | Doors | 50020 - Weather Stripping Torn | Weatherstripping is torn, bottom middle of back entry door, hinge side | 0.25 | | |

Exterior  
50020 - Weather Stripping Torn  
Weatherstripping is torn, bottom middle of back entry door, hinge side

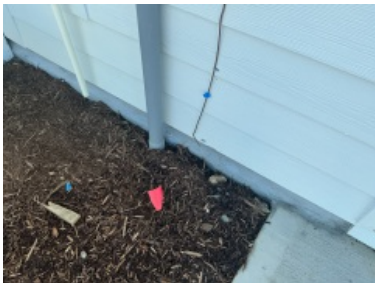
| Room | Trade | Item | Description | Points | Initials | |
|---|---|---|---|---|---|--|
| Exterior | Electric | 855 - Other Installation Issue | Grounding wire anchor not engaged, at back meter base | 0.25 | | |

Exterior  
855 - Other Installation Issue  
Grounding wire anchor not engaged, at back meter base

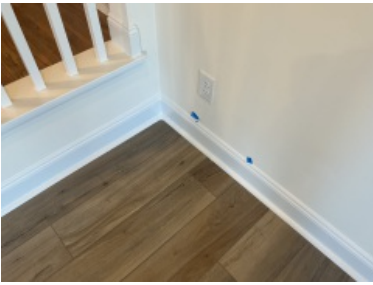
| Room | Trade | Item | Description | Points | Initials | |
|---|---|---|---|---|---|--|
| Family Room | Interior_Trim | 1500D - Damage | Baseboard damaged, family room, right of stair landing | 0.25 | | |

Family Room  
1500D - Damage  
Baseboard damaged, family room, right of stair landing

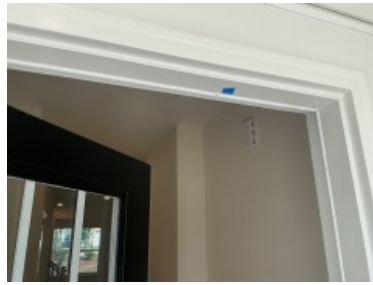
| Room | Trade | Item | Description | Points | Initials | |
|---|---|---|---|---|---|--|
| Foyer | Doors | 50020 - Weather Stripping Torn | Weatherstripping torn, top center of front entry door | 0.25 | | |

Foyer  
50020 - Weather Stripping Torn  
Weatherstripping torn, top center of front entry door

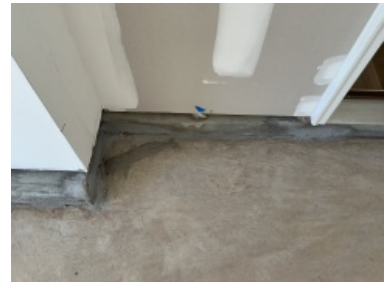
| Room | Trade | Item | Description | Points | Initials | |
|---|---|---|---|---|---|--|
| Garage | Foundation | 420 - Exposed Ties/Clips | Sill foam visible garage wall, right side | 0.25 | | |

Garage  
420 - Exposed Ties/Clips  
Sill foam visible garage wall, right side

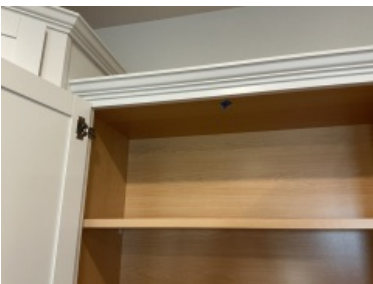
| Room | Trade | Item | Description | Points | Initials | |
|---|---|---|---|---|---|--|
| Kitchen/Dinette | Cabinets | 1600D - Damage | Upper cabinet right of corner cabinet is damaged, top front edge | 0.25 | | |

Kitchen/Dinette  
1600D - Damage  
Upper cabinet right of corner cabinet is damaged, top front edge

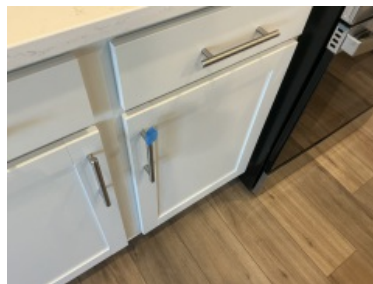
| Room | Trade | Item | Description | Points | Initials | |
|---|---|---|---|---|---|--|
| Kitchen/Dinette | Cabinets | 1640 - Knob Installation | Lower cabinet left of range, handle is loose | 0.25 | | |

Kitchen/Dinette  
1640 - Knob Installation  
Lower cabinet left of range, handle is loose

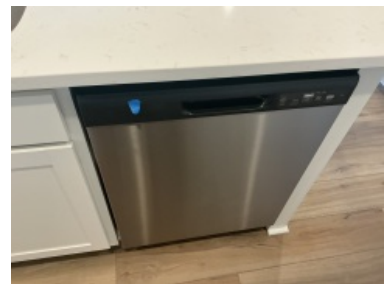
| Room | Trade | Item | Description | Points | Initials | |
|---|---|---|---|---|---|--|
| Kitchen/Dinette | Plumbing | 790 - Minor Leak | Dishwasher leaks | 0.25 | | |

Kitchen/Dinette  
790 - Minor Leak  
Dishwasher leaks

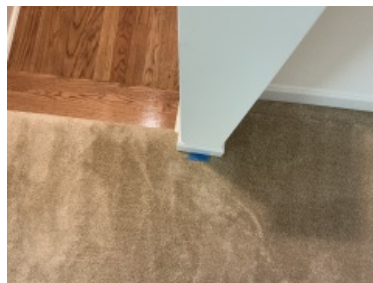
| Room | Trade | Item | Description | Points | Initials | |
|---|---|---|---|---|---|--|
| Stairs/Hall | Interior_Trim | 1560 - Out of plumb/square | Baseboard out of square, front edge of stair kneewall, top of stairs | 0.25 | | |

Stairs/Hall  
1560 - Out of plumb/square  
Baseboard out of square, front edge of stair kneewall, top of stairs
