| Builder | DRB Group |
| Community | Mason Glenn SF (NC)(RAL) |
| Street Address | 101 Millview Way |
| Type | New Review |

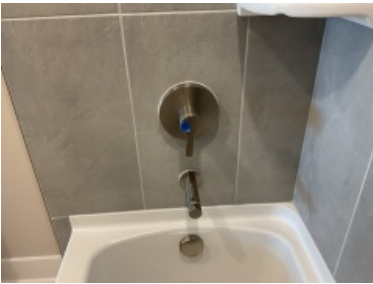
| Room | Trade | Item | Description | Points | Initials | |
|---|---|---|---|---|---|--|
| Bath - Hall | Plumbing | 701 - Fixture Improperly Installed | Shower handle knot square to spout when turned off | 0.25 | | |

Bath - Hall  
701 - Fixture Improperly Installed  
Shower handle knot square to spout when turned off

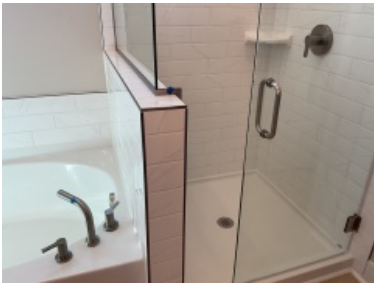
| Room | Trade | Item | Description | Points | Initials | |
|---|---|---|---|---|---|--|
| Bath - Owner's | Plumbing | 761 - Missing Pieces | Shower enclosure missing glass panel left of shower door | 0.25 | | |

Bath - Owner's  
761 - Missing Pieces  
Shower enclosure missing glass panel left of shower door

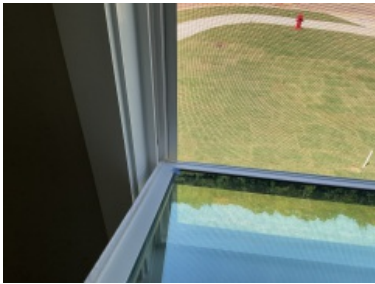
| Room | Trade | Item | Description | Points | Initials | |
|---|---|---|---|---|---|--|
| Bedroom 1 | Windows | 13000D - Damage | Damaged vinyl trim on exterior of lower sash at bottom left corner of left window in the middle left bedroom | 0.25 | | |

Bedroom 1  
13000D - Damage  
Damaged vinyl trim on exterior of lower sash at bottom left corner of left window in the middle left bedroom

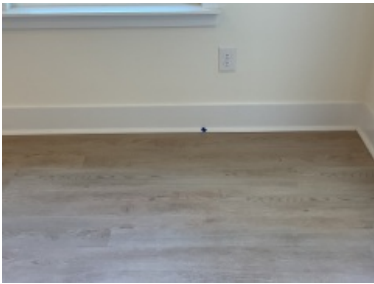
| Room | Trade | Item | Description | Points | Initials | |
|---|---|---|---|---|---|--|
| Dining Room | Interior_Trim | 1500 - Miscellaneous | Gap between floor and shoe mold on left wall under the right window near the single slab patio door | 0.25 | | |

Dining Room  
1500 - Miscellaneous  
Gap between floor and shoe mold on left wall under the right window near the single slab patio door

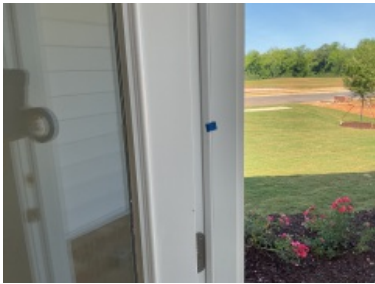
| Room | Trade | Item | Description | Points | Initials | |
|---|---|---|---|---|---|--|
| Dining Room | Doors | 50020 - Weather Stripping Torn | Weatherstripping is torn on the hinge side of patio door slab above middle hinge | 0.25 | | |

Dining Room  
50020 - Weather Stripping Torn  
Weatherstripping is torn on the hinge side of patio door slab above middle hinge

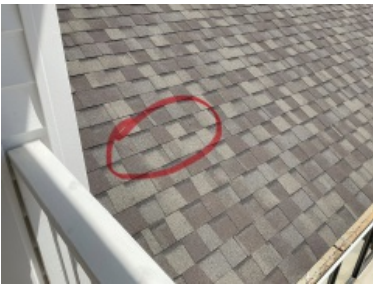
| Room | Trade | Item | Description | Points | Initials | |
|---|---|---|---|---|---|--|
| Exterior | Cleaning | 1920 - Trash and Debris | Debris on roof over garage, next to second story deck on front of home | 0.25 | | |

Exterior  
1920 - Trash and Debris  
Debris on roof over garage, next to second story deck on front of home

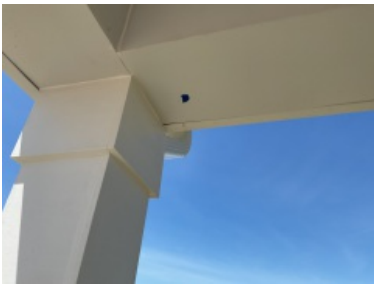
| Room | Trade | Item | Description | Points | Initials | |
|---|---|---|---|---|---|--|
| Exterior | Siding | 4000 - Miscellaneous | Gap between metal wrap and beam above left column on second story deck | 0.25 | | |

Exterior  
4000 - Miscellaneous  
Gap between metal wrap and beam above left column on second story deck

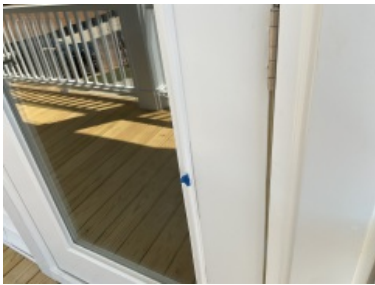
| Room | Trade | Item | Description | Points | Initials | |
|---|---|---|---|---|---|--|
| Exterior | Doors | 50005 - Missing Pieces | Exterior trim around glass on second story deck door is partially caulked to door | 0.25 | | |

Exterior  
50005 - Missing Pieces  
Exterior trim around glass on second story deck door is partially caulked to door

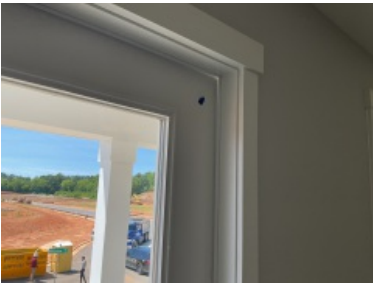
| Room | Trade | Item | Description | Points | Initials | |
|---|---|---|---|---|---|--|
| Exterior | Doors | 50030 - Daylight Through Exterior Door Edge | Daylight comes through second story patio door at the top corner over the strike plate | 0.25 | | |

Exterior  
50030 - Daylight Through Exterior Door Edge  
Daylight comes through second story patio door at the top corner over the strike plate

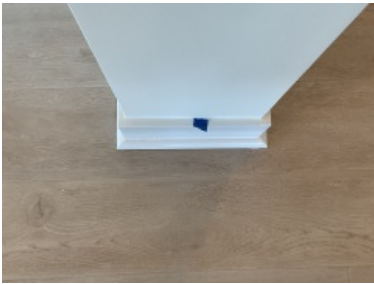
| Room | Trade | Item | Description | Points | Initials | |
|---|---|---|---|---|---|--|
| Family Room | Framing | 1030 - Out of Square/Level | Small wall left of entry to primary bedroom is not square | 0.25 | | |

Family Room  
1030 - Out of Square/Level  
Small wall left of entry to primary bedroom is not square

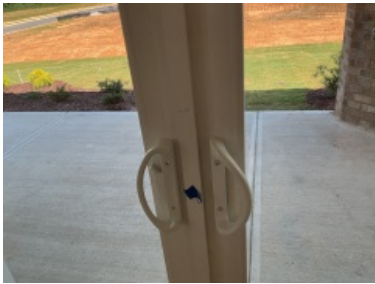
| Room | Trade | Item | Description | Points | Initials | |
|---|---|---|---|---|---|--|
| Family Room | Doors | 50000D - Damage | Center rail where sliding glass doors come together is scratched in the middle | 0.25 | | |

Family Room  
50000D - Damage  
Center rail where sliding glass doors come together is scratched in the middle

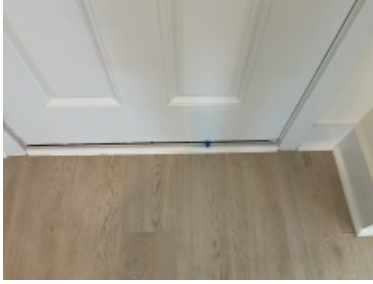
| Room | Trade | Item | Description | Points | Initials | |
|---|---|---|---|---|---|--|
| Foyer | Doors | 50000D - Damage | Interior door sweep on front door is partially painted | 0.25 | | |

Foyer  
50000D - Damage  
Interior door sweep on front door is partially painted

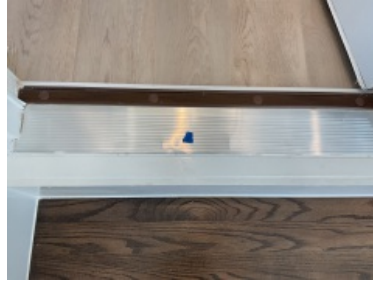
| Room | Trade | Item | Description | Points | Initials | |
|---|---|---|---|---|---|--|
| Garage | Exterior_Trim | 20000D - Damage | Threshold to home entry is dented | 0.25 | | |

Garage  
20000D - Damage  
Threshold to home entry is dented

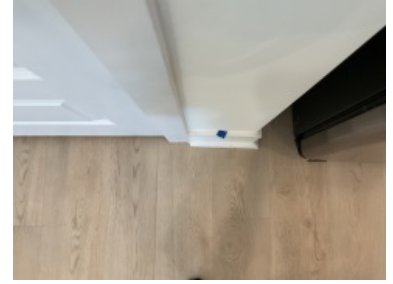
| Room | Trade | Item | Description | Points | Initials | |
|---|---|---|---|---|---|--|
| Kitchen/Dinette | Framing | 1030 - Out of Square/Level | Small wall right of pantry closet next to refrigerator is not square | 0.25 | | |

Kitchen/Dinette  
1030 - Out of Square/Level  
Small wall right of pantry closet next to refrigerator is not square

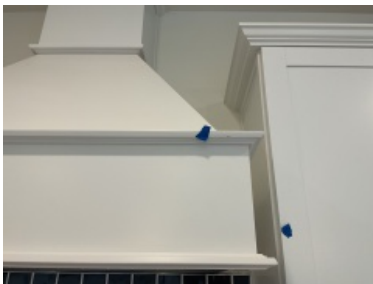
| Room | Trade | Item | Description | Points | Initials | |
|---|---|---|---|---|---|--|
| Kitchen/Dinette | Cabinets | 1600D - Damage | Gouge on front edge of range hood trim near the right side | 0.25 | | |

Kitchen/Dinette  
1600D - Damage  
Gouge on front edge of range hood trim near the right side

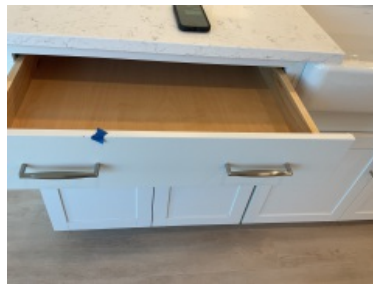
| Room | Trade | Item | Description | Points | Initials | |
|---|---|---|---|---|---|--|
| Kitchen/Dinette | Cabinets | 1600D - Damage | Top edge of drawer front is chipped on drawer left of sink | 0.25 | | |

Kitchen/Dinette  
1600D - Damage  
Top edge of drawer front is chipped on drawer left of the sink

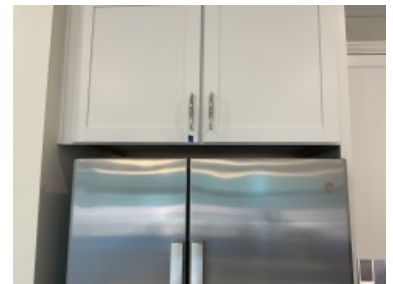
| Room | Trade | Item | Description | Points | Initials | |
|---|---|---|---|---|---|--|
| Kitchen/Dinette | Cabinets | 1630 - Drawer/Door Issue | Cabinet doors over the refrigerator are not lined up on the bottom | 0.25 | | |

Kitchen/Dinette  
1630 - Drawer/Door Issue  
Cabinet doors over the refrigerator are not lined up on the bottom

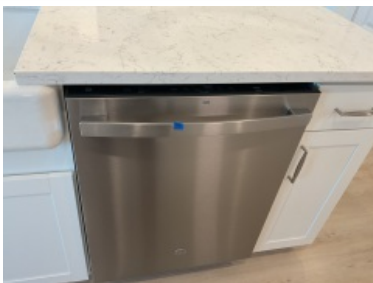
| Room | Trade | Item | Description | Points | Initials | |
|---|---|---|---|---|---|--|
| Kitchen/Dinette | Appliances | 1835 - Inoperable Appliance | Cannot test dishwasher due to no water | 1 | | |

Kitchen/Dinette  
1835 - Inoperable Appliance  
Cannot test dishwasher due to no water

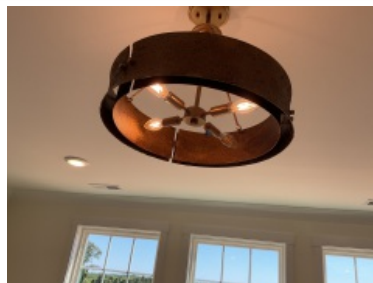
| Room | Trade | Item | Description | Points | Initials | |
|---|---|---|---|---|---|--|
| Loft | Electric | 807 - Bulb Burned Out or Missing | Lightbulb burned out in light fixture of loft | 0.25 | | |

Loft  
807 - Bulb Burned Out or Missing  
Lightbulb burned out in light fixture of loft

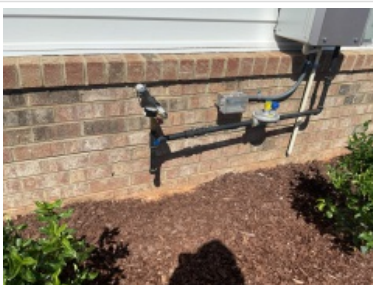
| Room | Trade | Item | Description | Adjustment | Initials | |
|---|---|---|---|---|---|---|
| Exterior | Exterior_Appointments | 12000 - Miscellaneous | No gas meter for home on right side of house | | | |

Exterior  
12000 - Miscellaneous  
No gas meter for home on right side of house

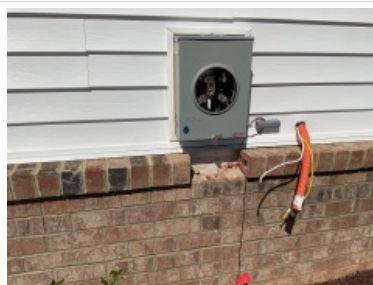
| Room | Trade | Item | Description | Adjustment | Initials | |
|---|---|---|---|---|---|---|
| Exterior | Foundation | 405 - Missing Parts and Pieces | Brick missing under electrical meter on left side of home | | | |

Exterior  
405 - Missing Parts and Pieces  
Brick missing under electrical meter on left side of home

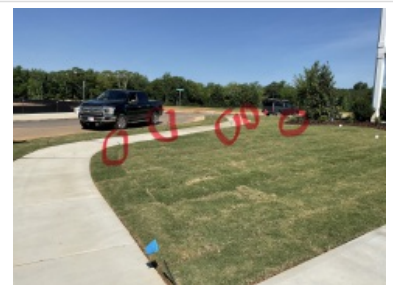
| Room | Trade | Item | Description | Adjustment | Initials | |
|---|---|---|---|---|---|---|
| Exterior | Plumbing | 760 - Missing Fixture | Sprinkler system missing heads | | | |

Exterior  
760 - Missing Fixture  
Sprinkler system missing heads

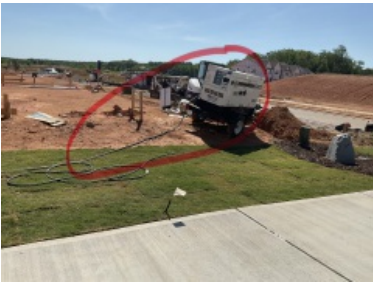
| Room | Trade | Item | Description | Adjustment | Initials | |
|---|---|---|---|---|---|---|
| Exterior | Electric | 800 - Miscellaneous | House running off generator | | | |

Exterior  
800 - Miscellaneous  
House running off generator

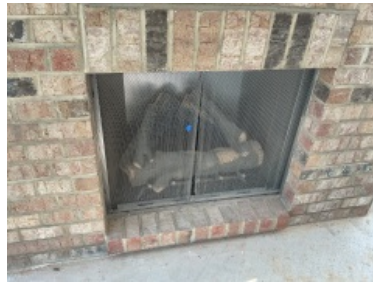
| Room | Trade | Item | Description | Adjustment | Initials | |
|---|---|---|---|---|---|---|
| Exterior | Major_Item | Fireplace Inoperable | Fireplace is not working | | | |

Exterior  
Fireplace Inoperable  
Fireplace is not working

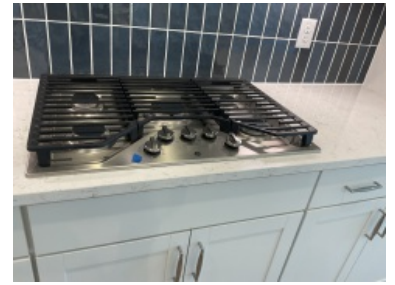
| Room | Trade | Item | Description | Adjustment | Initials | |
|---|---|---|---|---|---|---|
| Kitchen/Dinette | Appliances | 1835 - Inoperable Appliance | Cooktop is not operating | | | |

Kitchen/Dinette  
1835 - Inoperable Appliance  
Cooktop is not operating
