| Builder | DRB Group |
| Community | Neill's Pointe (NC)(RAL) |
| Street Address | 177 Steel Springs Ln |
| Type | New Review |

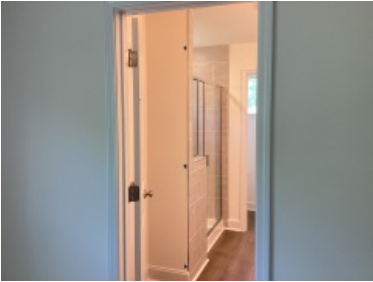
| Room | Trade | Item | Description | Points | Initials | |
|---|---|---|---|---|---|--|
| Bath - Owner's | Ceramic | 1220 - Tile Installation Issue | Inconsistent gap at schluter strip at left side of shower tile, bathroom side | 0.25 | | |

Bath - Owner's  
1220 - Tile Installation Issue  
Inconsistent gap at schluter strip at left side of shower tile, bathroom side

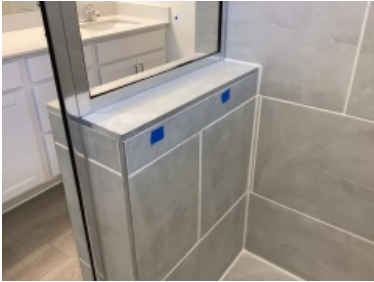
| Room | Trade | Item | Description | Points | Initials | |
|---|---|---|---|---|---|--|
| Bath - Owner's | Ceramic | 1220 - Tile Installation Issue | Inconsistent reveal at top of tile edge at top of shower wall , shower side | 0.25 | | |

Bath - Owner's  
1220 - Tile Installation Issue  
Inconsistent reveal at top of tile edge at top of shower wall , shower side

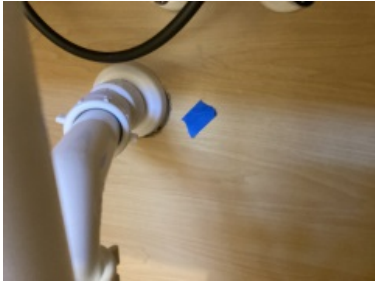
| Room | Trade | Item | Description | Points | Initials | |
|---|---|---|---|---|---|--|
| Bath - Owner's | Plumbing | 710 - Escutcheon Issue | Gap at escutcheon under left sink | 0.25 | | |

Bath - Owner's  
710 - Escutcheon Issue  
Gap at escutcheon under left sink

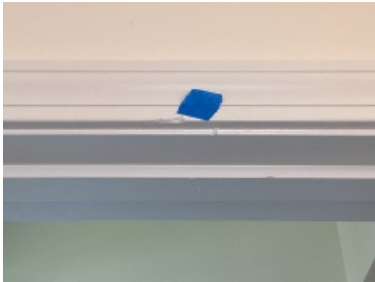
| Room | Trade | Item | Description | Points | Initials | |
|---|---|---|---|---|---|--|
| Bath - Powder | Interior_Trim | 1500D - Damage | Damage to door trim at top of door | 0.25 | | |

Bath - Powder  
1500D - Damage  
Damage to door trim at top of door

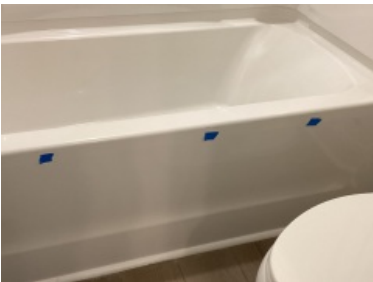
| Room | Trade | Item | Description | Points | Initials | |
|---|---|---|---|---|---|--|
| Bath - Shared | Plumbing | 700D - Damage | Black marks on edge of tub | 0.25 | | |

Bath - Shared  
700D - Damage  
Black marks on edge of tub

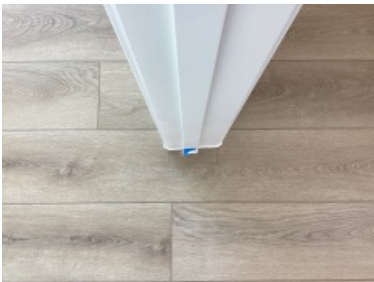
| Room | Trade | Item | Description | Points | Initials | |
|---|---|---|---|---|---|--|
| Bedroom 2 | Framing | 1030 - Out of Square/Level | Out of square at strike side of entry door, FR bedroom | 0.25 | | |

Bedroom 2  
1030 - Out of Square/Level  
Out of square at strike side of entry door, FR bedroom

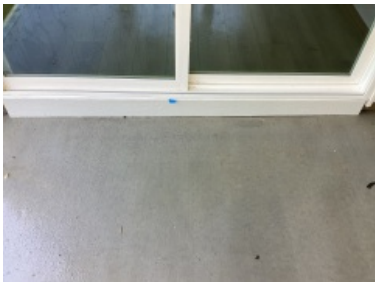
| Room | Trade | Item | Description | Points | Initials | |
|---|---|---|---|---|---|--|
| Exterior | Exterior_Trim | 20060 - Ext. Trim Out of Plumb/Square | Kickboard not square under SGD | 0.25 | | |

Exterior  
20060 - Ext. Trim Out of Plumb/Square  
Kickboard not square under SGD

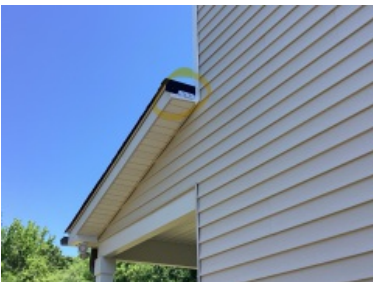
| Room | Trade | Item | Description | Points | Initials | |
|---|---|---|---|---|---|--|
| Exterior | Roofing | 2020 - Plastic Wrappers Left On | Tape visible on flashing at left side of house, at back porch roof | 0.25 | | |

Exterior  
2020 - Plastic Wrappers Left On  
Tape visible on flashing at left side of house, at back porch roof

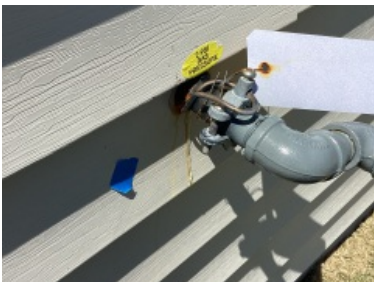
| Room | Trade | Item | Description | Points | Initials | |
|---|---|---|---|---|---|--|
| Exterior | Siding | 4000D - Damage | Stains on siding at gas line at right side of house | 0.25 | | |

Exterior  
4000D - Damage  
Stains on siding at gas line at right side of house

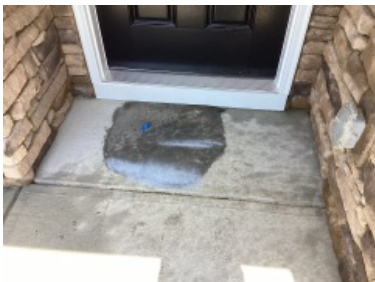
| Room | Trade | Item | Description | Points | Initials | |
|---|---|---|---|---|---|--|
| Exterior | Concrete_Flatwork | 500 - Miscellaneous | Inconsistent finish on front porch under front door | 0.25 | | |

Exterior  
500 - Miscellaneous  
Inconsistent finish on front porch under front door

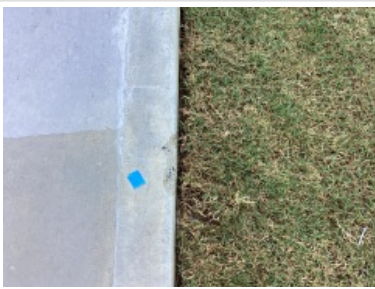
| Room | Trade | Item | Description | Points | Initials | |
|---|---|---|---|---|---|--|
| Exterior | Concrete_Flatwork | 500D - Damage | Damage to back patio on back edge | 0.25 | | |

Exterior  
500D - Damage  
Damage to back patio on back edge

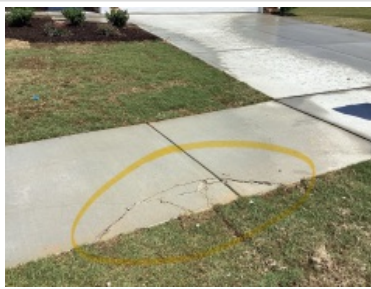
| Room | Trade | Item | Description | Points | Initials | |
|---|---|---|---|---|---|--|
| Exterior | Concrete_Flatwork | 500D - Damage | Damage to sidewalk at left of driveway | 0.25 | | |

Exterior  
500D - Damage  
Damage to sidewalk at left of driveway

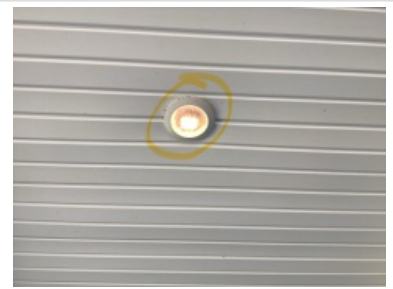
| Room | Trade | Item | Description | Points | Initials | |
|---|---|---|---|---|---|--|
| Exterior | Electric | 860 - Damage | Ceiling light is stained at back porch | 0.25 | | |

Exterior  
860 - Damage  
Ceiling light is stained at back porch

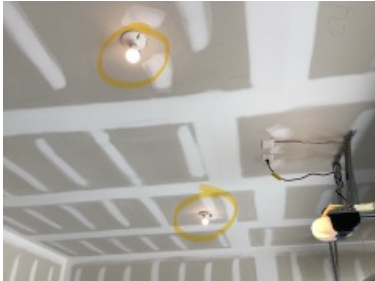
| Room | Trade | Item | Description | Points | Initials | |
|---|---|---|---|---|---|--|
| Garage | Electric | 855 - Other Installation Issue | Gaps visible around ceiling lights in garage | 0.25 | | |

Garage  
855 - Other Installation Issue  
Gaps visible around ceiling lights in garage

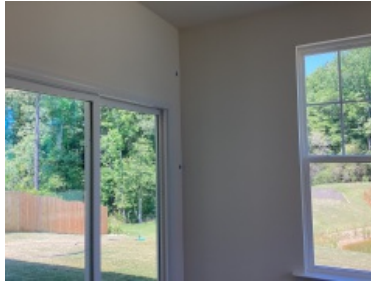
| Room | Trade | Item | Description | Points | Initials | |
|---|---|---|---|---|---|--|
| Kitchen/Dinette | Framing | 1050 - Bowed Wall | Wall bows at corner to right of SGD | 0.25 | | |

Kitchen/Dinette  
1050 - Bowed Wall  
Wall bows at corner to right of SGD

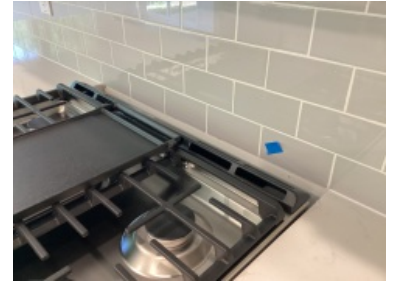
| Room | Trade | Item | Description | Points | Initials | |
|---|---|---|---|---|---|--|
| Kitchen/Dinette | Ceramic | 1220 - Tile Installation Issue | Gap in tile visible behind range | 0.25 | | |

Kitchen/Dinette  
1220 - Tile Installation Issue  
Gap in tile visible behind range

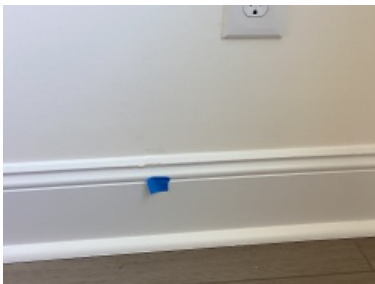
| Room | Trade | Item | Description | Points | Initials | |
|---|---|---|---|---|---|--|
| Kitchen/Dinette | Interior_Trim | 1500D - Damage | Damage to baseboard, between windows in corner of dining area | 0.25 | | |

Kitchen/Dinette  
1500D - Damage  
Damage to baseboard, between windows in corner of dining area

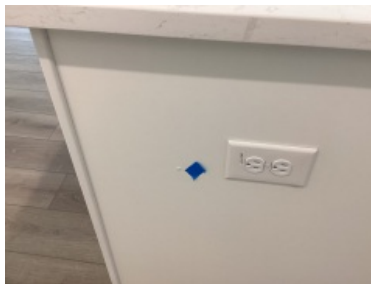
| Room | Trade | Item | Description | Points | Initials | |
|---|---|---|---|---|---|--|
| Kitchen/Dinette | Cabinets | 1600D - Damage | Damage at left side of island | 0.25 | | |

Kitchen/Dinette  
1600D - Damage  
Damage at left side of island

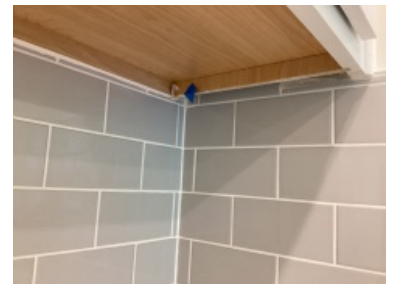
| Room | Trade | Item | Description | Points | Initials | |
|---|---|---|---|---|---|--|
| Kitchen/Dinette | Cabinets | 1600D - Damage | Damage to bottom of upper cabinet, right of fridge | 0.25 | | |

Kitchen/Dinette  
1600D - Damage  
Damage to bottom of upper cabinet, right of fridge

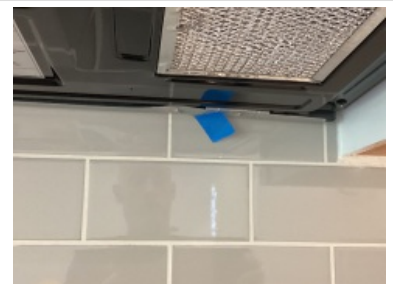
| Room | Trade | Item | Description | Points | Initials | |
|---|---|---|---|---|---|--|
| Kitchen/Dinette | Appliances | 1800D - Damage | Damage to microwave bracket on right side | 0.25 | | |

Kitchen/Dinette  
1800D - Damage  
Damage to microwave bracket on right side

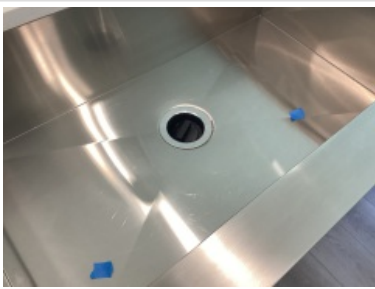
| Room | Trade | Item | Description | Points | Initials | |
|---|---|---|---|---|---|--|
| Kitchen/Dinette | Plumbing | 700D - Damage | Scratches in sink | 0.25 | | |

Kitchen/Dinette  
700D - Damage  
Scratches in sink

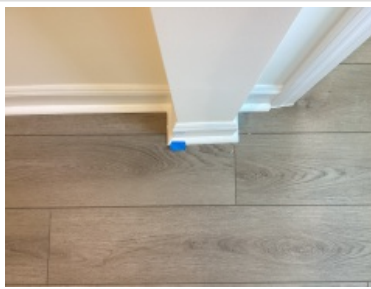
| Room | Trade | Item | Description | Points | Initials | |
|---|---|---|---|---|---|--|
| Stairs/Hall | Framing | 1030 - Out of Square/Level | Out of square at bottom left of powder room door | 0.25 | | |

Stairs/Hall  
1030 - Out of Square/Level  
Out of square at bottom left of powder room door
