New Review - Home Quality Review

| Builder | DRB Group |
|---|---|
| Community | North First Street TH (NC)(RAL) |
| Street Address | 1274 Hammond Drive |
| Date | 5/21/2026 |

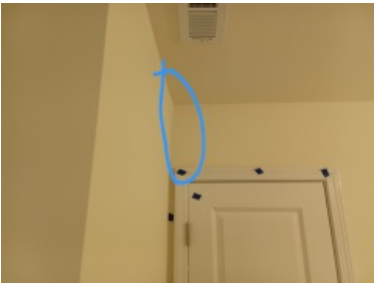
| Room | Trade | Item | Description | Points | Initials | |
|---|---|---|---|---|---|--|
| Bath - Hall | Drywall | 1400 - Miscellaneous | Comer above hinge side of door not plumb. | 0.25 | | |

Bath - Hall  
1400 - Miscellaneous  
Comer above hinge side of door not plumb.

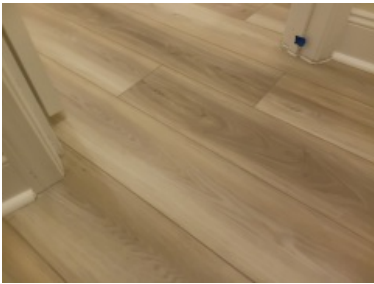
| Room | Trade | Item | Description | Points | Initials | |
|---|---|---|---|---|---|--|
| Bath - Owner's | Interior_Trim | 1510 - Not Pieced Together Well | Right door jamb when in toilet room is cut short and filled with caulk. | 0.25 | | |

Bath - Owner's  
1510 - Not Pieced Together Well  
Right door jamb when in toilet room is cut short and filled with caulk.

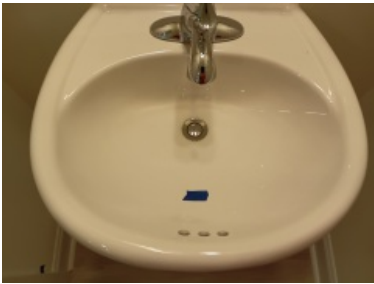
| Room | Trade | Item | Description | Points | Initials | |
|---|---|---|---|---|---|--|
| Bath - Powder | Plumbing | 720 - Sink/Tub Not Holding Water | Sink does not hold water. | 0.25 | | |

Bath - Powder  
720 - Sink/Tub Not Holding Water  
Sink does not hold water.

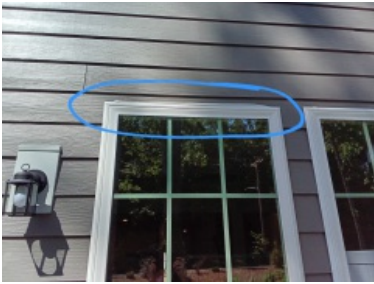
| Room | Trade | Item | Description | Points | Initials | |
|---|---|---|---|---|---|--|
| Exterior | Cleaning | 1915 - Exterior Presentation | House wrap visible above lower left window at rear patio. | 0.25 | | |

Exterior  
1915 - Exterior Presentation  
House wrap visible above lower left window at rear patio.

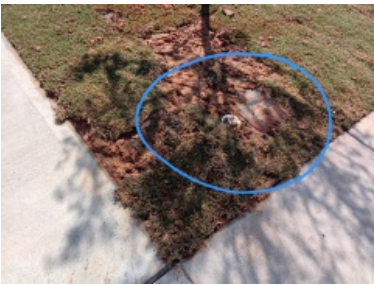
| Room | Trade | Item | Description | Points | Initials | |
|---|---|---|---|---|---|--|
| Exterior | Landscaping | 300 - Miscellaneous | Sod is displaced at right side of driveway. | 0.25 | | |

Exterior  
300 - Miscellaneous  
Sod is displaced at right side of driveway.

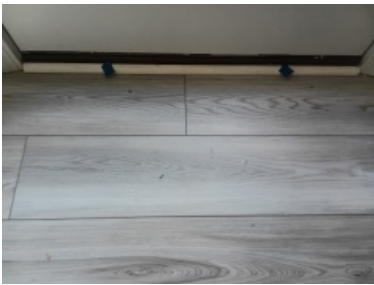
| Room | Trade | Item | Description | Points | Initials | |
|---|---|---|---|---|---|--|
| Family Room | Paint | 1730 - Item Not Painted | Base shoe not finished painted at rear entry door. | 0.25 | | |

Family Room  
1730 - Item Not Painted  
Base shoe not finished painted at rear entry door.

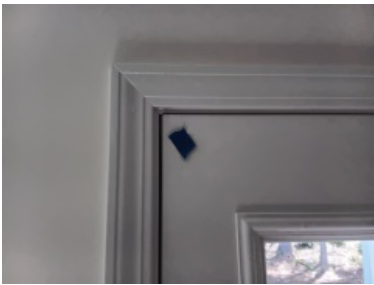
| Room | Trade | Item | Description | Points | Initials | |
|---|---|---|---|---|---|--|
| Family Room | Doors | 50030 - Daylight Through Exterior Door Edge | Daylight visible at top left comer of rear entry door. | 0.25 | | |

Family Room  
50030 - Daylight Through Exterior Door Edge  
Daylight visible at top left corner of rear entry door.

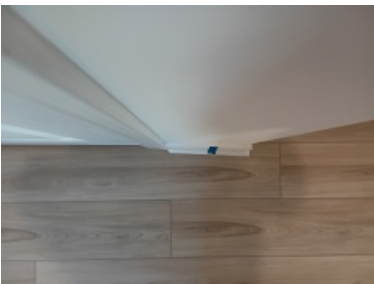
| Room | Trade | Item | Description | Points | Initials | |
|---|---|---|---|---|---|--|
| Foyer | Framing | 1030 - Out of Square/Level | Short wall right of closet not square. | 0.25 | | |

Foyer  
1030 - Out of Square/Level  
Short wall right of closet not square.

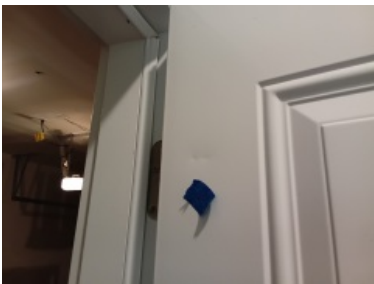
| Room | Trade | Item | Description | Points | Initials | |
|---|---|---|---|---|---|--|
| Garage | Doors | 50000D - Damage | House entry door has damage cold side by top hinge. | 0.25 | | |

Garage  
50000D - Damage  
House entry door has damage cold side by top hinge.

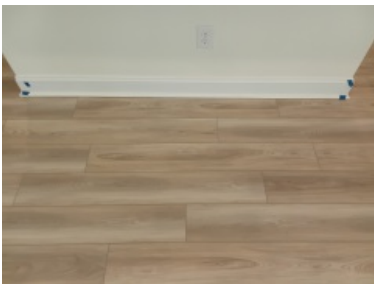
| Room | Trade | Item | Description | Points | Initials | |
|---|---|---|---|---|---|--|
| Kitchen/Dinette | Framing | 1030 - Out of Square/Level | Bar side of island is not square with flooring. | 0.25 | | |

Kitchen/Dinette  
1030 - Out of Square/Level  
Bar side of island is not square with flooring.

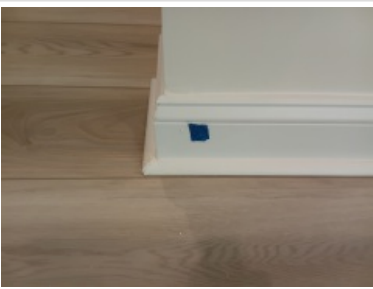
| Room | Trade | Item | Description | Points | Initials | |
|---|---|---|---|---|---|--|
| Kitchen/Dinette | Interior_Trim | 1500D - Damage | Nail sticking out of baseboard at bar side of island at left comer. | 0.25 | | |

Kitchen/Dinette  
1500D - Damage  
Nail sticking out of baseboard at bar side of island at left corner.

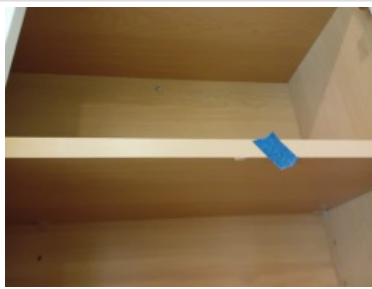
| Room | Trade | Item | Description | Points | Initials | |
|---|---|---|---|---|---|--|
| Kitchen/Dinette | Cabinets | 1600D - Damage | 3rd cabinet left of microwave top shelf is damaged. | 0.25 | | |

Kitchen/Dinette  
1600D - Damage  
3rd cabinet left of microwave top shelf is damaged.

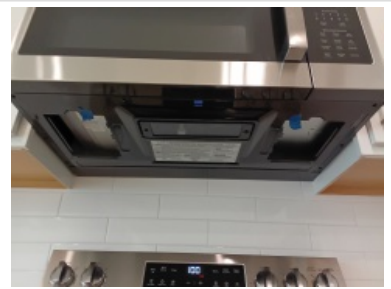
| Room | Trade | Item | Description | Points | Initials | |
|---|---|---|---|---|---|--|
| Kitchen/Dinette | Appliances | 1805 - Missing Pieces | Filters under microwave missing. | 0.25 | | |

Kitchen/Dinette  
1805 - Missing Pieces  
Filters under microwave missing.

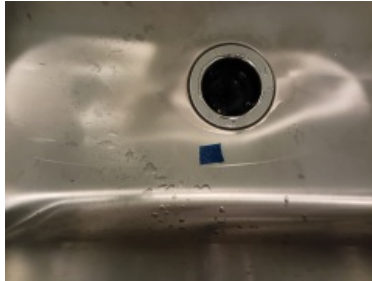
| Room | Trade | Item | Description | Points | Initials | |
|---|---|---|---|---|---|--|
| Kitchen/Dinette | Plumbing | 700D - Damage | Scratches in bottom of sink. | 0.25 | | |

Kitchen/Dinette  
700D - Damage  
Scratches in bottom of sink.

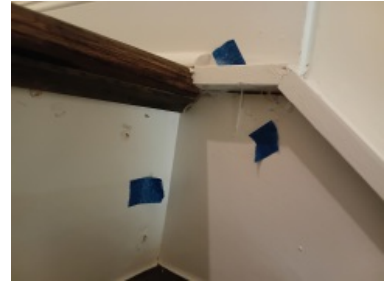
| Room | Trade | Item | Description | Points | Initials | |
|---|---|---|---|---|---|--|
| Stairs/Hall | Interior_Trim | 1500D - Damage | Nail sticking out at right side step before second landing. | 0.25 | | |

Stairs/Hall  
1500D - Damage  
Nail, sticking out at right side step before second landing.

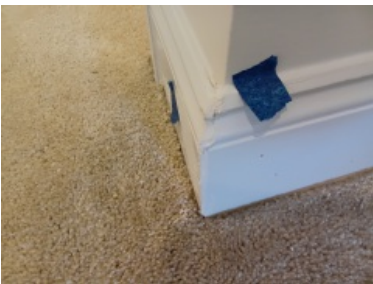
| Room | Trade | Item | Description | Points | Initials | |
|---|---|---|---|---|---|--|
| Stairs/Hall | Interior_Trim | 1510 - Not Pieced Together Well | Baseboard mitre at right of hall bath not pieced together well. | 0.25 | | |

Stairs/Hall  
1510 - Not Pieced Together Well  
Baseboard mitre at right of hall bath not pieced together well.

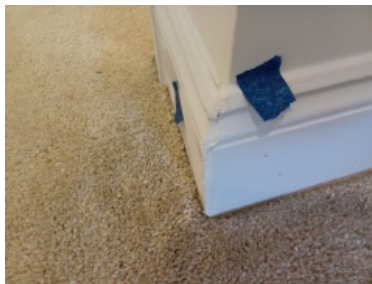
| Room | Trade | Item | Description | Points | Initials | |
|---|---|---|---|---|---|--|
| Stairs/Hall | Interior_Trim | 1510 - Not Pieced Together Well | Inconsistent gap between right casing and wall at upstairs hall closet. | 0.25 | | |

Stairs/Hall  
1510 - Not Pieced Together Well  
Inconsistent gap between right casing and wall at upstairs hall closet.

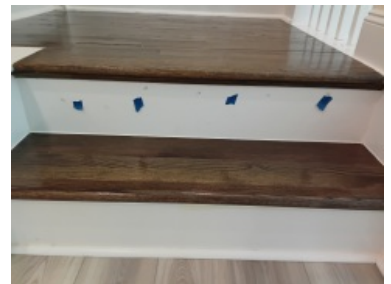
| Room | Trade | Item | Description | Points | Initials | |
|---|---|---|---|---|---|--|
| Stairs/Hall | Stairs_and_Rails | 21000 - Miscellaneous | Nail heads visible at riser at first landing. | 0.25 | | |

Stairs/Hall  
21000 - Miscellaneous  
Nail heads visible at riser at first landing.
