| Builder | DRB Group |
| Community | North First Street TH (NC)(RAL) |
| Street Address | 1286 Hammond Drive |
| Type | New Review |

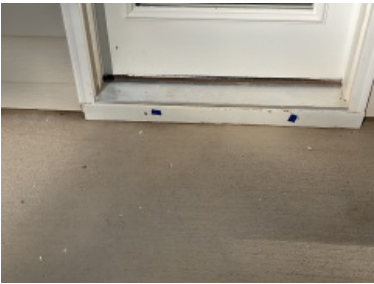
| Room | Trade | Item | Description | Points | Initials | |
|---|---|---|---|---|---|--|
| Exterior | Paint | 1700D - Damage | Rear threshold support had screw heads visible. | 0.25 | | |

Exterior  
1700D - Damage  
Rear threshold support had screw heads visible.

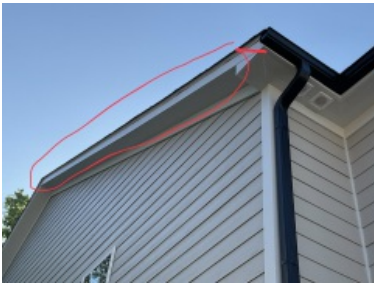
| Room | Trade | Item | Description | Points | Initials | |
|---|---|---|---|---|---|--|
| Exterior | Exterior_Trim | 20040 - Ext. Trim Not Pieced Together Properly | Drip edge, left side, front pitch, has inconsistent gaps. | 0.25 | | |

Exterior  
20040 - Ext. Trim Not Pieced Together Properly  
Drip edge, left side, front pitch, has inconsistent gaps.

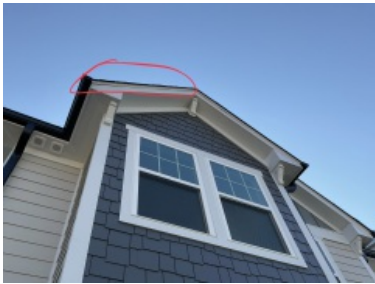
| Room | Trade | Item | Description | Points | Initials | |
|---|---|---|---|---|---|--|
| Exterior | Exterior_Trim | 20040 - Ext. Trim Not Pieced Together Properly | Drip edge, rear of townhouse, left pitch, had inconsistent gaps. | 0.25 | | |

Exterior  
20040 - Ext. Trim Not Pieced Together Properly  
Drip edge, rear of townhouse, left pitch, had inconsistent gaps.

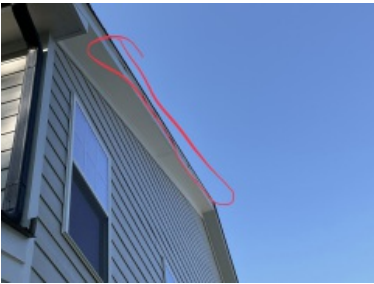
| Room | Trade | Item | Description | Points | Initials | |
|---|---|---|---|---|---|--|
| Exterior | Exterior_Trim | 20040 - Ext. Trim Not Pieced Together Properly | Drip edge, rear pitch, left side, had inconsistent gaps. | 0.25 | | |

Exterior  
20040 - Ext. Trim Not Pieced Together Properly  
Drip edge, rear pitch, left side, had inconsistent gaps.

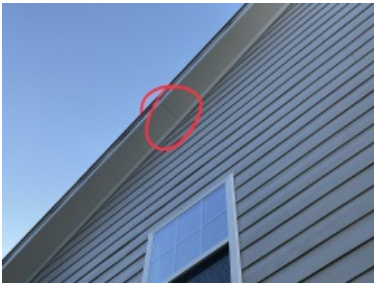
| Room | Trade | Item | Description | Points | Initials | |
|---|---|---|---|---|---|--|
| Exterior | Exterior_Trim | 20040 - Ext. Trim Not Pieced Together Properly | Soffit on left rear pitch, is not pieced together well. | 0.25 | | |

Exterior  
20040 - Ext. Trim Not Pieced Together Properly  
Soffit on left rear pitch, is not pieced together well.

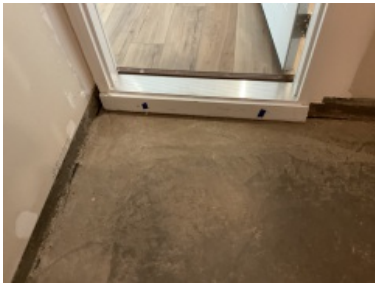
| Room | Trade | Item | Description | Points | Initials | |
|---|---|---|---|---|---|--|
| Garage | Paint | 1710 - Nail Holes Not Filled & Colored | Garage entry door, threshold support, has visible screws. | 0.25 | | |

Garage  
1710 - Nail Holes Not Filled & Colored  
Garage entry door, threshold support, has visible screws.

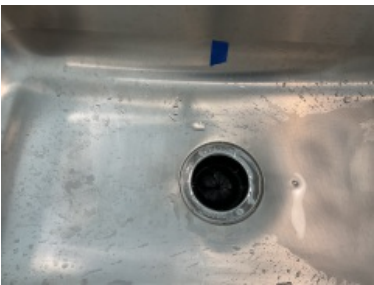
| Room | Trade | Item | Description | Points | Initials | |
|---|---|---|---|---|---|--|
| Kitchen/Dinette | Appliances | 1801 - Miscellaneous | Garbage disposal making a loud noise. | 0.25 | | |

Kitchen/Dinette  
1801 - Miscellaneous  
Garbage disposal making a loud noise.

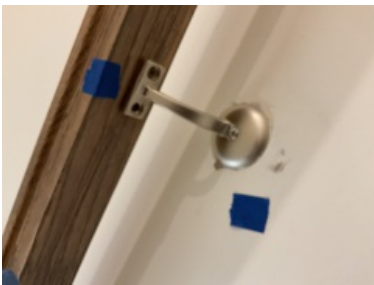
| Room | Trade | Item | Description | Points | Initials | |
|---|---|---|---|---|---|--|
| Stairs/Hall | Stairs_and_Rails | 21005 - Missing Pieces | Top handrail holder, is missing a screw. | 0.25 | | |

Stairs/Hall  
21005 - Missing Pieces  
Top handrail holder, is missing a screw.
