New Review - Home Quality Review

| Builder | DRB Group |
| Community | Provisions at Courtland SF (NC)(RAL) |
| Street Address | 331 Flourishing Street |

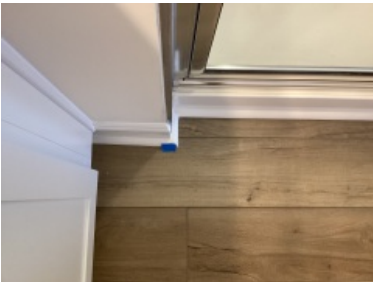
| Room | Trade | Item | Description | Points | Initials | |
|---|---|---|---|---|---|--|
| Bath - Owner's | Framing | 1030 - Out of Square/Level | Out of square at bottom left of shower door | 0.25 | | |

Bath - Owner's  
1030 - Out of Square/Level  
Out of square at bottom left of shower door

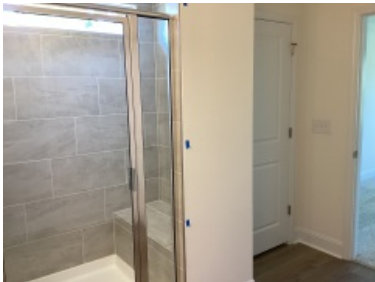
| Room | Trade | Item | Description | Points | Initials | |
|---|---|---|---|---|---|--|
| Bath - Owner's | Ceramic | 1220 - Tile Installation Issue | Inconsistent drywall reveal at right side of shower tile, bathroom side | 0.25 | | |

Bath - Owner's  
1220 - Tile Installation Issue  
Inconsistent drywall reveal at right side of shower tile, bathroom side

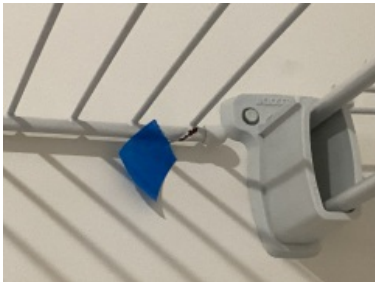
| Room | Trade | Item | Description | Points | Initials | |
|---|---|---|---|---|---|--|
| Bath - Owner's | Closet_Shelving | 17000D - Damage | Damage to shelf, far right end of middle long shelfe | 0.25 | | |

Bath - Owner's  
17000D - Damage  
Damage to shelf, far right end of middle long shelf

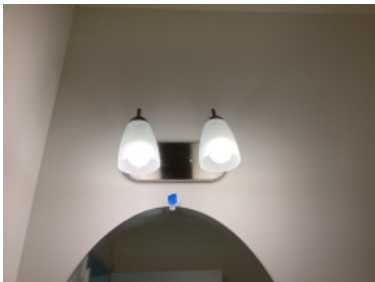
| Room | Trade | Item | Description | Points | Initials | |
|---|---|---|---|---|---|--|
| Bath - Powder | Bath_Accessories | 18040 - Mirror Crooked | Mirror is not centered with sink and light | 0.25 | | |

Bath - Powder  
18040 - Mirror Crooked  
Mirror is not centered with sink and light

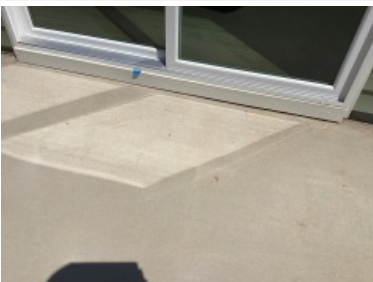
| Room | Trade | Item | Description | Points | Initials | |
|---|---|---|---|---|---|--|
| Exterior | Exterior_Trim | 20060 - Ext. Trim Out of Plumb/Square | Kickboard not square/ plumb under SGD | 0.25 | | |

Exterior  
20060 - Ext. Trim Out of Plumb/Square  
Kickboard not square/ plumb under SGD

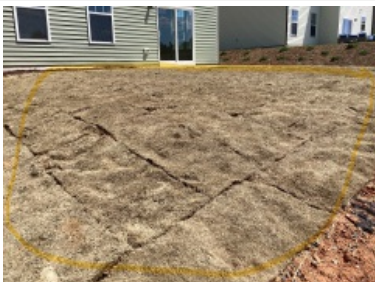
| Room | Trade | Item | Description | Points | Initials | |
|---|---|---|---|---|---|--|
| Exterior | Landscaping | 330 - Dying Sod/Seed/Shrubs/Tree | Dying sod in backyard | 0.25 | | |

Exterior  
330 - Dying Sod/Seed/Shrubs/Tree  
Dying sod in backyard

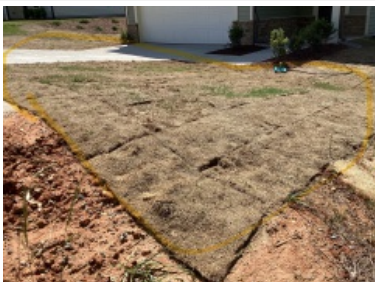
| Room | Trade | Item | Description | Points | Initials | |
|---|---|---|---|---|---|--|
| Exterior | Landscaping | 330 - Dying Sod/Seed/Shrubs/Tree | Dying sod in front yard | 0.25 | | |

Exterior  
330 - Dying Sod/Seed/Shrubs/Tree  
Dying sod in front yard

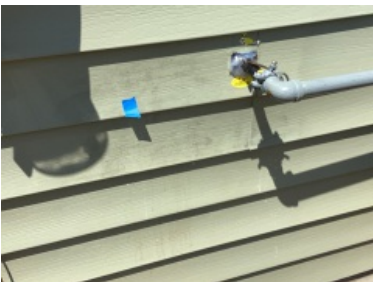
| Room | Trade | Item | Description | Points | Initials | |
|---|---|---|---|---|---|--|
| Exterior | Siding | 4000D - Damage | Stains on siding by gas line , left side of house | 0.25 | | |

Exterior  
4000D - Damage  
Stains on siding by gas line , left side of house

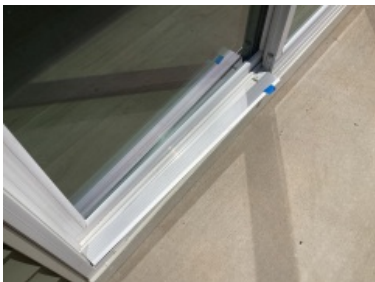
| Room | Trade | Item | Description | Points | Initials | |
|---|---|---|---|---|---|--|
| Exterior | Doors | 50005 - Missing Pieces | Threshold not attached at SGD | 0.25 | | |

Exterior  
50005 - Missing Pieces  
Threshold not attached at SGD

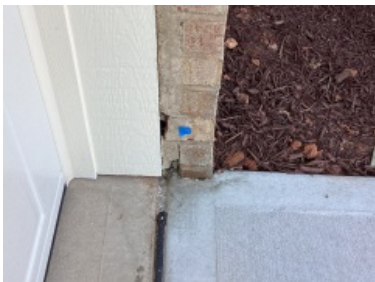
| Room | Trade | Item | Description | Points | Initials | |
|---|---|---|---|---|---|--|
| Exterior | Brick_Stone_Stucco | 5000D - Damage | Damage to brick at right side of garage door | 0.25 | | |

Exterior  
5000D - Damage  
Damage to brick at right side of garage door

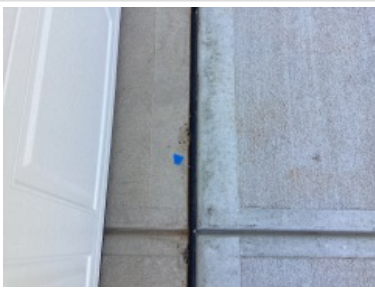
| Room | Trade | Item | Description | Points | Initials | |
|---|---|---|---|---|---|--|
| Exterior | Concrete_Flatwork | 500D - Damage | Damage to driveway under overhead door | 0.25 | | |

Exterior  
500D - Damage  
Damage to driveway under overhead door

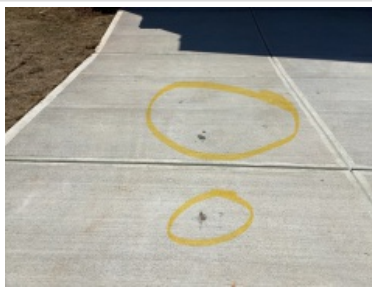
| Room | Trade | Item | Description | Points | Initials | |
|---|---|---|---|---|---|--|
| Exterior | Concrete_Flatwork | 520 - Stain | Stains on left side of driveway | 0.25 | | |

Exterior  
520 - Stain  
Stains on left side of driveway

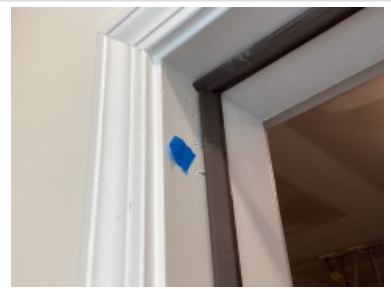
| Room | Trade | Item | Description | Points | Initials | |
|---|---|---|---|---|---|--|
| Garage | Interior_Trim | 1500D - Damage | Nail sharps at top strike side of garage door | 0.25 | | |

Garage  
1500D - Damage  
Nail sharps at top strike side of garage door

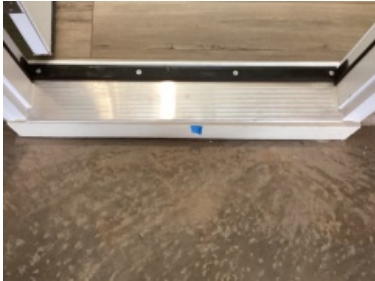
| Room | Trade | Item | Description | Points | Initials | |
|---|---|---|---|---|---|--|
| Garage | Exterior_Trim | 20060 - Ext. Trim Out of Plumb/Square | Kickboard not square/plumb under door to house | 0.25 | | |

Garage  
20060 - Ext. Trim Out of Plumb/Square  
Kickboard not square/plumb under door to house

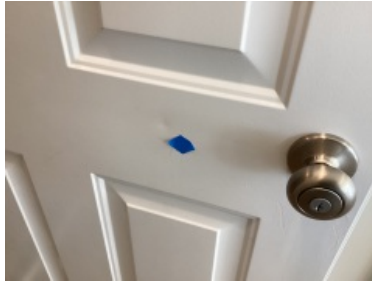
| Room | Trade | Item | Description | Points | Initials | |
|---|---|---|---|---|---|--|
| Garage | Doors | 50000D - Damage | Dent in garage door | 0.25 | | |

Garage  
50000D - Damage  
Dent in garage door

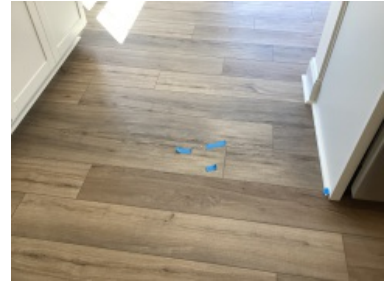
| Room | Trade | Item | Description | Points | Initials | |
|---|---|---|---|---|---|--|
| Kitchen/Dinette | Flooring | 1300 - Miscellaneous | Soft spot in flooring, to left of dishwasher | 0.25 | | |

Kitchen/Dinette  
1300 - Miscellaneous  
Soft spot in flooring, to left of dishwasher

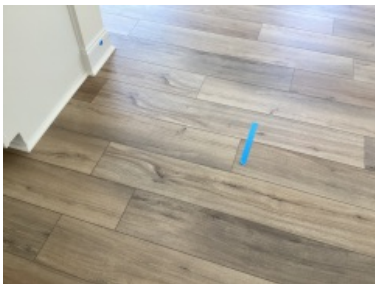
| Room | Trade | Item | Description | Points | Initials | |
|---|---|---|---|---|---|--|
| Kitchen/Dinette | Flooring | 1360 - Item Under Flooring | Bump under flooring at right of island | 0.25 | | |

Kitchen/Dinette  
1360 - Item Under Flooring  
Bump under flooring at right of island

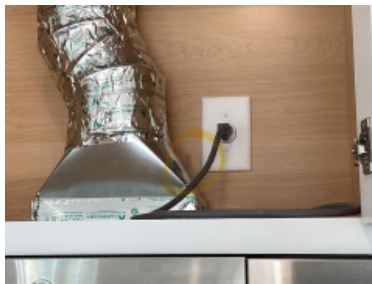
| Room | Trade | Item | Description | Points | Initials | |
|---|---|---|---|---|---|--|
| Kitchen/Dinette | Cabinets | 1600D - Damage | Damage to back of cabinet above microwave | 0.25 | | |

Kitchen/Dinette  
1600D - Damage  
Damage to back of cabinet above microwave

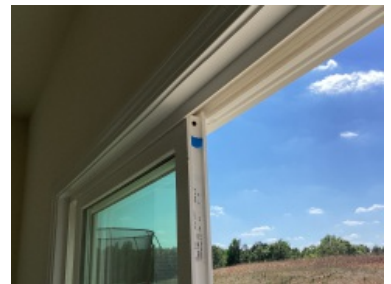
| Room | Trade | Item | Description | Points | Initials | |
|---|---|---|---|---|---|--|
| Kitchen/Dinette | Doors | 50005 - Missing Pieces | Missing screw cap at top of SGD | 0.25 | | |

Kitchen/Dinette  
50005 - Missing Pieces  
Missing screw cap at top of SGD

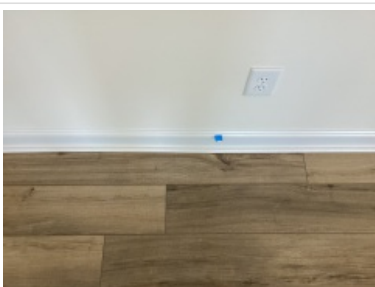
| Room | Trade | Item | Description | Points | Initials | |
|---|---|---|---|---|---|--|
| Living | Framing | 1050 - Bowed Wall | Wall bows, under thermostat | 0.25 | | |

Living  
1050 - Bowed Wall  
Wall bows, under thermostat

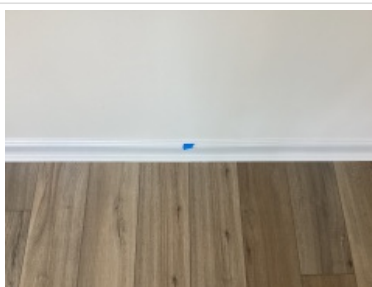
| Room | Trade | Item | Description | Points | Initials | |
|---|---|---|---|---|---|--|
| Living | Framing | 1050 - Bowed Wall | Wall bows, wall to right of windows | 0.25 | | |

Living  
1050 - Bowed Wall  
Wall bows, wall to right of windows

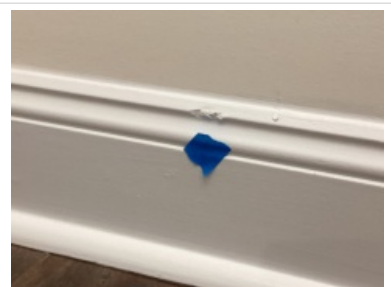
| Room | Trade | Item | Description | Points | Initials | |
|---|---|---|---|---|---|--|
| Stairs/Hall | Interior_Trim | 1500D - Damage | Damage to baseboard at stairs landing | 0.25 | | |

Stairs/Hall  
1500D - Damage  
Damage to baseboard at stairs landing
