| Builder | DRB Group |
| Community | Sidney Creek SF 30's (NC)(RAL) |
| Street Address | 1613 Briar Brook Lane |
| Type | New Review |

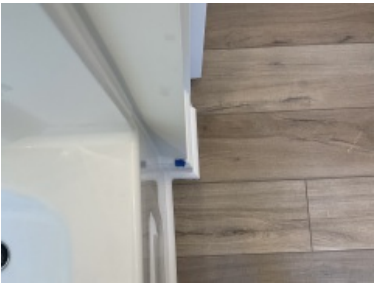
| Room | Trade | Item | Description | Points | Initials | |
|---|---|---|---|---|---|--|
| Bath - Hall | Framing | 1030 - Out of Square/Level | Small wall right of the shower spout is not square | 0.25 | | |

Bath - Hall  
1030 - Out of Square/Level  
Small wall right of the shower spout is not square

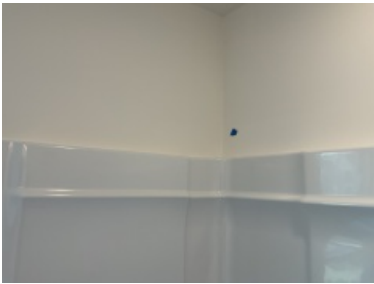
| Room | Trade | Item | Description | Points | Initials | |
|---|---|---|---|---|---|--|
| Bath - Hall | Drywall | 1400 - Miscellaneous | Drywall bows out in left corner over the surround | 0.25 | | |

Bath - Hall  
1400 - Miscellaneous  
Drywall bows out in left corner over the surround

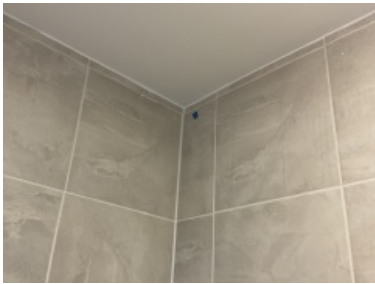
| Room | Trade | Item | Description | Points | Initials | |
|---|---|---|---|---|---|--|
| Bath - Owner's | Ceramic | 1220 - Tile Installation Issue | Small tile in top left back corner is leaning in towards wall over the bench | 0.25 | | |

Bath - Owner's  
1220 - Tile Installation Issue  
Small tile in top left back corner is leaning in towards wall over the bench

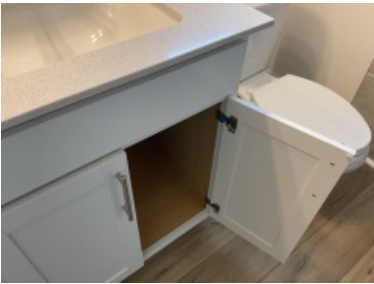
| Room | Trade | Item | Description | Points | Initials | |
|---|---|---|---|---|---|--|
| Bath - Owner's | Cabinets | 1630 - Drawer/Door Issue | Top hinge of right cabinet door under the right sink is loose | 0.25 | | |

Bath - Owner's  
1630 - Drawer/Door Issue  
Top hinge of right cabinet door under the right sink is loose

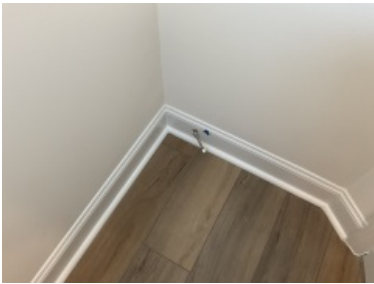
| Room | Trade | Item | Description | Points | Initials | |
|---|---|---|---|---|---|--|
| Bath - Powder | Doors | 5000D - Damage | Doorstop is not fully secured | 0.25 | | |

Bath - Powder  
50000D - Damage  
Doorstop is not fully secured

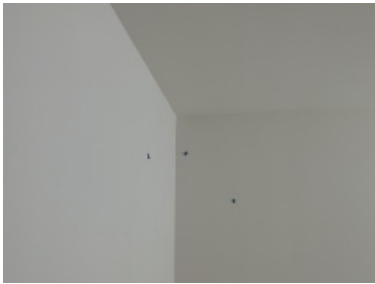
| Room | Trade | Item | Description | Points | Initials | |
|---|---|---|---|---|---|--|
| Bedroom 1 | Drywall | 1400 - Miscellaneous | Wave in drywall in top corner of left wall and wall with switch in the back right bedroom | 0.25 | | |

Bedroom 1  
1400 - Miscellaneous  
Wave in drywall in top corner of left wall and wall with switch In the back right bedroom

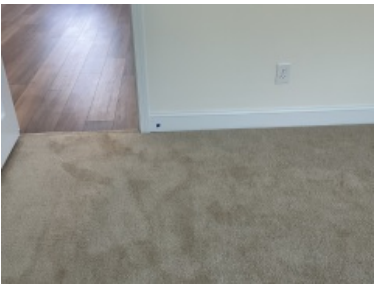
| Room | Trade | Item | Description | Points | Initials | |
|---|---|---|---|---|---|--|
| Bedroom 1 | Interior_Trim | 1500 - Miscellaneous | Inconsistent gap between baseboard and carpet underneath light switch in back right bedroom | 0.25 | | |

Bedroom 1  
1500 - Miscellaneous  
Inconsistent gap between baseboard and carpet underneath light switch in back right bedroom

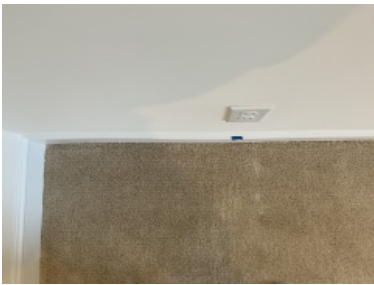
| Room | Trade | Item | Description | Points | Initials | |
|---|---|---|---|---|---|--|
| Bedroom 2 | Interior_Trim | 1560 - Out of plumb/square | Bowed baseboard on left wall under outlet closest to closet wall in front right bedroom | 0.25 | | |

Bedroom 2  
1560 - Out of plumb/square  
Bowed baseboard on left wall under outlet closest to closet wall in front right bedroom

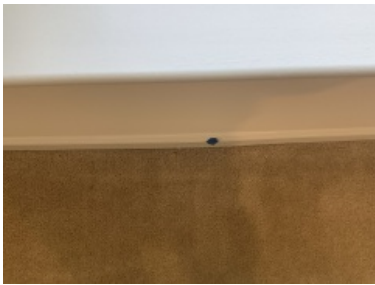
| Room | Trade | Item | Description | Points | Initials | |
|---|---|---|---|---|---|--|
| Bedroom 2 | Interior_Trim | 1560 - Out of plumb/square | Bowed baseboard under window in front right bedroom | 0.25 | | |

Bedroom 2  
1560 - Out of plumb/square  
Bowed baseboard under window in front right bedroom

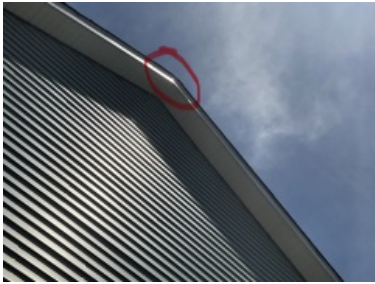
| Room | Trade | Item | Description | Points | Initials | |
|---|---|---|---|---|---|--|
| Exterior | Roofing | 2000D - Damage | Tom shingle on edge of roof at Apex on right side | 0.25 | | |

Exterior  
2000D - Damage  
Torn shingle on edge of roof at Apex on right side

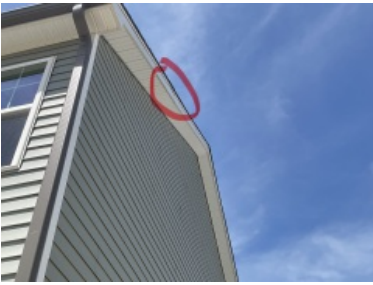
| Room | Trade | Item | Description | Points | Initials | |
|---|---|---|---|---|---|--|
| Exterior | Siding | 4000D - Damage | Metal edge under shingles on left side of home towards the back is bent | 0.25 | | |

Exterior  
4000D - Damage  
Metal edge under shingles on left side of home towards the back is bent

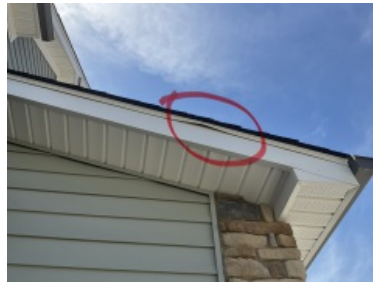
| Room | Trade | Item | Description | Points | Initials | |
|---|---|---|---|---|---|--|
| Exterior | Siding | 4000D - Damage | Metal edge under shingles on right side of garage near front porch is bent | 0.25 | | |

Exterior  
4000D - Damage  
Metal edge under shingles on right side of garage near front porch is bent

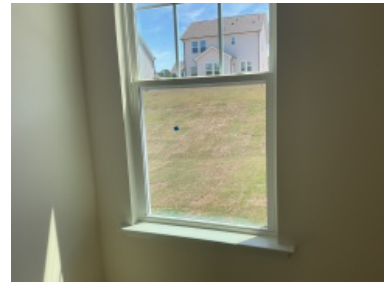
| Room | Trade | Item | Description | Points | Initials | |
|---|---|---|---|---|---|--|
| Family Room | Windows | 13010 - Difficult to Open | Far left window in family room difficult to open/close | 0.25 | | |

Family Room  
13010 - Difficult to Open  
Far left window in family room difficult to open/close

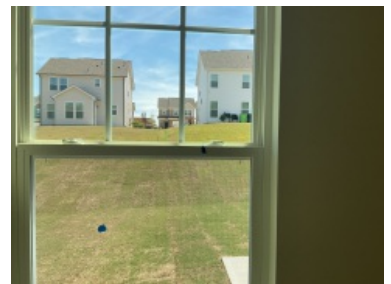
| Room | Trade | Item | Description | Points | Initials | |
|---|---|---|---|---|---|--|
| Family Room | Windows | 13020 - Latch issues | Far left window cannot get lower sash down far enough to lock | 0.25 | | |

Family Room  
13020 - Latch issues  
Far left window cannot get lower sash down far enough to lock

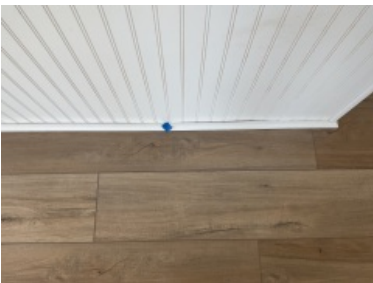
| Room | Trade | Item | Description | Points | Initials | |
|---|---|---|---|---|---|--|
| Kitchen/Dinette | Interior_Trim | 1560 - Out of plumb/square | Inconsistent gap on front of island between shoe mold and beadboard near the right side | 0.25 | | |

Kitchen/Dinette  
1560 - Out of plumb/square  
Inconsistent gap on front of island between shoe mold and beadboard near the right side

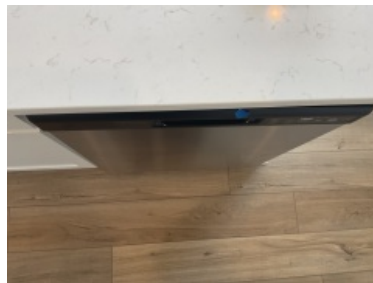
| Room | Trade | Item | Description | Points | Initials | |
|---|---|---|---|---|---|--|
| Kitchen/Dinette | Appliances | 1830 - Installed Incorrectly | Dishwasher is crooked to the countertop | 0.25 | | |

Kitchen/Dinette  
1830 - Installed Incorrectly  
Dishwasher is crooked to the countertop

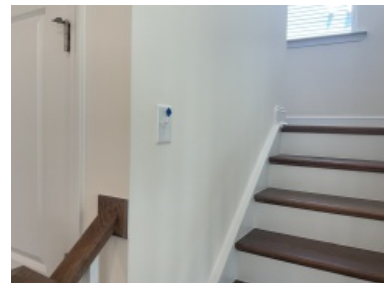
| Room | Trade | Item | Description | Points | Initials | |
|---|---|---|---|---|---|--|
| Stairs/Hall | Electric | 855 - Other Installation Issue | Light switch at bottom of stairs, does not turn any lights on or off | 0.25 | | |

Stairs/Hall  
855 - Other Installation Issue  
Light switch at bottom of stairs, does not turn any lights on or off
