New Review - Home Quality Review

| Builder | DRB Group |
|---|---|
| Community | Sidney Creek SF 30's (NC)(RAL) |
| Street Address | 1601 Briar Brook Lane |
| Date | 5/29/2026 |

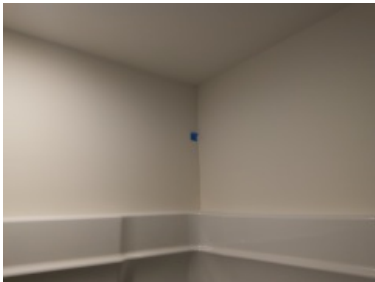
| Room | Trade | Item | Description | Points | Initials | |
|---|---|---|---|---|---|--|
| Bath - Hall | Drywall | 1400D -Damage | Right rear vertical corner above tub surround is wavy/curved | 0.25 | | |

Bath - Hall  
1400D - Damage  
Right rear vertical corner above tub surround is wavy/curved

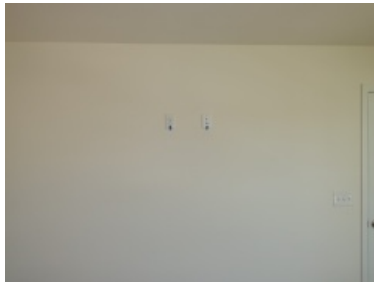
| Room | Trade | Item | Description | Points | Initials | |
|---|---|---|---|---|---|--|
| Bedroom - Owner's | Electric | 810 - Crooked Outlet/Switch | Back wall tv receptacle and data covers are both crooked | 0.25 | | |

Bedroom - Owner's  
810 - Crooked Outlet/Switch  
Back wall tv receptacle and data covers are both crooked

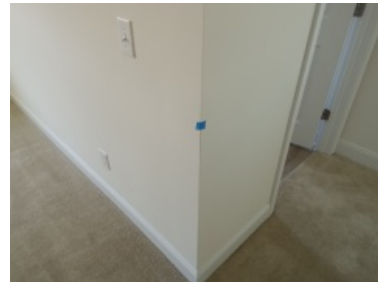
| Room | Trade | Item | Description | Points | Initials | |
|---|---|---|---|---|---|--|
| Bonus | Drywall | 1400D -Damage | 2nd floor bonus room, corner of wall left of laundry room door has a flattened area on the corner edge | 0.25 | | |

Bonus  
1400D - Damage  
2nd floor bonus room, corner of wall left of laundry room door has a flattened area on the corner edge

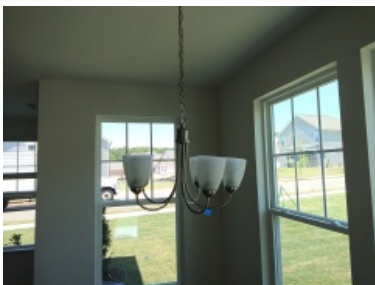
| Room | Trade | Item | Description | Points | Initials | |
|---|---|---|---|---|---|--|
| Dining Room | Electric | 811 - Light Crooked | Pendant light is hanging crooked | 0.25 | | |

Dining Room  
811 - Light Crooked  
Pendant light is hanging crooked

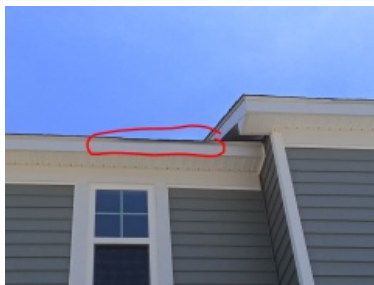
| Room | Trade | Item | Description | Points | Initials | |
|---|---|---|---|---|---|--|
| Exterior | Roofing | 2000D - Damage | 2nd level roof above front porch on left side, the shingle overhang and drip edge is damaged/compressed | 0.25 | | |

Exterior  
2000D - Damage  
2nd level roof above front porch on left side, the shingle overhang and drip edge is damaged/compressed

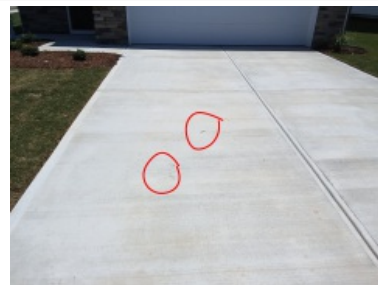
| Room | Trade | Item | Description | Points | Initials | |
|---|---|---|---|---|---|--|
| Exterior | Concrete_Flatwork | 520 - Stain | Dark stains/spots on left side driveway pad | 0.25 | | |

Exterior  
520 - Stain  
Dark stains/spots on left side driveway pad

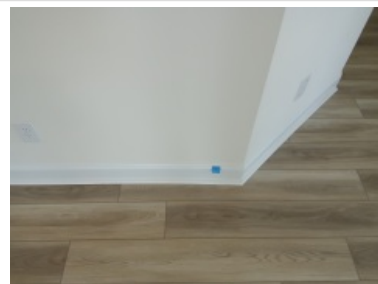
| Room | Trade | Item | Description | Points | Initials | |
|---|---|---|---|---|---|--|
| Family Room | Framing | 1050 - Bowed Wall | Back wall in family room is bowed, far right of pedestrian door to garage | 0.25 | | |

Family Room  
1050 - Bowed Wall  
Back wall in family room is bowed, far right of pedestrian door to garage

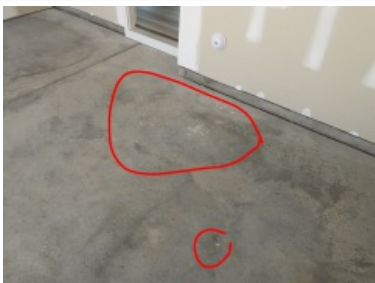
| Room | Trade | Item | Description | Points | Initials | |
|---|---|---|---|---|---|--|
| Garage | Concrete_Flatwork | 520 - Stain | White colored stains on concrete slab floor | 0.25 | | |

Garage  
520 - Stain  
White colored stains on concrete slab floor

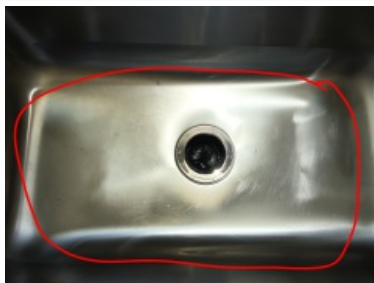
| Room | Trade | Item | Description | Points | Initials | |
|---|---|---|---|---|---|--|
| Kitchen/Dinette | Plumbing | 700D - Damage | Scrapes and scratches throughout bottom of sink | 0.25 | | |

Kitchen/Dinette  
700D - Damage  
Scrapes and scratches throughout bottom of sink

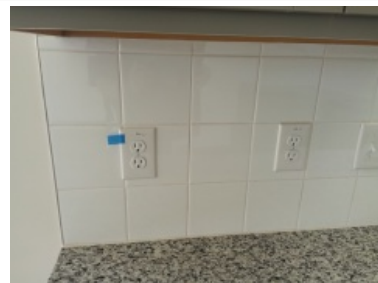
| Room | Trade | Item | Description | Points | Initials | |
|---|---|---|---|---|---|--|
| Kitchen/Dinette | Electric | 810 - Crooked Outlet/Switch | Receptacle cover on far left of backsplash on rear wall, is out of alignment compared to the others | 0.25 | | |

Kitchen/Dinette  
810 - Crooked Outlet/Switch  
Receptacle cover on far left of backsplash on rear wall, is out of alignment compared to the others

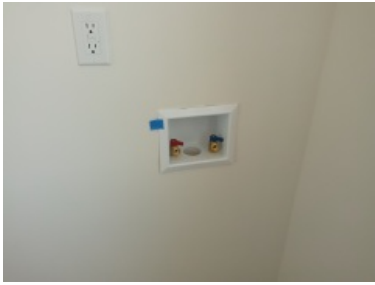
| Room | Trade | Item | Description | Points | Initials | |
|---|---|---|---|---|---|--|
| Laundry Room | Plumbing | 707 - Laundry Supply Box or Shutoff Access Issues | Supply box outer ring is not secure, easily comes off | 0.25 | | |

Laundry Room  
707 - Laundry Supply Box or Shutoff Access Issues  
Supply box outer ring is not secure, easily comes off

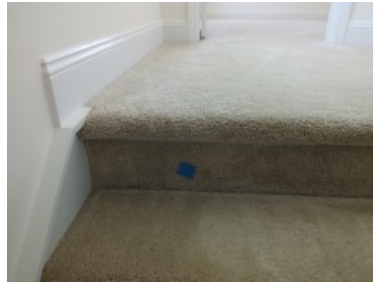
| Room | Trade | Item | Description | Points | Initials | |
|---|---|---|---|---|---|--|
| Stairs/Hall | Flooring | 1350 - Carpet Installation | Mud/orange spot on left side of top rise of steps | 0.25 | | |

Stairs/Hall  
1350 - Carpet Installation  
Mud/orange spot on left side of top rise of steps
