| Builder | DRB Group |
| Community | Sidney Creek SF 30's (NC)(RAL) |
| Street Address | 1589 Briar Brook Lane |
| Date | 6/10/2026 |

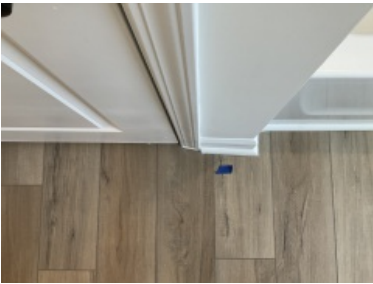
| Room | Trade | Item | Description | Points | Initials | |
|---|---|---|---|---|---|--|
| Bath - Hall | Interior_Trim | 1560 - Out of plumb/square | Shoe mould on right side of linen closet not square with floor | 0.25 | | |

Bath - Hall  
1560 - Out of plumb/square  
Shoe mould on right side of linen closet not square with floor

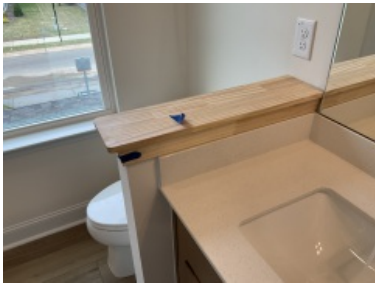
| Room | Trade | Item | Description | Points | Initials | |
|---|---|---|---|---|---|--|
| Bath - Hall | Paint | 1730 - Item Not Painted | Trim on left side of vanity not painted | 0.25 | | |

Bath - Hall  
1730 - Item Not Painted  
Trim on left side of vanity not painted

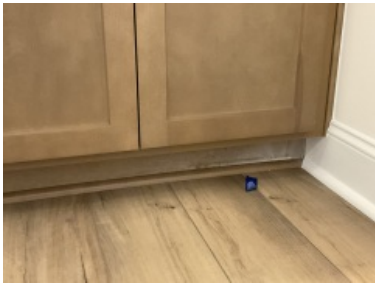
| Room | Trade | Item | Description | Points | Initials | |
|---|---|---|---|---|---|--|
| Bath - Owner's | Cleaning | TIC | Paint overspray on right side of vanity toe kick | 0 | | |

Bath - Owner's  
TIC  
Paint overspray on right side of vanity toe kick

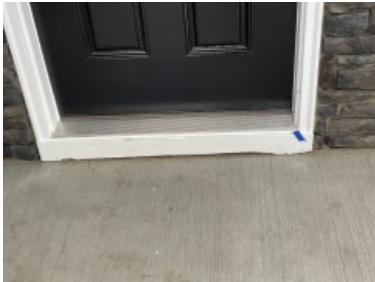
| Room | Trade | Item | Description | Points | Initials | |
|---|---|---|---|---|---|--|
| Exterior | Exterior_Trim | 20000D - Damage | Kick board at front door miscut along bottom and right edge | 0.25 | | |

Exterior  
20000D - Damage  
Kick board at front door miscut along bottom and right edge

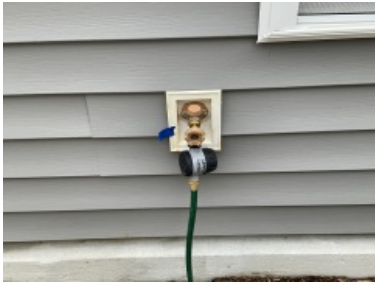
| Room | Trade | Item | Description | Points | Initials | |
|---|---|---|---|---|---|--|
| Exterior | Exterior_Trim | 20000D - Damage | Trim at left side hose bib stained | 0.25 | | |

Exterior  
20000D - Damage  
Trim at left side hose bib stained

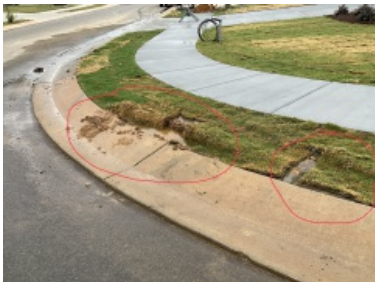
| Room | Trade | Item | Description | Points | Initials | |
|---|---|---|---|---|---|--|
| Exterior | Landscaping | 300D - Damage | Sod in left side of front yard at curb disturbed | 0.25 | | |

Exterior  
300D - Damage  
Sod in left side of front yard at curb disturbed

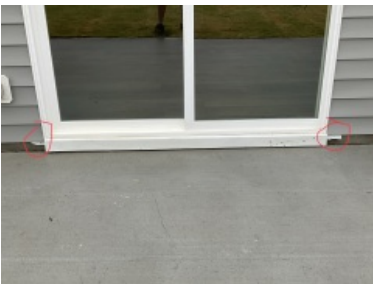
| Room | Trade | Item | Description | Points | Initials | |
|---|---|---|---|---|---|--|
| Exterior | Siding | 4000 - Miscellaneous | House wrap visible on both sides of SGD | 0.25 | | |

Exterior  
4000 - Miscellaneous  
House wrap visible on both sides of SGD

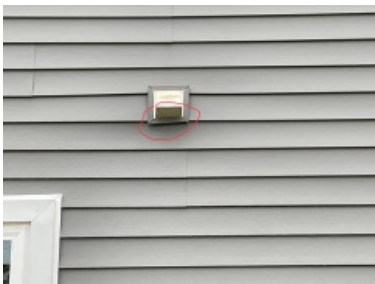
| Room | Trade | Item | Description | Points | Initials | |
|---|---|---|---|---|---|--|
| Exterior | Siding | 4020 - J Channel/Trim Not Square | Bottom j channel at right side vent crooked | 0.25 | | |

Exterior  
4020 - J Channel/Trim Not Square  
Bottom j channel at right side vent crooked

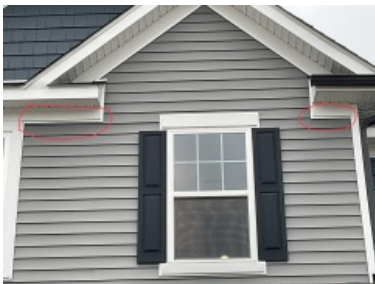
| Room | Trade | Item | Description | Points | Initials | |
|---|---|---|---|---|---|--|
| Exterior | Siding | 4020 - J Channel/Trim Not Square | Inconsistent reveal between siding and j channel at front water tables | 0.25 | | |

Exterior  
4020 - J Channel/Trim Not Square  
Inconsistent reveal between siding and j channel at front water tables

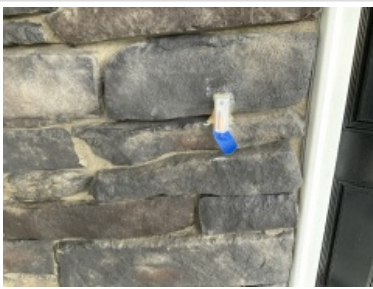
| Room | Trade | Item | Description | Points | Initials | |
|---|---|---|---|---|---|--|
| Exterior | Brick_Stone_Stucco | 5000 - Miscellaneous | Excess caulk at door chime button | 0.25 | | |

Exterior  
5000 - Miscellaneous  
Excess caulk at door chime button

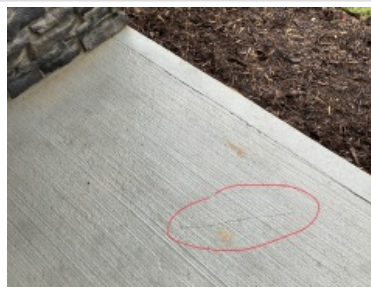
| Room | Trade | Item | Description | Points | Initials | |
|---|---|---|---|---|---|--|
| Exterior | Concrete_Flatwork | 500D - Damage | Gouge in right side of front porch slab | 0.25 | | |

Exterior  
500D - Damage  
Gouge in right side of front porch slab

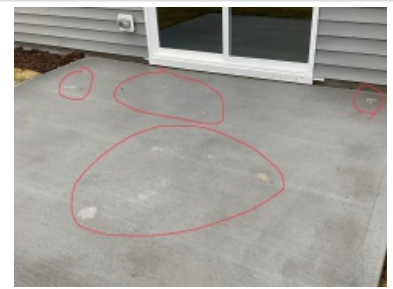
| Room | Trade | Item | Description | Points | Initials | |
|---|---|---|---|---|---|--|
| Exterior | Concrete_Flatwork | 520 - Stain | Patio slab stained | 0.25 | | |

Exterior  
520 - Stain  
Patio slab stained

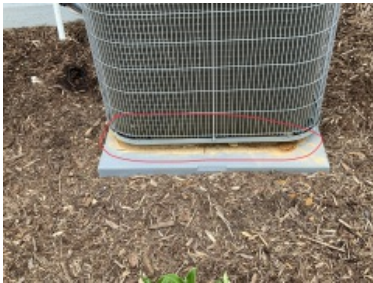
| Room | Trade | Item | Description | Points | Initials | |
|---|---|---|---|---|---|--|
| Exterior | HVAC | 600 - Miscellaneous | Mud on hvac platform | 0.25 | | |

Exterior  
600 - Miscellaneous  
Mud on hvac platform

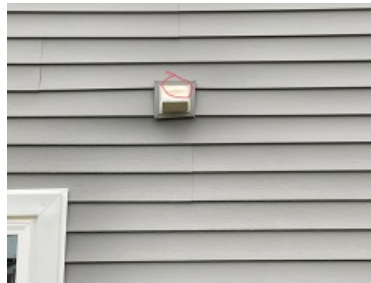
| Room | Trade | Item | Description | Points | Initials | |
|---|---|---|---|---|---|--|
| Exterior | HVAC | 600D - Damage | Trim at right side vent stained | 0.25 | | |

Exterior  
600D - Damage  
Trim at right side vent stained

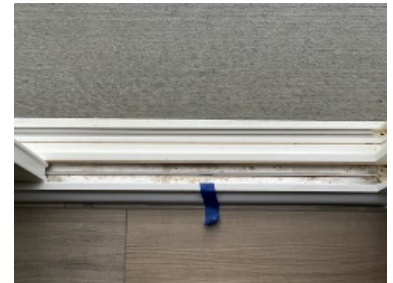
| Room | Trade | Item | Description | Points | Initials | |
|---|---|---|---|---|---|--|
| Exterior | Cleaning | TIC | SGD track dirty | 0 | | |

Exterior  
TIC  
SGD track dirty

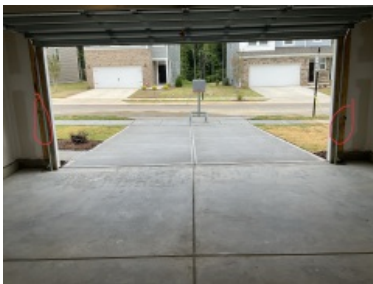
| Room | Trade | Item | Description | Points | Initials | |
|---|---|---|---|---|---|--|
| Garage | Framing | 1000 - Miscellaneous | Black marks on framing on each side of garage door | 0.25 | | |

Garage  
1000 - Miscellaneous  
Black marks on framing on each side of garage door

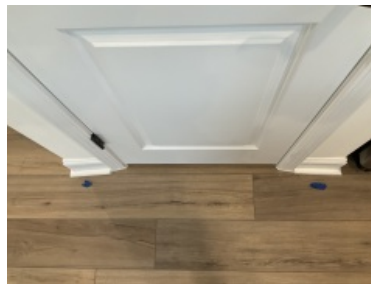
| Room | Trade | Item | Description | Points | Initials | |
|---|---|---|---|---|---|--|
| Kitchen/Dinette | Interior_Trim | 1560 - Out of plumb/square | Shoe mould on each side of pantry door not square with floor | 0.25 | | |

Kitchen/Dinette  
1560 - Out of plumb/square  
Shoe mould on each side of pantry door not square with floor

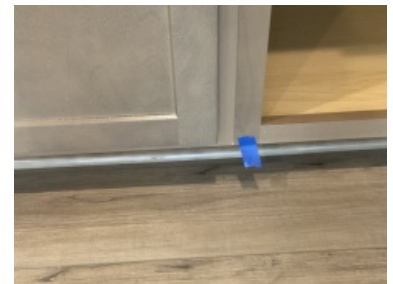
| Room | Trade | Item | Description | Points | Initials | |
|---|---|---|---|---|---|--|
| Kitchen/Dinette | Cabinets | 1600D - Damage | Bottom frame at 1st and 2nd base cabinets intersection right of refrigerator chipped | 0.25 | | |

Kitchen/Dinette  
1600D - Damage  
Bottom frame at 1st and 2nd base cabinets intersection right of refrigerator chipped

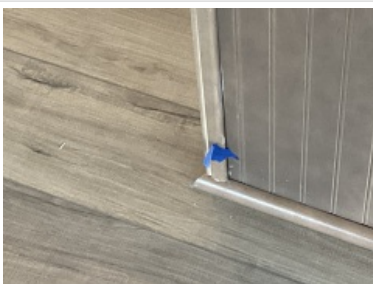
| Room | Trade | Item | Description | Points | Initials | |
|---|---|---|---|---|---|--|
| Kitchen/Dinette | Cabinets | 1600D - Damage | Front comer trim on left side of island chipped | 0.25 | | |

Kitchen/Dinette  
1600D - Damage  
Front corner trim on left side of island chipped

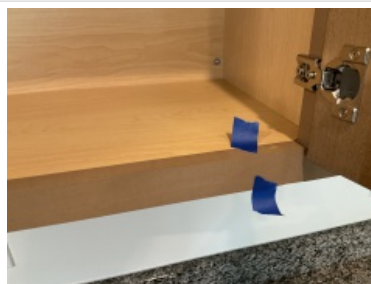
| Room | Trade | Item | Description | Points | Initials | |
|---|---|---|---|---|---|--|
| Kitchen/Dinette | Cabinets | 1600D - Damage | Wall cabinet right of refrigerator, bottom frame on right side damaged | 0.25 | | |

Kitchen/Dinette  
1600D - Damage  
Wall cabinet right of refrigerator, bottom frame on right side damaged

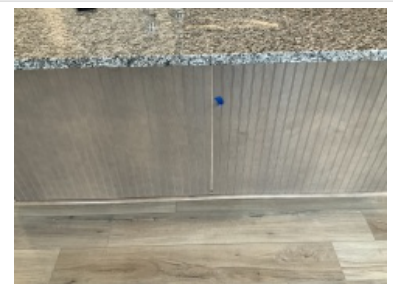
| Room | Trade | Item | Description | Points | Initials | |
|---|---|---|---|---|---|--|
| Kitchen/Dinette | Cabinets | 1605 - Missing Pieces | Crack between bead board on front of island | 0.25 | | |

Kitchen/Dinette  
1605 - Missing Pieces  
Crack between bead board on front of island

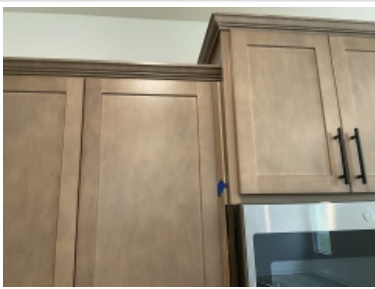
| Room | Trade | Item | Description | Points | Initials | |
|---|---|---|---|---|---|--|
| Kitchen/Dinette | Cabinets | 1610 - Manufacturer | Filler strip left of microwave not matching cabinets | 0.25 | | |

Kitchen/Dinette  
1610 - Manufacturer  
Filler strip left of microwave not matching cabinets

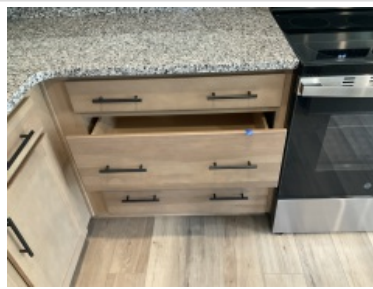
| Room | Trade | Item | Description | Points | Initials | |
|---|---|---|---|---|---|--|
| Kitchen/Dinette | Cabinets | 1630 - Drawer/Door Issue | Middle drawer left of range tight | 0.25 | | |

Kitchen/Dinette  
1630 - Drawer/Door Issue  
Middle drawer left of range tight

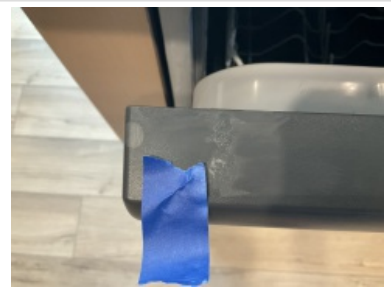
| Room | Trade | Item | Description | Points | Initials | |
|---|---|---|---|---|---|--|
| Kitchen/Dinette | Appliances | 1800D - Damage | Top left of dishwasher door stained | 0.25 | | |

Kitchen/Dinette  
1800D - Damage  
Top left of dishwasher door stained

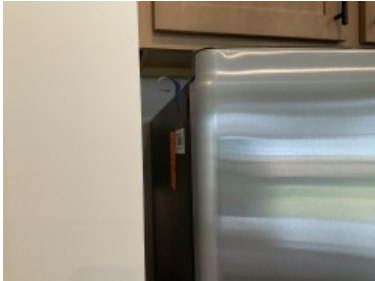
| Room | Trade | Item | Description | Points | Initials | |
|---|---|---|---|---|---|--|
| Kitchen/Dinette | Cleaning | 1925 - Shipping Materials/Labels | Labels on left side of refrigerator | 0.25 | | |

Kitchen/Dinette  
1925 - Shipping Materials/Labels  
Labels on left side of refrigerator
