| Builder | DRB Group |
| Community | Sidney Creek SF 30's (NC)(RAL) |
| Street Address | 1577 Briar Brook Lane |
| Date | 5/12/2026 |

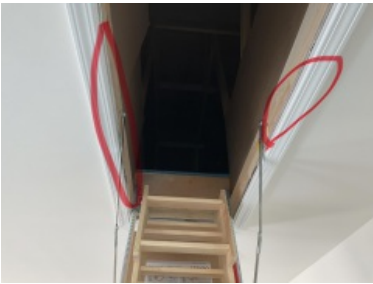
| Room | Trade | Item | Description | Points | Initials | |
|---|---|---|---|---|---|--|
| Attic | Doors | 50000D - Damage | Weatherstripping on attic access door is partially painted in various areas | 0.25 | | |

Attic  
50000D - Damage  
Weatherstripping on attic access door is partially painted in various areas

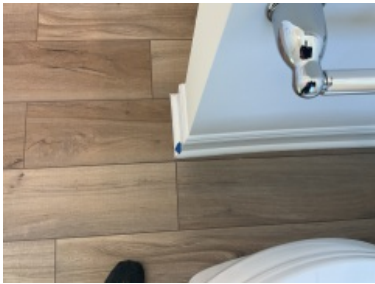
| Room | Trade | Item | Description | Points | Initials | |
|---|---|---|---|---|---|--|
| Bath - Hall | Framing | 1030 - Out of Square/Level | Half wall with toilet paper holder on it is not square to floor | 0.25 | | |

Bath - Hall  
1030 - Out of Square/Level  
Half wall with toilet paper holder on it is not square to floor

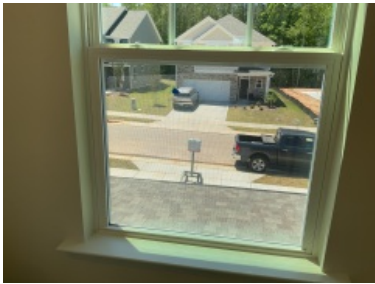
| Room | Trade | Item | Description | Points | Initials | |
|---|---|---|---|---|---|--|
| Bath - Hall | Windows | 13010 - Difficult to Open | Window will not open | 0.25 | | |

Bath - Hall  
13010 - Difficult to Open  
Window will not open

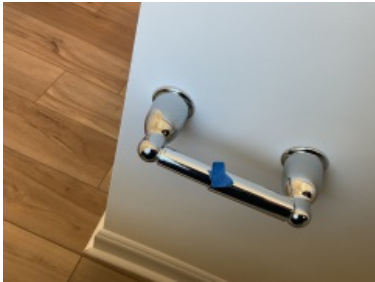
| Room | Trade | Item | Description | Points | Initials | |
|---|---|---|---|---|---|--|
| Bath - Hall | Bath_Accessories | 18050D - Damage | Toilet paper holder is scratched | 0.25 | | |

Bath - Hall  
18050D - Damage  
Toilet paper holder is scratched

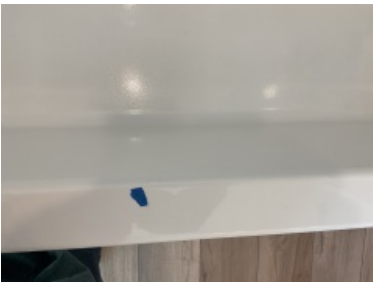
| Room | Trade | Item | Description | Points | Initials | |
|---|---|---|---|---|---|--|
| Bath - Hall | Plumbing | 700D - Damage | Scratches on inside top edge of tub across from toilet | 0.25 | | |

Bath - Hall  
700D - Damage  
Scratches on inside top edge of tub across from toilet

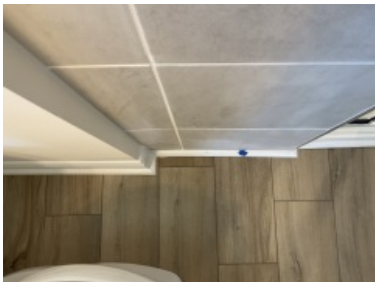
| Room | Trade | Item | Description | Points | Initials | |
|---|---|---|---|---|---|--|
| Bath - Owner's | Framing | 1030 - Out of Square/Level | Small pony wall left of glass door to shower is not square | 0.25 | | |

Bath - Owner's  
1030 - Out of Square/Level  
Small pony wall left of glass door to shower is not square

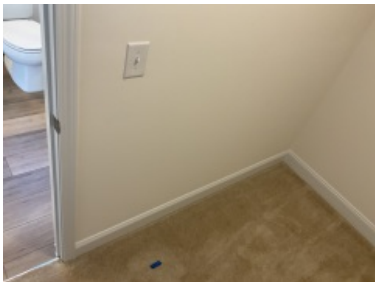
| Room | Trade | Item | Description | Points | Initials | |
|---|---|---|---|---|---|--|
| Bath - Owner's | Framing | 1076 - Floor Squeak | Floor squeak in closet in front of switch | 0.25 | | |

Bath - Owner's  
1076 - Floor Squeak  
Floor squeak in closet in front of switch

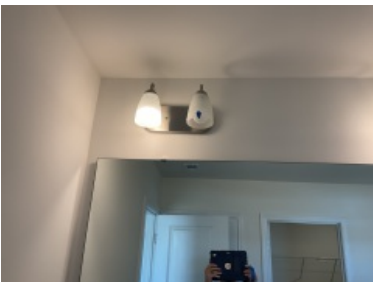
| Room | Trade | Item | Description | Points | Initials | |
|---|---|---|---|---|---|--|
| Bath - Owner's | Electric | 807 - Bulb Burned Out or Missing | Bulb out in vanity light over left sink | 0.25 | | |

Bath - Owner's  
807 - Bulb Burned Out or Missing  
Bulb out in vanity light over left sink

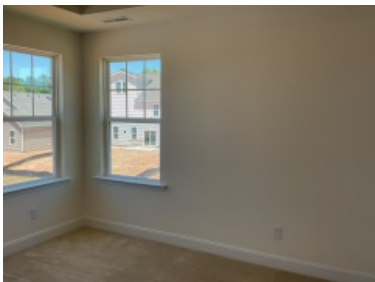
| Room | Trade | Item | Description | Points | Initials | |
|---|---|---|---|---|---|--|
| Bedroom - Owner's | Windows | 13010 - Difficult to Open | The left window on the back wall is very difficult to open/close | 0.25 | | |

Bedroom - Owner's  
13010 - Difficult to Open  
The left window on the back wall is very difficult to open/close

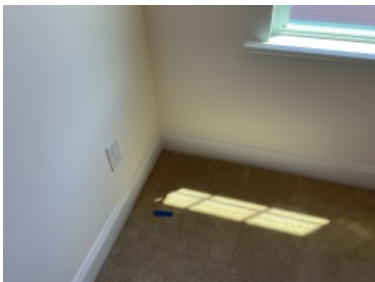
| Room | Trade | Item | Description | Points | Initials | |
|---|---|---|---|---|---|--|
| Bedroom 1 | Framing | 1076 - Floor Squeak | Floor squeak in back left corner of room, left of window in back right bedroom | 0.25 | | |

Bedroom 1  
1076 - Floor Squeak  
Floor squeak in back left corner of room, left of window in back right bedroom

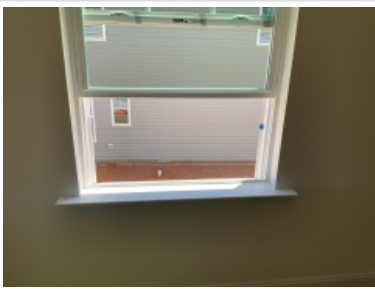
| Room | Trade | Item | Description | Points | Initials | |
|---|---|---|---|---|---|--|
| Bedroom 1 | Windows | 13005 - Missing Pieces | The window in the back right bedroom is missing a screen | 0.25 | | |

Bedroom 1  
13005 - Missing Pieces  
The window in the back right bedroom is missing a screen

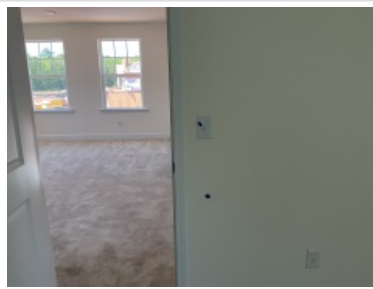
| Room | Trade | Item | Description | Points | Initials | |
|---|---|---|---|---|---|--|
| Bedroom 1 | Electric | 810 - Crooked Outlet/Switch | Light switch is crooked in the back right bedroom | 0.25 | | |

Bedroom 1  
810 - Crooked Outlet/Switch  
Light switch is crooked in the back right bedroom

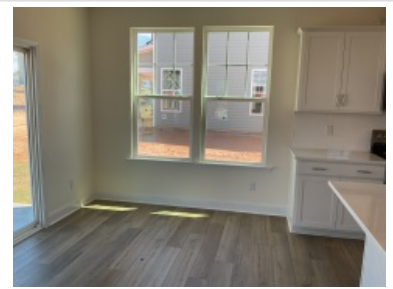
| Room | Trade | Item | Description | Points | Initials | |
|---|---|---|---|---|---|--|
| Dining Room | Windows | 13010 - Difficult to Open | Both windows in the dining room are very hard to open and close | 0.25 | | |

Dining Room  
13010 - Difficult to Open  
Both windows in the dining room are very hard to open and close

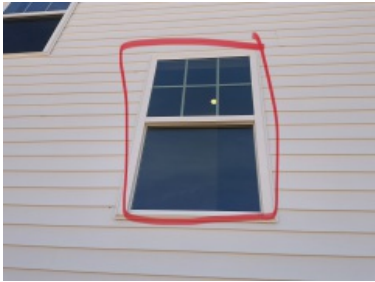
| Room | Trade | Item | Description | Points | Initials | |
|---|---|---|---|---|---|--|
| Exterior | Windows | 13005 - Missing Pieces | Window in the middle of the left side of the house about 8 feet off the ground is missing a screen | 0.25 | | |

Exterior  
13005 - Missing Pieces  
Window in the middle of the left side of the house about 8 feet off the ground is missing a screen

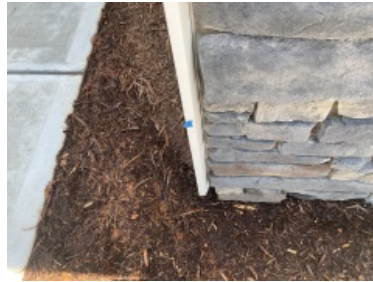
| Room | Trade | Item | Description | Points | Initials | |
|---|---|---|---|---|---|--|
| Exterior | Siding | 4000D - Damage | Corner board right of garage door is dented on the edge | 0.25 | | |

Exterior  
4000D - Damage  
Corner board right of garage door is dented on the edge

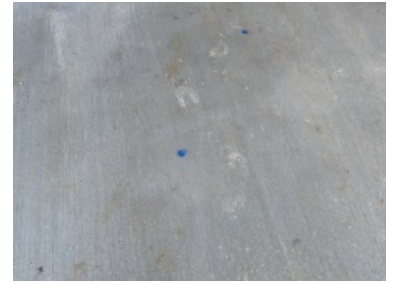
| Room | Trade | Item | Description | Points | Initials | |
|---|---|---|---|---|---|--|
| Exterior | Concrete_Flatwork | 500D - Damage | Hole in front porch stoop in the middle | 0.25 | | |

Exterior  
500D - Damage  
Hole in front porch stoop in the middle

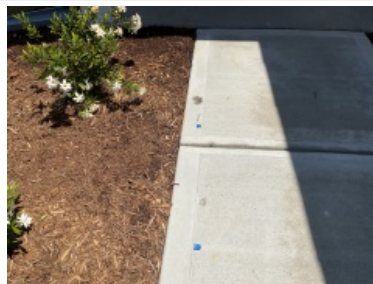
| Room | Trade | Item | Description | Points | Initials | |
|---|---|---|---|---|---|--|
| Exterior | Concrete_Flatwork | 500D - Damage | Several holes in the lead walk on the left edge | 0.25 | | |

Exterior  
500D - Damage  
Several holes in the lead walk on the left edge

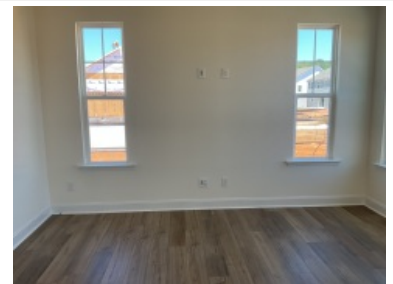
| Room | Trade | Item | Description | Points | Initials | |
|---|---|---|---|---|---|--|
| Family Room | Windows | 13010 - Difficult to Open | Both windows on the left wall are very hard to open and close | 0.25 | | |

Family Room  
13010 - Difficult to Open  
Both windows on the left wall are very hard to open and close

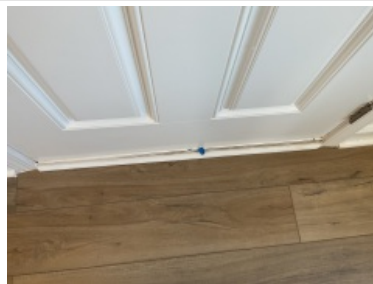
| Room | Trade | Item | Description | Points | Initials | |
|---|---|---|---|---|---|--|
| Foyer | Doors | 50000D - Damage | Interior door sweep to front door is partially painted | 0.25 | | |

Foyer  
50000D - Damage  
Interior door sweep to front door is partially painted

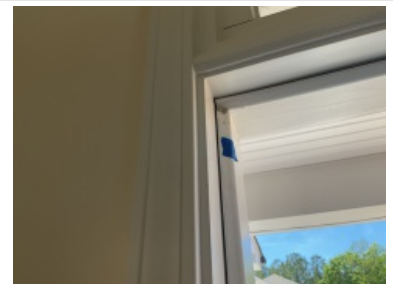
| Room | Trade | Item | Description | Points | Initials | |
|---|---|---|---|---|---|--|
| Foyer | Doors | 50020 - Weather Stripping Torn | Hole in weatherstripping near the top on the strike plate side | 0.25 | | |

Foyer  
50020 - Weather Stripping Torn  
Hole in weatherstripping near the top on the strike plate side

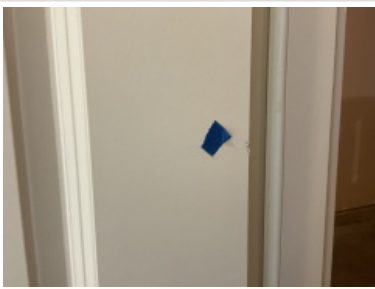
| Room | Trade | Item | Description | Points | Initials | |
|---|---|---|---|---|---|--|
| Garage | Doors | 50000D - Damage | Fire door is gouged on inside edge near the middle hinge | 0.25 | | |

Garage  
50000D - Damage  
Fire door is gouged on inside edge near the middle hinge

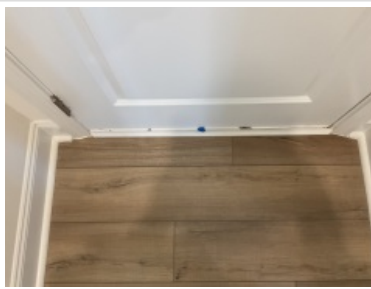
| Room | Trade | Item | Description | Points | Initials | |
|---|---|---|---|---|---|--|
| Garage | Doors | 50000D - Damage | Interior door sweep to fire door is partially painted | 0.25 | | |

Garage  
50000D - Damage  
Interior door sweep to fire door is partially painted

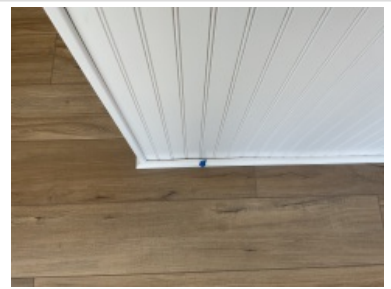
| Room | Trade | Item | Description | Points | Initials | |
|---|---|---|---|---|---|--|
| Kitchen/Dinette | Interior_Trim | 1510 - Not Pieced Together Well | Inconsistent gap between shoe mold and bead board on left side at front of island | 0.25 | | |

Kitchen/Dinette  
1510 - Not Pieced Together Well  
Inconsistent gap between shoe mold and bead board on left side at front of island

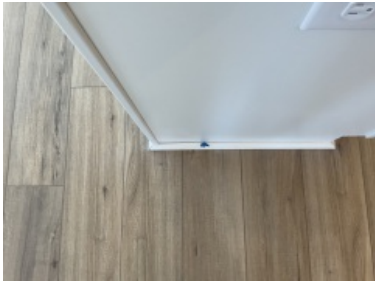
| Room | Trade | Item | Description | Points | Initials | |
|---|---|---|---|---|---|--|
| Kitchen/Dinette | Interior_Trim | 1510 - Not Pieced Together Well | Inconsistent gap between shoe mold and left panel of island facing family room or stairs | 0.25 | | |

Kitchen/Dinette  
1510 - Not Pieced Together Well  
Inconsistent gap between shoe mold and left panel of island facing family room or stairs

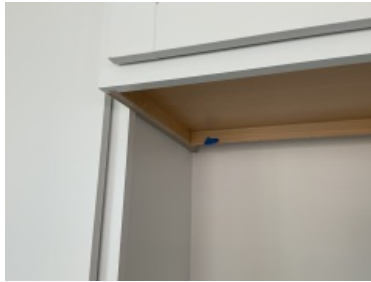
| Room | Trade | Item | Description | Points | Initials | |
|---|---|---|---|---|---|--|
| Kitchen/Dinette | Cabinets | 1600D - Damage | Nail sticking out on back of cabinet over refrigerator area on the left side | 0.25 | | |

Kitchen/Dinette  
1600D - Damage  
Nail sticking out on back of cabinet over refrigerator area on the left side

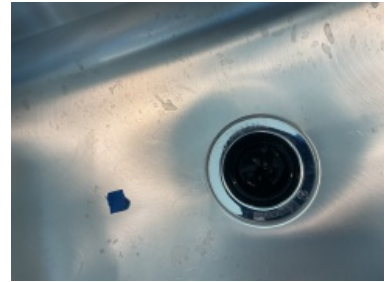
| Kitchen/Dinette | Plumbing | 700D - Damage | Scratches in the bottom of the sink, left of the drain | 0.25 | | |

Kitchen/Dinette  
700D - Damage  
Scratches in the bottom of the sink, left of the drain

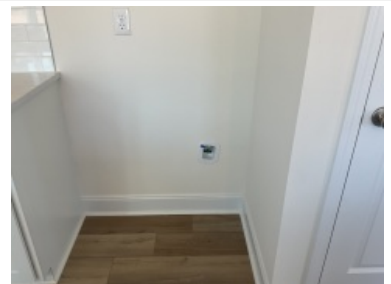
| Kitchen/Dinette | Plumbing | 701 - Fixture Improperly Installed (ex: not square) | Water valve for refrigerator is crooked | 0.25 | | |

Kitchen/Dinette  
701 - Fixture Improperly Installed (ex: not square)  
Water valve for refrigerator is crooked

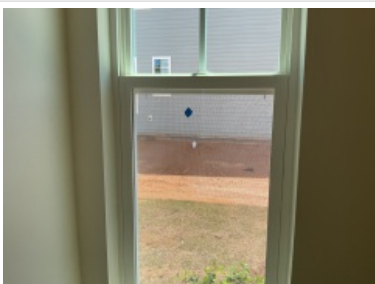
| Laundry Room | Windows | 13010 - Difficult to Open | Window will not open | 0.25 | | |

Laundry Room  
13010 - Difficult to Open  
Window will not open

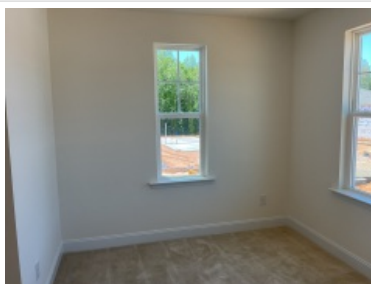
| Loft | Windows | 13010 - Difficult to Open | Small window in loft on front wall will not open | 0.25 | | |

Loft  
13010 - Difficult to Open  
Small window in loft on front wall will not open

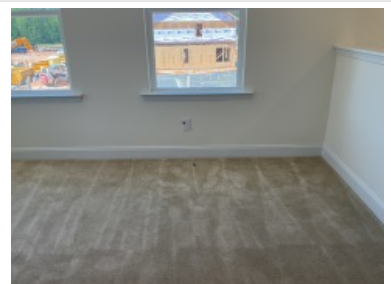
| Loft | Electric | 810 - Crooked Outlet/Switch | Outlet is crooked under right window on long wall | 0.25 | | |

Loft  
810 - Crooked Outlet/Switch  
Outlet is crooked under right window on long wall

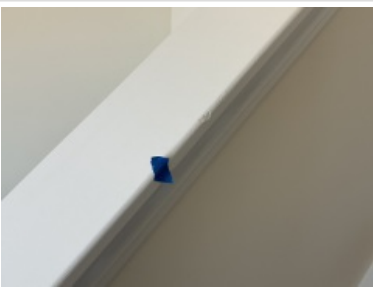
| Stairs/Hall | Interior_Trim | 1500D - Damage | The right edge of the cap board going from the the landing to the second floor is gouged | 0.25 | | |

Stairs/Hall  
1500D - Damage  
The right edge of the cap board going from the the landing to the second floor is gouged

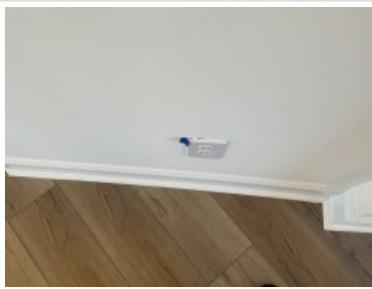
| Stairs/Hall | Electric | 810 - Crooked Outlet/Switch | Outlet on angled hallway, right of coat closet is not flush with drywall | 0.25 | | |

Stairs/Hall  
810 - Crooked Outlet/Switch  
Outlet on angled hallway, right of coat closet is not flush with drywall
