| Builder | DRB Group |
| Community | Sidney Creek SF 40's (NC)(RAL) |
| Street Address | 532 Hipwood Dr. |
| Date | 6/17/2026 |

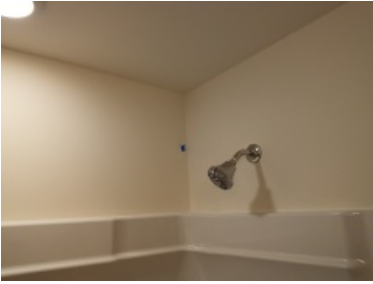
| Room | Trade | Item | Description | Points | Initials | |
|---|---|---|---|---|---|--|
| Bath - Hall | Drywall | 1410 - Major Drywal Issue | Vertical corner, left of shower head, above tub enclosure/surround is bowed | 0.25 | | |

Bath - Hall  
1410 - Major Drywal Issue  
Vertical corner, left of shower head, above tub enclosure/surround is bowed

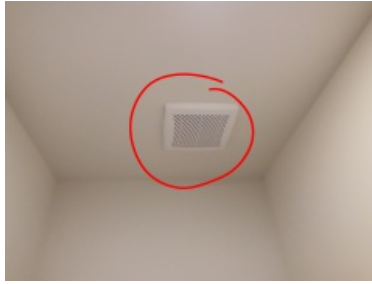
| Room | Trade | Item | Description | Points | Initials | |
|---|---|---|---|---|---|--|
| Bath - Owner's | HVAC | 615 - Bath Exhaust Issues | Exhaust fan in toilet closet is not working | 0.25 | | |

Bath - Owner's  
615 - Bath Exhaust Issues  
Exhaust fan in toilet closet is not working

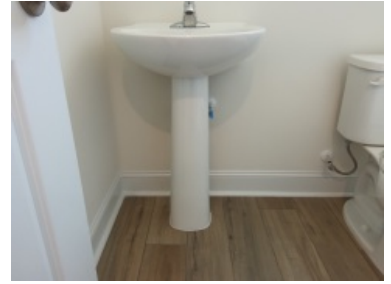
| Room | Trade | Item | Description | Points | Initials | |
|---|---|---|---|---|---|--|
| Bath - Powder | Plumbing | 721 - Pedastal Sink Water Lines Visible | Water line visible on right side of pedestal sink | 0.25 | | |

Bath - Powder  
721 - Pedastal Sink Water Lines Visible  
Water line visible on right side of pedestal sink

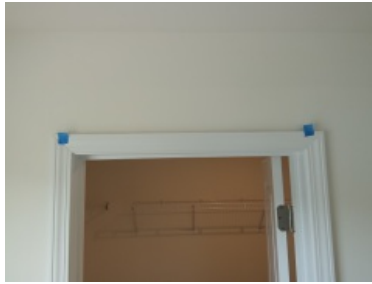
| Room | Trade | Item | Description | Points | Initials | |
|---|---|---|---|---|---|--|
| Bedroom - Owner's | Interior_Trim | 1510 - Not Pieced Together Well | Right and left mitered top corners of closet door are not pieced together well | 0.25 | | |

Bedroom - Owner's  
1510 - Not Pieced Together Well  
Right and left mitered top corners of closet door are not pieced together well

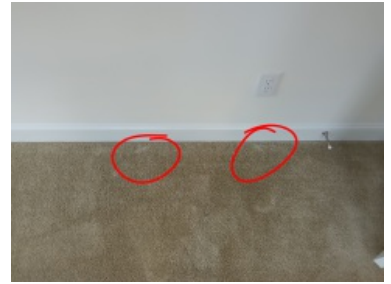
| Room | Trade | Item | Description | Points | Initials | |
|---|---|---|---|---|---|--|
| Bedroom 1 | Flooring | 1300D - Damage | BR1, front left, White marks on carpet, back wall, left of door stop | 0.25 | | |

Bedroom 1  
1300D - Damage  
BR1, front left, White marks on carpet, back wall, left of door stop

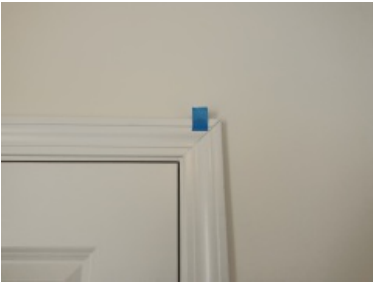
| Room | Trade | Item | Description | Points | Initials | |
|---|---|---|---|---|---|--|
| Bedroom 2 | Interior_Trim | 1510 - Not Pieced Together Well | BR2, left rear, case molding to closet, top right mitered corner is not pieced together well | 0.25 | | |

Bedroom 2  
1510 - Not Pieced Together Well  
BR2, left rear, case molding to closet, top right mitered corner is not pieced together well

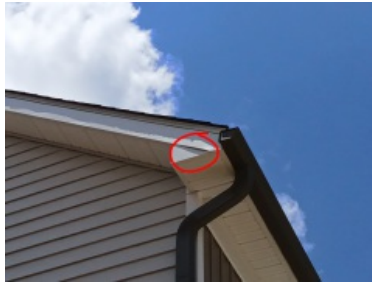
| Room | Trade | Item | Description | Points | Initials | |
|---|---|---|---|---|---|--|
| Exterior | Exterior_Trim | 20000 - Miscellaneous | House left, metal is not secured flush at right end of rake, behind gutter | 0.25 | | |

Exterior  
20000 - Miscellaneous  
House left, metal is not secured flush at right end of rake, behind gutter

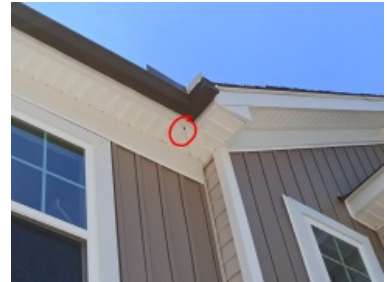
| Room | Trade | Item | Description | Points | Initials | |
|---|---|---|---|---|---|--|
| Exterior | Exterior_Trim | 20050 - Ext. Trim Miscut | 2nd level soffit. Open gap at corner of soffit, above right side of garage door. | 0.25 | | |

Exterior  
20050 - Ext. Trim Miscut  
2nd level soffit. Open gap at corner of soffit, above right side of garage door.

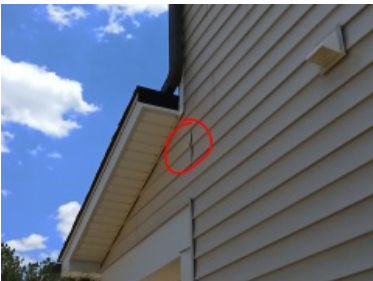
| Room | Trade | Item | Description | Points | Initials | |
|---|---|---|---|---|---|--|
| Exterior | Siding | 4000 - Miscellaneous | Right side of front porch roof, beneath downspout, a piece of siding is unzipped | 0.25 | | |

Exterior  
4000 - Miscellaneous  
Right side of front porch roof, beneath downspout, a piece of siding is unzipped

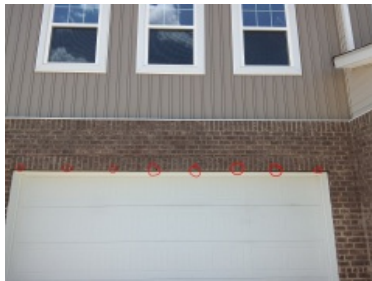
| Room | Trade | Item | Description | Points | Initials | |
|---|---|---|---|---|---|--|
| Exterior | Brick_Stone_Stucco | 5005 - Missing Pieces | Honeycomb/foam blocks are missing at weep holes above garage door lintel | 0.25 | | |

Exterior  
5005 - Missing Pieces  
Honeycomb/foam blocks are missing at weep holes above garage door lintel

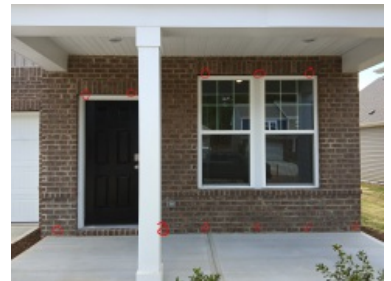
| Room | Trade | Item | Description | Points | Initials | |
|---|---|---|---|---|---|--|
| Exterior | Brick_Stone_Stucco | 5005 - Missing Pieces | Honeycomb/foam inserts missing at weep holes above front door, front windows and along base of front porch wall | 0.25 | | |

Exterior  
5005 - Missing Pieces  
Honeycomb/foam inserts missing at weep holes above front door, front windows and along base of front porch wall

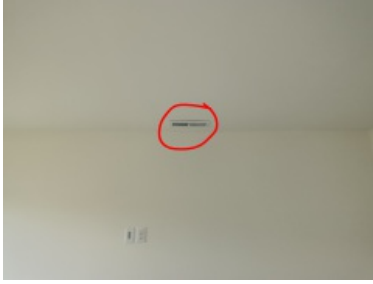
| Room | Trade | Item | Description | Points | Initials | |
|---|---|---|---|---|---|--|
| Family Room | HVAC | 610 - Floor/Ceiling/Wall Register Installation | Ceiling register on right side wall is not flush with ceiling | 0.25 | | |

Family Room  
610 - Floor/Ceiling/Wall Register Installation  
Ceiling register on right side wall is not flush with ceiling

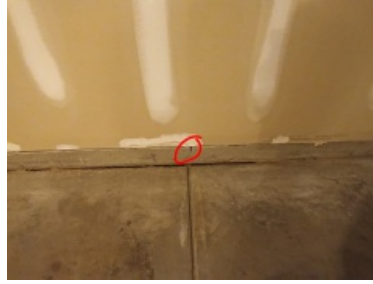
| Room | Trade | Item | Description | Points | Initials | |
|---|---|---|---|---|---|--|
| Garage | Foundation | 400D - Damage | Right side foundation wall in garage, above relief cut in floor, is cut | 0.25 | | |

Garage  
400D - Damage  
Right side foundation wall in garage, above relief cut in floor, is cut

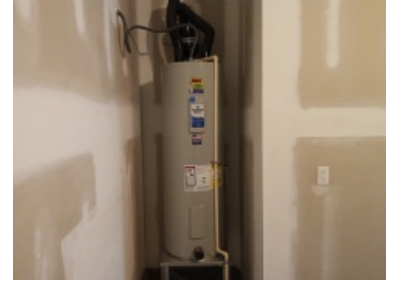
| Room | Trade | Item | Description | Points | Initials | |
|---|---|---|---|---|---|--|
| Garage | Major_Item | No Hotwater | No hot water - whole house | 1 | | |

Garage  
No Hotwater  
No hot water - whole house

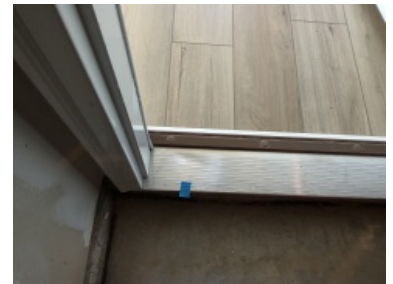
| Room | Trade | Item | Description | Points | Initials | |
|---|---|---|---|---|---|--|
| General | Doors | 50000D - Damage | Threshold is dented on latch side of pedestrian door to garage | 0.25 | | |

General  
50000D - Damage  
Threshold is dented on latch side of pedestrian door to garage

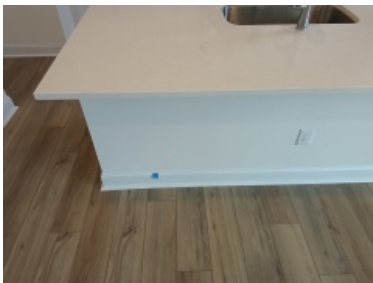
| Room | Trade | Item | Description | Points | Initials | |
|---|---|---|---|---|---|--|
| Kitchen/Dinette | Framing | 1050 - Bowed Wall | Front left side of island wall is bowed | 0.25 | | |

Kitchen/Dinette  
1050 - Bowed Wall  
Front left side of island wall is bowed

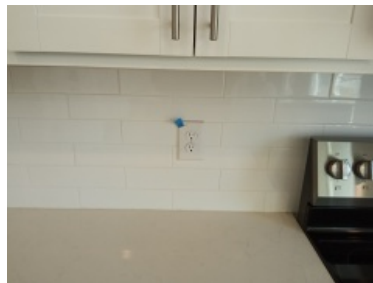
| Room | Trade | Item | Description | Points | Initials | |
|---|---|---|---|---|---|--|
| Kitchen/Dinette | Ceramic | 1220 - Tile Installation Issue | Open gap in tile at top of receptacle left of range | 0.25 | | |

Kitchen/Dinette  
1220 - Tile Installation Issue  
Open gap in tile at top of receptacle left of range

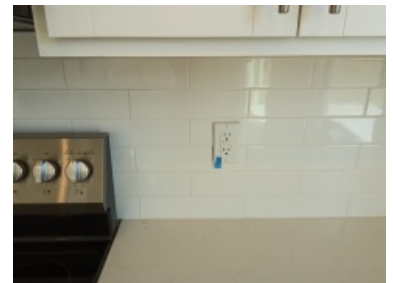
| Room | Trade | Item | Description | Points | Initials | |
|---|---|---|---|---|---|--|
| Kitchen/Dinette | Ceramic | 1220 - Tile Installation Issue | Open gap in tile on left side of receptacle, right of range | 0.25 | | |

Kitchen/Dinette  
1220 - Tile Installation Issue  
Open gap in tile on left side of receptacle, right of range

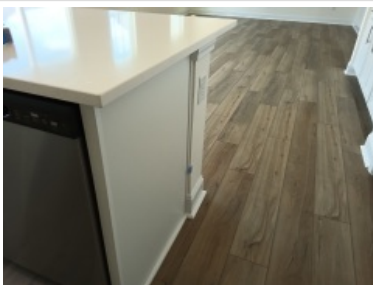
| Room | Trade | Item | Description | Points | Initials | |
|---|---|---|---|---|---|--|
| Kitchen/Dinette | Drywall | 1410 - Major Drywal Issue | Drywall on right outer side of island is bowed/wavy | 0.25 | | |

Kitchen/Dinette  
1410 - Major Drywal Issue  
Drywall on right outer side of island is bowed/wavy

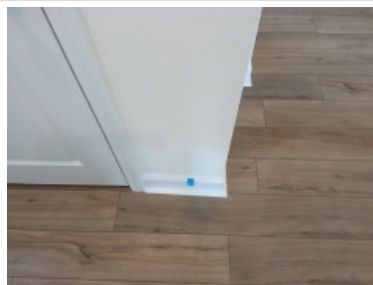
| Room | Trade | Item | Description | Points | Initials | |
|---|---|---|---|---|---|--|
| Stairs/Hall | Framing | 1030 - Out of Square/Level | Wall right of coat closet is not square | 0.25 | | |

Stairs/Hall  
1030 - Out of Square/Level  
Wall right of coat closet is not square

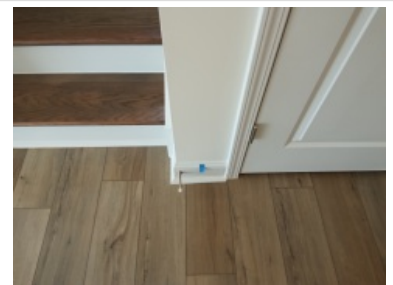
| Room | Trade | Item | Description | Points | Initials | |
|---|---|---|---|---|---|--|
| Stairs/Hall | Framing | 1030 - Out of Square/Level | Wall right of stairway is not square | 0.25 | | |

Stairs/Hall  
1030 - Out of Square/Level  
Wall right of stairway is not square
