| Builder | DRB Group |
| Community | Sidney Creek TH (NC)(RAL) |
| Street Address | 644 Sefton Park Dr. |
| Type | New Review |

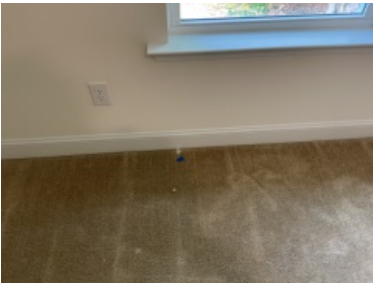
| Room | Trade | Item | Description | Points | Initials | |
|---|---|---|---|---|---|--|
| Bedroom - Owner's | Cleaning | 1905 - Floors Dirty | Stain on master bedroom carpet, back left under window | 0.25 | | |

Bedroom - Owner's  
1905 - Floors Dirty  
Stain on master bedroom carpet, back left under window

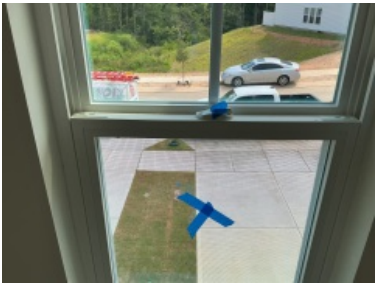
| Room | Trade | Item | Description | Points | Initials | |
|---|---|---|---|---|---|--|
| Bedroom 1 | Windows | 13000D - Damage | Front right bedroom, front window lock is loose and window difficult to open | 0.25 | | |

Bedroom 1  
13000D - Damage  
Front right bedroom, front window lock is loose and window difficult to open

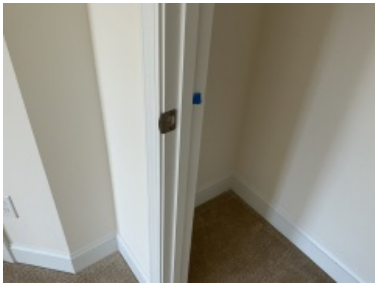
| Room | Trade | Item | Description | Points | Initials | |
|---|---|---|---|---|---|--|
| Bedroom 1 | Doors | 50000D - Damage | Front right bedroom closet door jamb is chipped, left middle side | 0.25 | | |

Bedroom 1  
50000D - Damage  
Front right bedroom closet door jamb is chipped left middle side

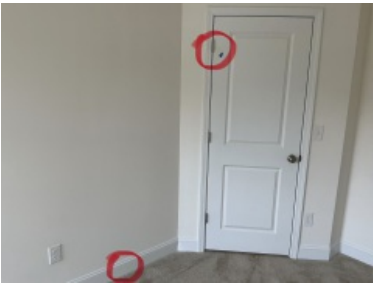
| Room | Trade | Item | Description | Points | Initials | |
|---|---|---|---|---|---|--|
| Bedroom 1 | Doors | 50005 - Missing Pieces | Front right bedroom door missing hinge or base bump | 0.25 | | |

Bedroom 1  
50005 - Missing Pieces  
Front right bedroom door missing hinge or base bump

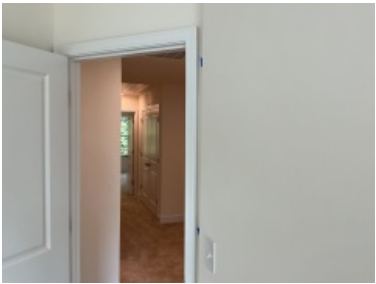
| Room | Trade | Item | Description | Points | Initials | |
|---|---|---|---|---|---|--|
| Bedroom 2 | Interior_Trim | 1500D - Damage | Front left bedroom door casing not flush to wall, inconsistent gaps. Right side, bedroom side | 0.25 | | |

Bedroom 2  
1500D - Damage  
Front left bedroom door casing not flush to wall, inconsistent gaps. Right side, bedroom side

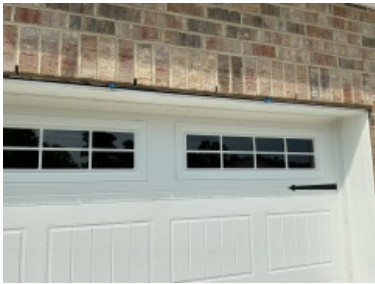
| Room | Trade | Item | Description | Points | Initials | |
|---|---|---|---|---|---|--|
| Exterior | Paint | 1730 - Item Not Painted | Lintel above garage door is not painted at edge | 0.25 | | |

Exterior  
1730 - Item Not Painted  
Lintel above garage door is not painted at edge

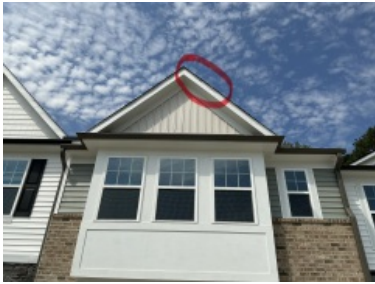
| Room | Trade | Item | Description | Points | Initials | |
|---|---|---|---|---|---|--|
| Exterior | Roofing | 2000D - Damage | Drip edge not flush and is raised, front gable, right side | 0.25 | | |

Exterior  
2000D - Damage  
Drip edge not flush and is raised, front gable, right side

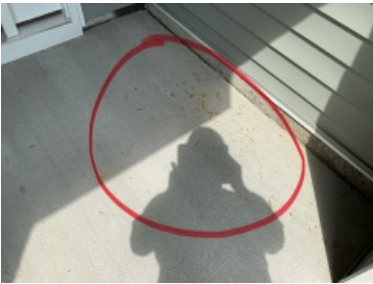
| Room | Trade | Item | Description | Points | Initials | |
|---|---|---|---|---|---|--|
| Exterior | Concrete_Flatwork | 520 - Stain | Stains on front porch slab | 0.25 | | |

Exterior  
520 - Stain  
Stains on front porch slab

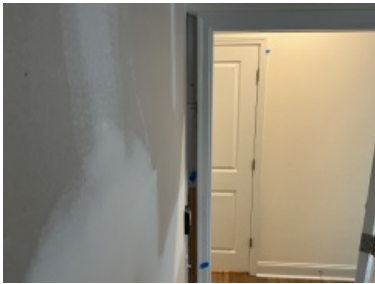
| Room | Trade | Item | Description | Points | Initials | |
|---|---|---|---|---|---|--|
| Garage | Drywall | 1405 - Missing Pieces | Drywall missing, left side of garage entry door, garage side | 0.25 | | |

Garage  
1405 - Missing Pieces  
Drywall missing, left side of garage entry door, garage side

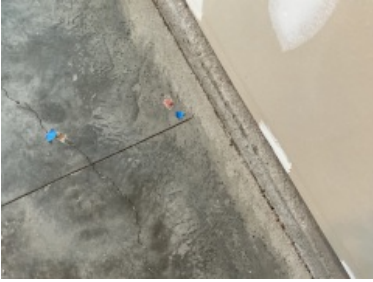
| Room | Trade | Item | Description | Points | Initials | |
|---|---|---|---|---|---|--|
| Garage | Concrete_Flatwork | 500D - Damage | Gouge in garage slab and fire caulk stains | 0.25 | | |

Garage  
500D - Damage  
Gouge in garage slab and fire caulk stains

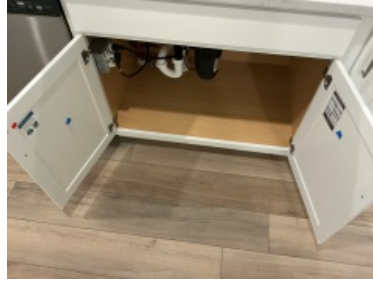
| Room | Trade | Item | Description | Points | Initials | |
|---|---|---|---|---|---|--|
| Kitchen/Dinette | Builder_Specific | 10010 - No Service Contact List | Contractor list missing, cabinet doors under sink | 0.25 | | |

Kitchen/Dinette  
10010 - No Service Contact List  
Contractor list missing, cabinet doors under sink

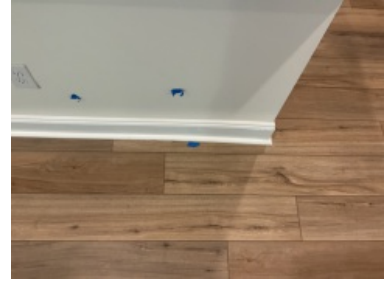
| Room | Trade | Item | Description | Points | Initials | |
|---|---|---|---|---|---|--|
| Kitchen/Dinette | Interior_Trim | 1560 - Out of plumb/square | Front right of kitchen island, base board is bowed | 0.25 | | |

Kitchen/Dinette  
1560 - Out of plumb/square  
Front right of kitchen island, base board is bowed

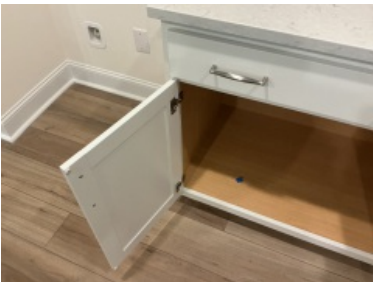
| Room | Trade | Item | Description | Points | Initials | |
|---|---|---|---|---|---|--|
| Kitchen/Dinette | Cabinets | 1600D - Damage | Lower cabinet, right of fridge opening, bottom skin is damaged | 0.25 | | |

Kitchen/Dinette  
1600D - Damage  
Lower cabinet, right of fridge opening, bottom skin is damaged

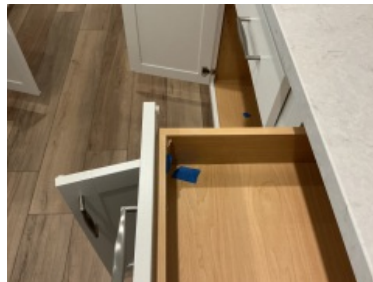
| Room | Trade | Item | Description | Points | Initials | |
|---|---|---|---|---|---|--|
| Kitchen/Dinette | Cabinets | 1630 - Drawer/Door Issue | Top drawer, right of fridge opening is damaged, inside left edge | 0.25 | | |

Kitchen/Dinette  
1630 - Drawer/Door Issue  
Top drawer, right of fridge opening is damaged, inside left edge

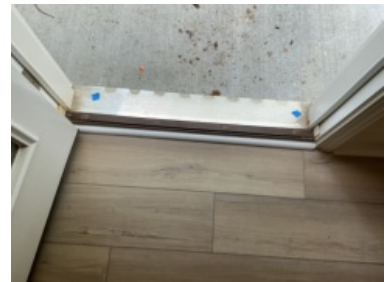
| Room | Trade | Item | Description | Points | Initials | |
|---|---|---|---|---|---|--|
| Kitchen/Dinette | Exterior_Trim | 20070 - Tarnished Threshold | Back entry door, threshold is tarnished | 0.25 | | |

Kitchen/Dinette  
20070 - Tarnished Threshold  
Back entry door, threshold is tarnished

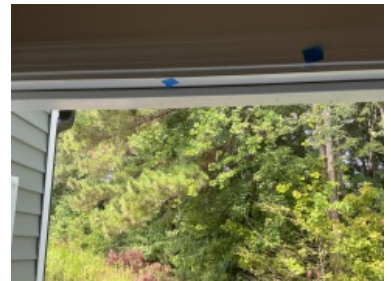
| Room | Trade | Item | Description | Points | Initials | |
|---|---|---|---|---|---|--|
| Kitchen/Dinette | Doors | 50000D - Damage | Chip in top center of back entry door jamb | 0.25 | | |

Kitchen/Dinette  
50000D - Damage  
Chip in top center of back entry door jamb

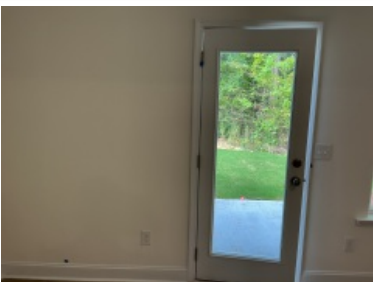
| Room | Trade | Item | Description | Points | Initials | |
|---|---|---|---|---|---|--|
| Kitchen/Dinette | Doors | 50005 - Missing Pieces | Back entry door is missing hinge or basebump | 0.25 | | |

Kitchen/Dinette  
50005 - Missing Pieces  
Back entry door is missing hinge or basebump

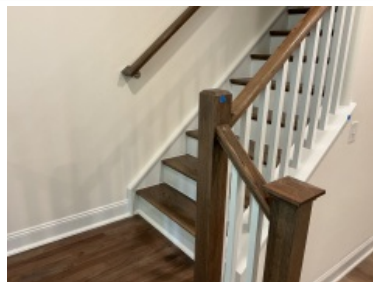
| Room | Trade | Item | Description | Points | Initials | |
|---|---|---|---|---|---|--|
| Stairs/Hall | Stairs_and_Rails | 21005 - Missing Pieces | Newel post top cap missing , bottom right of stairs at first landing | 0.25 | | |

Stairs/Hall  
21005 - Missing Pieces  
Newel post top cap missing , bottom right of stairs at first landing
