| Builder | DRB Group |
| Community | Sidney Creek TH (NC)(RAL) |
| Street Address | 672 Sefton Park Dr. |
| Type | New Review |

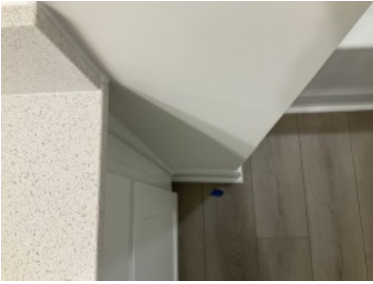
| Room | Trade | Item | Description | Points | Initials | |
|---|---|---|---|---|---|--|
| Bath - Hall | Interior_Trim | 1560 - Out of plumb/square | Shoe mould right of vanity not square with floor | 0.25 | | |

Bath - Hall  
1560 - Out of plumb/square  
Shoe mould right of vanity not square with floor

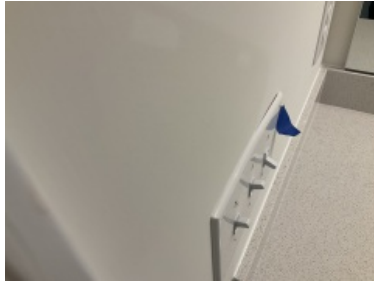
| Room | Trade | Item | Description | Points | Initials | |
|---|---|---|---|---|---|--|
| Bath - Hall | Electric | 810 - Crooked Outlet/Switch | Gap between wall and switch plate | 0.25 | | |

Bath - Hall  
810 - Crooked Outlet/Switch  
Gap between wall and switch plate

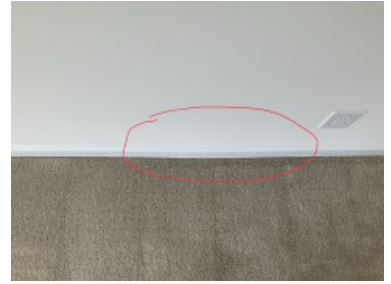
| Room | Trade | Item | Description | Points | Initials | |
|---|---|---|---|---|---|--|
| Bedroom - Owner's | Framing | 1050 - Bowed Wall | Right side wall near bathroom door bowed | 0.25 | | |

Bedroom - Owner's  
1050 - Bowed Wall  
Right side wall near bathroom door bowed

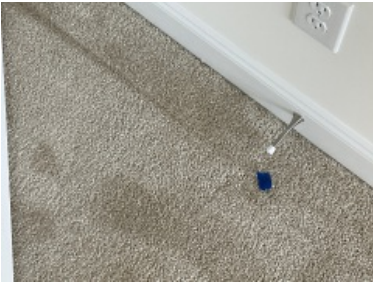
| Room | Trade | Item | Description | Points | Initials | |
|---|---|---|---|---|---|--|
| Bedroom - Owner's | Flooring | 1300D - Damage | Paint on carpet behind entry door | 0.25 | | |

Bedroom - Owner's  
1300D - Damage  
Paint on carpet behind entry door

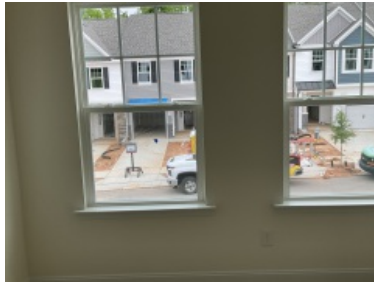
| Room | Trade | Item | Description | Points | Initials | |
|---|---|---|---|---|---|--|
| Bedroom 1 | Windows | 13010 - Difficult to Open | Right front bedroom, left front window hard to open | 0.25 | | |

Bedroom 1  
13010 - Difficult to Open  
Right front bedroom, left front window hard to open

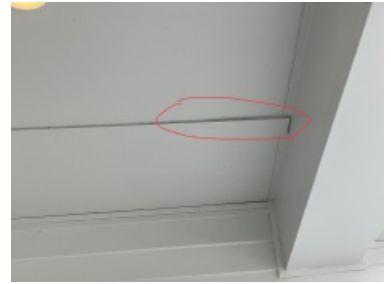
| Room | Trade | Item | Description | Points | Initials | |
|---|---|---|---|---|---|--|
| Exterior | Exterior_Trim | 20040 - Ext. Trim Not Pieced Together Properly | Gap between trim at board on front porch ceiling | 0.25 | | |

Exterior  
20040 - Ext. Trim Not Pieced Together Properly  
Gap between trim at board on front porch ceiling

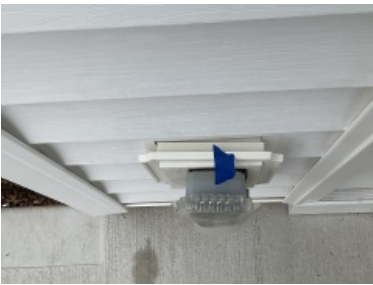
| Room | Trade | Item | Description | Points | Initials | |
|---|---|---|---|---|---|--|
| Exterior | Exterior_Trim | 20060 - Ext. Trim Out of Plumb/Square | Trim at outlet on utility room wall not square | 0.25 | | |

Exterior  
20060 - Ext. Trim Out of Plumb/Square  
Trim at outlet on utility room wall not square

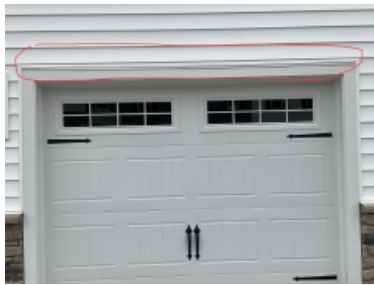
| Room | Trade | Item | Description | Points | Initials | |
|---|---|---|---|---|---|--|
| Exterior | Siding | 4020 - J Channel/Trim Not Square | Inconsistent reveal between siding and j channel above garage door | 0.25 | | |

Exterior  
4020 - J Channel/Trim Not Square  
Inconsistent reveal between siding and j channel above garage door

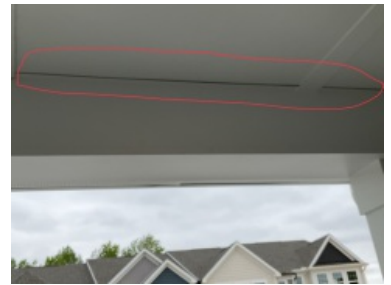
| Room | Trade | Item | Description | Points | Initials | |
|---|---|---|---|---|---|--|
| Exterior | Siding | 4030 - Soffit/Fascia Issues | Gap between front porch soffit and metal trim | 0.25 | | |

Exterior  
4030 - Soffit/Fascia Issues  
Gap between front porch soffit and metal trim

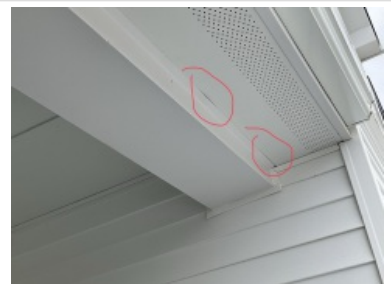
| Room | Trade | Item | Description | Points | Initials | |
|---|---|---|---|---|---|--|
| Exterior | Siding | 4030 - Soffit/Fascia Issues | Gap between soffit and metal trim at right side of front porch | 0.25 | | |

Exterior  
4030 - Soffit/Fascia Issues  
Gap between soffit and metal trim at right side of front porch

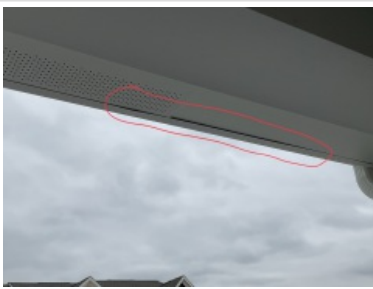
| Room | Trade | Item | Description | Points | Initials | |
|---|---|---|---|---|---|--|
| Exterior | Siding | 4030 - Soffit/Fascia Issues | Gap between trim and soffit in front of front porch | 0.25 | | |

Exterior  
4030 - Soffit/Fascia Issues  
Gap between trim and soffit in front of front porch

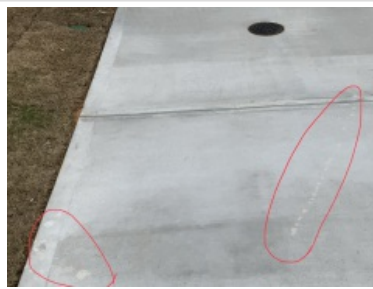
| Room | Trade | Item | Description | Points | Initials | |
|---|---|---|---|---|---|--|
| Exterior | Concrete_Flatwork | 520 - Stain | Paint stains on left side of driveway near CO | 0.25 | | |

Exterior  
520 - Stain  
Paint stains on left side of driveway near CO

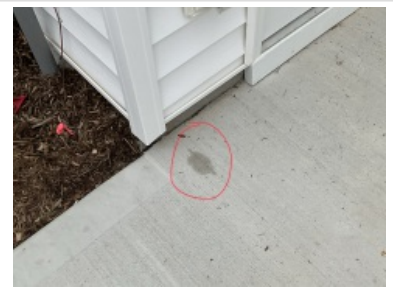
| Room | Trade | Item | Description | Points | Initials | |
|---|---|---|---|---|---|--|
| Exterior | Concrete_Flatwork | 520 - Stain | Patio stained in front of utility room | 0.25 | | |

Exterior  
520 - Stain  
Patio stained in front of utility room

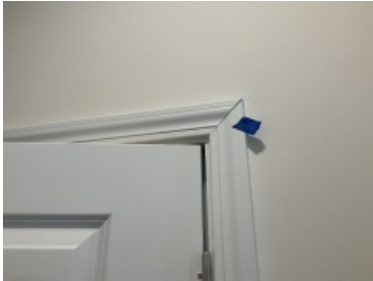
| Room | Trade | Item | Description | Points | Initials | |
|---|---|---|---|---|---|--|
| Foyer | Interior_Trim | 1510 - Not Pieced Together Well | Top right casing at garage door not flush | 0.25 | | |

Foyer  
1510 - Not Pieced Together Well  
Top right casing at garage door not flush

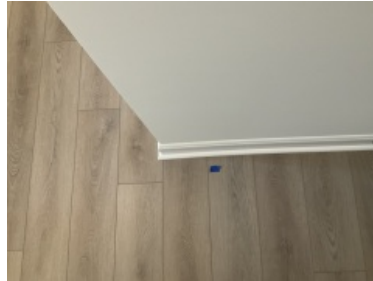
| Room | Trade | Item | Description | Points | Initials | |
|---|---|---|---|---|---|--|
| Foyer | Interior_Trim | 1560 - Out of plumb/square | Shoe mould right of closet bowed | 0.25 | | |

Foyer  
1560 - Out of plumb/square  
Shoe mould right of closet bowed

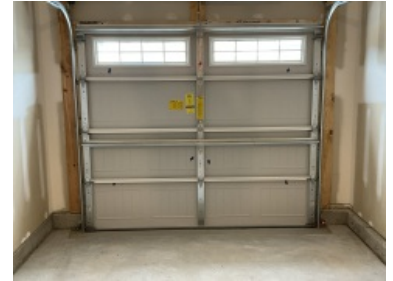
| Room | Trade | Item | Description | Points | Initials | |
|---|---|---|---|---|---|--|
| Garage | Garage_Doors | 9005 - Missing Pieces | Sharp screws exposed | 0.25 | | |

Garage  
9005 - Missing Pieces  
Sharp screws exposed

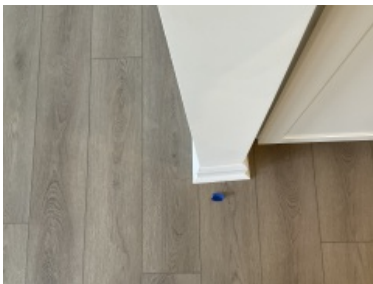
| Room | Trade | Item | Description | Points | Initials | |
|---|---|---|---|---|---|--|
| Kitchen/Dinette | Interior_Trim | 1560 - Out of plumb/square | Shoe mould left of pantry cabinet not square | 0.25 | | |

Kitchen/Dinette  
1560 - Out of plumb/square  
Shoe mould left of pantry cabinet not square

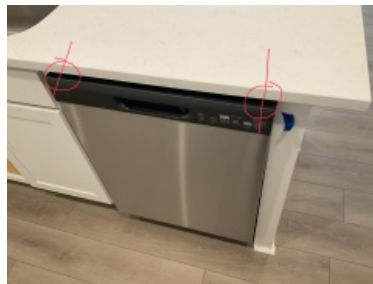
| Room | Trade | Item | Description | Points | Initials | |
|---|---|---|---|---|---|--|
| Kitchen/Dinette | Appliances | 1830 - Installed Incorrectly | Dishwasher not square with front edge of counter top and door rubs cabinet at top right | 0.25 | | |

Kitchen/Dinette  
1830 - Installed Incorrectly  
Dishwasher not square with front edge of counter top and door rubs cabinet at top right

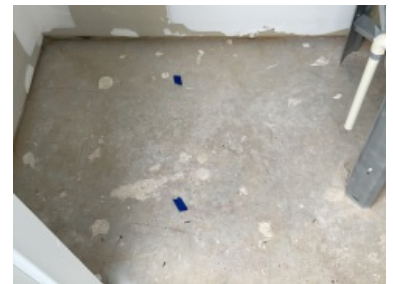
| Room | Trade | Item | Description | Points | Initials | |
|---|---|---|---|---|---|--|
| Utility Room | Cleaning | TIC | Floor not scraped | 0 | | |

Utility Room  
TIC  
Floor not scraped
