| Builder | DRB Group |
| Community | Sidney Creek TH (NC)(RAL) |
| Street Address | 678 Sefton Park Dr. |
| Type | New Review |

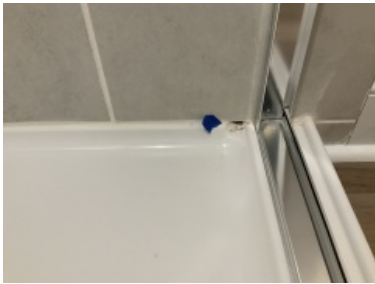
| Room | Trade | Item | Description | Points | Initials | |
|---|---|---|---|---|---|--|
| Bath - Owner's | Ceramic | 1220 - Tile Installation Issue | Front weep hole in shower blocked | 0.25 | | |

Bath - Owner's  
1220 - Tile Installation Issue  
Front weep hole in shower blocked

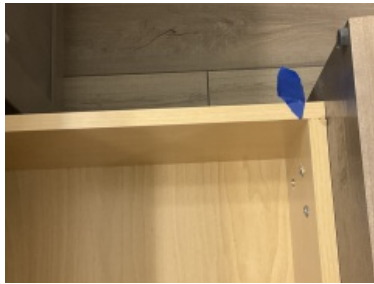
| Room | Trade | Item | Description | Points | Initials | |
|---|---|---|---|---|---|--|
| Bath - Owner's | Cabinets | 1600D - Damage | Middle drawer chipped on right side | 0.25 | | |

Bath - Owner's  
1600D - Damage  
Middle drawer chipped on right side

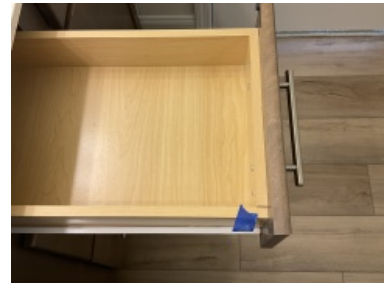
| Room | Trade | Item | Description | Points | Initials | |
|---|---|---|---|---|---|--|
| Bath - Owner's | Cabinets | 1600D - Damage | Top drawer separating on left side | 0.25 | | |

Bath - Owner's  
1600D - Damage  
Top drawer separating on left side

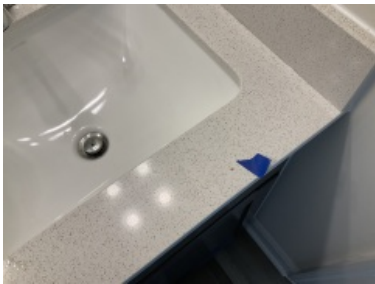
| Room | Trade | Item | Description | Points | Initials | |
|---|---|---|---|---|---|--|
| Bath - Owner's | Counter_Tops | 40000D - Damage | Red spot in front of right side sink | 0.25 | | |

Bath - Owner's  
40000D - Damage  
Red spot in front of right side sink

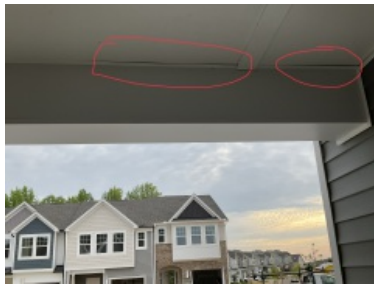
| Room | Trade | Item | Description | Points | Initials | |
|---|---|---|---|---|---|--|
| Exterior | Exterior_Trim | 20000 - Miscellaneous | Gap between front porch ceiling and metal trim at porch beam | 0.25 | | |

Exterior  
20000 - Miscellaneous  
Gap between front porch ceiling and metal trim at porch beam

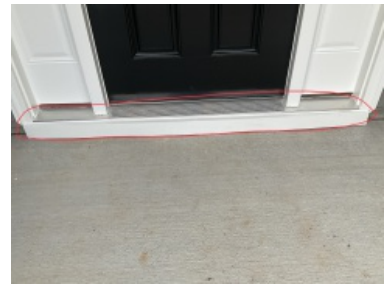
| Room | Trade | Item | Description | Points | Initials | |
|---|---|---|---|---|---|--|
| Exterior | Exterior_Trim | 20060 - Ext. Trim Out of Plumb/Square | Inconsistent reveal between kick board and front door threshold | 0.25 | | |

Exterior  
20060 - Ext. Trim Out of Plumb/Square  
Inconsistent reveal between kick board and front door threshold

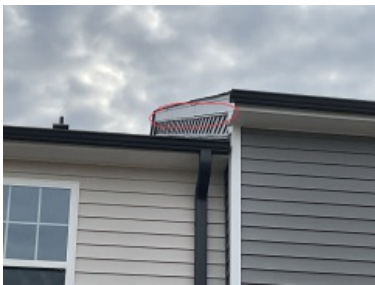
| Room | Trade | Item | Description | Points | Initials | |
|---|---|---|---|---|---|--|
| Exterior | Siding | 4020 - J Channel/Trim Not Square | J channel at back left on rake crooked | 0.25 | | |

Exterior  
4020 - J Channel/Trim Not Square  
J channel at back left on rake crooked

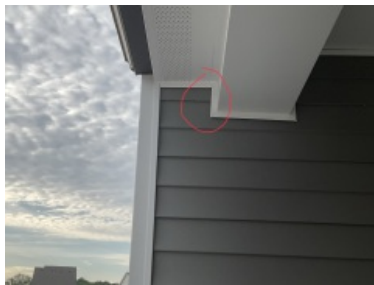
| Room | Trade | Item | Description | Points | Initials | |
|---|---|---|---|---|---|--|
| Exterior | Siding | 4020 - J Channel/Trim Not Square | J channel on left side of front porch beam at garage wall not square | 0.25 | | |

Exterior  
4020 - J Channel/Trim Not Square  
J channel on left side of front porch beam at garage wall not square

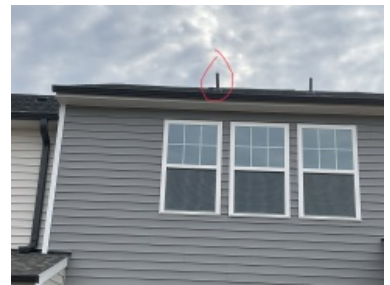
| Room | Trade | Item | Description | Points | Initials | |
|---|---|---|---|---|---|--|
| Exterior | Plumbing | 700D - Damage | Vent pipe on rear roof not plumb | 0.25 | | |

Exterior  
700D - Damage  
Vent pipe on rear roof not plumb

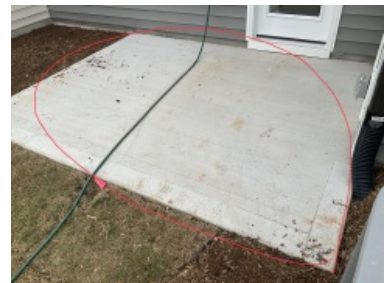
| Room | Trade | Item | Description | Points | Initials | |
|---|---|---|---|---|---|--|
| Exterior | Cleaning | TIC | Patio slab dirty | 0 | | |

Exterior  
TIC  
Patio slab dirty

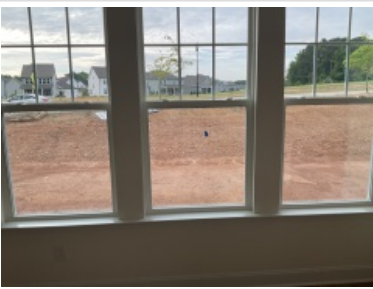
| Room | Trade | Item | Description | Points | Initials | |
|---|---|---|---|---|---|--|
| Family Room | Windows | 13010 - Difficult to Open | Could not open middle window | 0.25 | | |

Family Room  
13010 - Difficult to Open  
Could not open middle window

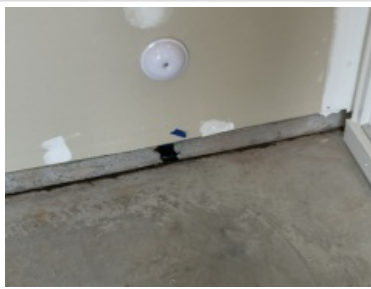
| Room | Trade | Item | Description | Points | Initials | |
|---|---|---|---|---|---|--|
| Garage | Foundation | 400D - Damage | Hole in foundation below CO | 0.25 | | |

Garage  
400D - Damage  
Hole in foundation below CO

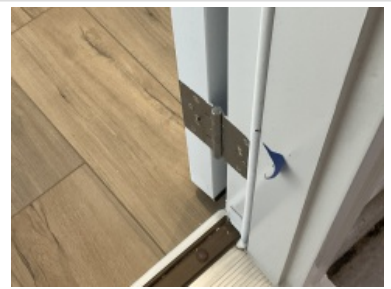
| Room | Trade | Item | Description | Points | Initials | |
|---|---|---|---|---|---|--|
| Garage | Doors | 50020 - Weather Stripping Tom | Weather strip tom at bottom hinge | 0.25 | | |

Garage  
50020 - Weather Stripping Torn  
Weather strip torn at bottom hinge

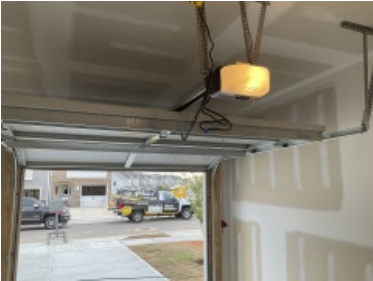
| Room | Trade | Item | Description | Points | Initials | |
|---|---|---|---|---|---|--|
| Garage | Garage_Doors | 9020 - Installation | Power cord at opener hanging down | 0.25 | | |

Garage  
9020 - Installation  
Power cord at opener hanging down

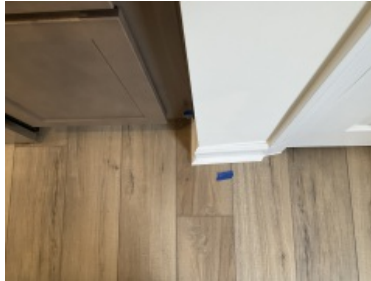
| Room | Trade | Item | Description | Points | Initials | |
|---|---|---|---|---|---|--|
| Kitchen/Dinette | Framing | 1030 - Out of Square/Level | Wall on left side of pantry closet not square | 0.25 | | |

Kitchen/Dinette  
1030 - Out of Square/Level  
Wall on left side of pantry closet not square

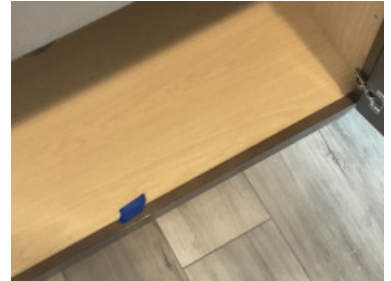
| Room | Trade | Item | Description | Points | Initials | |
|---|---|---|---|---|---|--|
| Kitchen/Dinette | Cabinets | 1600D - Damage | Bottom frame at front of sink base chipped near middle | 0.25 | | |

Kitchen/Dinette  
1600D - Damage  
Bottom frame at front of sink base chipped near middle

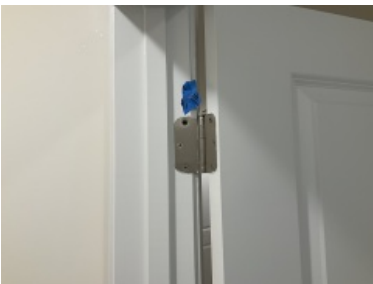
| Room | Trade | Item | Description | Points | Initials | |
|---|---|---|---|---|---|--|
| Laundry Room | Doors | 50010 - Hinge Screw/Pin Issues | Screw at top hinge of right side door not matching other screws | 0.25 | | |

Laundry Room  
50010 - Hinge Screw/Pin Issues  
Screw at top hinge of right side door not matching other screws

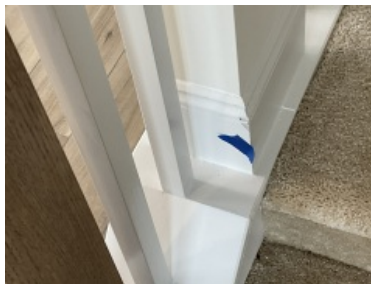
| Room | Trade | Item | Description | Points | Initials | |
|---|---|---|---|---|---|--|
| Stairs/Hall | Interior_Trim | 1500D - Damage | Baseboard at bottom of stairs on left side at post chipped | 0.25 | | |

Stairs/Hall  
1500D - Damage  
Baseboard at bottom of stairs on left side at post chipped

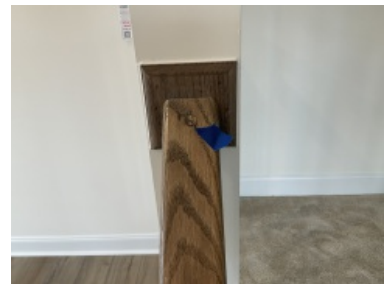
| Room | Trade | Item | Description | Points | Initials | |
|---|---|---|---|---|---|--|
| Stairs/Hall | Stairs_and_Rails | 21000 - Miscellaneous | Plug in top of handrail left side bottom of stairs | 0.25 | | |

Stairs/Hall  
21000 - Miscellaneous  
Plug in top of handrail left side bottom of stairs

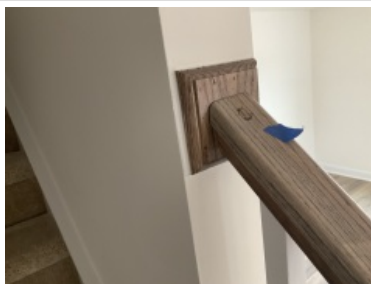
| Room | Trade | Item | Description | Points | Initials | |
|---|---|---|---|---|---|--|
| Stairs/Hall | Stairs_and_Rails | 21000 - Miscellaneous | Plug in top of handrail on right side at curb wall | 0.25 | | |

Stairs/Hall  
21000 - Miscellaneous  
Plug in top of handrail on right side at curb wall

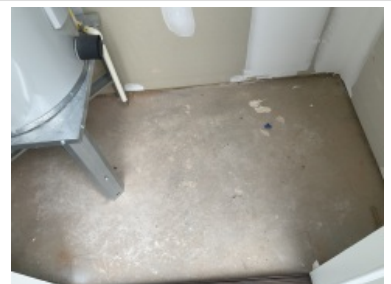
| Room | Trade | Item | Description | Points | Initials | |
|---|---|---|---|---|---|--|
| Utility Room | Cleaning | TIC | Floor not scraped | 0 | | |

Utility Room  
TIC  
Floor not scraped
