| Builder | DRB Group |
| Community | The Farm at Neill's Creek (NC)(RAL) |
| Street Address | 192 Peach Grove Way |
| Date | 6/18/2026 |

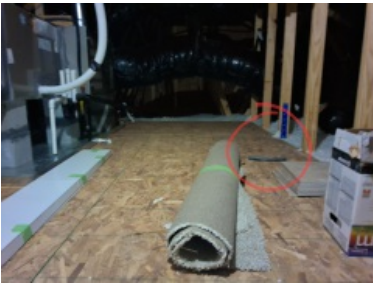
| Room | Trade | Item | Description | Points | Initials | |
|---|---|---|---|---|---|--|
| Attic | Cleaning | 1910 - Construction Items Left Behind | platform in attic not clean- conduit on platform | 0.25 | | |

Attic  
1910 - Construction Items Left Behind  
platform in attic not clean- conduit on platform

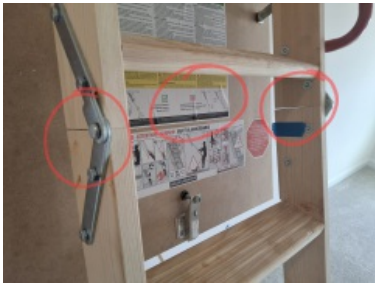
| Room | Trade | Item | Description | Points | Initials | |
|---|---|---|---|---|---|--|
| Attic | Stairs_and_Rails | 21000 - Miscellaneous | pull down stairs not cut to eliminate gap between rails at second hinge set | 0.25 | | |

Attic  
21000 - Miscellaneous  
pull down stairs not cut to eliminate gap between rails at second hinge set

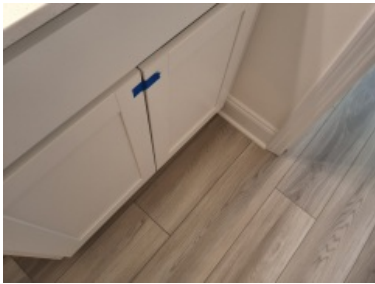
| Room | Trade | Item | Description | Points | Initials | |
|---|---|---|---|---|---|--|
| Bath - 1st Floor Full | Cabinets | 1630 - Drawer/Door Issue | at vanity, cabinet doors don't align with each other- right comes out past left | 0.25 | | |

Bath - 1st Floor Full  
1630 - Drawer/Door Issue  
at vanity, cabinet doors don't align with each other- right comes out past left

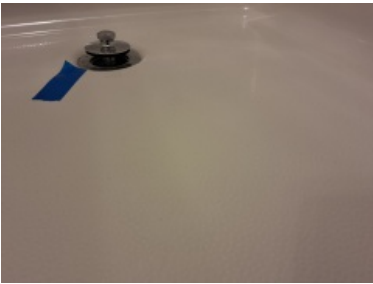
| Room | Trade | Item | Description | Points | Initials | |
|---|---|---|---|---|---|--|
| Bath - 1st Floor Full | Cleaning | 1920 - Trash and Debris | debris in tub drain | 0.25 | | |

Bath - 1st Floor Full  
1920 - Trash and Debris  
debris in tub drain

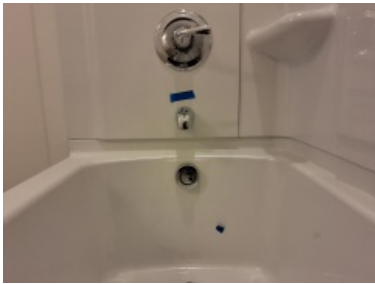
| Room | Trade | Item | Description | Points | Initials | |
|---|---|---|---|---|---|--|
| Bath - 1st Floor Full | Plumbing | 701 - Fixture Improperly Installed (ex: not square) | tub faucet is installed crooked | 0.25 | | |

Bath - 1st Floor Full  
701 - Fixture Improperly Installed (ex: not square)  
tub faucet is installed crooked

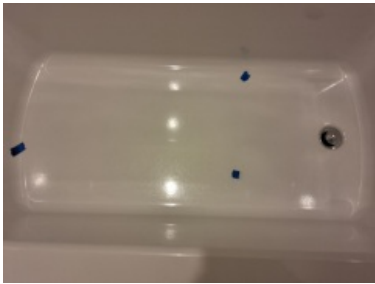
| Room | Trade | Item | Description | Points | Initials | |
|---|---|---|---|---|---|--|
| Bath - Hall | Plumbing | 700D - Damage | tub has rust staining | 0.25 | | |

Bath - Hall  
700D - Damage  
tub has rust staining

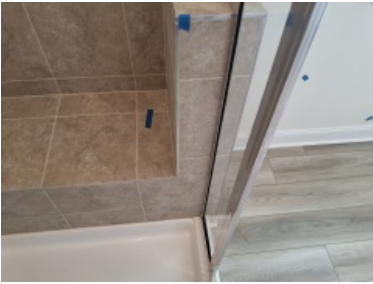
| Room | Trade | Item | Description | Points | Initials | |
|---|---|---|---|---|---|--|
| Bath - Owner's | Framing | 1020 - Out of Plumb | shower half wall is not square/ plumb left to right and top to bottom- noteable at tile install, floor install, and shower wall install | 0.25 | | |

Bath - Owner's  
1020 - Out of Plumb  
shower half wall is not square/ plumb left to right and top to bottom- noteable at tile install, floor install, and shower wall install

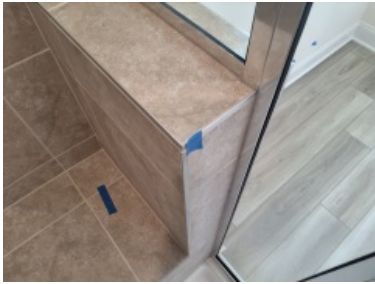
| Room | Trade | Item | Description | Points | Initials | |
|---|---|---|---|---|---|--|
| Bath - Owner's | Ceramic | 1220 - Tile Installation Issue | at half wall, schluter not alined at interior corner above seat | 0.25 | | |

Bath - Owner's  
1220 - Tile Installation Issue  
at half wall, schluter not alined at interior corner above seat

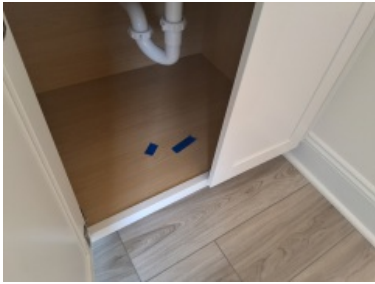
| Room | Trade | Item | Description | Points | Initials | |
|---|---|---|---|---|---|--|
| Bath - Owner's | Cabinets | 1600D - Damage | at rightmost vanity, bottom of cabinet is damaged/ gauged | 0.25 | | |

Bath - Owner's  
1600D - Damage  
at rightmost vanity, bottom of cabinet is damaged/ gauged

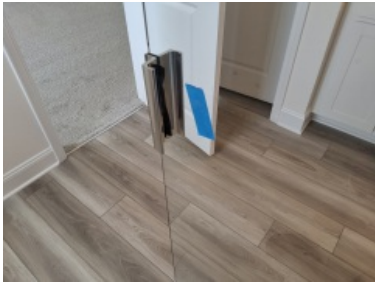
| Room | Trade | Item | Description | Points | Initials | |
|---|---|---|---|---|---|--|
| Bath - Owner's | Bath_Accessories | 18060 - Shower Enclosure Not Operating Properly | enclosure door, at handle, gasket not cut/ trimmed | 0.25 | | |

Bath - Owner's  
18060 - Shower Enclosure Not Operating Properly  
enclosure door, at handle, gasket not cut/ trimmed

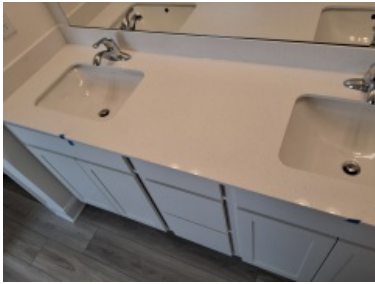
| Room | Trade | Item | Description | Points | Initials | |
|---|---|---|---|---|---|--|
| Bath - Owner's | Counter_Tops | 40040 - Out of Level/Square | counter overhang not consistent at vanity from left to right- over 1/4 | 0.25 | | |

Bath - Owner's  
40040 - Out of Level/Square  
counter overhang not consistent at vanity from left to right- over 1/4

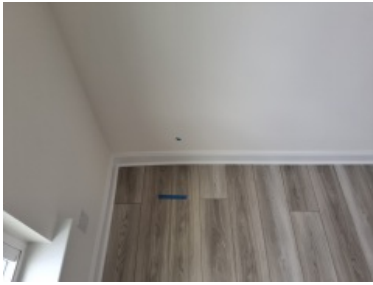
| Room | Trade | Item | Description | Points | Initials | |
|---|---|---|---|---|---|--|
| Bedroom - 1st Floor | Framing | 1050 - Bowed Wall | right wall, approaching window, bowed/ wavy approaching corner | 0.25 | | |

Bedroom - 1st Floor  
1050 - Bowed Wall  
right wall, approaching window, bowed/ wavy  
approaching corner

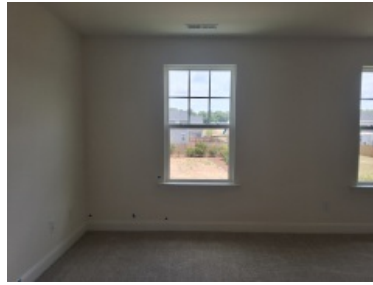
| Room | Trade | Item | Description | Points | Initials | |
|---|---|---|---|---|---|--|
| Bedroom - Owner's | Windows | 13010 - Difficult to Open | letmost window is difficult to open/ close- especially compared to right window in bedroom | 0.25 | | |

Bedroom - Owner's  
13010 - Difficult to Open  
leftmost window is difficult to open/ close- especially  
compared to right window in bedroom

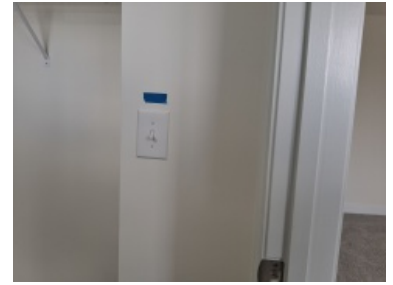
| Room | Trade | Item | Description | Points | Initials | |
|---|---|---|---|---|---|--|
| Bedroom 2 | Electric | 810 - Crooked Outlet/Switch | front right bedroom, switch plate not square/ level with corner | 0.25 | | |

Bedroom 2  
810 - Crooked Outlet/Switch  
front right bedroom, switch plate not square/ level with  
corner

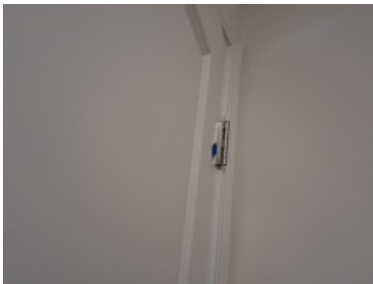
| Room | Trade | Item | Description | Points | Initials | |
|---|---|---|---|---|---|--|
| Bedroom 3 | Doors | 50010 - Hinge Screw/Pin Issues | back left bedroom closet, top hinge is scratched/ damaged | 0.25 | | |

Bedroom 3  
50010 - Hinge Screw/Pin Issues  
back left bedroom closet, top hinge is scratched/  
damaged

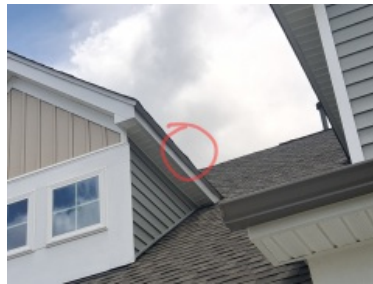
| Room | Trade | Item | Description | Points | Initials | |
|---|---|---|---|---|---|--|
| Exterior | Roofing | 2000D - Damage | at front left dormer, raised shigles at right overhang | 0.25 | | |

Exterior  
2000D - Damage  
at front left dormer, raised shingles at right overhang

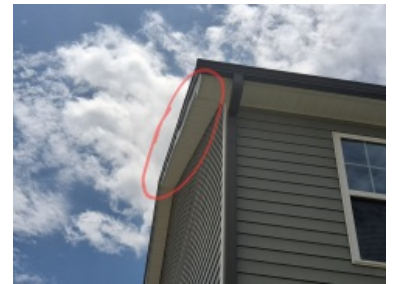
| Room | Trade | Item | Description | Points | Initials | |
|---|---|---|---|---|---|--|
| Exterior | Siding | 4030 - Soffit/Fascia Issues | at right of home, rear rake, fascia is bowed out midrun | 0.25 | | |

Exterior  
4030 - Soffit/Fascia Issues  
at right of home, rear rake, fascia is bowed out midrun

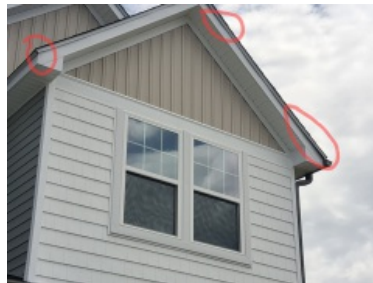
| Room | Trade | Item | Description | Points | Initials | |
|---|---|---|---|---|---|--|
| Exterior | Siding | 4040 - Drip Edge | at front right gable, drip edge not aligned at joints with visible house sheathing beneath- three locations | 0.25 | | |

Exterior  
4040 - Drip Edge  
at front right gable, drip edge not aligned at joints with  
visible house sheathing beneath- three locations

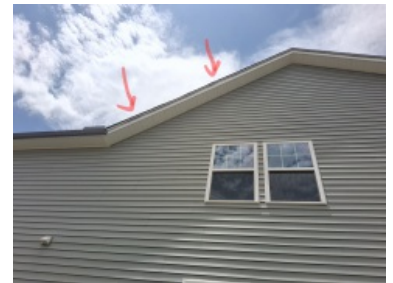
| Room | Trade | Item | Description | Points | Initials | |
|---|---|---|---|---|---|--|
| Exterior | Siding | 4040 - Drip Edge | at right of home, front rake, drip edge is bowed in two locations | 0.25 | | |

Exterior  
4040 - Drip Edge  
at right of home, front rake, drip edge is bowed in two  
locations

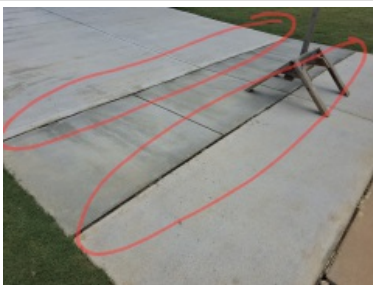
| Room | Trade | Item | Description | Points | Initials | |
|---|---|---|---|---|---|--|
| Exterior | Concrete_Flatwork | 500 - Miscellaneous | at front, sidewalk insert in driveway has concrete overpour onto driveway both, bottom panels and apron | 0.25 | | |

Exterior  
500 - Miscellaneous  
at front, sidewalk insert in driveway has concrete overpour  
onto driveway both, bottom panels and apron

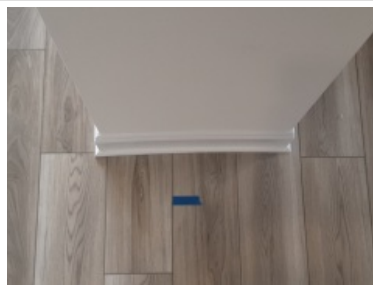
| Room | Trade | Item | Description | Points | Initials | |
|---|---|---|---|---|---|--|
| Foyer | Framing | 1050 - Bowed Wall | at transition wall from bathroom to dining room, wall bows in at center | 0.25 | | |

Foyer  
1050 - Bowed Wall  
at transition wall from bathroom to dining room, wall  
bows in at center

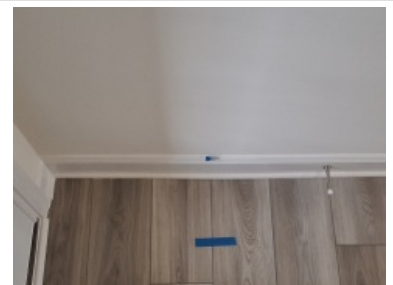
| Room | Trade | Item | Description | Points | Initials | |
|---|---|---|---|---|---|--|
| Foyer | Framing | 1050 - Bowed Wall | behind front door entry, the wall bows out from corner to base stop | 0.25 | | |

Foyer  
1050 - Bowed Wall  
behind front door entry, the wall bows out from corner to  
base stop

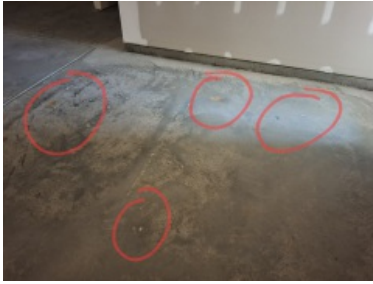
| Room | Trade | Item | Description | Points | Initials | |
|---|---|---|---|---|---|--|
| Garage | Concrete_Flatwork | 520 - Stain | top panel of garage, closest to entry to home, staining from plumbing glue and sealants | 0.25 | | |

Garage  
520 - Stain  
top panel of garage, closest to entry to home, staining from plumbing glue and sealants

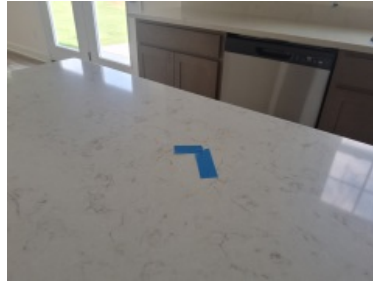
| Kitchen/Dinette | Counter_Tops | 40000D - Damage | island countertop is damaged closer to right side- dishwasher- side of island, under pendant prewire | 0.25 | | |

Kitchen/Dinette  
40000D - Damage  
island countertop is damaged closer to right side- dishwasher- side of island, under pendant prewire

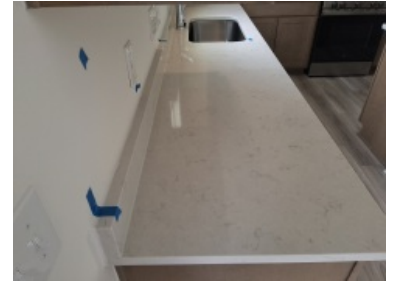
| Room | Trade | Item | Description | Points | Initials | |
|---|---|---|---|---|---|--|
| Kitchen/Dinette | Counter_Tops | 40040 - Out of Level/Square | counter/ splashblock over dishwasher, starting at sink and headed to slider, counter is not | 0.25 | | |

| | | | plumb/ square with wall- gap grows | | | |

Kitchen/Dinette  
40040 - Out of Level/Square  
counter/ splashblock over dishwasher, starting at sink and headed to slider, counter is not plumb/ square with wall- gap grows

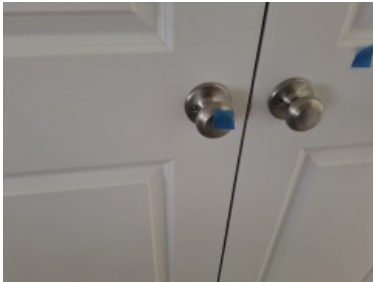
| Kitchen/Dinette | Doors | 50000D - Damage | pantry hardware on left door is damaged | 0.25 | | |

Kitchen/Dinette  
50000D - Damage  
pantry hardware on left door is damaged

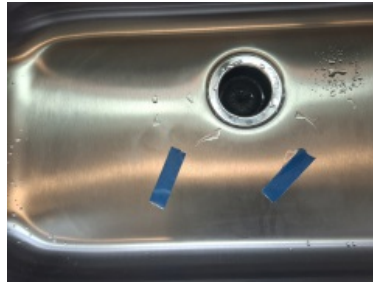
| Kitchen/Dinette | Plumbing | 700D - Damage | kitchen sink has damaged/ scuffing | 0.25 | | |

Kitchen/Dinette  
700D - Damage  
kitchen sink has damaged/ scuffing

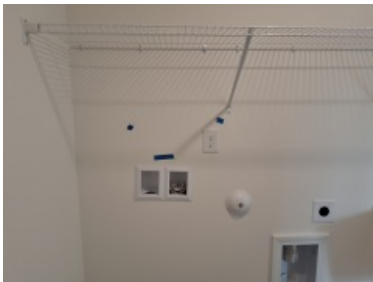
| Laundry Room | Plumbing | 707 - Laundry Supply Box or Shutoff Access Issues | laundry box/ trim not level | 0.25 | | |

Laundry Room  
707 - Laundry Supply Box or Shutoff Access Issues  
laundry box/ trim not level

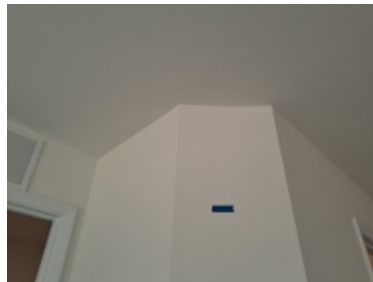
| Loft | Drywall | 1410 - Major Drywal Issue | drywall 45 degree wall return is bowed at ceiling juncture | 0.25 | | |

Loft  
1410 - Major Drywal Issue  
drywall 45 degree wall return is bowed at ceiling juncture

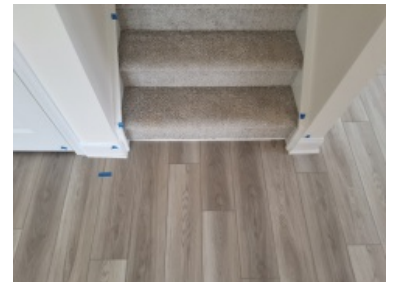
| Stairs/Hall | Interior_Trim | 1560 - Out of plumb/square | left of stainwell, approaching the coat closet, trim not square to flooring | 0.25 | | |

Stairs/Hall  
1560 - Out of plumb/square  
left of stairwell, approaching the coat closet, trim not square to flooring

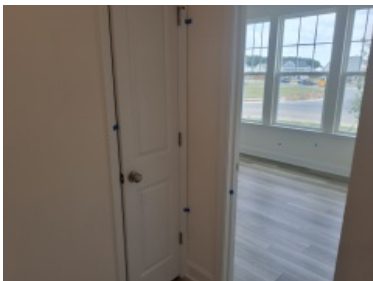
| Stairs/Hall | Interior_Trim | 1560 - Out of plumb/square | outside of first floor bedroom, closet casing not square with wall corner- reveal not consistent top to bottom | 0.25 | | |

Stairs/Hall  
1560 - Out of plumb/square  
outside of first floor bedroom, closet casing not square with wall corner- reveal not consistent top to bottom
