| Builder | DRB Group |
| Community | The Farm at Neill's Creek (NC)(RAL) |
| Street Address | 352 Peach Grove Way |
| Date | 5/15/2026 |

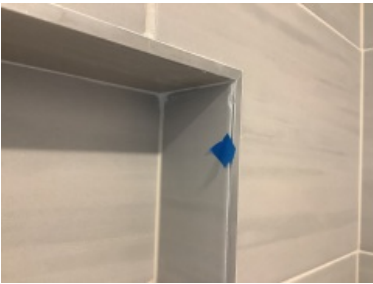
| Room | Trade | Item | Description | Points | Initials | |
|---|---|---|---|---|---|--|
| Bath - Owner's | Ceramic | 1200D - Damage | Chip in tile top right corner of niche | 0.25 | | |

Bath - Owner's  
1200D - Damage  
Chip in tile top right corner of niche

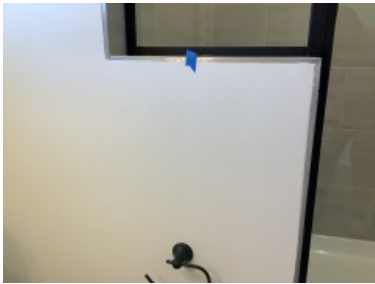
| Room | Trade | Item | Description | Points | Initials | |
|---|---|---|---|---|---|--|
| Bath - Owner's | Ceramic | 1200D - Damage | Tile edge strip scratched left of toilet facing bathroom | 0.25 | | |

Bath - Owner's  
1200D - Damage  
Tile edge strip scratched left of toilet facing bathroom

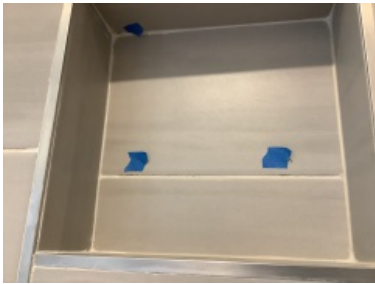
| Room | Trade | Item | Description | Points | Initials | |
|---|---|---|---|---|---|--|
| Bath - Owner's | Ceramic | 1210 - Grout Touchup | Grout touchup needed inside top of niche | 0.25 | | |

Bath - Owner's  
1210 - Grout Touchup  
Grout touchup needed inside top of niche

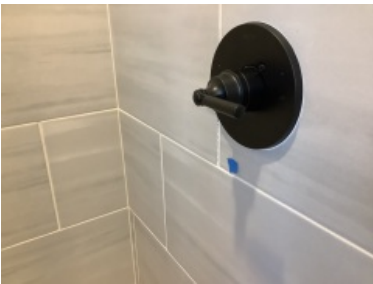
| Room | Trade | Item | Description | Points | Initials | |
|---|---|---|---|---|---|--|
| Bath - Owner's | Ceramic | 1210 - Grout Touchup | Inconsistent grout line under shower controls | 0.25 | | |

Bath - Owner's  
1210 - Grout Touchup  
Inconsistent grout line under shower controls

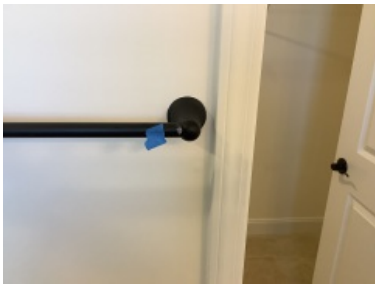
| Room | Trade | Item | Description | Points | Initials | |
|---|---|---|---|---|---|--|
| Bath - Owner's | Bath_Accessories | 18050D - Damage | Towel bar finish scratched | 0.25 | | |

Bath - Owner's  
18050D - Damage  
Towel bar finish scratched

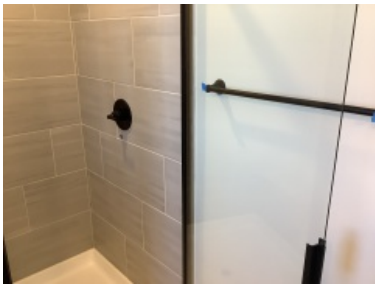
| Room | Trade | Item | Description | Points | Initials | |
|---|---|---|---|---|---|--|
| Bath - Owner's | Bath_Accessories | 18060 - Shower Enclosure Not Operating Properly | Glass shower door hits end of towel bar when opening | 0.25 | | |

Bath - Owner's  
18060 - Shower Enclosure Not Operating Properly  
Glass shower door hits end of towel bar when opening

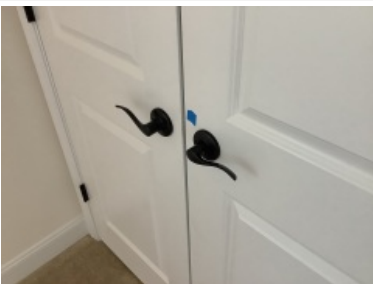
| Room | Trade | Item | Description | Points | Initials | |
|---|---|---|---|---|---|--|
| Bedroom 2 | Doors | 50050 - Door/Lock Needs Adjustment | Middle right bedroom closet doors do not sit flush when closed | 0.25 | | |

Bedroom 2  
50050 - Door/Lock Needs Adjustment  
Middle right bedroom closet doors do not sit flush when closed

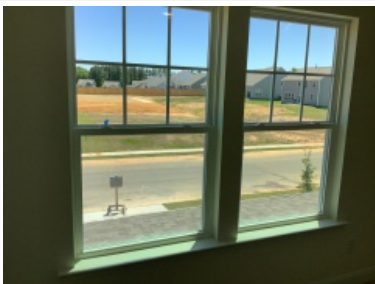
| Room | Trade | Item | Description | Points | Initials | |
|---|---|---|---|---|---|--|
| Bedroom 3 | Windows | 13020 - Latch issues | Front right bedroom, right window, right latch sticks when engaged | 0.25 | | |

Bedroom 3  
13020 - Latch issues  
Front right bedroom, right window, right latch sticks when engaged

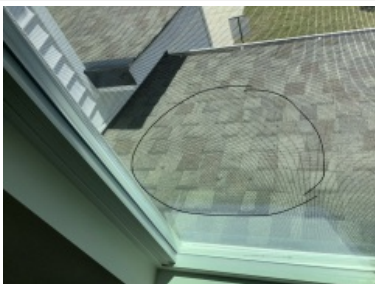
| Room | Trade | Item | Description | Points | Initials | |
|---|---|---|---|---|---|--|
| Exterior | Cleaning | 1915 - Exterior Presentation | Excess shingle pieces and debris on roof over front porch, visible from loft | 0.25 | | |

Exterior  
1915 - Exterior Presentation  
Excess shingle pieces and debris on roof over front porch, visible from loft

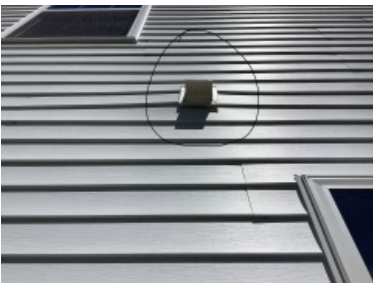
| Room | Trade | Item | Description | Points | Initials | |
|---|---|---|---|---|---|--|
| Exterior | Siding | 4000 - Miscellaneous | Bulge in siding at bath vent left front side | 0.25 | | |

Exterior  
4000 - Miscellaneous  
Bulge in siding at bath vent left front side

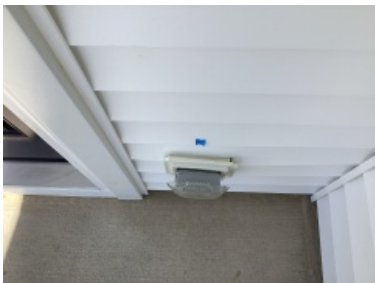
| Room | Trade | Item | Description | Points | Initials | |
|---|---|---|---|---|---|--|
| Exterior | Electric | 810 - Crooked Outlet/Switch | Receptacle and trim crooked at front porch | 0.25 | | |

Exterior  
810 - Crooked Outlet/Switch  
Receptacle and trim crooked at front porch

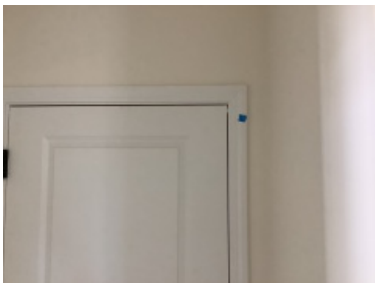
| Room | Trade | Item | Description | Points | Initials | |
|---|---|---|---|---|---|--|
| Garage | Doors | 50030 - Daylight Through Exterior Door Edge | Daylight visible top corner handle side at garage | 0.25 | | |

Garage  
50030 - Daylight Through Exterior Door Edge  
Daylight visible top corner handle side at garage

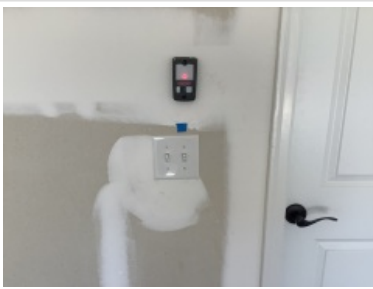
| Room | Trade | Item | Description | Points | Initials | |
|---|---|---|---|---|---|--|
| Garage | Electric | 810 - Crooked Outlet/Switch | Switch at entry door crooked | 0.25 | | |

Garage  
810 - Crooked Outlet/Switch  
Switch at entry door crooked

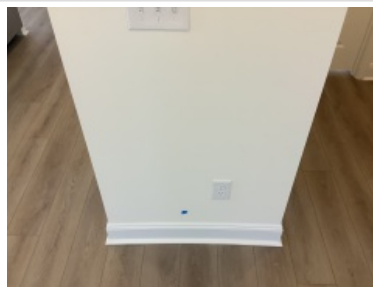
| Room | Trade | Item | Description | Points | Initials | |
|---|---|---|---|---|---|--|
| Kitchen/Dinette | Framing | 1050 - Bowed Wall | Bow in wall between laundry and kitchen at bottom of stairs | 0.25 | | |

Kitchen/Dinette  
1050 - Bowed Wall  
Bow in wall between laundry and kitchen at bottom of stairs

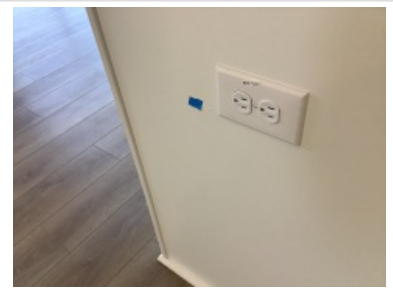
| Room | Trade | Item | Description | Points | Initials | |
|---|---|---|---|---|---|--|
| Kitchen/Dinette | Cabinets | 1600D - Damage | Penetration from inside cabinet visible next to outlet | 0.25 | | |

Kitchen/Dinette  
1600D - Damage  
Penetration from inside cabinet visible next to outlet

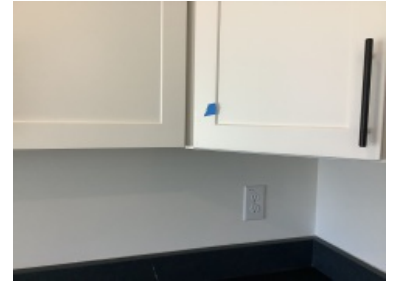
| Room | Trade | Item | Description | Points | Initials | |
|---|---|---|---|---|---|--|
| Kitchen/Dinette | Cabinets | 1600D - Damage | Tall cabinet door in corner right of range scratched | 0.25 | | |

Kitchen/Dinette  
1600D - Damage  
Tall cabinet door in Corner right of range scratched

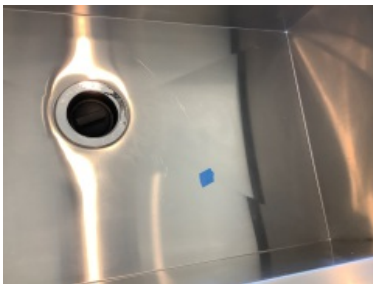
| Room | Trade | Item | Description | Points | Initials | |
|---|---|---|---|---|---|--|
| Kitchen/Dinette | Plumbing | 700D - Damage | Sink scratched right of disposal | 0.25 | | |

Kitchen/Dinette  
700D - Damage  
Sink scratched right of disposal

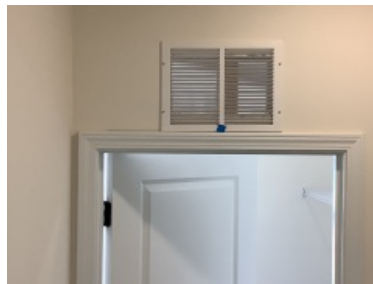
| Room | Trade | Item | Description | Points | Initials | |
|---|---|---|---|---|---|--|
| Laundry Room | HVAC | 660 - Ragged Drywall Visible Through Grate | Rough cut drywall visible from hall above laundry room | 0.25 | | |

Laundry Room  
660 - Ragged Drywall Visible Through Grate  
Rough cut drywall visible from hall above laundry room

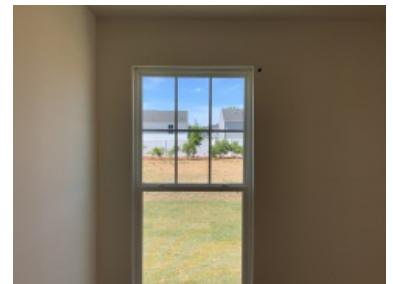
| Room | Trade | Item | Description | Points | Initials | |
|---|---|---|---|---|---|--|
| Living | Drywall | 1410 - Major Drywall Issue | Bow in drywall return at top left window | 0.25 | | |

Living  
1410 - Major Drywal Issue  
Bow in drywall return at top , left window

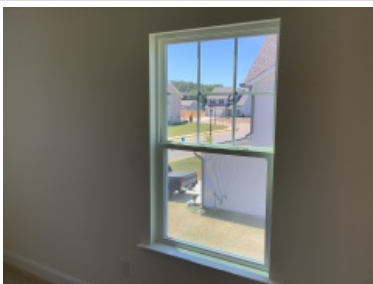
| Room | Trade | Item | Description | Points | Initials | |
|---|---|---|---|---|---|--|
| Loft | Windows | 13020 - Latch issues | Window next to stairs left side latch sticking, not operating smoothly | 0.25 | | |

Loft  
13020 - Latch issues  
Window next to stairs left side latch sticking, not operating smoothly

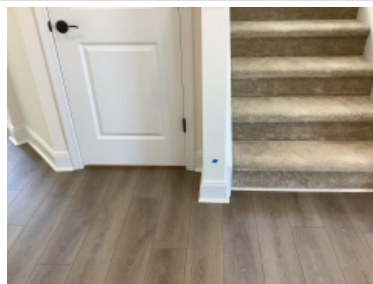
| Room | Trade | Item | Description | Points | Initials | |
|---|---|---|---|---|---|--|
| Stairs/Hall | Framing | 1030 - Out of Square/Level | Out of Square at floor left side bottom of stair | 0.25 | | |

Stairs/Hall  
1030 - Out of Square/Level  
Out of Square at floor left side bottom of stair

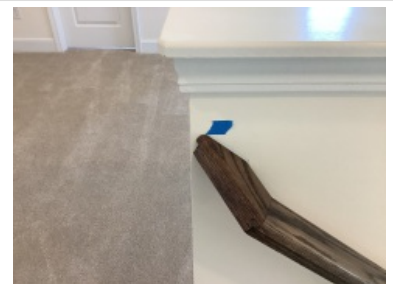
| Room | Trade | Item | Description | Points | Initials | |
|---|---|---|---|---|---|--|
| Stairs/Hall | Stairs_and_Rails | 21020 - Rails Loose/Not Secured | Handrail loose at top of stairs, rubbing wall | 0.25 | | |

Stairs/Hall  
21020 - Rails Loose/Not Secured  
Handrail loose at top of stairs, rubbing Wall
