Building Inspection Report

100 Brockville Street
Smiths Falls, Ont

Prepared for: Fernando Gonzalez & Adam Barrieau

Prepared by: Ottawa Valley Home Inspections Ltd.
Ottawa, Ontario

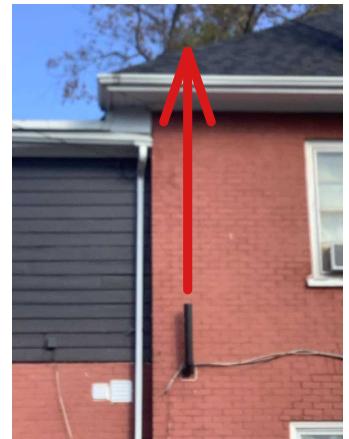
1. Method of Inspection: Binoculars
2. Not Present Unable to Inspect: Mostly Visible, Some restrictions present - Top of low sloped roof over addition only partly visible.
3. Maintenance Material: Asphalt / fiberglass shingle, Rolled roof material - Recommend adding roof vents for improved attic ventilation.
4. Type: Hip
5. Approximate Age: 2018, Vendor disclosed, Ask for receipt for warranty purposes
6. Acceptable Valleys: Preformed metal
7. Not Present Skylights:
8. Maintenance Plumbing Vents: Plastic, Cast Iron - Recommend extending the plastic plumbing stack so that it protrude 6 inches above the roof line for improved ventilation.

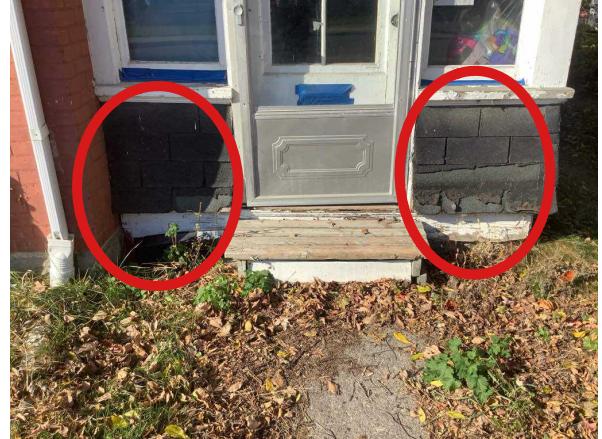
Exterior Surface type: Brick, Wood - Wood is rotting, shingles are deteriorated around the base of the covered entranceway. Requires repair.

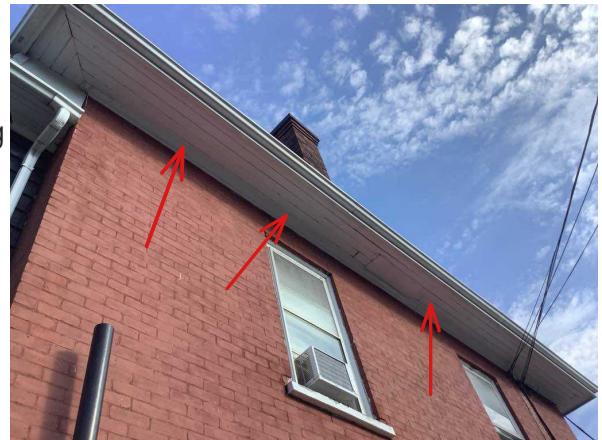
Fascia & Soffit: Wood, Metal - Wood soffit has no visible ventilation. Recommend installing if not present for improved attic ventilation.
Wood soffit and fascia requires scraping and painting in areas for protection.

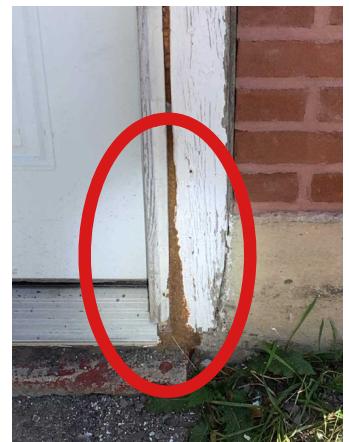
Spray foam should be replaced or covers with exterior rated material.

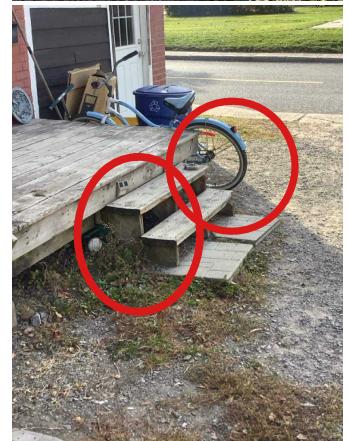
Entry Steps: Wood - Recommend installing guards on unit 2 steps for safety where not present.

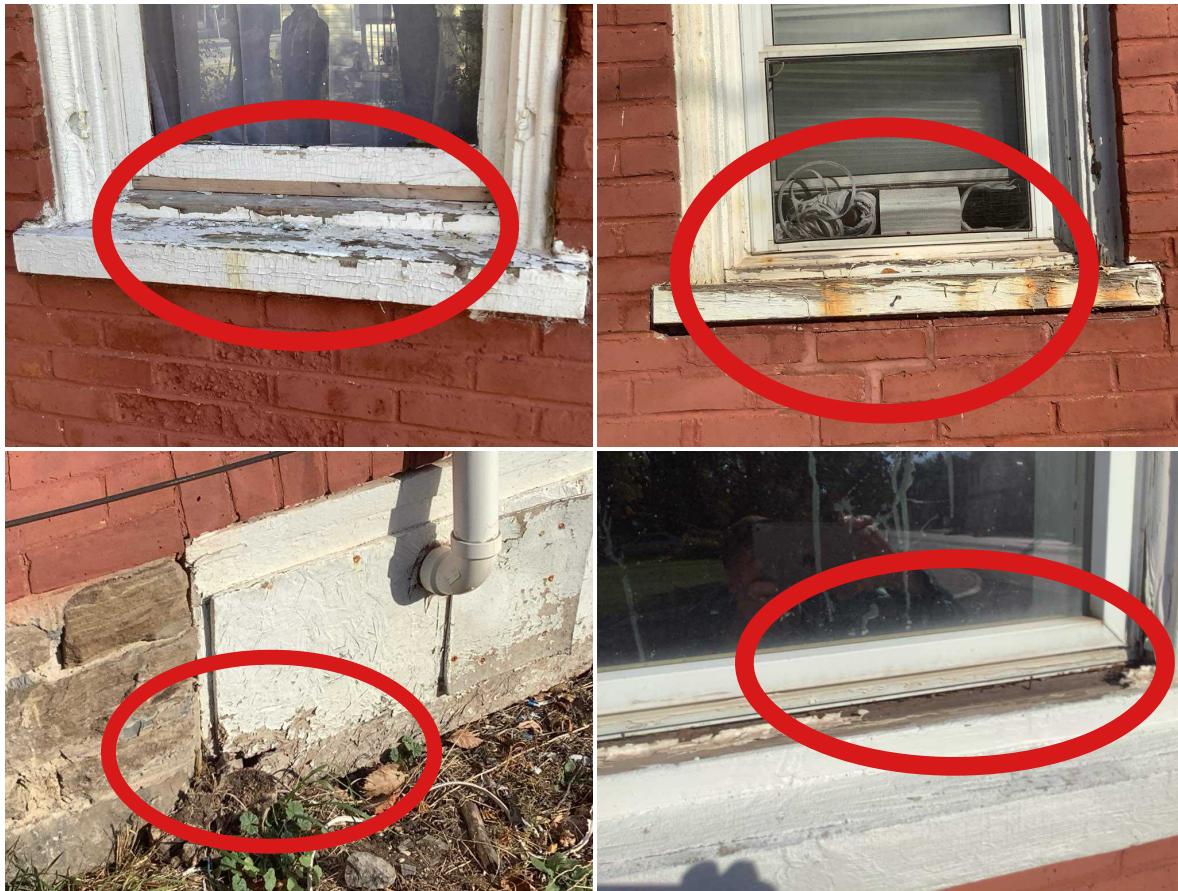
Windows: Wood, Single/Double Hung, Vinyl, Metal - Older wood windows are present and require scraping and painting in areas to protect the wood.
Older wood windows are present in areas and are rotting and deteriorating. Repair or replace soon is recommended.
Basement wood window covering is rotted and requires repair.
Window seal(s) have failed on some windows. Moisture and rust is noted between panes. Review and repair as required.
Recommend replacing caulking where caulking is cracked, old and/or missing. Caulking is a regular maintenance item.
Rear window missing allowing vermin intrusion. Nesting birds are present. Requires installation asap.
Recommend replacing spray foam sealant around windows with exterior rated sealant and/or flashing/trim.

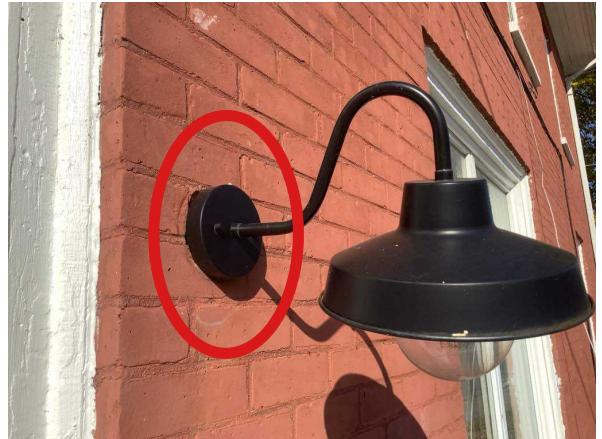
8. Defective Exterior Lighting: Wall mounted - Some exterior lights are loose and should be tightened and caulked to prevent water infiltration.

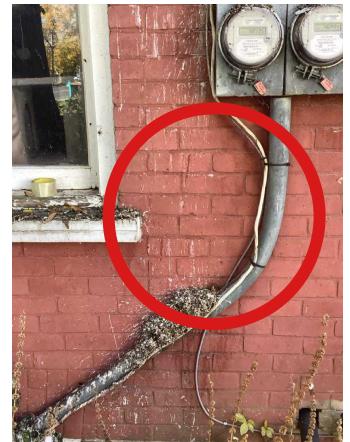
9. Maintenance Exterior Electrical Outlets: None visible - Recommend installing GFCI outlets on the exterior.
Exposed wiring is present that could easily be damaged. Should be protected by a conduit or similar. Wiring also does not appear to be exterior rated.

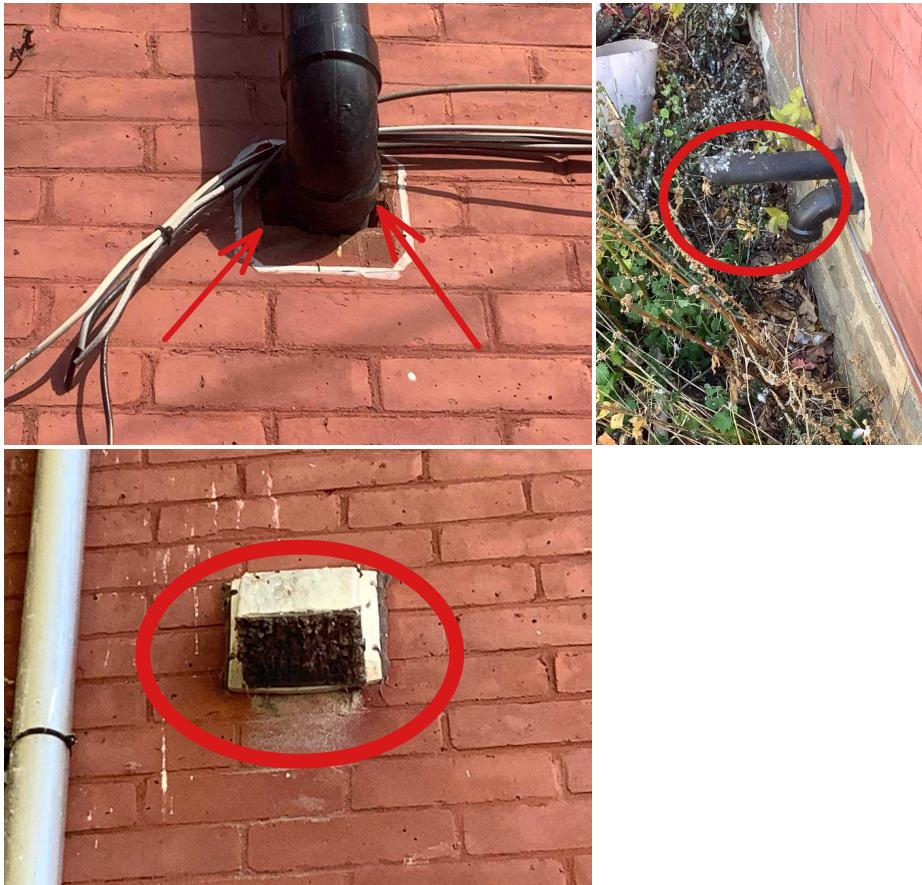
10. Maintenance Hose Bibs: None visible - Recommend installing frost free hose bib(s) where not present for improved freeze protection.
11. Defective Vents Furnace, Bathroom vent(s), side plumbing stack , Hot water tank, Dryer - Side plumbing stack requires caulking to prevent water and vermin intrusion. Furnace and or HWR vents are less than 12 inches from the intake. Recommend adding an extension, Dryer vent has lint buildup. Requires cleaning.

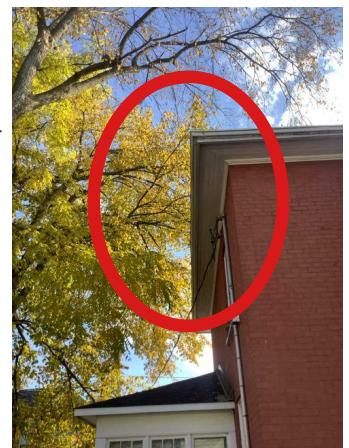
Greenery Trees - Trees / branches are close and overhanging the roof in areas - Recommend trimming back to prevent debris from accumulating on the roof and moss growing in the shade. Trees in proximity to the house could cause foundation problems with the roots. Review and repair as required. Occasionally removal is required.

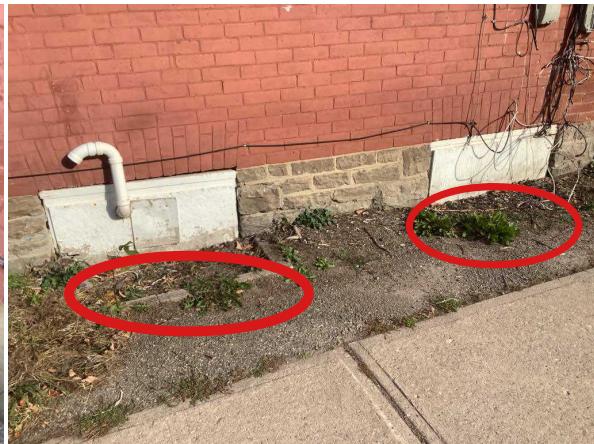
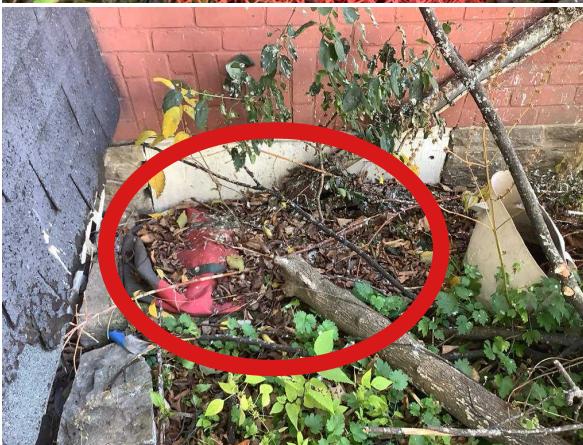
| 7. Defective | Window Wells: Concrete - Recommend 6" of clearance below the window to grade for improved drainage. |

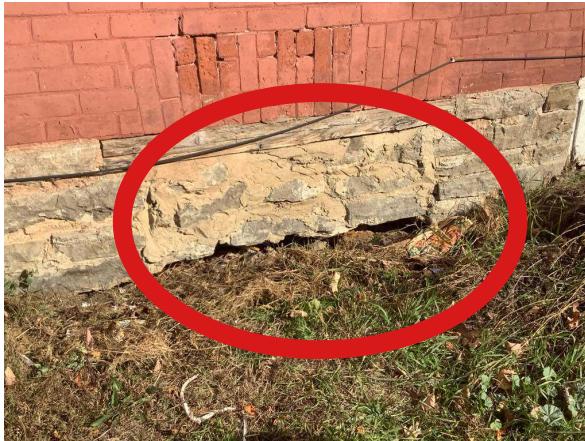
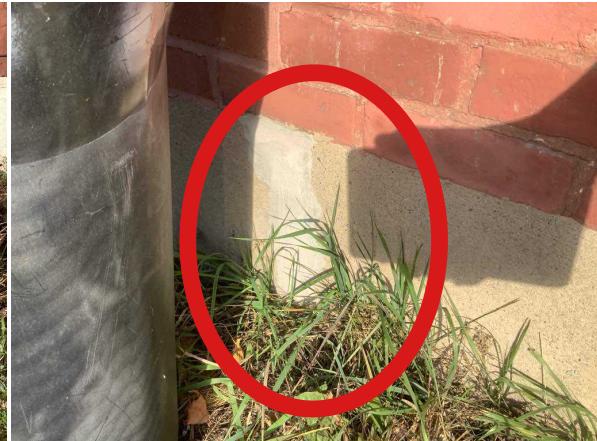
Foundation: Stone, Poured concrete - Recommend sealing all gaps in the foundation. Some crack(s) have been repaired on the exterior. Full extent of crack not visible for inspection. Further review and monitoring is recommended. Monitor for future change.

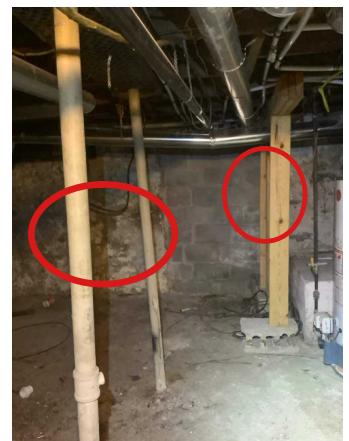
Columns Steel, Wood, Bricks - Temporary columns have been installed. Likely due to a sagging floor. Further review and repair recommended.

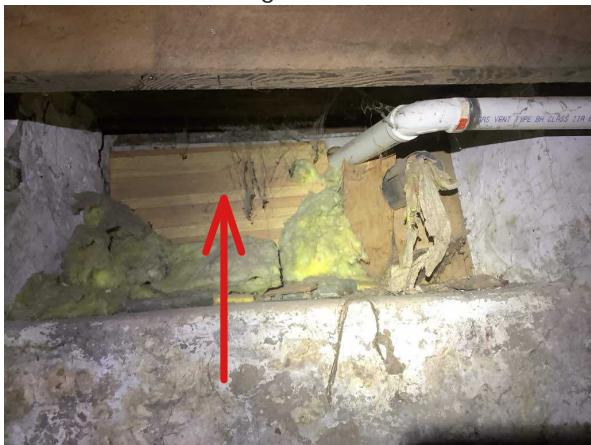
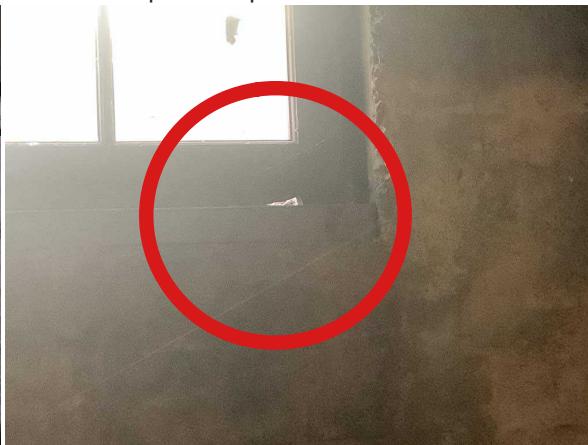
- 1. Acceptable Ceiling & Walls: Exposed foundation, Exposed ceiling joists
- 2. Acceptable Floor: Dirt, Bedrock
- 3. Acceptable Doors: Wood
- 4. Defective Windows: All sealed with wood. - Review all windows and window wells to ensure they are sealed properly and prevent water infiltration.
Holes around existing window allows vermin intrusion. Requires repair.

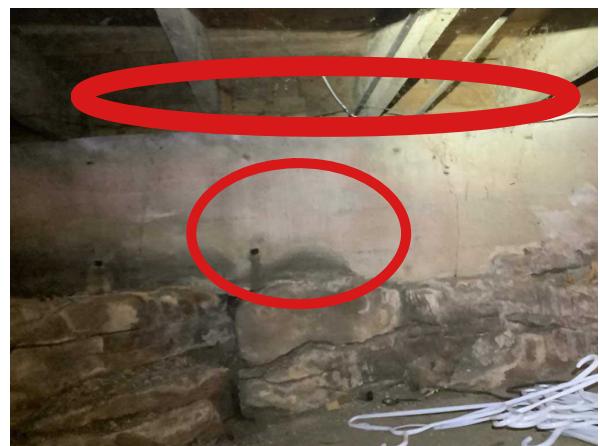
- 5. Acceptable Electrical: 110 VAC
- 6. Acceptable HVAC Source: Forced air registers
- 7. Acceptable Vapor Barrier: None present
- 8. Maintenance Insulation: None present - Recommend insulating all exterior basement foundation walls for improved thermal protection.
Recommend installing insulation and vapour barrier, where not present, in joist headers for improved thermal performance.

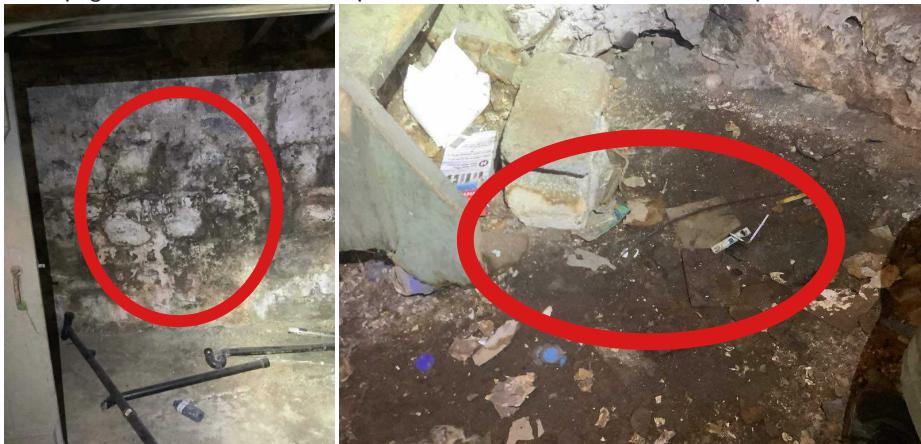
Moisture Location: Dampness and stains present - Stone foundation has moisture intrusion in areas and stains are present. Recommend improving exterior grade, eavestroughs and downspouts to keep water away from the exterior. Consider damp proofing the exterior.
Damp gravel/dirt floors are present in areas. Review and repair recommended.

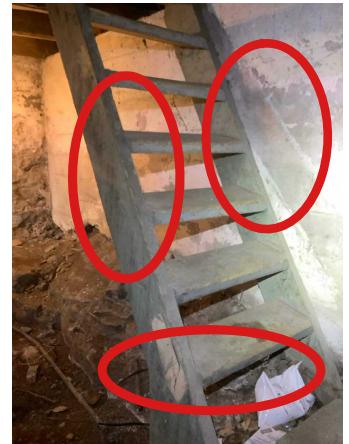
Stairs & Railings: Wood - Stairs are steep, not level, rotted at the bottom and are unsafe. Requires replacement for safety.
Guards and a handrail are required on the basement stairs for safety

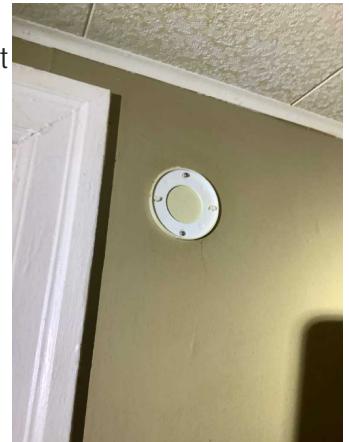
1. Acceptable Main service wire: Not visible
2. Acceptable Conductor Type: Romex, Non-metallic sheathed cable, BX
3. Acceptable Ground: Not visible
4. Defective CO Detectors Unit 3, unit 1 - CO detectors are mandatory by all bedrooms and recommended by any CO source. Install asap where not present. None present in unit 2
5. Defective Smoke Detectors Unit 3, unit 1 - Smoke detectors are mandatory on all floors. Recommend installing asap on all floors without one. None present in Unit 2.

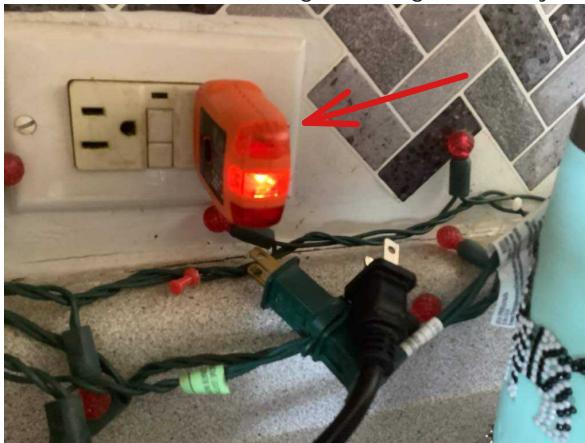
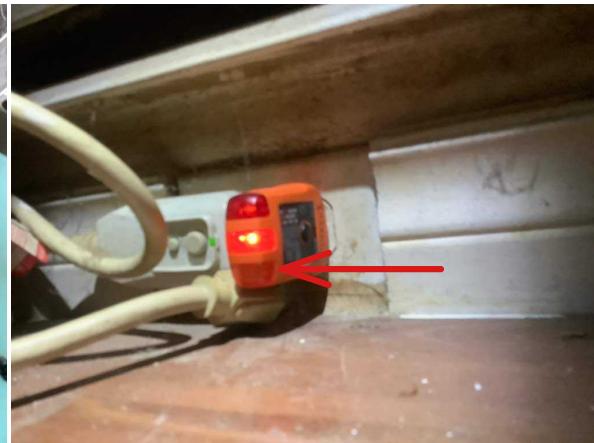
6. Acceptable Lights & Switches No visible issues
7. Acceptable GFCI Locations: Unit 3, unit 1, unit 2
8. Defective Outlets & Boxes Standard 3 prong - Some outlets are ungrounded in unit 2. Recommend review with an electrician and grounding for safety.

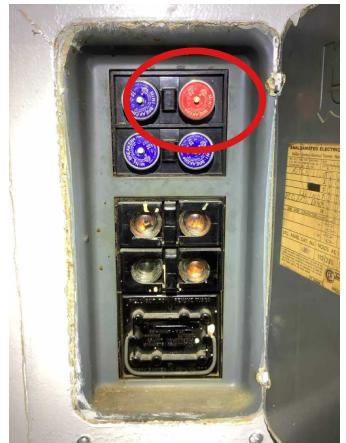
12. Defective Main Breaker/Fuse Size: 60amp x 3 - Fuse box present in unit 2.
Recommend upgrading to a modern breaker panel.
Overfusing present. Red 20a fuse should be a blue 15a fuse.

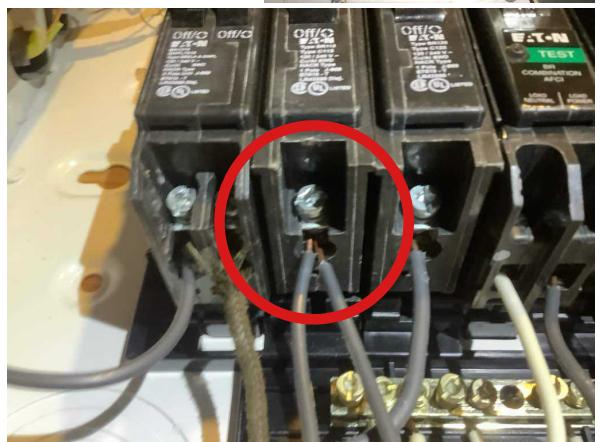
13. Defective Panel Wiring: Copper where visible - Some double tap(s) are present. These circuits should be moved to their own circuit breaker and should not share a breaker. It is recommended that a qualified electrician inspect the new circuits and properly connect the new circuits to an individual breaker(s) for each circuit.

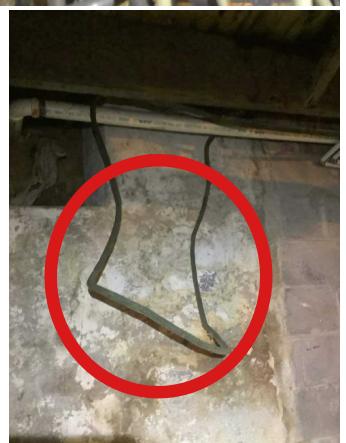
14. Defective Distribution Wiring: Copper where visible - Loose sloppy wiring is present in areas. Should be attached properly to walls or other surfaces.
Recommend repair.

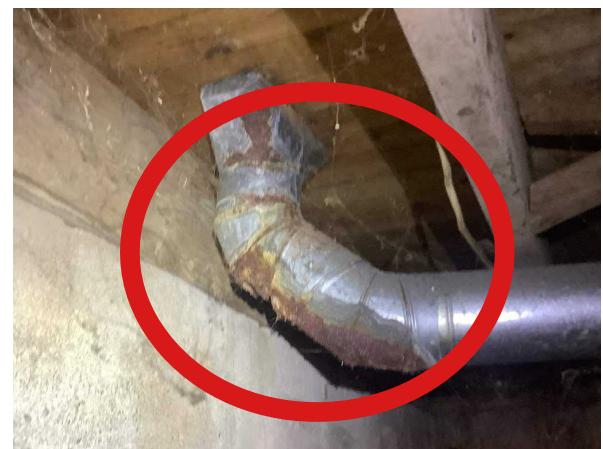
2. Manufacturer: Lennox
3. Model Number: G26Q3/4-100-6 Serial Number: 5802J 37165
4. Type: Forced air Speed & Capacity: Single speed, 100k btu input
5. Area Served: Main floor of building Approximate Age: 2002
6. Efficiency: High Efficiency
7. Acceptable Fuel Type Natural Gas
8. Acceptable Furnace: Burners not visible
9. Acceptable Blower Fan/Filter: Direct drive, disposable filter
10. Defective Distribution: Metal ducting - Some ducts have rusted and require replacement t.

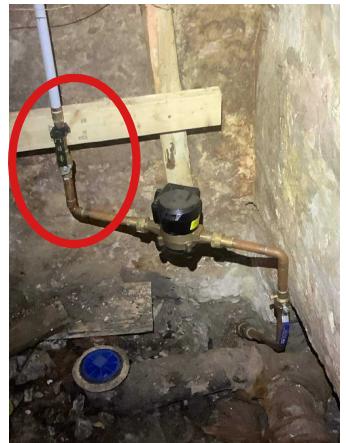
1. Acceptable Main Supply Line: Copper where visible
2. Acceptable Main Water Shutoff: At the meter, at the front of the house in the basement. - Green valve

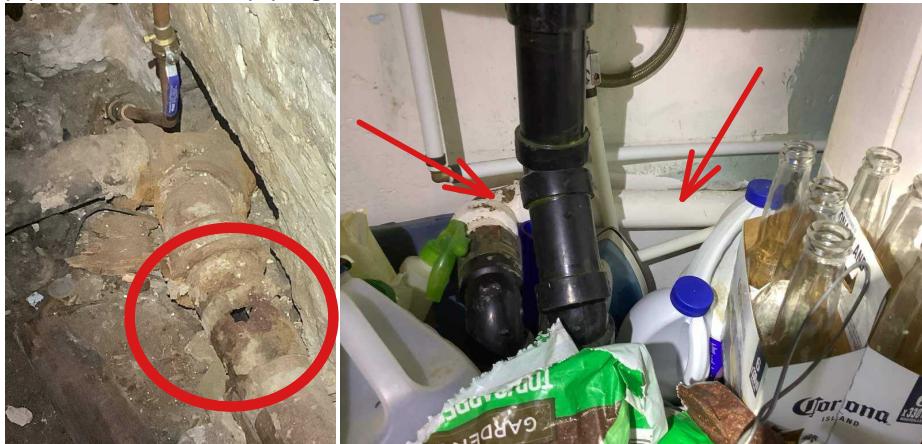
3. Acceptable Main Water Lines: Plastic where visible
4. Defective Drain Pipes: Cast iron, Plastic, Galvanized - Cast iron drain pipes are present. These pipes can rust and leak inside the house or underground out to the street. Monitor and review or replace.
The main cast iron drain is rusted with a hole present. Sewage is visible. Requires immediate repair.

Galvanized drain pipes are present in areas. These pipes usually rust from the inside out eventually leaking. This is possibly an insurance issue. Recommend reviewing with your insurer and replacing pipes with modern piping.

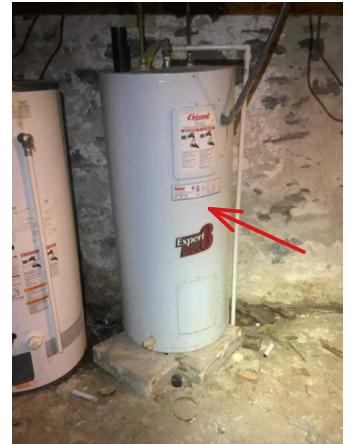
6. Acceptable Floor Drain: Drain on gravel / dirt floor
7. Maintenance Sinks & Faucets Bathroom(s), kitchen - Recommend installing a drip pan under the washer machine in unit 1 and 3 in case the machine leaks.
Left side sink in unit 1 WR not connected. Requires repair.
8. Maintenance Toilets and Tubs: Bathroom - Toilet is loose in 1WR. Recommend repair
-
- Basement x 3 Water Heater
9. Defective Water Heater: Functional at time of inspection - 2008 Giant tank is 16 years old and nearing the end of its average lifespan. Plan for replacement soon.

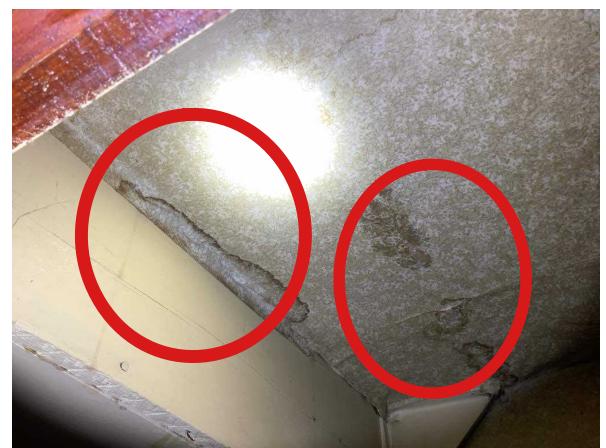
1. Acceptable Closets: Single
2. Defective Ceilings & Walls: Painted drywall / plaster - Some stains are present on the ceiling in the main floor closet in unit 3. Currently not showing signs of elevated moisture. Recommend review and repair as required.

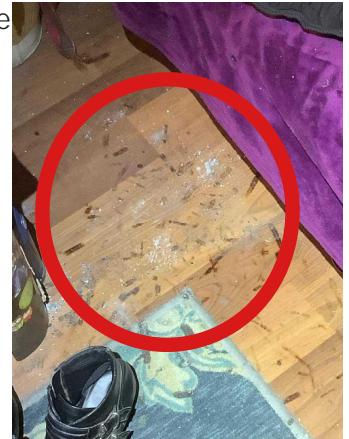
Floor: Hardwood / Softwood, Vinyl, Laminate, Ceramic/slate/porcelain tile
- Some floors are not level in areas. This is common on older buildings.
Review and repair as required
Many burn marks on bedroom floor in unit 2. Flooring requires repair.

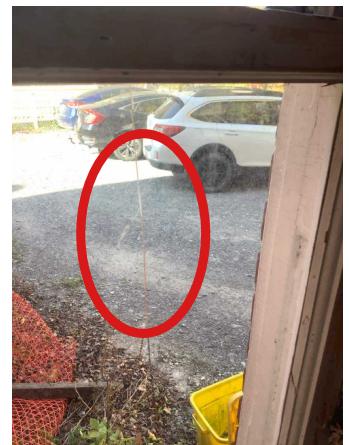
Windows: Wood, Single/Double Hung, Single and storm pane - Some single pane windows are present and not very thermally efficient in the winter. Review and upgrade as required.
Some windows are cracked in areas should be repaired.
Some windows are sticking and will not open/close. Recommemnd repair.
Older wood windows are present. Consider upgrading.
Older windows are present. Require scraping and painting for weather protection. Recommend uograding.
Some screens are missing. Recommend locating and installing.

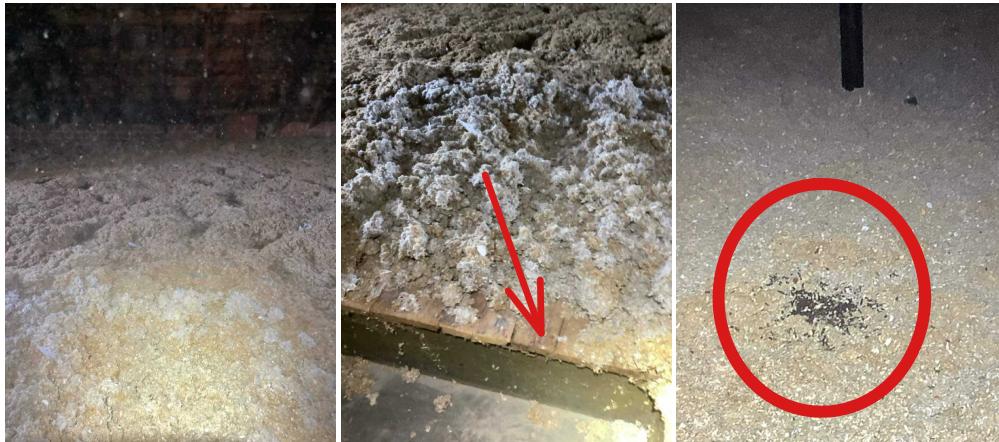
1. Method of Inspection: From the top of the stairs at the hatch
2. Acceptable Unable to Inspect: Mostly Visible
3. Acceptable Roof Structure: Rafters
4. Acceptable Sheathing: Wood planking
5. Defective Ventilation: Window vents - Attic ventilation appears to Insufficient for size of the attic. Further review and repair recommended.
6. Not Inspected, Defective Insulation Type: Cellulose where visible on floor. - But visible under attic floor for inspection.
Vermin droppings are present in the attic. Possible bat droppings. Recommend remediation.
Recommend adding fixed insulation to the hatch and add a hatch gasket to prevent moist air from entering the attic.

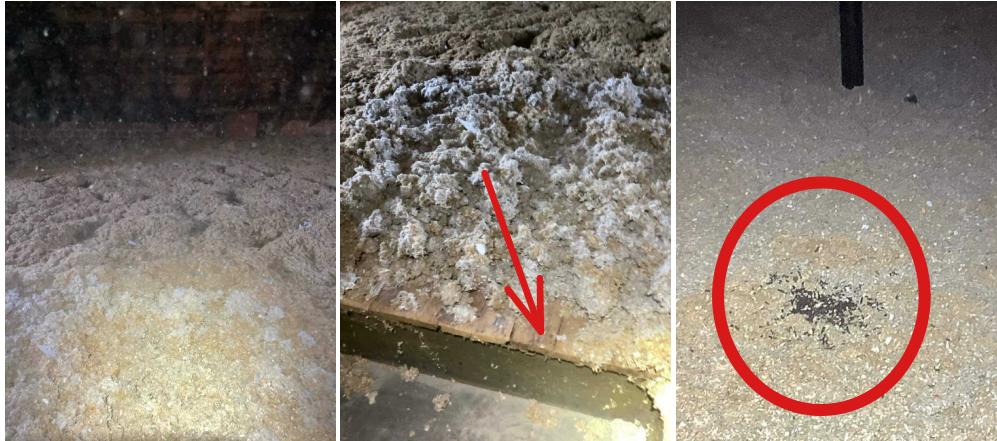
Vermin droppings are present in the attic. Possible bat droppings. Recommend remediation.

Recommend adding fixed insulation to the hatch and add a hatch gasket to prevent moist air from entering the attic.

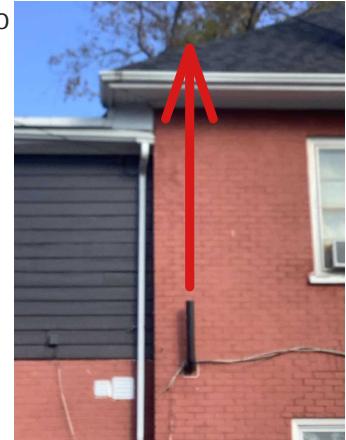
1. Main Roof Surface Material: Asphalt / fiberglass shingle, Rolled roof material - Recommend adding roof vents for improved attic ventilation.
2. Plumbing Vents: Plastic, Cast Iron - Recommend extending the plastic plumbing stack so that it protrude 6 inches above the roof line for improved ventilation.

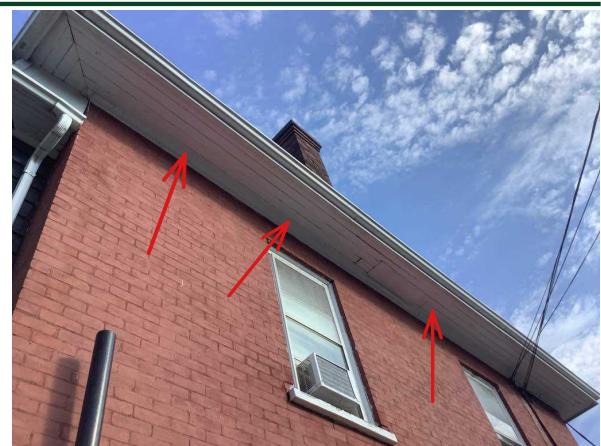
3. Fascia & Soffit: Wood, Metal - Wood soffit has no visible ventilation. Recommend installing if not present for improved attic ventilation. Wood soffit and fascia requires scraping and painting in areas for protection.

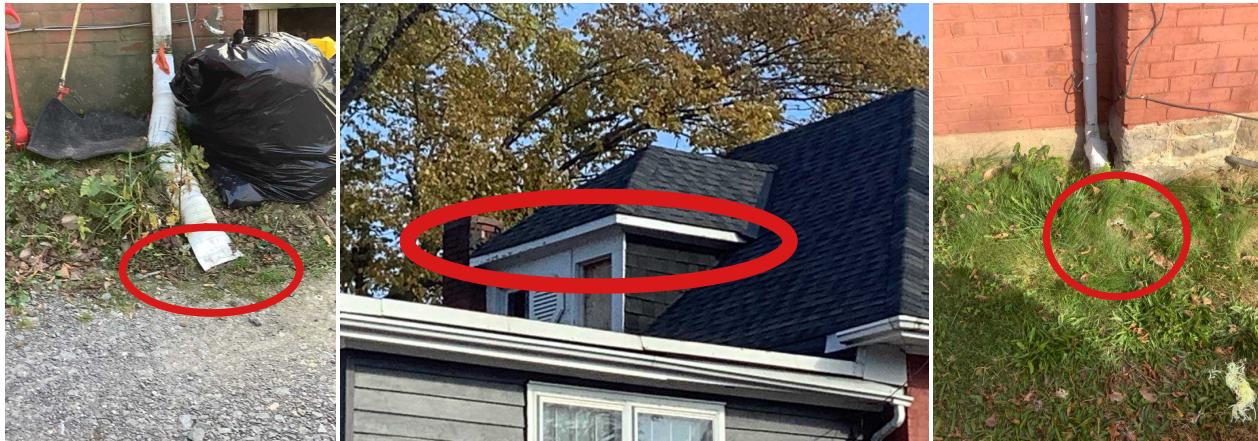
Eavestrough & Downspouts: (continued)

4. Eavestrough & Downspouts: Metal - Some downspouts discharge too close to house and/or garage. Recommend 5'-6' extension to keep the water away from the building. Recommend installing eavestrough and downspouts on all roof edges where they are not currently present to prevent discharge to a lower roof which can cause premature deterioration of the lower shingles.

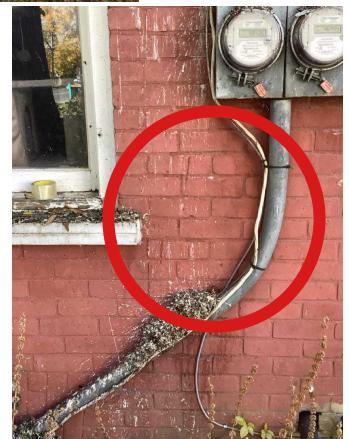
5. Exterior Electrical Outlets: None visible - Recommend installing GFCI outlets on the exterior.

Exposed wiring is present that could easily be damaged. Should be protected by a conduit or similar. Wiring also does not appear to be exterior rated.

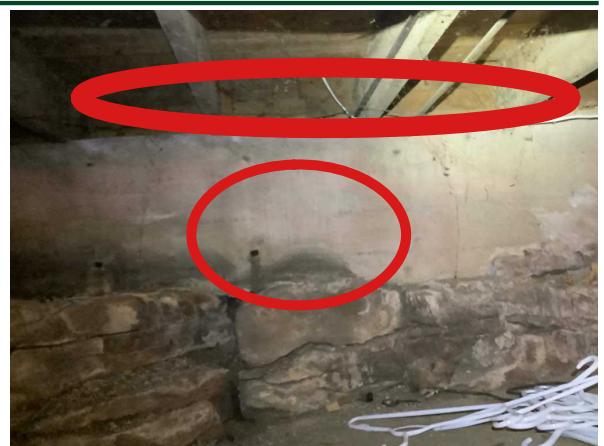
7. Downstairs Basement Insulation: None present - Recommend insulating all exterior basement foundation walls for improved thermal protection.

Recommend installing insulation and vapour barrier, where not present, in joist headers for improved thermal performance.

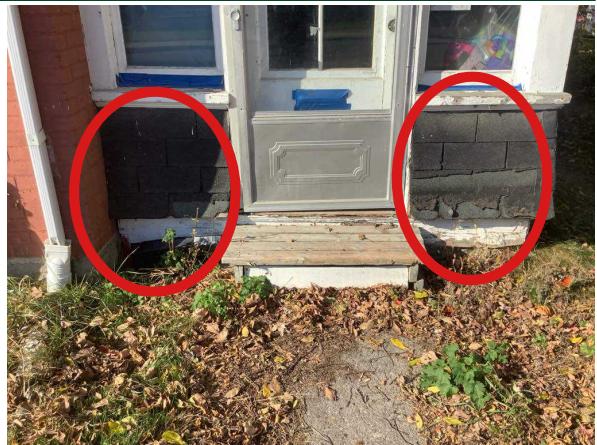
1. Exterior Surface type: Brick, Wood - Wood is rotting, shingles are deteriorated around the base of the covered entranceway. Requires repair.

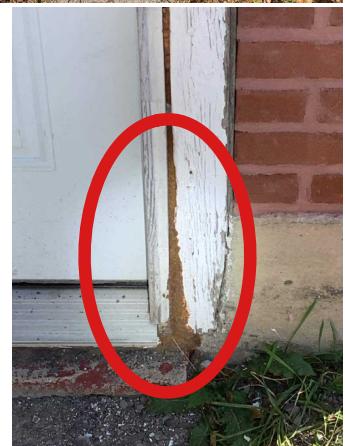
2. Entry Door: Metal - All gaps around the entry door should be caulked to prevent water and bug intrusion.
Spray foam should be replaced or covers with exterior rated material.

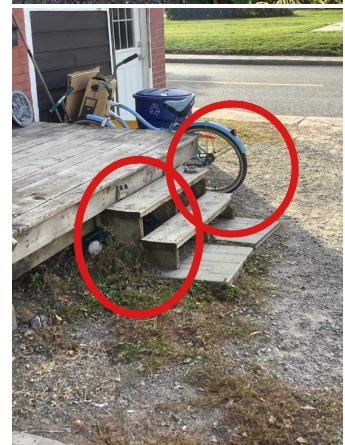
3. Entry Steps: Wood - Recommend installing guards on unit 2 steps for safety where not present.

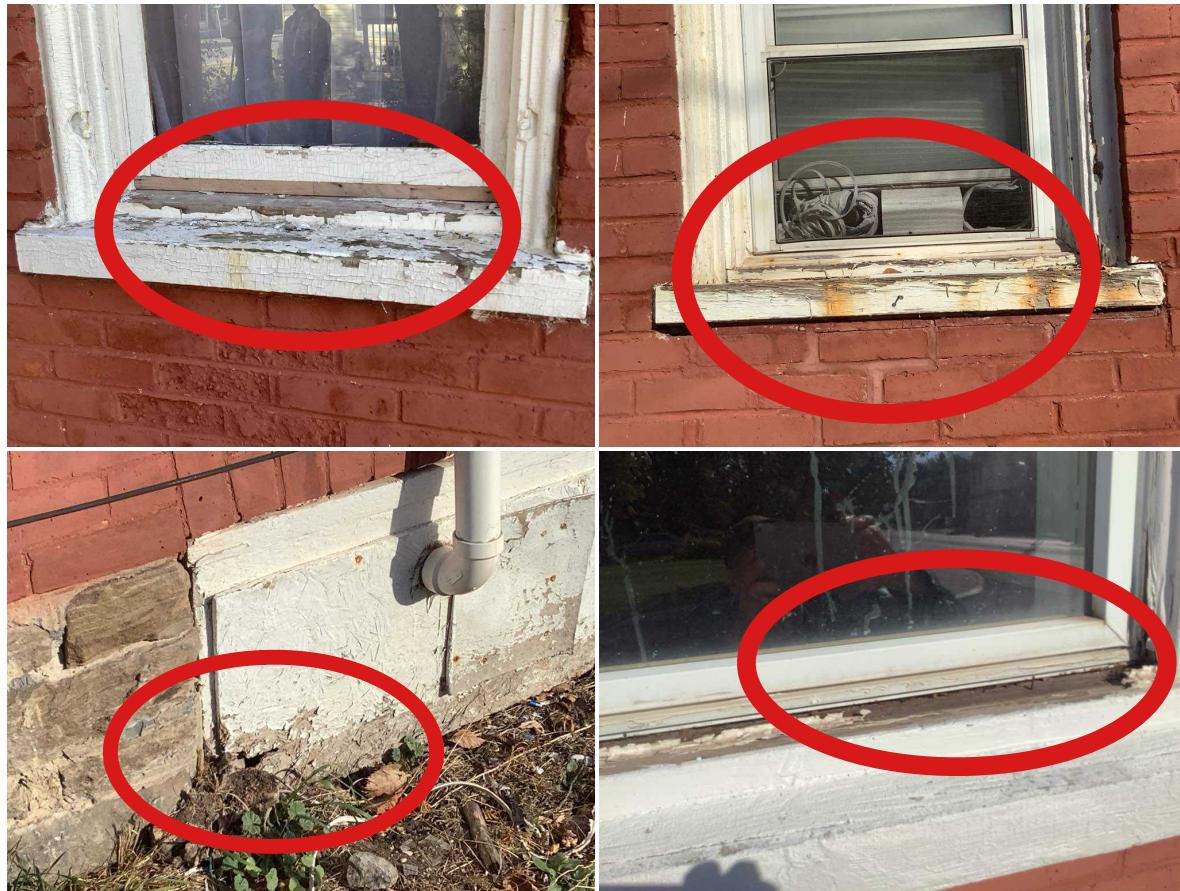
4. Windows: Wood, Single/Double Hung, Vinyl, Metal - Older wood windows are present and require scraping and painting in areas to protect the wood.
Older wood windows are present in areas and are rotting and deteriorating. Repair or replace soon is recommended.
Basement wood window covering is rotted and requires repair.
Window seal(s) have failed on some windows. Moisture and rust is noted between panes. Review and repair as required.
Recommend replacing caulking where caulking is cracked, old and/or missing. Caulking is a regular maintenance item.
Rear window missing allowing vermin intrusion. Nesting birds are present. Requires installation asap.
Recommend replacing spray foam sealant around windows with exterior rated sealant and/or flashing/trim.

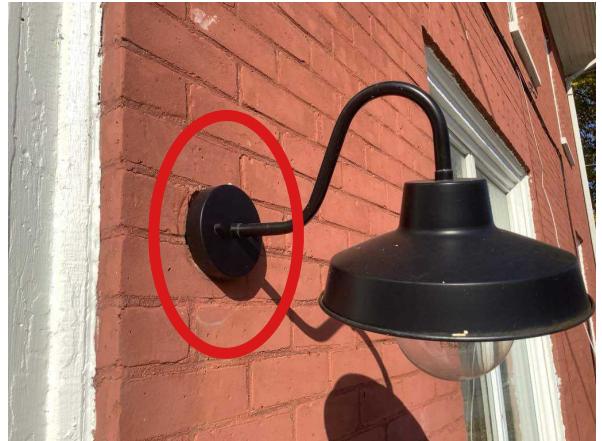
5. Exterior Lighting: Wall mounted - Some exterior lights are loose and should be tightened and caulked to prevent water infiltration.

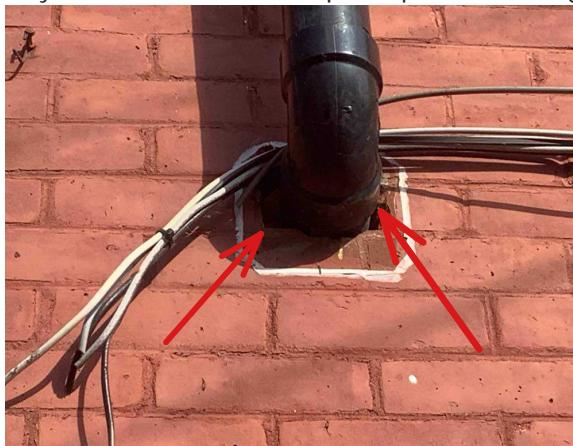
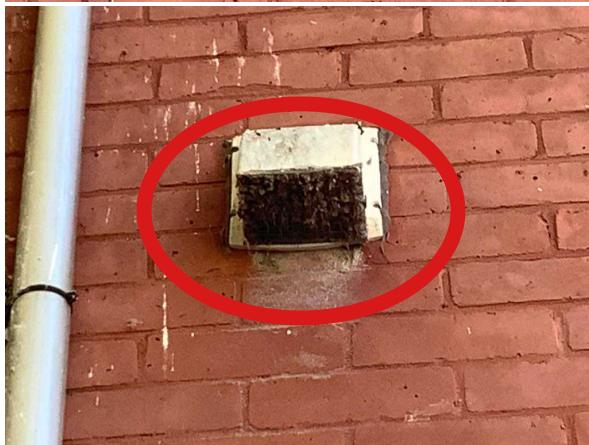
6. Vents Furnace, Bathroom vent(s), side plumbing stack , Hot water tank, Dryer - Side plumbing stack requires caulking to prevent water and vermin intrusion. Furnace and or HWR vents are less than 12 inches from the intake. Recommend adding an extension, Dryer vent has lint buildup. Requires cleaning.

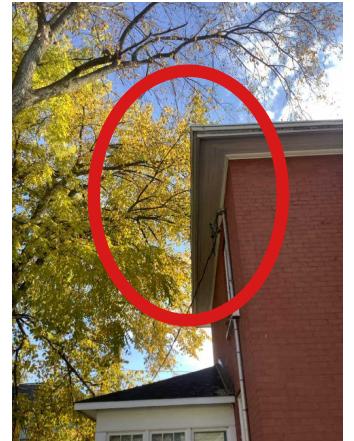
7. Greenery Trees - Trees / branches are close and overhanging the roof in areas - Recommend trimming back to prevent debris from accumulating on the roof and moss growing in the shade. Trees in proximity to the house could cause foundation problems with the roots. Review and repair as required. Occasionally removal is required.

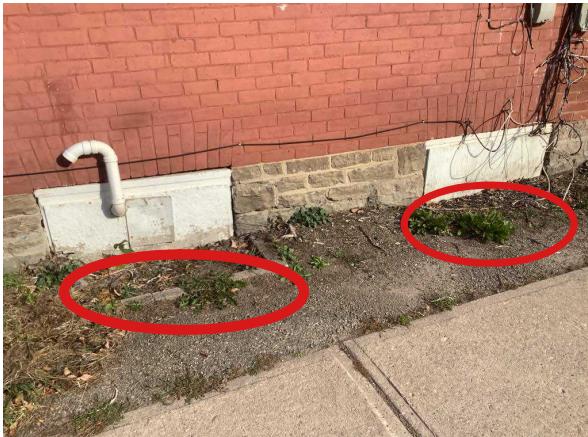
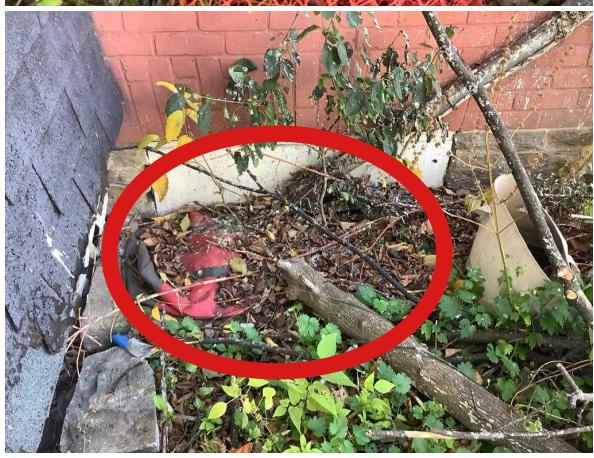
8. Window Wells: Concrete - Recommend 6" of clearance below the window to grade for improved drainage.

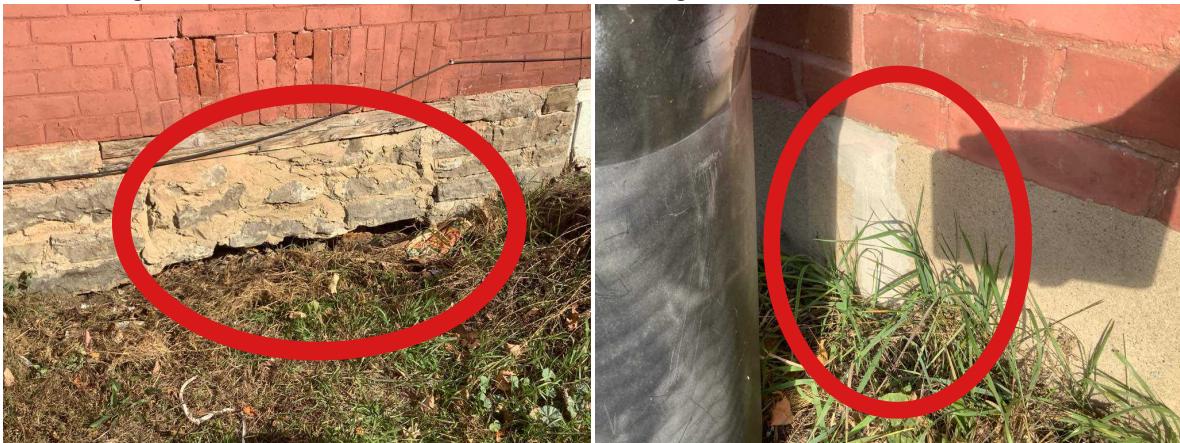
9. Foundation: Stone, Poured concrete - Recommend sealing all gaps in the foundation.

Some crack(s) have been repaired on the exterior. Full extent of crack not visible for inspection. Further review and monitoring is recommended. Monitor for future change.

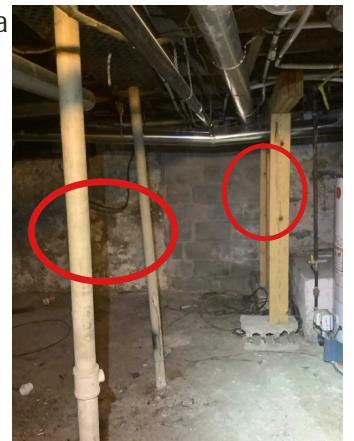
10. Columns Steel, Wood, Bricks - Temporary columns have been installed. Likely due to a sagging floor. Further review and repair recommended.

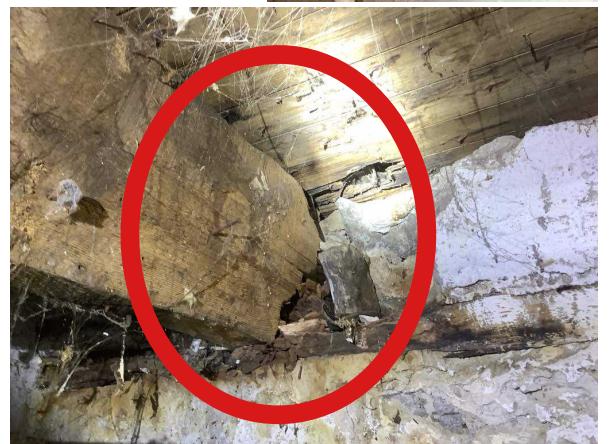
11. Joists Wood - Joist end is rotted and requires repair asap. (Left of HWT tanks)

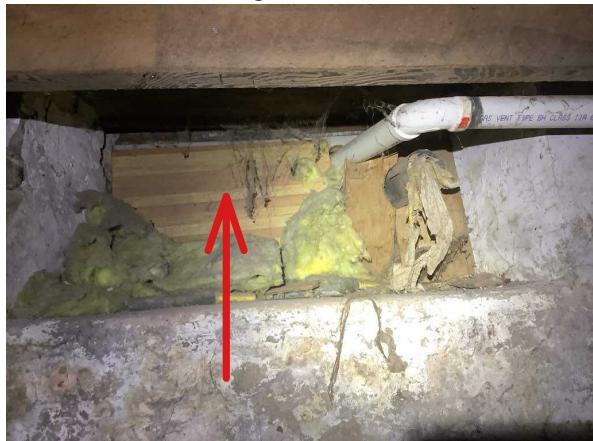
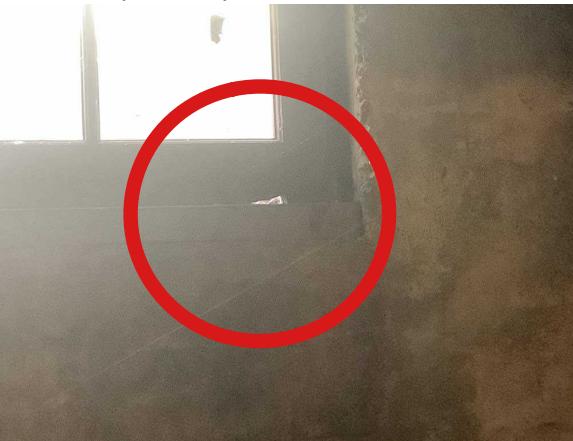
12. Downstairs Basement Windows: All sealed with wood. - Review all windows and window wells to ensure they are sealed properly and prevent water infiltration.
Holes around existing window allows vermin intrusion. Requires repair.

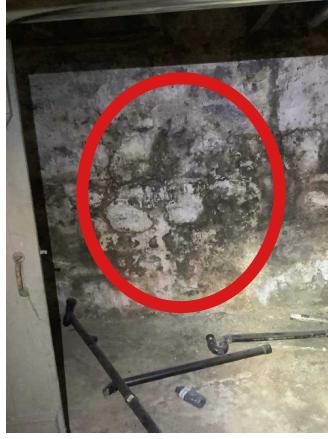
13. Downstairs Basement Moisture Location: Dampness and stains present - Stone foundation has moisture intrusion in areas and stains are present. Recommend improving exterior grade, eavestroughs and downspouts to keep water away from the exterior. Consider damp proofing the exterior.
Damp gravel/dirt floors are present in areas. Review and repair recommended.

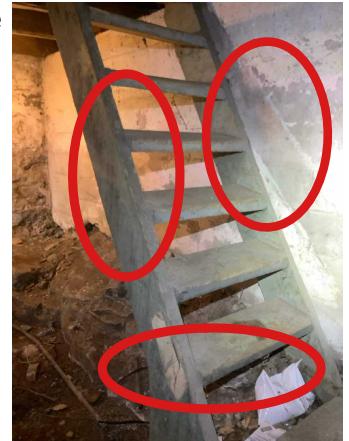
14. Downstairs Basement Stairs & Railings: Wood - Stairs are steep, not level, rotted at the bottom and are unsafe. Requires replacement for safety.
Guards and a handrail are required on the basement stairs for safety

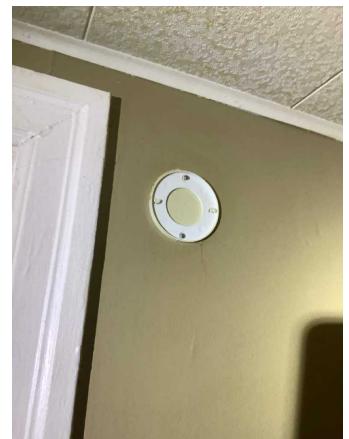
15. CO Detectors Unit 3, unit 1 - CO detectors are mandatory by all bedrooms and recommended by any CO source.
Install asap where not present. None present in unit 2
16. Smoke Detectors Unit 3, unit 1 - Smoke detectors are mandatory on all floors.
Recommend installing asap on all floors without one. None present in Unit 2.

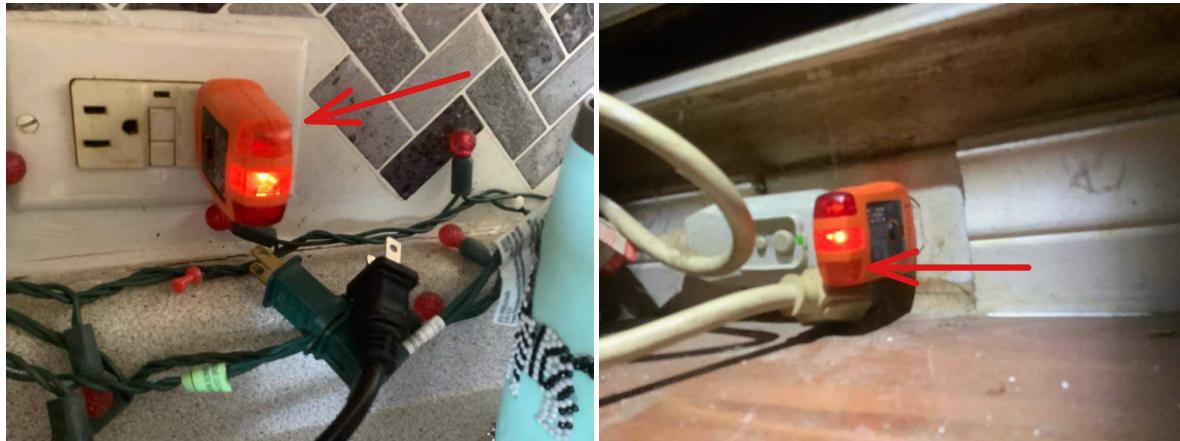
Outlets & Boxes (continued)

17. Outlets & Boxes Standard 3 prong - Some outlets are ungrounded in unit 2. Recommend review with an electrician and grounding for safety.

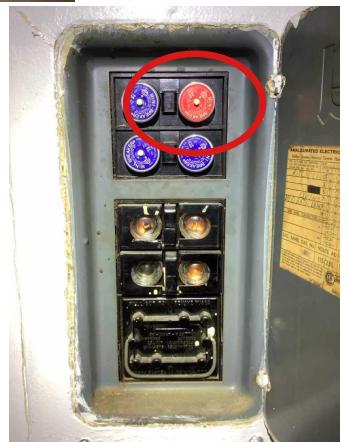
18. Basement Electric Panel Main Breaker/Fuse Size: 60amp x 3 - Fuse box present in unit
2. Recommend upgrading to a modern breaker panel.
Overfusing present. Red 20a fuse should be a blue 15a fuse.

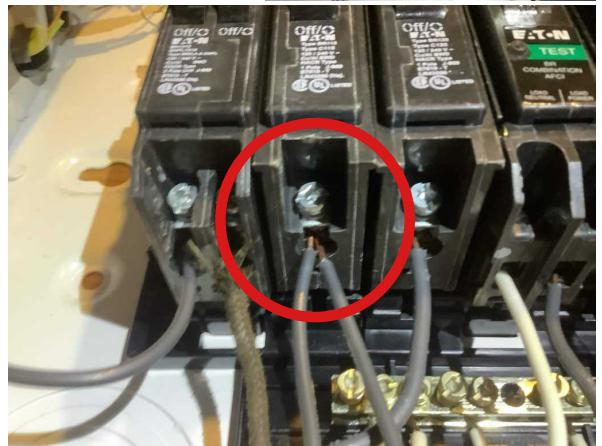
19. Basement Electric Panel Panel Wiring: Copper where visible -
Some double tap(s) are present. These circuits should be moved to
their own circuit breaker and should not share a breaker. It is
recommended that a qualified electrician inspect the new circuits
and properly connect the new circuits to an individual breaker(s) for
each circuit.

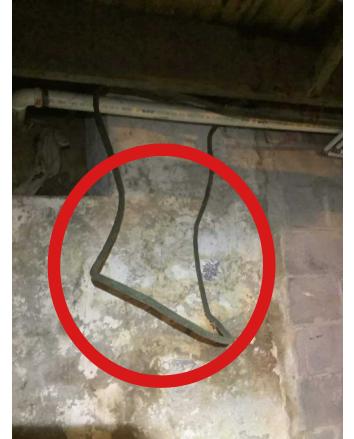
20. Basement Electric Panel Distribution Wiring: Copper where visible - Loose sloppy wiring is present in areas. Should be attached properly to walls or other surfaces. Recommend repair.

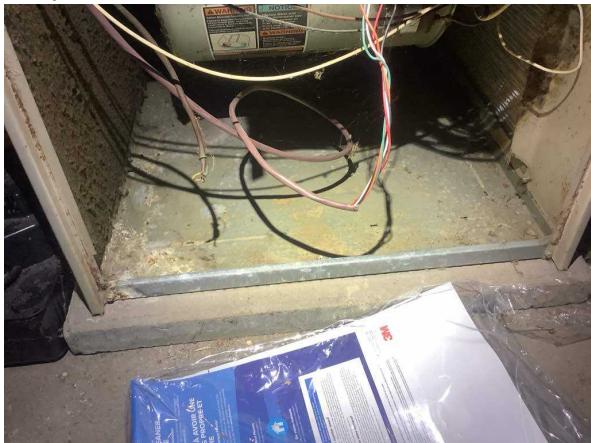
21. Basement Heating System Heating System Operation: Functional at time of inspection - Service annually - 2002 furnace is past the end of its average lifespan (average lifespan is 15-20 years). Plan for replacement very soon. Unit 2 has baseboard heaters. Heaters are old and deteriorated. Not mounted to the wall properly. Require repair or replacement.

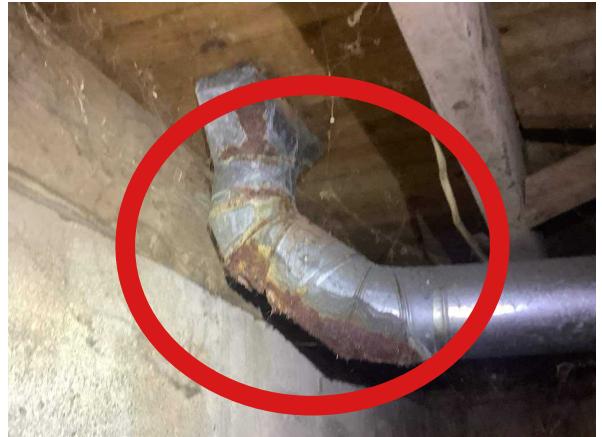
22. Basement Heating System Distribution: Metal ducting - Some ducts have rusted and require replacement t.

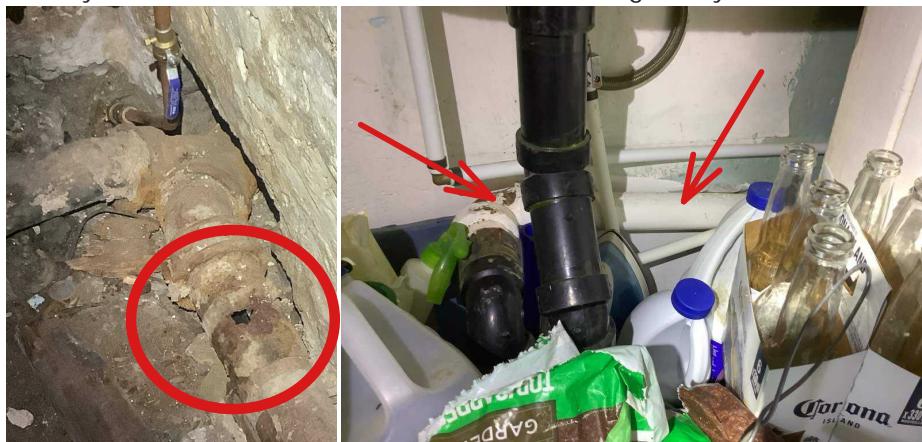
The main cast iron drain is rusted with a hole present. Sewage is visible. Requires immediate repair.

Galvanized drain pipes are present in areas. These pipes usually rust from the inside out eventually leaking. This is possibly an insurance issue. Recommend reviewing with your insurer and replacing pipes with modern piping.
