Building Inspection Report

100 Brockville Street
Smiths Falls, Ont

Prepared for: Fernando Gonzalez & Adam Barrieau

Prepared by: Ottawa Valley Home Inspections Ltd.
Ottawa, Ontario

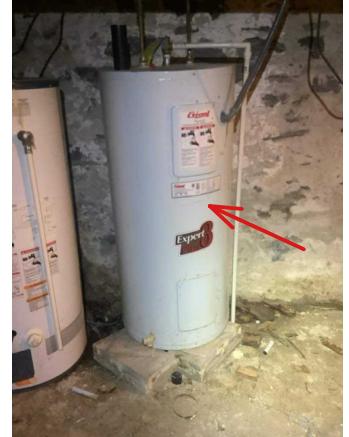
24. Basement x 3 Water Heater Water Heater: Functional at time of inspection - 2008
Giant tank is 16 years old and nearing the end of its average lifespan. Plan for replacement soon.

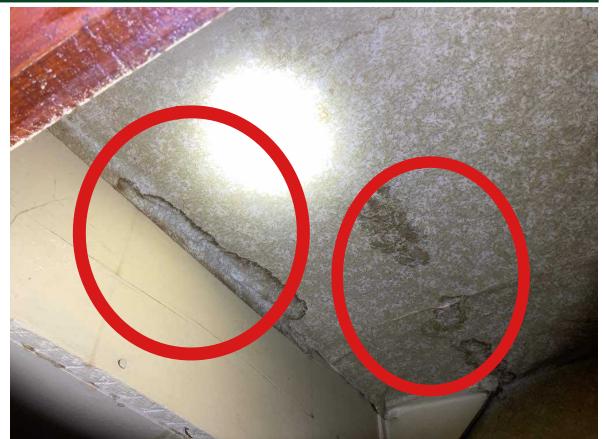
25. All units Living Space Ceilings & Walls: Painted drywall / plaster -
Some stains are present on the ceiling in the main floor closet in unit 3. Currently not showing signs of elevated moisture.
Recommend review and repair as required.

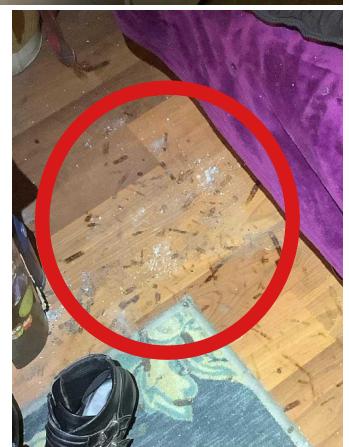
26. All units Living Space Floor: Hardwood / Softwood, Vinyl, Laminate,
Ceramic/slate/porcelain tile - Some floors are not level in areas. This is common on older buildings. Review and repair as required
Many burn marks on bedroom floor in unit 2. Flooring requires repair.

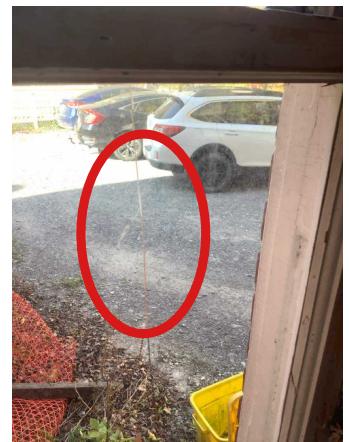
28. All units Living Space Windows: Wood, Single/Double Hung, Single and storm pane - Some single pane windows are present and not very thermally efficient in the winter. Review and upgrade as required.
Some windows are cracked in areas should be repaired.
Some windows are sticking and will not open/close. Recommend repair.
Older wood windows are present. Consider upgrading.
Older windows are present. Require scraping and painting for weather protection.
Recommend upgrading.
Some screens are missing. Recommend locating and installing.
